**Dante Fratta and Jose Pincheira
Department of Civil and Environmental Engineering
University of Wisconsin Madison**

WHRP 08-06

**EVALUATION OF FIBERGLASS WRAPPED
CONCRETE BRIDGE COLUMNS**

Final Report

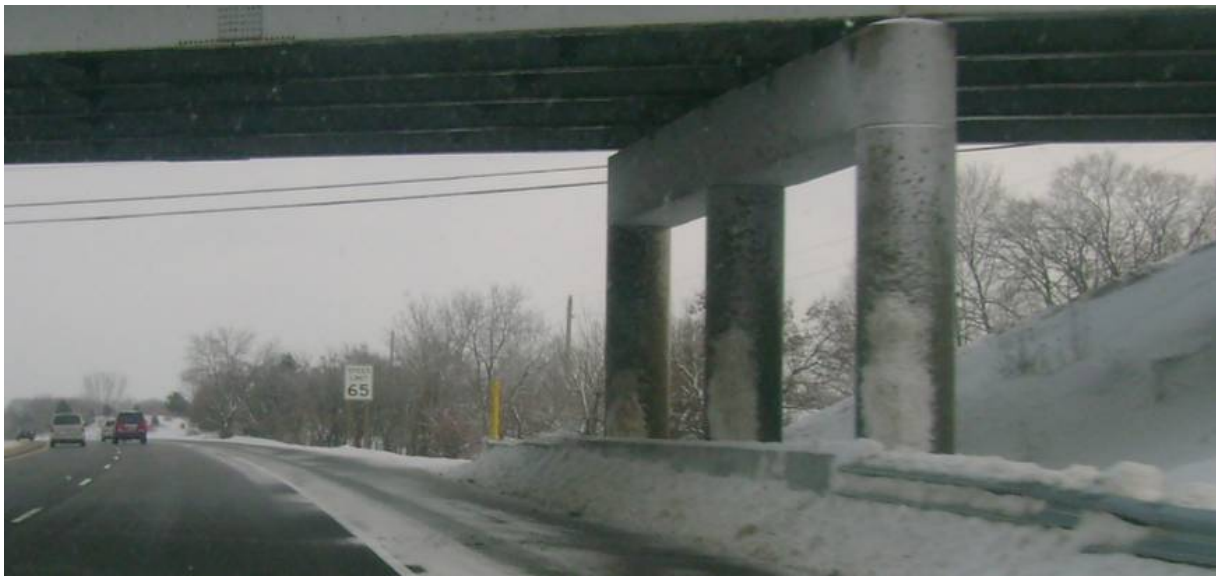
Figure 1.1: Snow and deicing solution splash on bridge columns (Interstate I-94 East bound – December 2008).

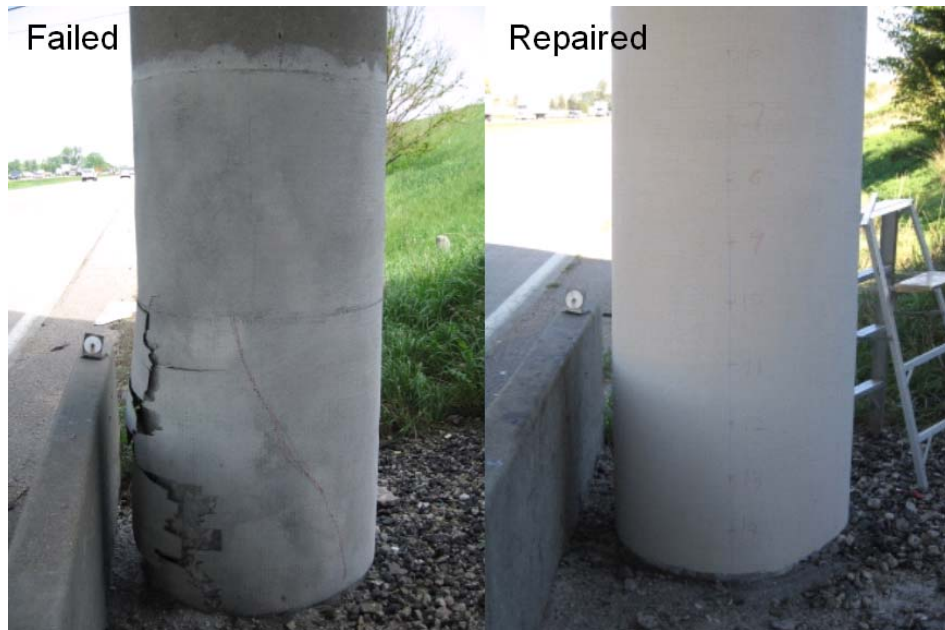
Figure 3.1: Evidence of corrosion activity in fiberglass wrapped column in bridge B-53-71 (I-39/90 under State highway 59). (a) May 2007 and (b) September 2007. After 10 years, WisDOT needed to re-wrap the column because corrosion continued under the fiberglass wrap.

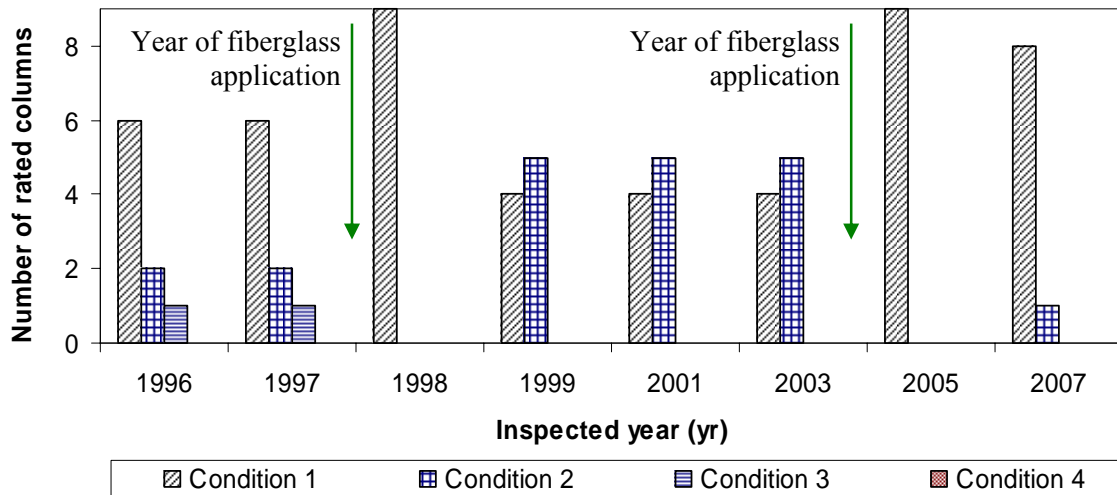
Year	Relevant inspection report comments
12/1996 ~ 4/1999	Columns G, H, and I have been repaired and look good. Columns A, B, and C have spalls and delaminated areas with exposed rusty rebar.
7/2001	Columns G, H, and I have been repaired and look good. Columns A, B, and C have spalls and delaminated areas with exposed rusty rebar. Delamination/spall at columns G, H and I (pier 1) and at columns A, B, and C (pier 3)
6/2003	Columns H and I have 2" by 2" spalls with exposed rebar. Column C has a 2" by 2" spalls with exposed rebar.
6/2005	Columns G and H have spalled areas repaired. Column C have spalled areas repaired Three columns are wrapped with fiber wrap.
6/2007	Vertical cracks in column G. Four columns are wrapped with fiber wrap. <i>Note: New fiberglass wrapping was applied column G after this research team initial visual survey.</i>

Figure 3.3: Timeline of inspected conditions of columns and maintenance operations in B-11-17 bridge (Condition rating definitions are summarized in Table 3.3).

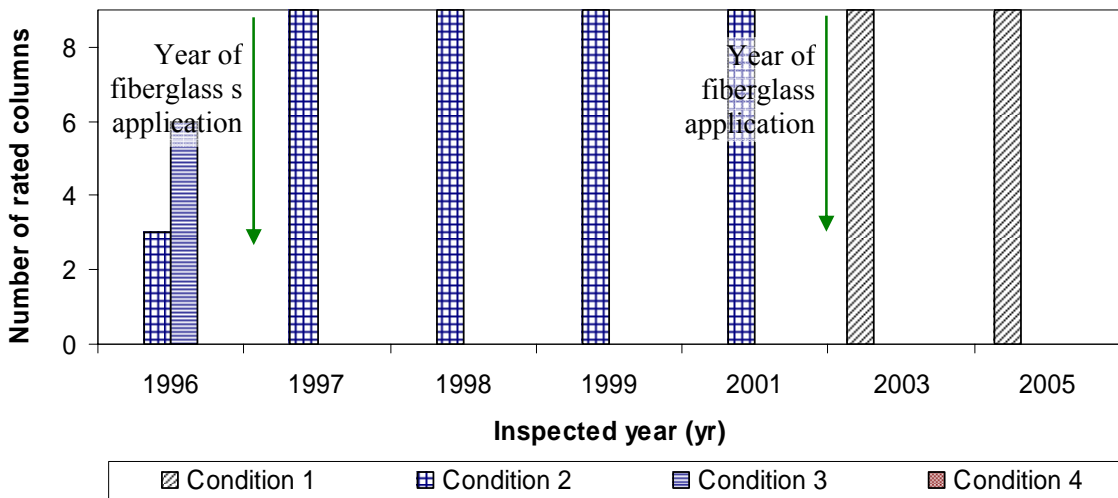
Year	Relevant inspection report comments
3/1996 ~ 11/2001	All columns are repaired and have fiber wraps on them (look good).
12/2003 ~ 12/2005	All columns have fiber wraps on them (sound solid).

Figure 3.5: Timeline of inspected conditions of columns and maintenance operations in the B-13-113 bridge (Condition rating definitions are summarized in Table 3.3).

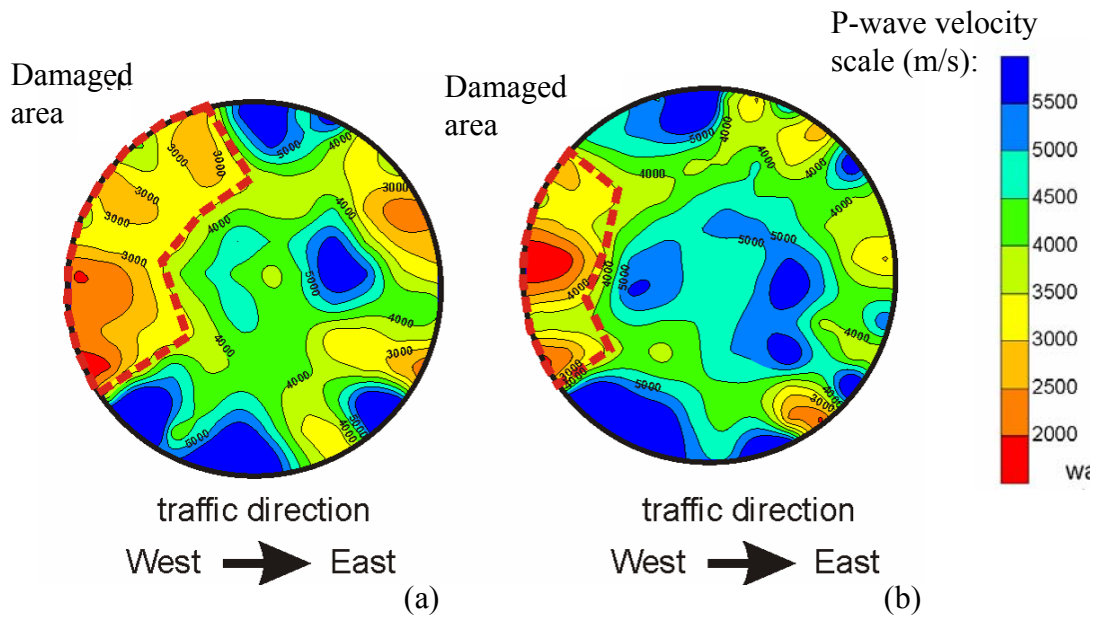
Figure 4.8: P-wave velocity tomographic images on Bridge B-28-45 column B: (a) Section at 0.8 m high (b) Section at 0.4 m high (The dashed line limits damaged areas).

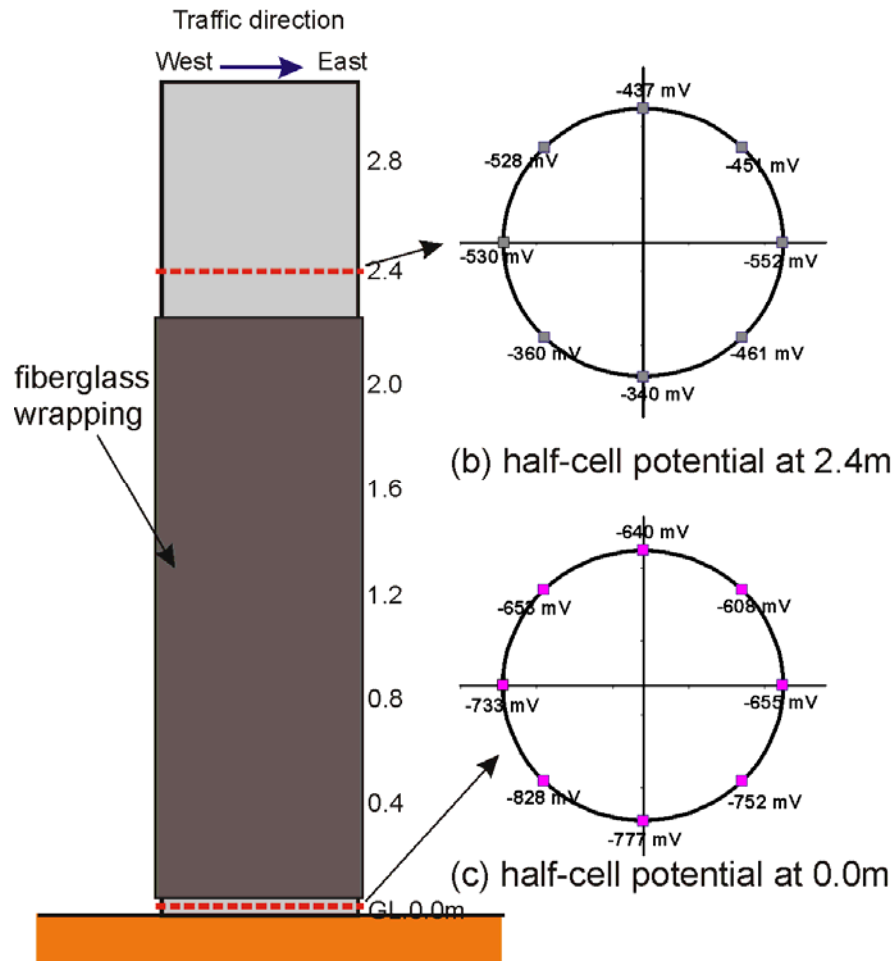
Figure 4.28: Half cell potential measurement in Bridge B-28-45 column A (fall 2007): (a) above wrap and (b) below wrap.

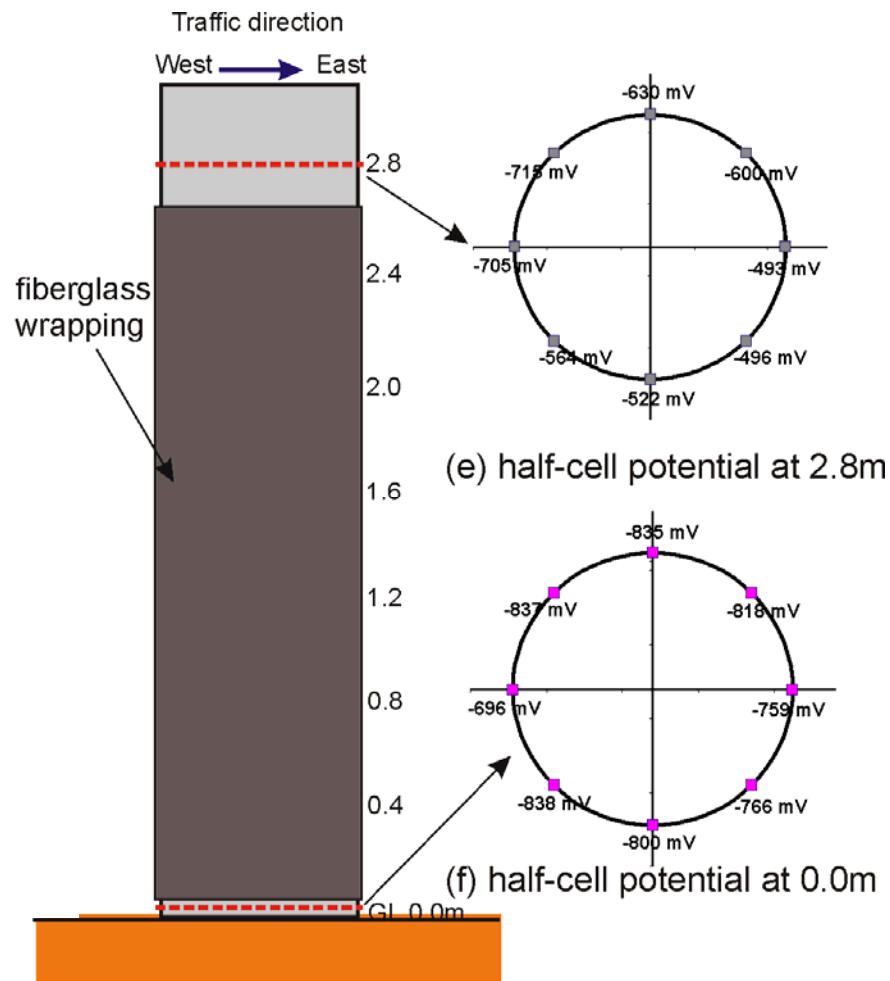
Figure 4.29: Half cell potential measurement in Bridge B-28-45 column B (fall 2007): (a) above wrap and (b) below wrap.

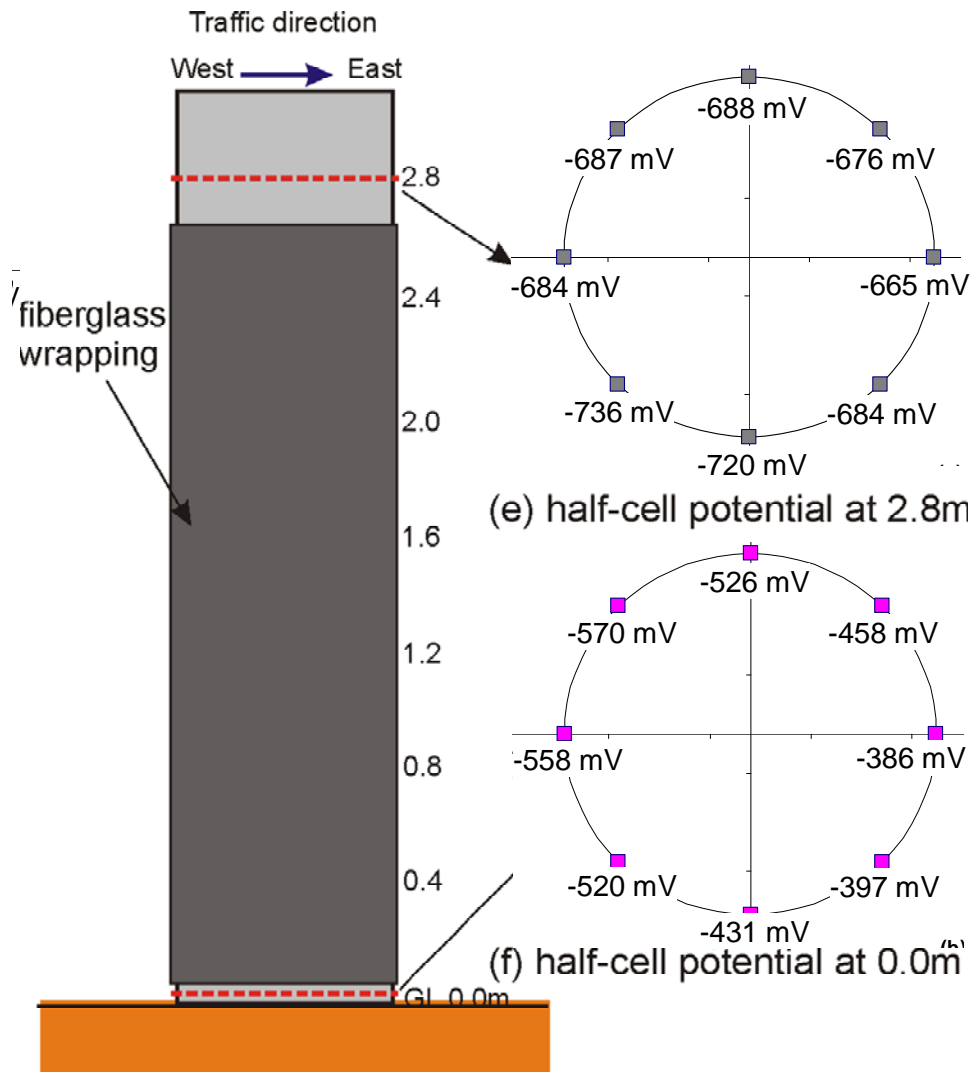
Figure 4.31: Half cell potential measurement in Bridge B-28-45 column B (summer 2008): (a) above wrap and (b) below wrap.

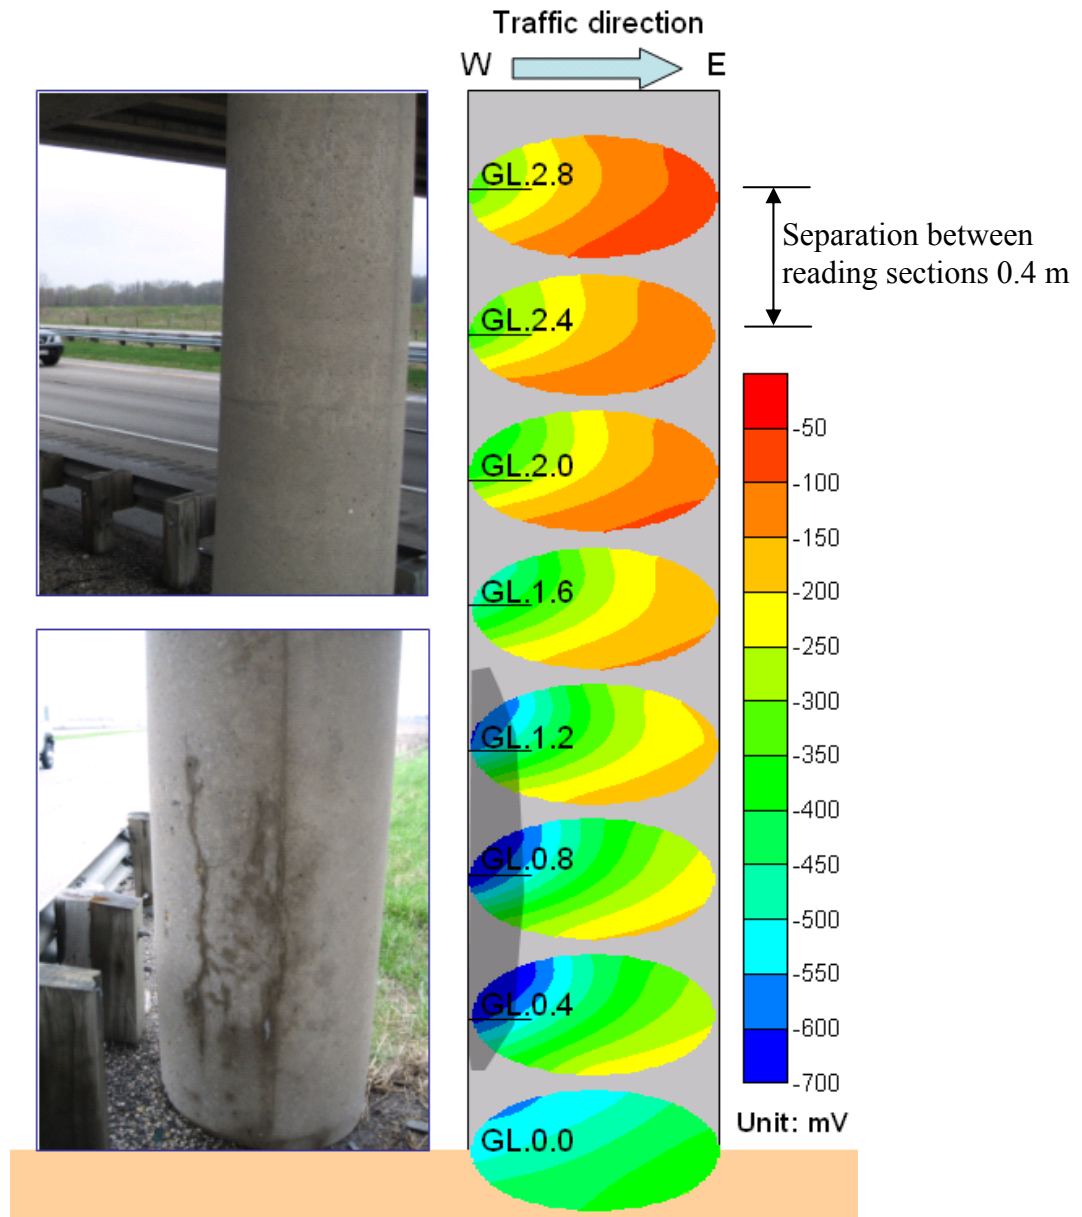
Figure 4.32: Half cell potential measurements in Bridge B-28-45 column C: View of the columns and half-cell potential measurement results (measurement at 0.2 m intervals above ground level - GL).

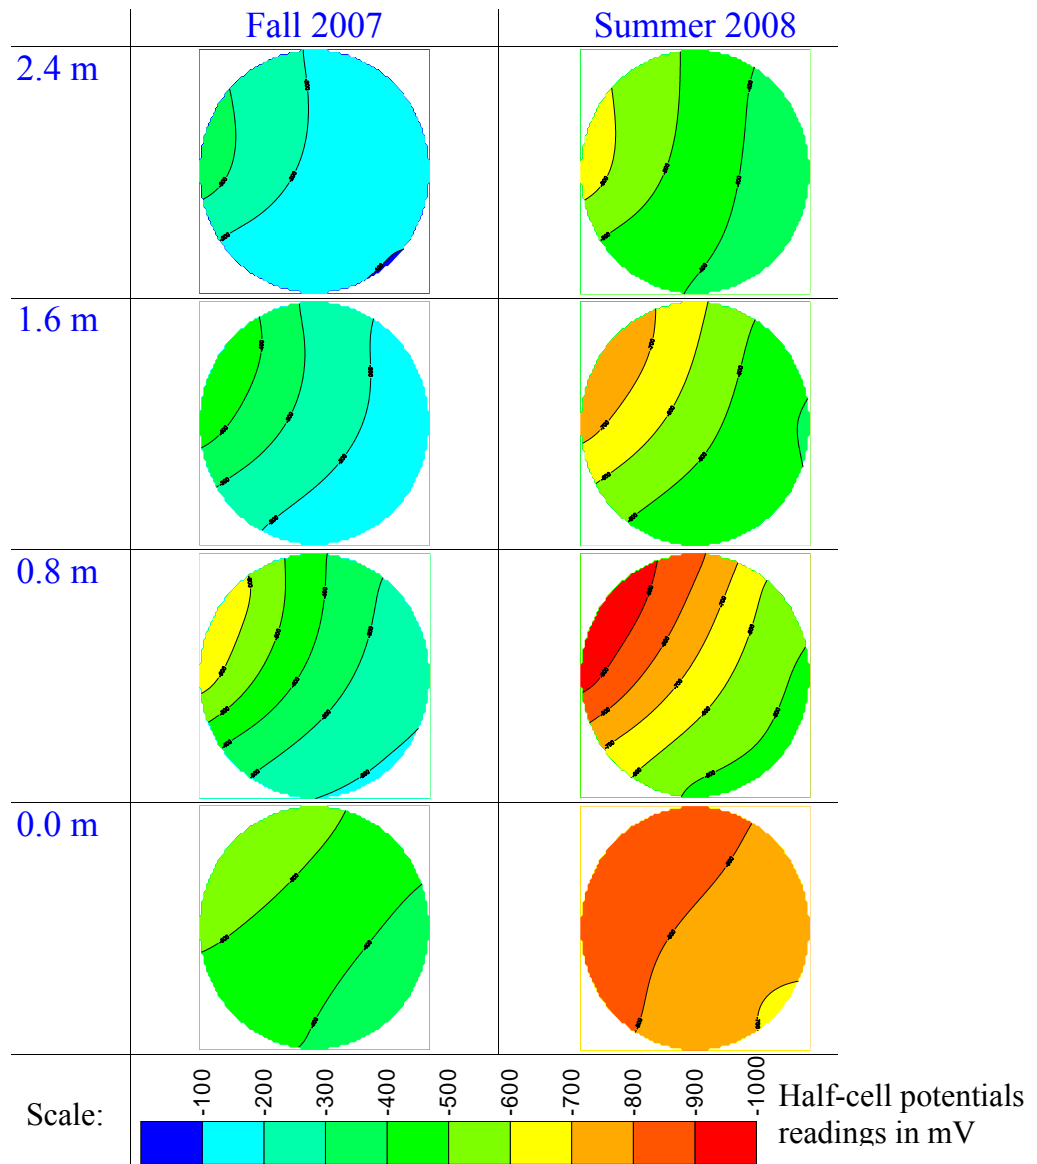
Figure 4.33: Half cell potential measurements in Bridge B-28-45 column C: Comparison of measurements collected on fall 2007 and summer 2008.

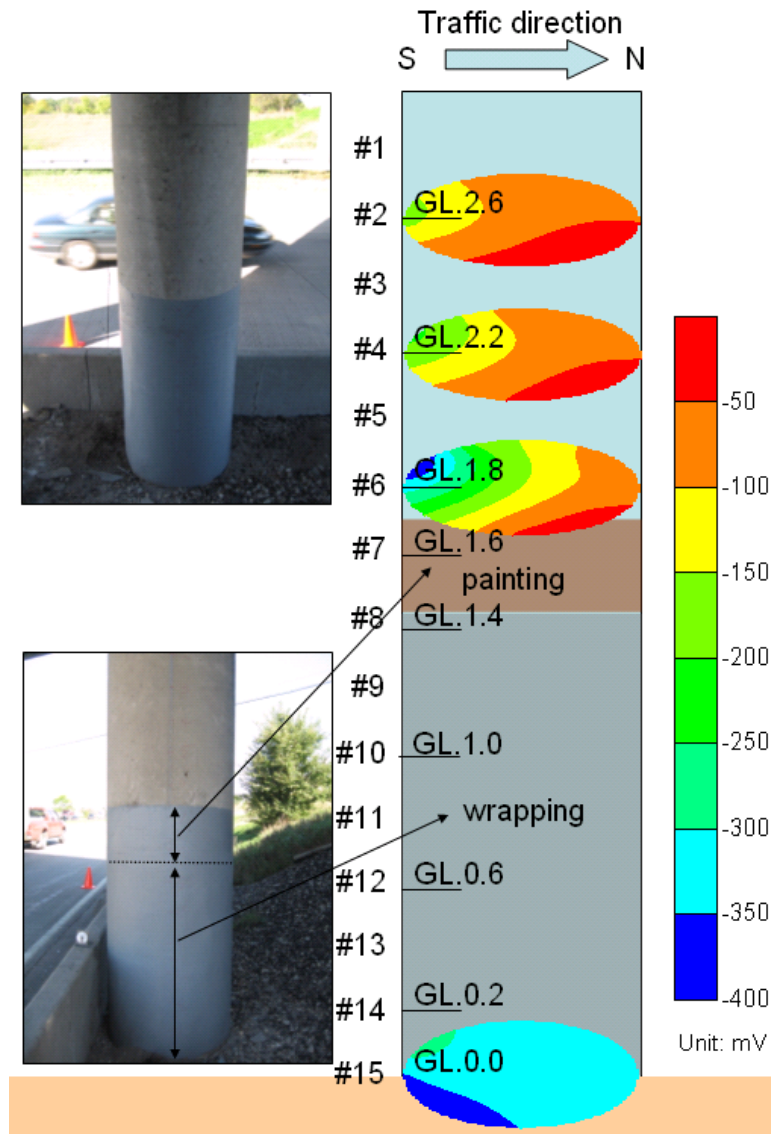
Figure 4.34: Half cell potential measurement in Bridge B-53-71 column B (fall 2007) at 0.2 m intervals above ground level (GL).

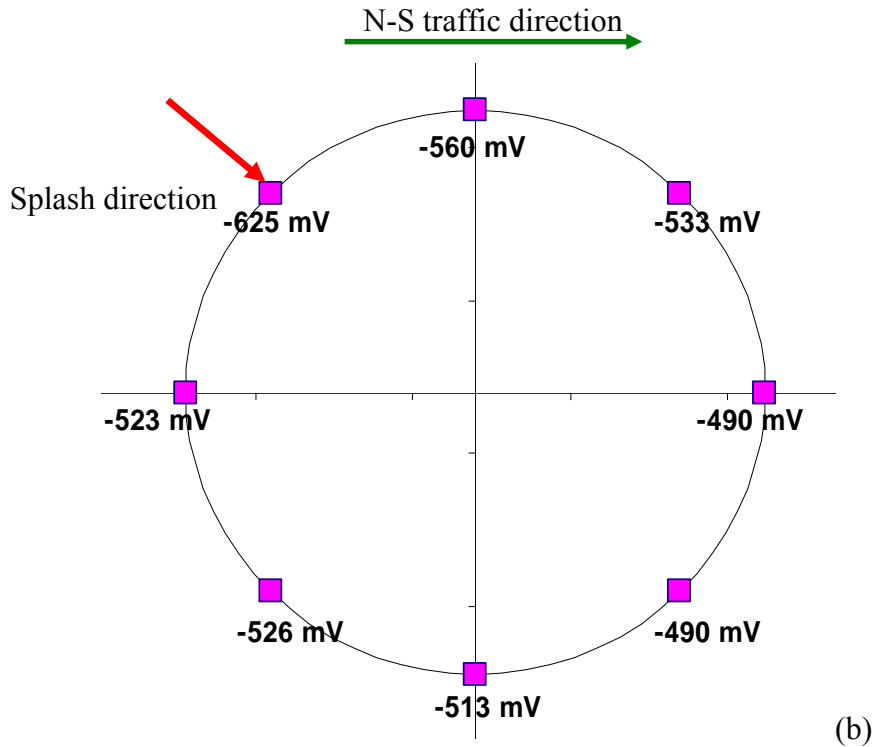
Figure 4.36: Half cell potential measurement in Bridge B-13-144 column G. Data collected just below the fiberglass wrap.
