## **Analysis of Concrete Pavement Joints to Predict the Onset of Distress**

SPR # 0092-05-05

WHRP 07-13

## ***FINAL REPORT***

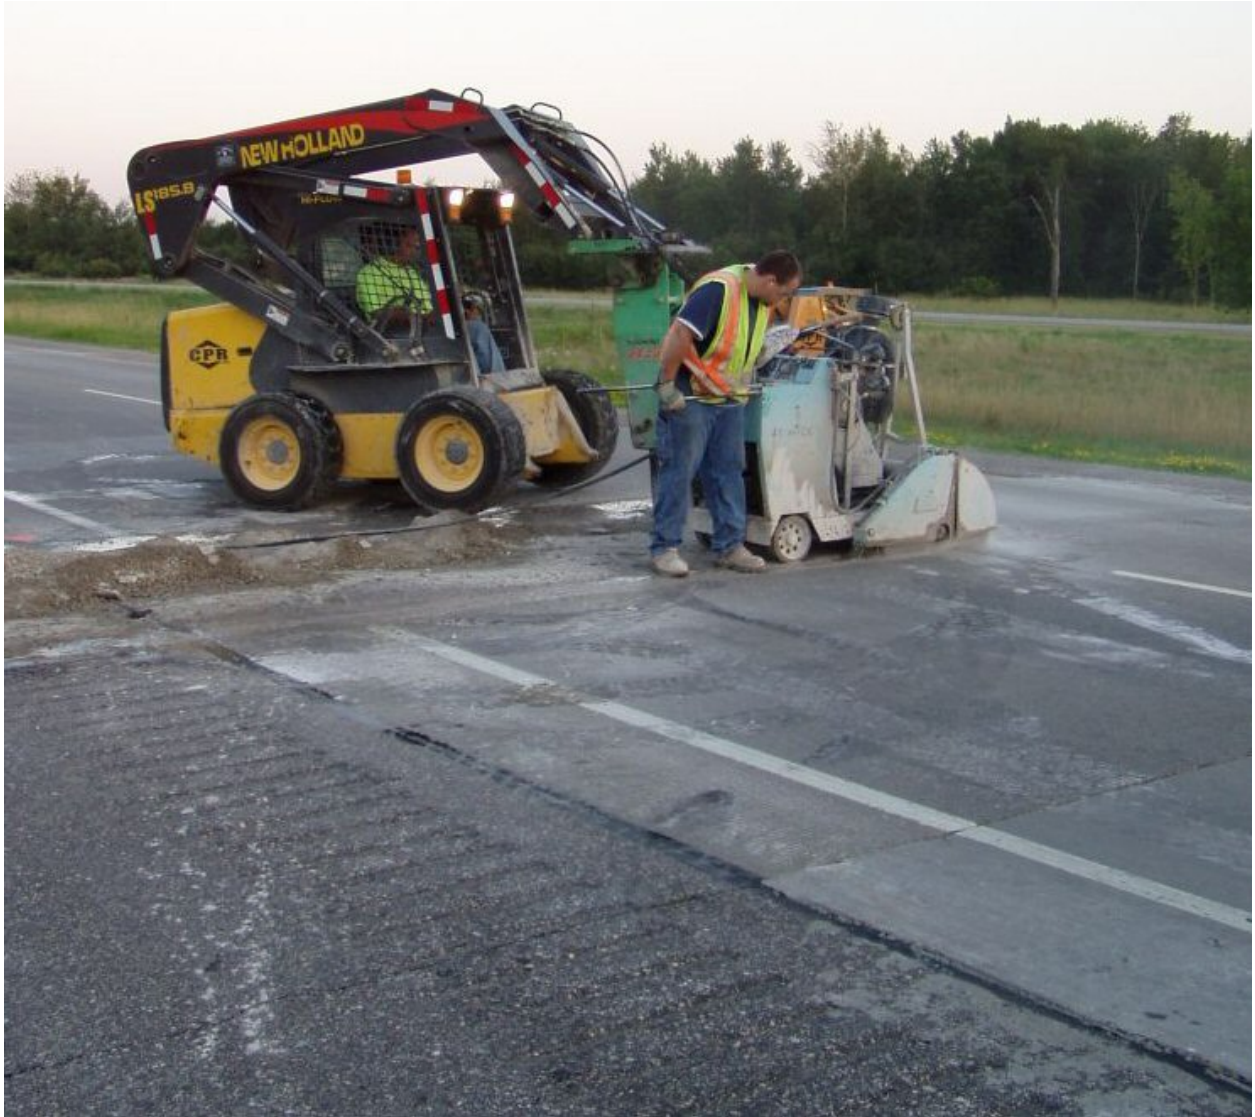
*Figure 1. Sawing on both sides of repair area (flanking distressed joint).*

1. Full-depth sawing of the existing pavement at approximately 5 ft. both upstream and downstream of the distressed joint. A third parallel sawcut is made within a few inches of the upstream cut in order to expedite removal of the edge of the repaired area.
2. A hydraulic hammer on a skid steer is used to chip out the corner of the slab within the narrow trench.
3. A concrete cutter is then lowered into the trench starting at the removed corner, and removes the remaining concrete within the trench.
4. A Slab Crab bucket attached to a large excavator then removes the slab pieces, depositing them into a series of end dump trailers for subsequent transportation to a designated landfill.
5. Once removed, the area is cleaned and dowels are drilled and inserted prior to placement of fast-track patching concrete.

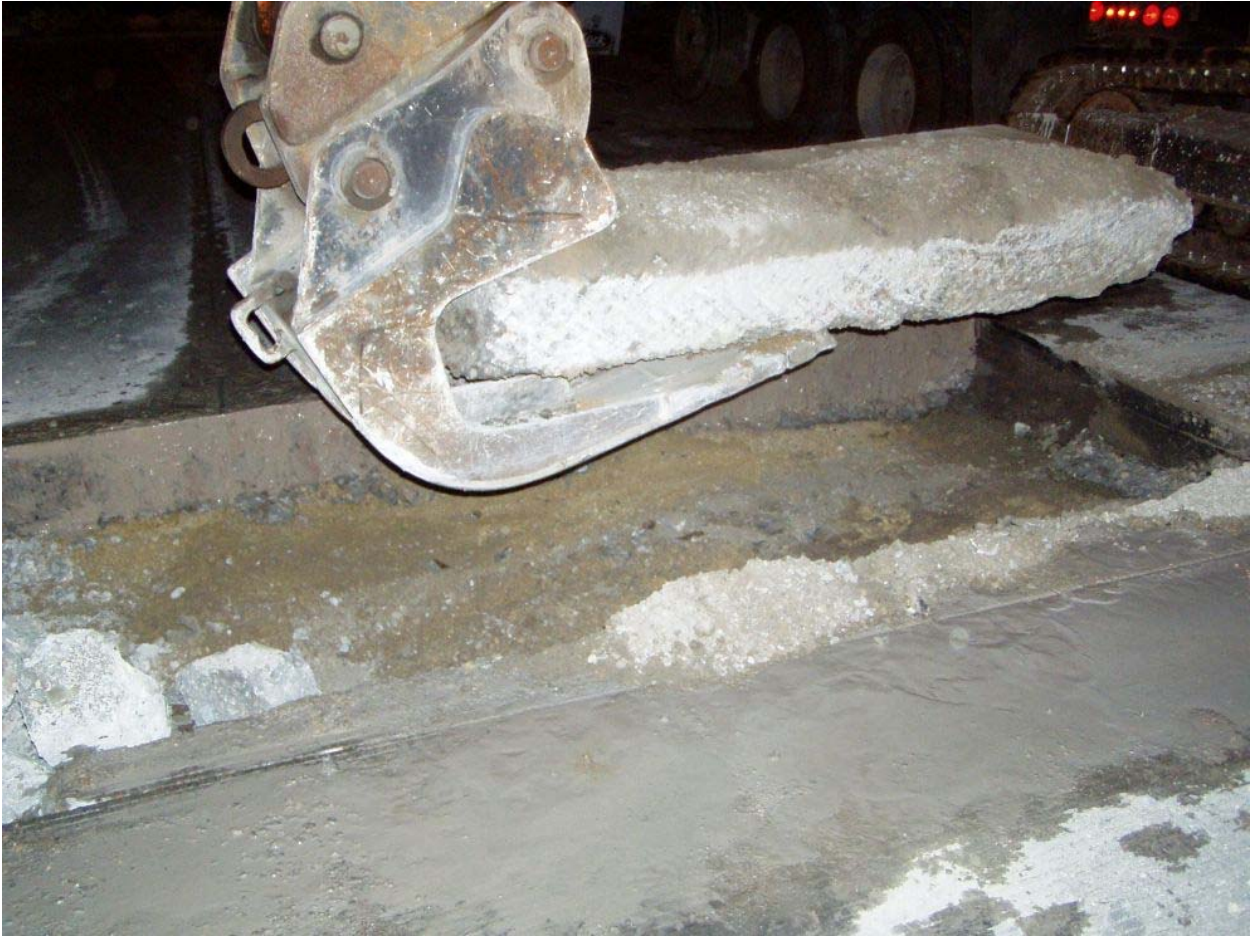
*Figure 4. Slab Crab bucket removing damaged concrete in repair area.*

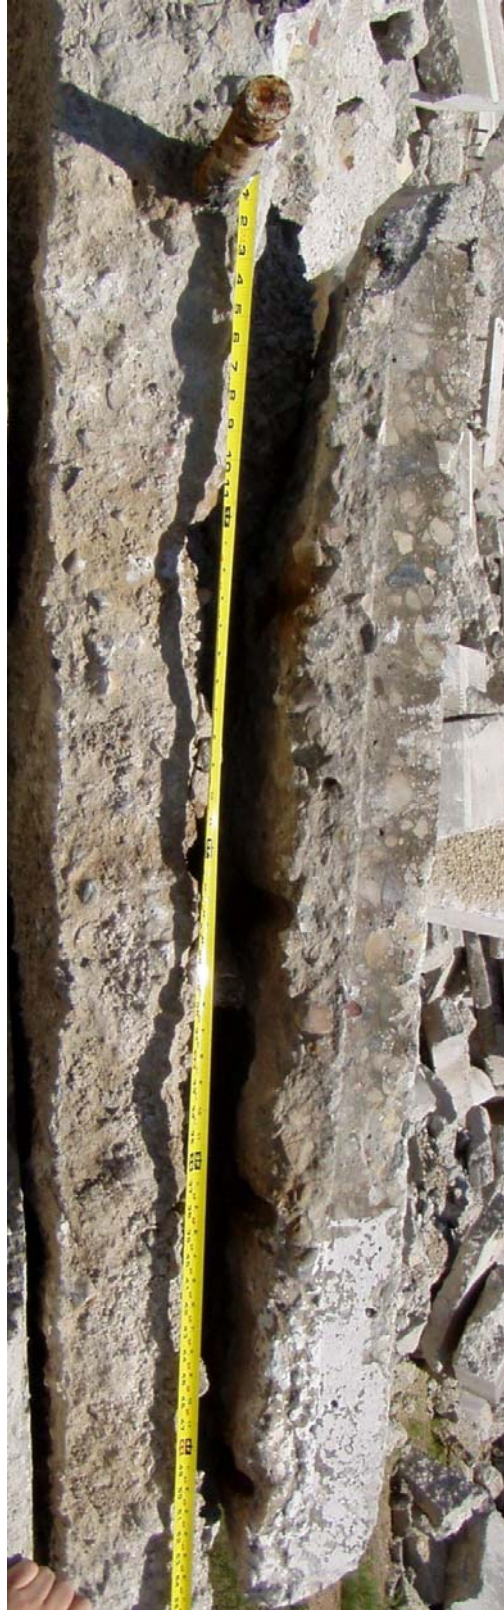
*Figure 11 Mid-depth delamination of slab extended from corner (bottom of photo) to approximately 5 ft. from edge (top of photo), before appearing as surface crack.*

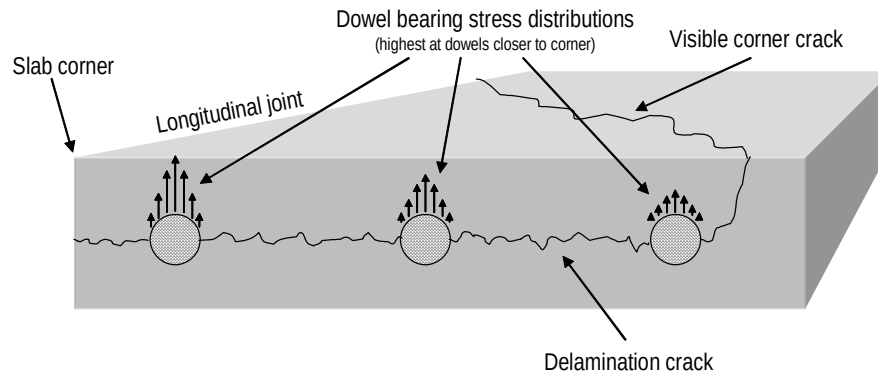
Figure 20 further illustrates how the curled slabs can induce stresses near the individual dowels. Due to the lack of biaxial rigidity of a slab near a corner, this effect will be especially pronounced at that location. Furthermore, traffic loading can compound this under certain configurations of curl and wheel load. As these stresses continue to increase, they will eventually initiate and propagate cracks in the horizontal direction. Illustrated in Figure 21, it can be seen that the stresses at the dowels decrease with distance from the longitudinal joint. At some point, the stresses that propagate the crack will be smaller than the strength, and under repeated loading cycles, the crack will instead turn upward and appear at the surface of the slab.

Figure 21. Corner cracking mechanism due to dowel bearing stresses.

The most typical distress observed on this pavement section is a form of delamination that is occurring at the dowel line at approximately mid slab. As illustrated in Figure 21, the distress would normally be hidden from view except that it is limited in lateral extent, and within 3 to 5 ft. from the corner, propagates upwards in the form of a corner crack.

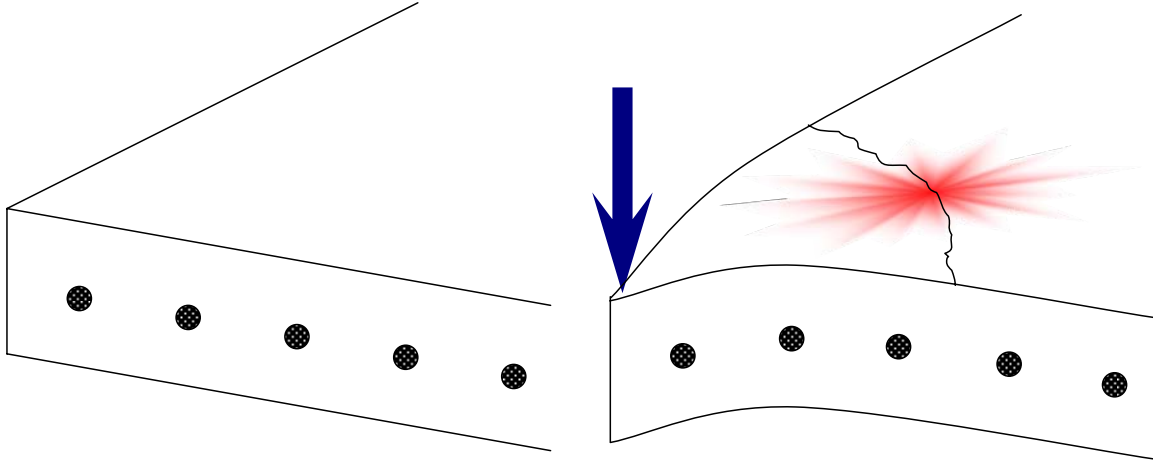
Manifestation of the corner cracking distress is illustrated in Figure 24. When an external (wheel) load is applied near the corner of a slab, stresses will develop in the top fibers of the slab. When high enough, these stresses will lead to cracking. This mode of distress is exacerbated by the delamination distress previously described. The development of corner cracking on thick slabs such as those nominally constructed on this pavement is rare. However, the effective slab thickness is approximately half of the nominal thickness due to the presence of the delamination. Furthermore, the presence of the tip of the horizontal crack at mid-depth led to a weakened plane that further promoted crack growth.

Figure 24. Illustration of corner cracking distress due to external loading.

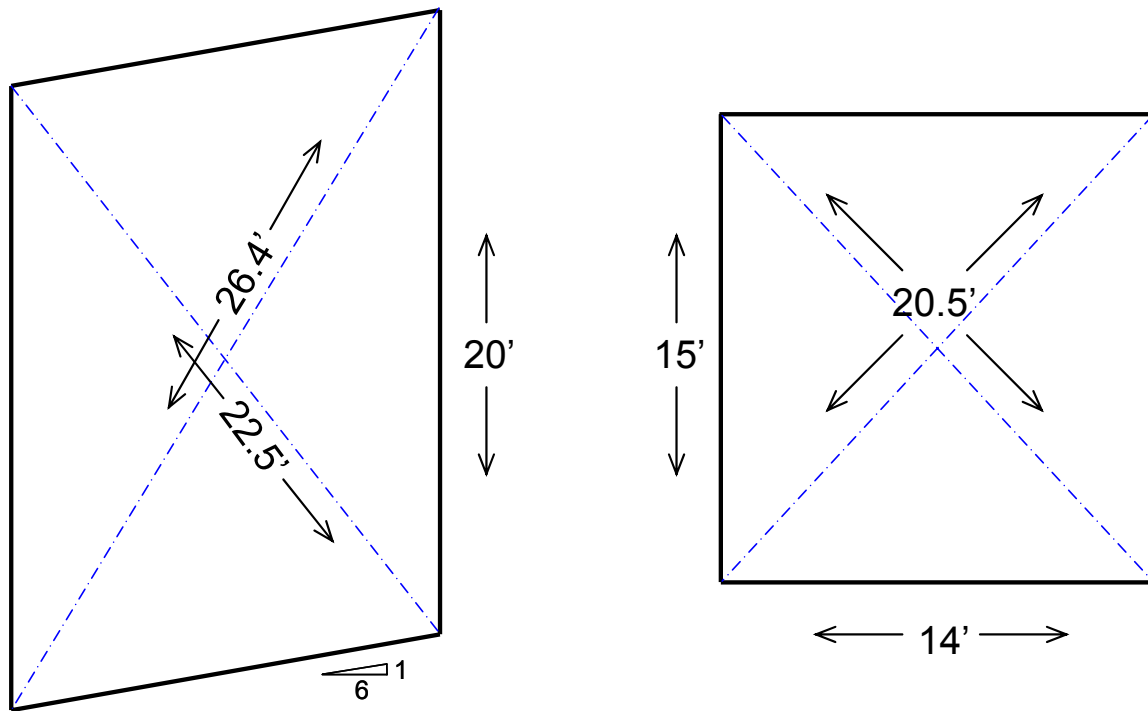
Lateral slab dimensions are a sensitive input to mid-panel cracking. The longer the effective dimensions, the higher the stress, and the greater the potential for a mid-panel crack. Figure 25 illustrates the dimensions of the extreme example from this pavement section to one that is more typical in JCP construction today. Due to the skewed joints, the effective length of the slab is not the same as the nominal length. As illustrated here, the extreme corner-to-corner dimension of a 20-ft. panel with skewed joints can be as long as 26.4 ft., which is 2 ft. longer than the same dimension for a slab with square joints, and nearly 6 ft. longer than a slab with a square joints

and a nominal slab length of 15 ft. The resulting increase in slab length can increase the mid-panel stresses due to curling/warping and subgrade drag. According to the FEM, a typical 5% increase in stress due to the presence of the skewed joint can be expected due to curling/warping restraint. This is illustrated in Figure 26. When subgrade drag theory is applied, an increase in slab length from 15 to 20 ft. can lead to a corresponding increase of stress of 40 to 50%.

Figure 25. Illustration of longer effective panel lengths due to nominal joint spacing compounded by skewed joints.

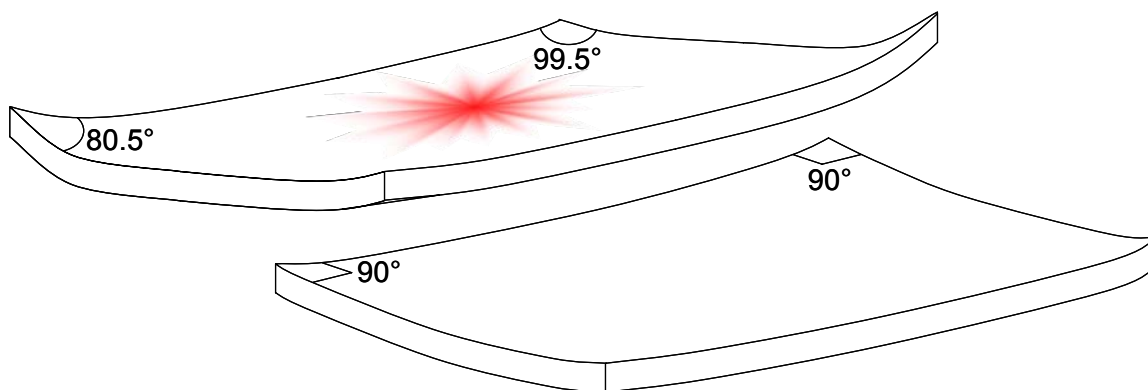
Figure 26. Illustration of higher center slab stress due to skewed joints.
