# AN ASSET MANAGEMENT APPROACH FOR DRAINAGE INFRASTRUCTURE AND CULVERTS

Project 06-08  
June 2008

Midwest Regional University Transportation Center  
College of Engineering  
Department of Civil and Environmental Engineering  
University of Wisconsin, Madison  
Wisconsin, Madison

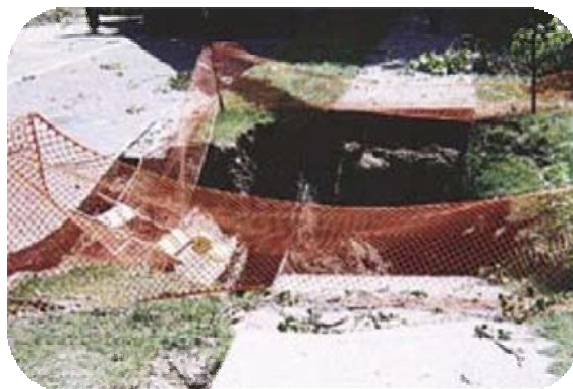
Figure 1.2: Culvert Failure in Muskegon, Michigan

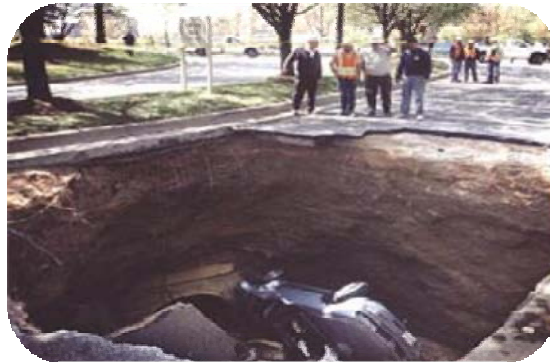
Figure 1.3: 84" Diameter CMP Failure in Maryland

- The failure of a 17 year old 84" diameter CMP culvert in Maryland resulted in the injury of two people, when their car fell into a 20' long by 30' wide by 20' deep sinkhole as shown in the Figure 1.3.

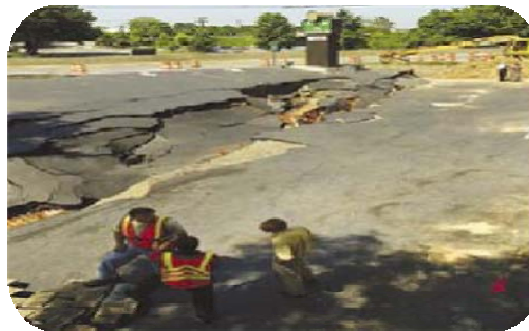
Figure 1.4: Failure of 126" diameter CMP in Charlotte, North Carolina

- The failure of a 20 year old, 126" diameter CMP in Charlotte, North Carolina resulted in a massive sinkhole as shown in Figure 1.4. The cost of replacement was approximately \$300,000.

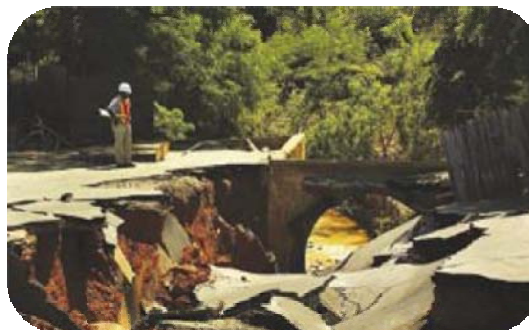
Figure 1.5: Failure of a 30 year old, 96" diameter CMP in Hickory, North Carolina

- The Failure of a 30 year old, 96" diameter CMP in Hickory, North Carolina resulted in the formation of a massive sinkhole as shown in Figure 1.5. The sinkhole affected the safety of US highway 70 and caused conflicts between property owner, city and NCDOT as a liability and responsibility for damages. The cost of repair was \$ 1.5 Million.

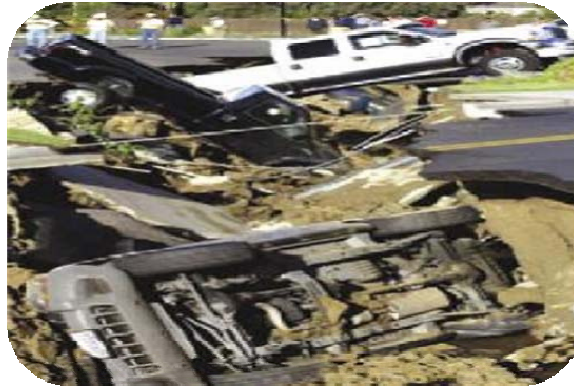
Figure 1.6: Failure of 30-Year Old CMP in Bakersfield, California

- The failure of a 30 year old CMP in Downtown, Bakersfield, California as shown in Figure 1.6, created lot of problems and precipitated the road crossings by the city. As a result of the following incident, CMP is no longer permitted in California.

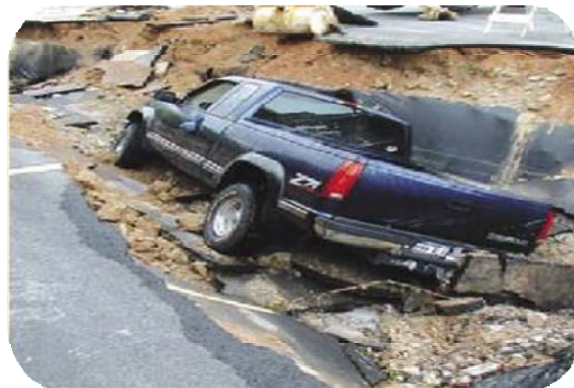
Figure 1.7: Failure of a 30-Year Old, 96" CMP in West Bountiful, Utah

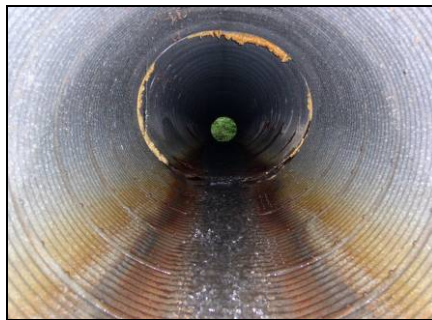
*Corrosion* – Corrosion is the destruction of pipe materials by chemical action. Metal culverts or reinforcements in concrete pipes are attacked by corrosion as the process of returning metals to their native state of oxides or salts. Figure 2.12 shows corrosion in metal culvert. *Chemical corrosion* of culverts may occur in the presence of soils and water containing acids, alkalis, dissolved salts, and organic industrial wastes. Sulfates, carbonates, and chlorides degrade concrete which is a process often accelerated in regions where freeze-thaw cycles leave the material open to deeper penetration by the offending elements. *Electrochemical corrosion* of metal culverts may occur due to the presence of water or some other liquid to act as an electrolyte, as well as materials acting as an anode, cathode, and conductor. As electrons move from anode to cathode, metal ions are released into solution, with characteristic pitting at the anode. The culvert will act as both anode and cathode forming an electrolytic cell around the material. Figure 2.12 shows a similar type of corrosion in culvert.

Figure 2.12: Corrosion in Culverts

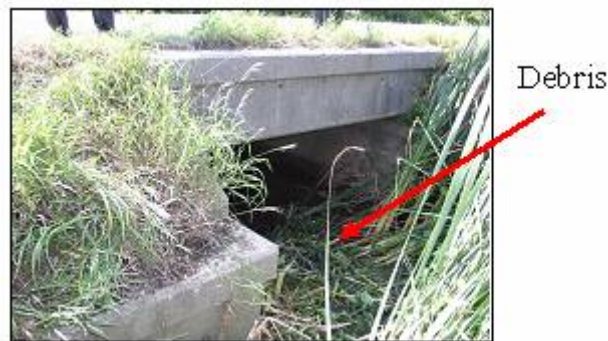
Figure 2.13: Debris at the Opening of the Culvert

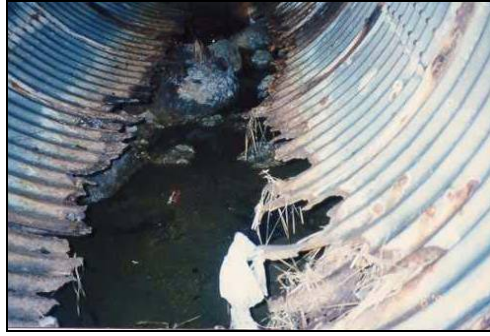
*Bed load* – Bed load is the main cause for abrasion. Figure 2.14 shows abrasion in culvert. Critical factors in evaluating bed load potential are the size, shape, and hardness of the bed load material, and the velocity and frequency of flow in the culvert. Flow velocities greater than 4.5 m/sec that carry a bed load are considered very abrasive. Steel culverts are most susceptible to the dual action of abrasion and corrosion when they are exposed to low resistivity and/or low pH environments, which shorten their service life.

Figure 2.14: Deterioration due to Abrasion (Caltrans, 2003)

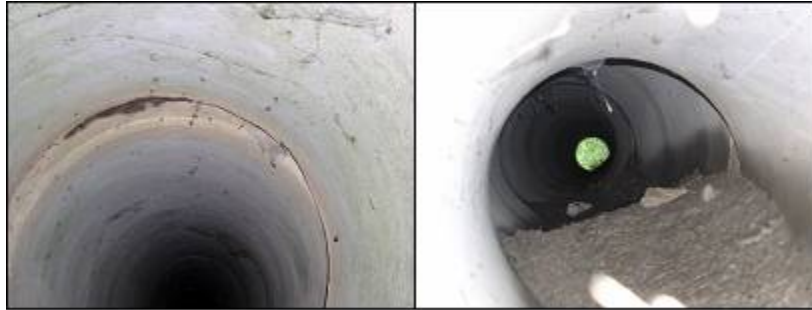
Figure 2.15: Culvert Pipe showing Cracks and Joint Separation

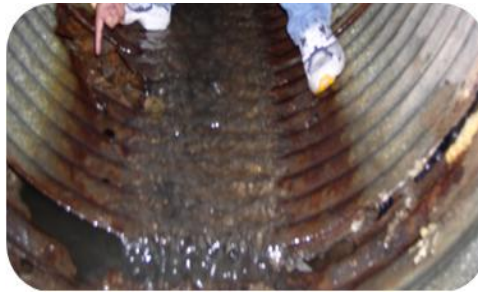
Figure 9.1: Big Hole and Corrosion in the Invert of the Culvert 25001273A01

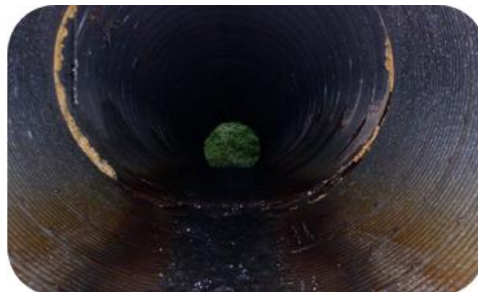
Figure 9.2: Misalignment of the Culvert 25001273A01

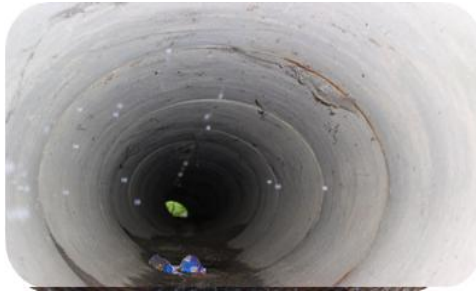
Figure 9.3: Misalignment of the Culvert

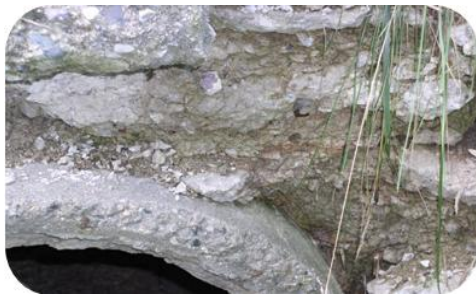
Figure 9.4: Failure of the Headwall due to Heavy Spalling

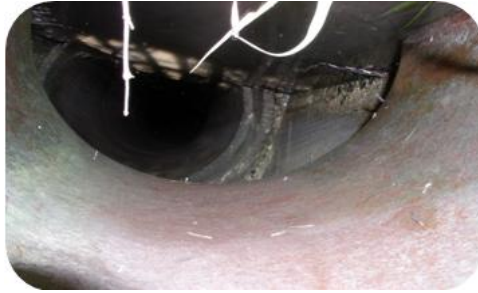
Figure 9.5: Significant Misalignment of the Culvert Structure

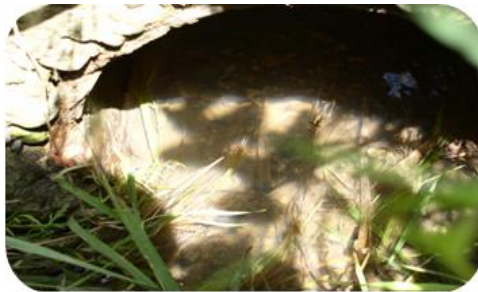
Figure 9.6: Vegetation and Heavy Spalling in the Headwall

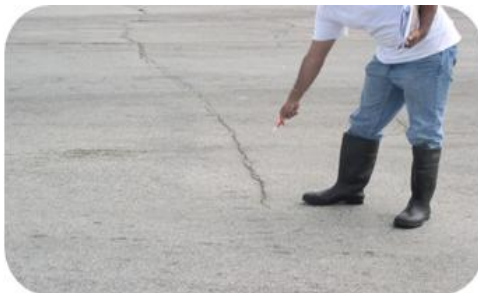
Figure 9.7: Cracks on the Roadway Surface

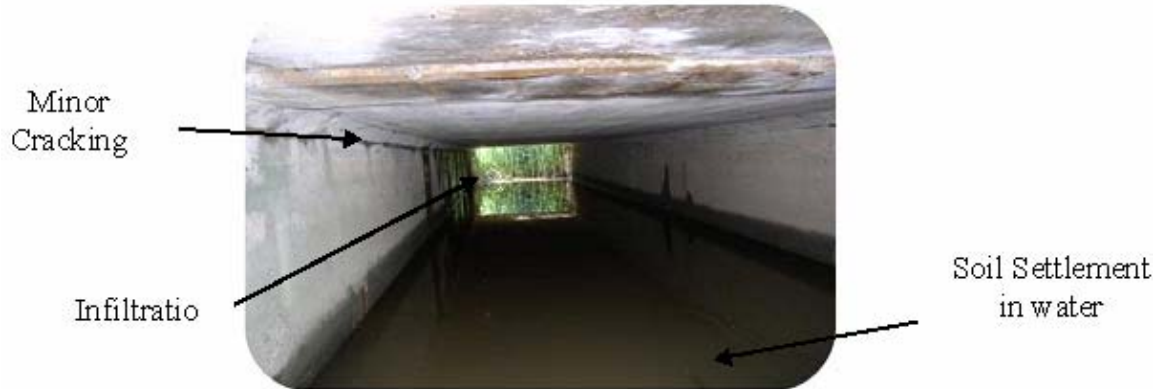
Figure 9.8: Condition of Culvert 31000131B04

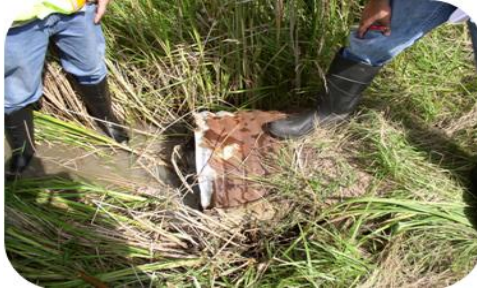
Figure 9.9: Corrosion on the Outside Surface of the CMP

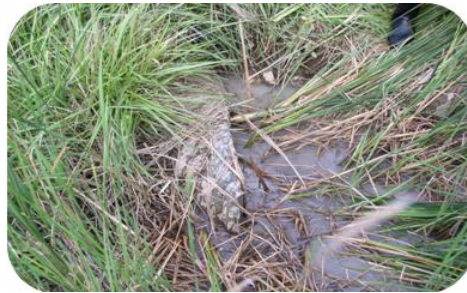
Figure 9.10: Total Failure of the Culvert End

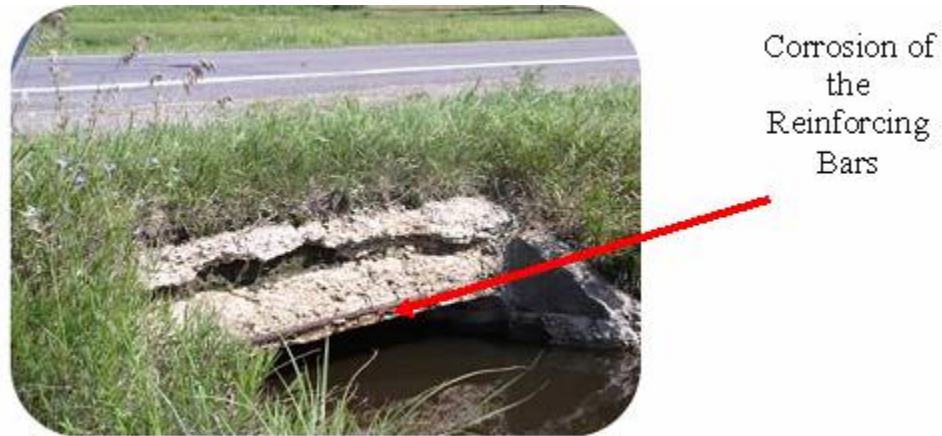
Figure 9.11: Condition of Culvert Structure 31000131B05
