# **DEVELOPMENT AND LAYOUT OF A PROTOCOL FOR THE FIELD PERFORMANCE OF CONCRETE DECK AND CRACK SEALANTS**

Project 07-13  
August 2009

Midwest Regional University Transportation Center  
College of Engineering  
Department of Civil and Environmental Engineering  
University of Wisconsin, Madison

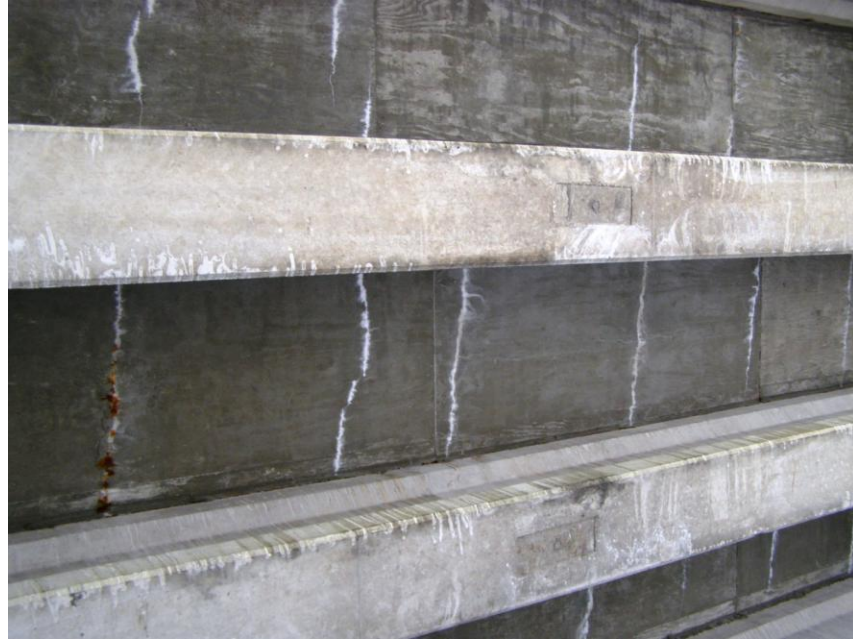
**Figure 3.8** Evidence of efflorescence and rust stains on the underside of the deck of bridge B-13-0034.

but it had a few transverse cracks and a few longitudinal cracks in all three spans, as shown in Fig. 3.7 for the left lane. Some of these cracks extended through the depth of the deck, as evidenced by efflorescence and rust stains on the underside of the deck (see Fig. 3.8).

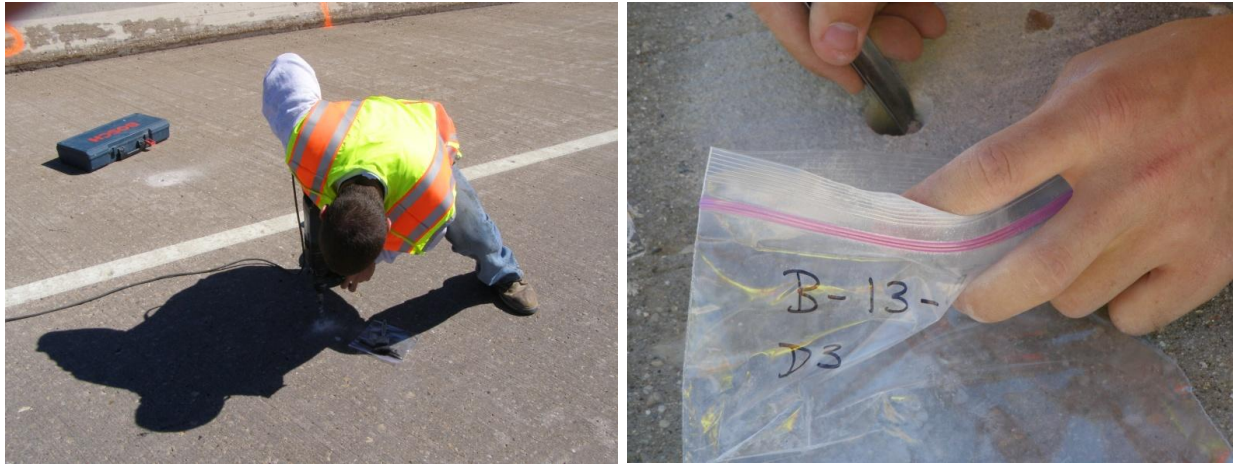
**Figure 4.2** Extraction of powder samples in the field.

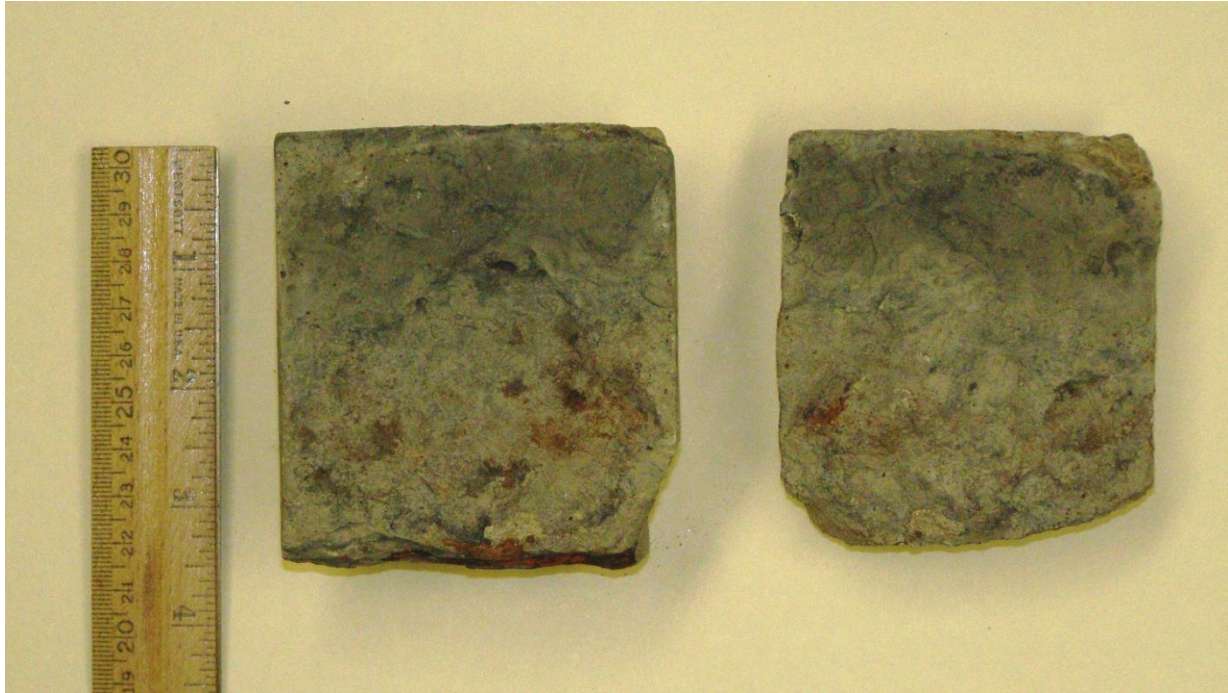
**Figure 4.3** Evidence of carbon dioxide penetration through cracks in bridge B-13-0337.

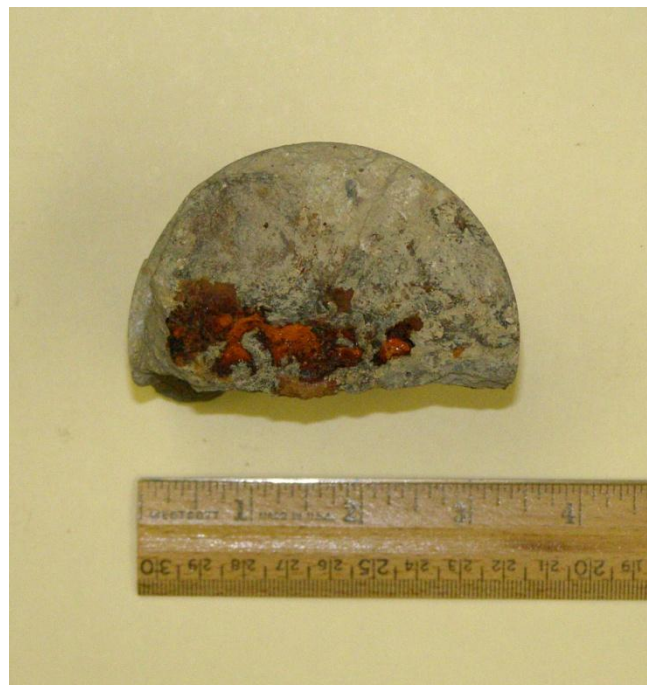
approximately 3-1/2 in., i.e. the full depth of the core. Although no bars were severed with the core, rust stains on the bottom of the core at the bar level (see Fig. 4.4) show that bar corrosion activity is present. This result was expected since the chloride ion content level at the bar level in a crack should be about the same as that at the surface (Pincheira et al., 2008). For bridge B-13-0337, the average chloride ion content near the surface was measured at about 21 lb/cy which far exceeds the corrosion threshold content level of 1 to 1.5 lb/cy commonly for black bars (Pincheira et al., 2008).

**Figure 4.4** Rust stains on the bottom of a core extracted from B-13-0337.

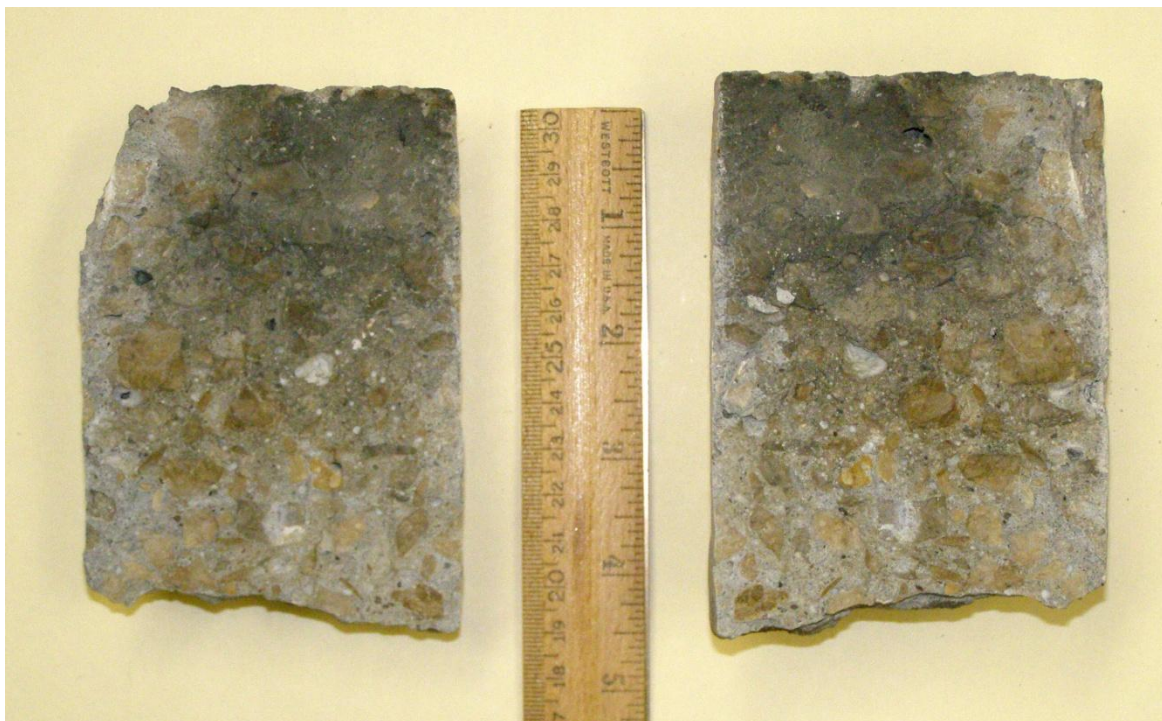
Fig. 4.5 shows a photograph through a crack in a core extracted from bridge B-14-0034. Again, the penetration of carbon dioxide through the crack is evident (approximately 3-1/2 in.). This deck, however, is newer than that of B-13-0034 and is reinforced with epoxy coated bars. No bars were extracted with the core shown in Fig. 4.5. However, a second core extracted from this bridge severed a portion of the top bar of the top mat. In addition, the bar markings of the bottom bar of the top mat could be clearly seen on the bottom face of the core as shown in Fig. 4.6. As can be seen, there was no evidence of corrosion in this case, despite the fact that this bridge had a chloride ion content near the surface of about 14 lb/cy and significant carbon dioxide penetration through cracks.

**Figure 4.5** Evidence of carbon dioxide penetration through cracks in bridge B-14-0034.

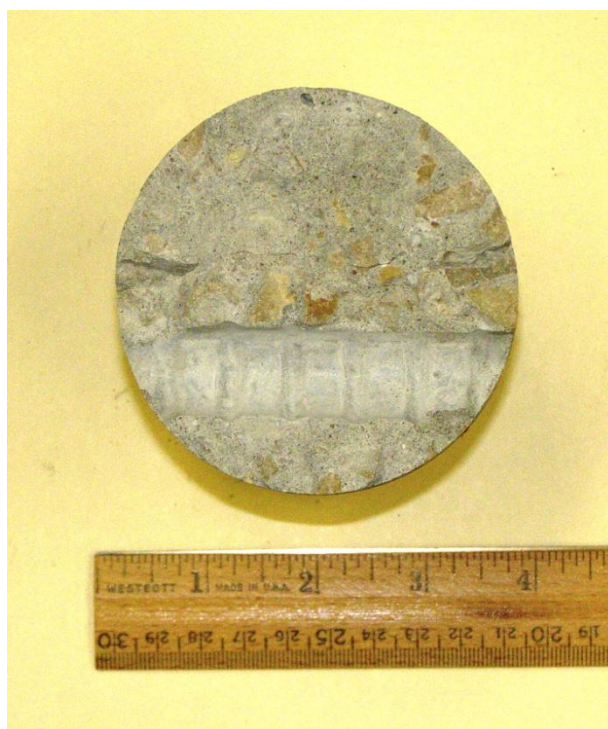
**Figure 4.6** Bar markings (clean) on the bottom of a core extracted from bridge B-14-0034.
