Marquette University

June 2010

WHRP 10-09

1. Report No. WHRP 10-09	2. Government Accession No	3. Recipient's Catalog No	
4. Title and Subtitle In-Situ Monitoring and Testing of IBRC Bridges in Wisconsin		5. Report Date June 2010	6. Performing Organization Code Wisconsin Highway Research Program

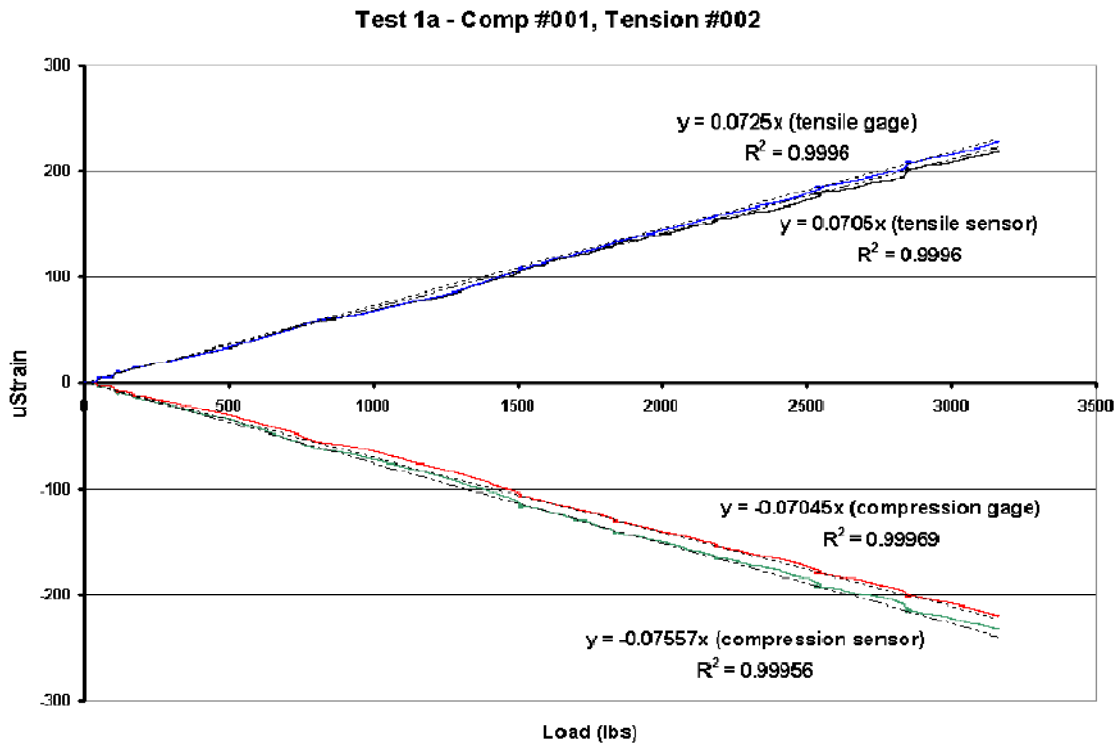
Figure 2.14: Typical response of strain gages and sensors under applied loading.

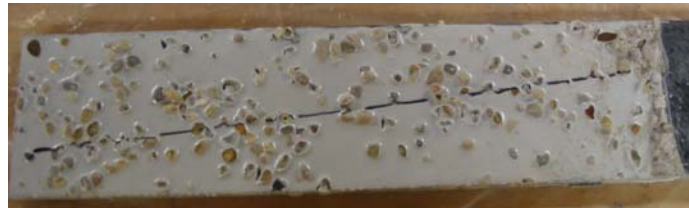
Figure 2.18 : Typical single-shear specimen failure: (a) failure surfaces; (b) typical 254 mm line drawn to check aggregate coverage (Berg 2004).

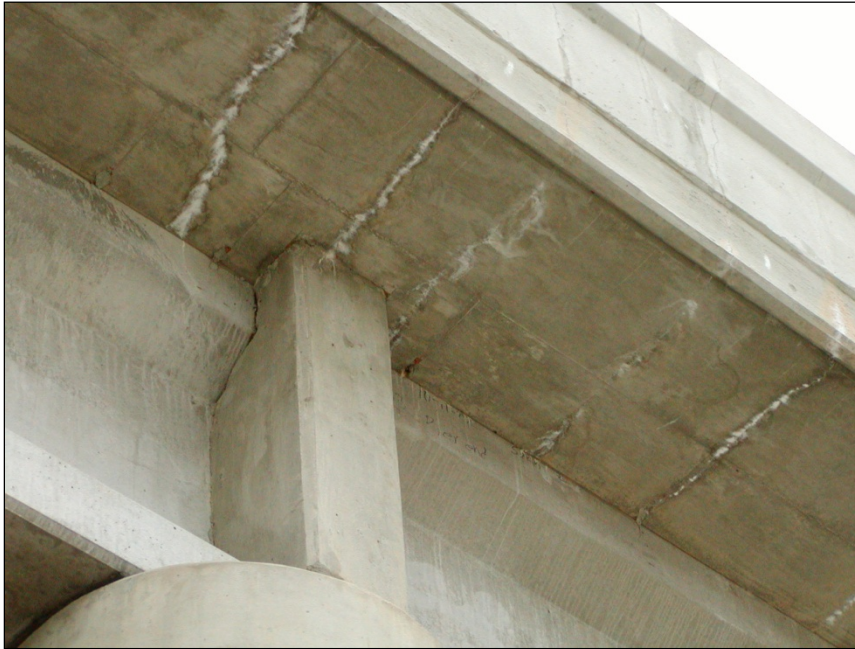
Figure 3.7 (3) Cracking with Efflorescence South Side of B-20-133 Above Central Pier

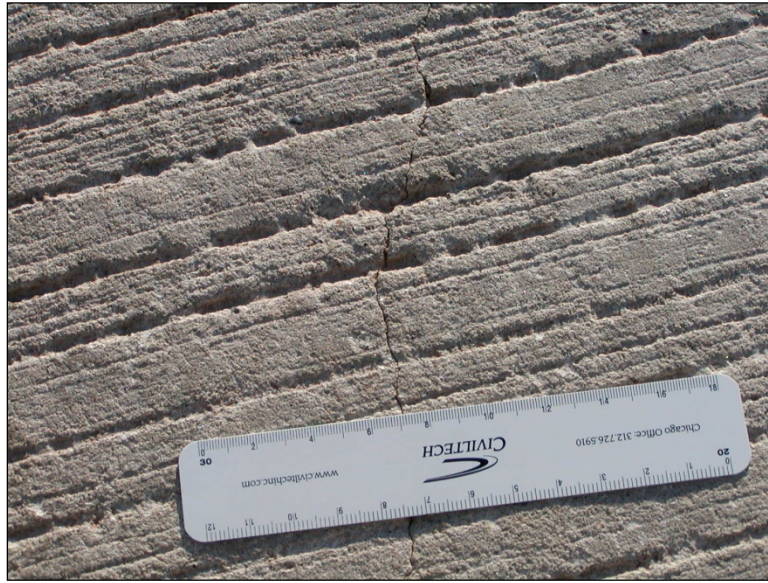
Figure 3.21 (6) Hairline Crack on Deck of B-20-149 with Scale

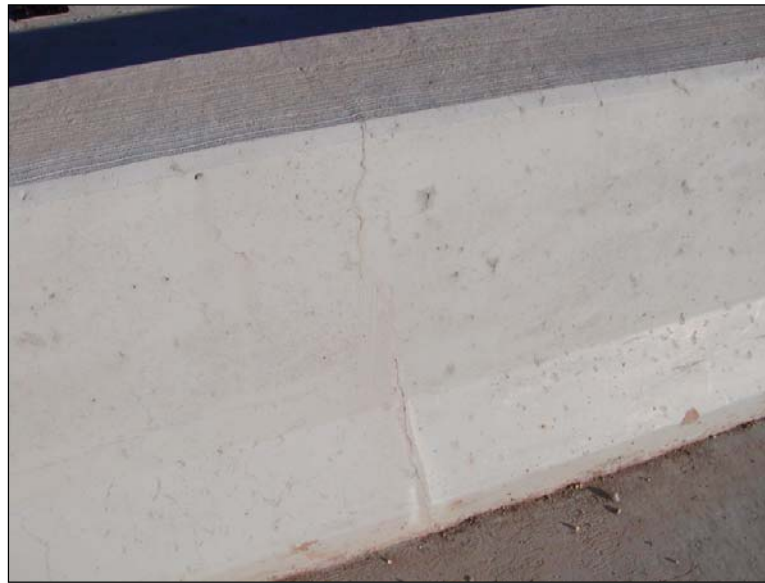
Figure 3.34 (5) Northern Parapet Crack on B-20-149

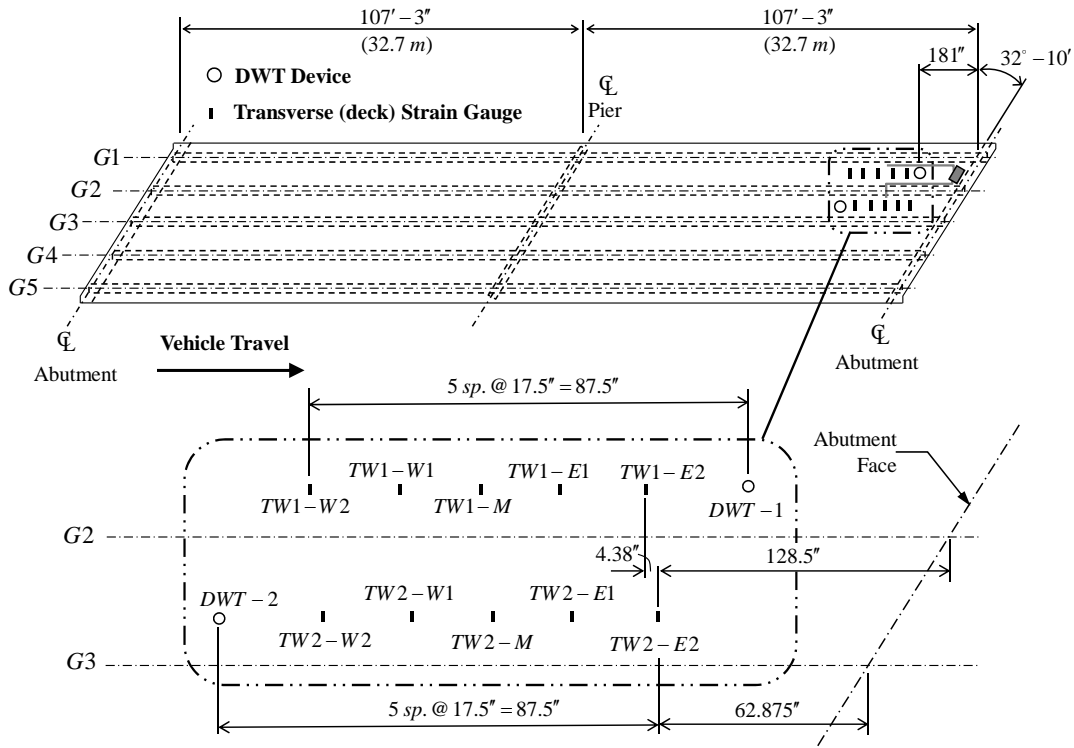
Figure 4.5 Instrumentation Layout and Instrumentation Plan Detail for B-20-133.

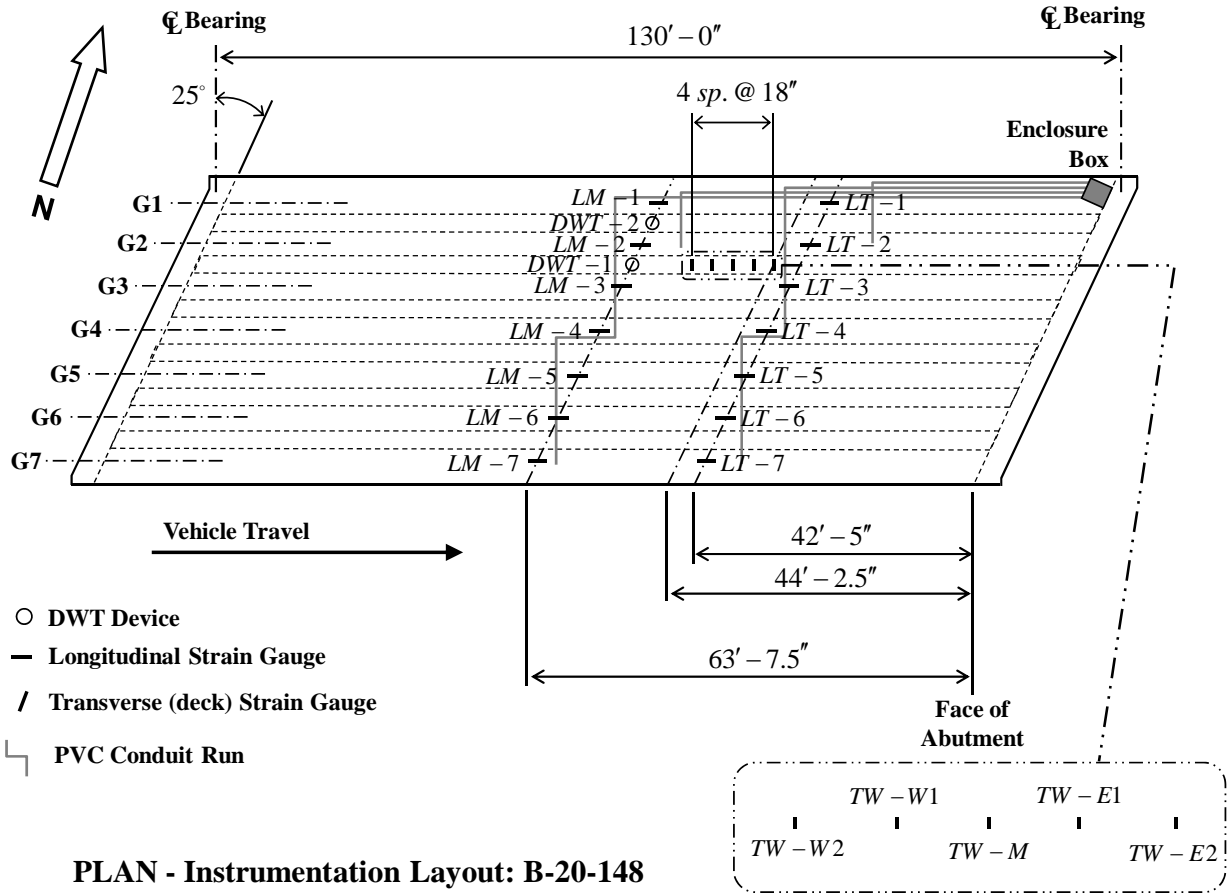
Figure 4.8 B-20-148 Instrumentation Plan with Sensor Locations, PVC Conduit Runs and Enclosure Box Location.

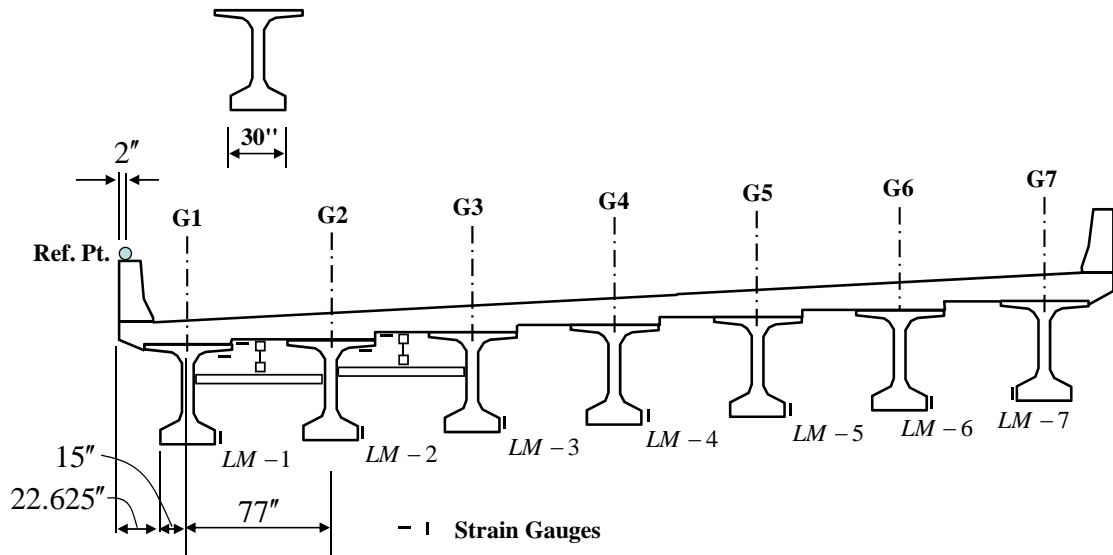
Figure 4.10 B-20-148 Cross-Sections with Instrumentation Locations and Layout: (a) Sensor Locations within Bridge Cross-Section; (b) Reference Point Location Used to Locate Sensors.

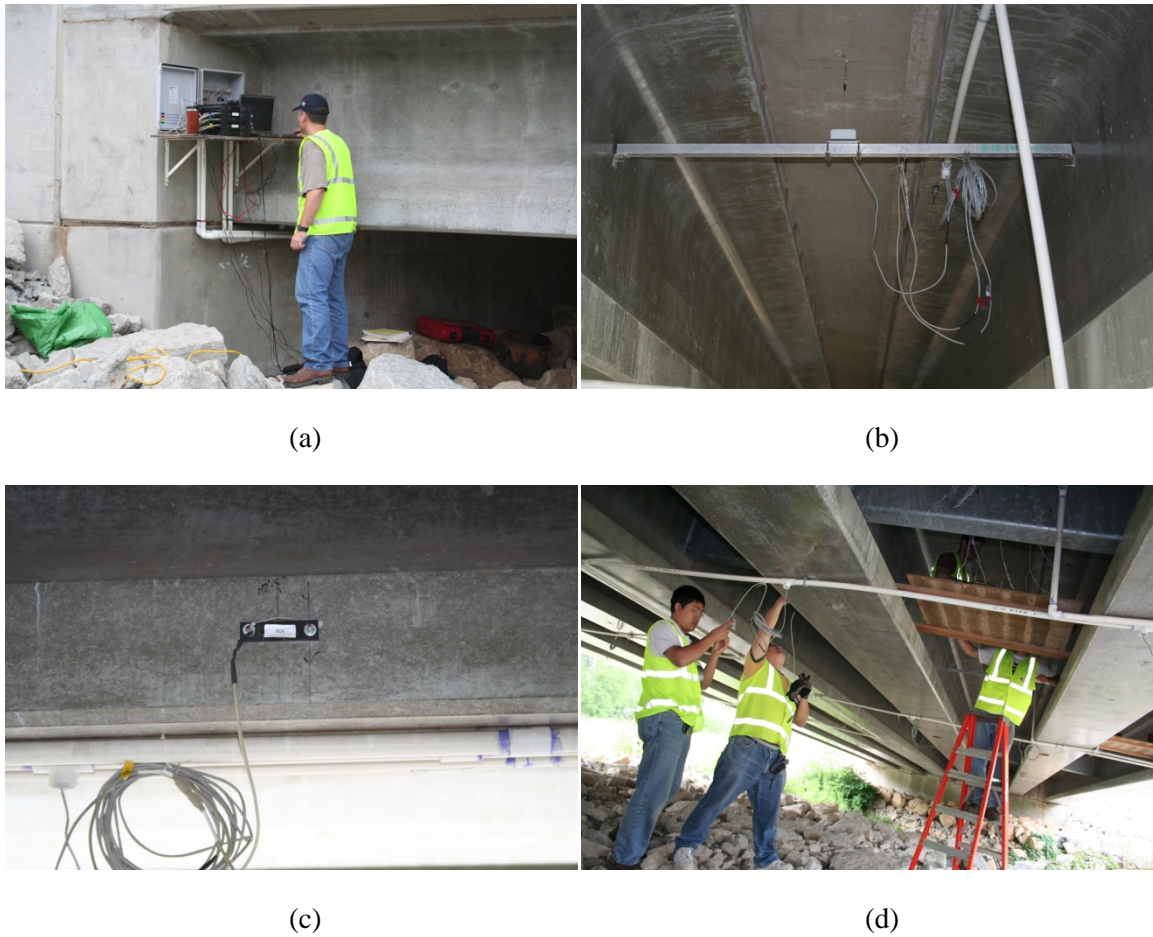
Figure 4.12 B-20-148 Data Acquisition System and Instrumentation: (a) Data Acquisition System and Enclosure; (b) Draw Wire Transducer Installation; (c) Strain Gauge Installation; (d) Sensor Wiring Runs and Sensor Installation.

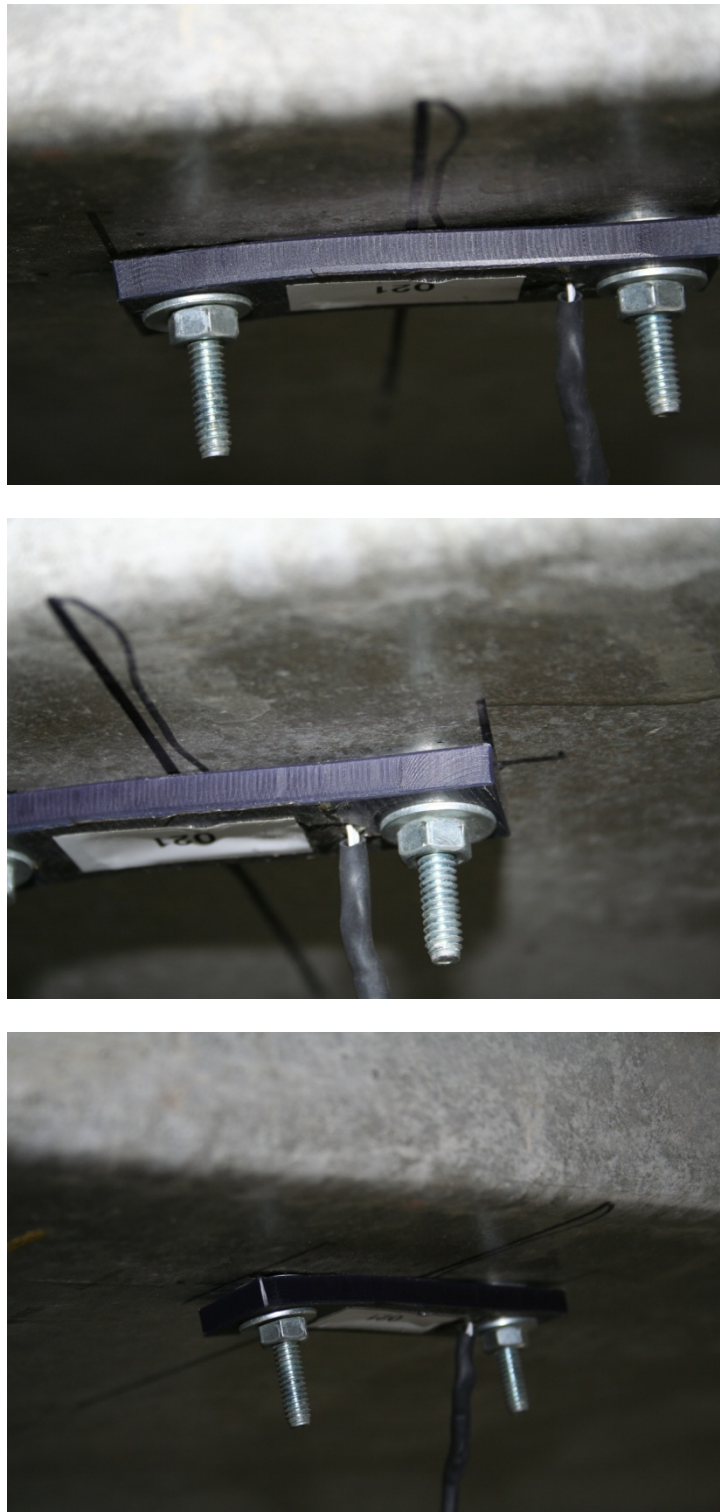
Figure 4.37 Strain Sensor Installation Error with Potential to Cause Error in Strain Readings.
