# PLANIMETRIC CHANNEL CHANGE ALONG THE LOWER CHIPPEWA RIVER IN WEST-CENTRAL WISCONSIN, 1938-2008

Nicholas E. King, Amy E. Wichlacz, Dr. Douglas J. Faulkner, University of Wisconsin - Eau Claire Geography and Anthropology Department

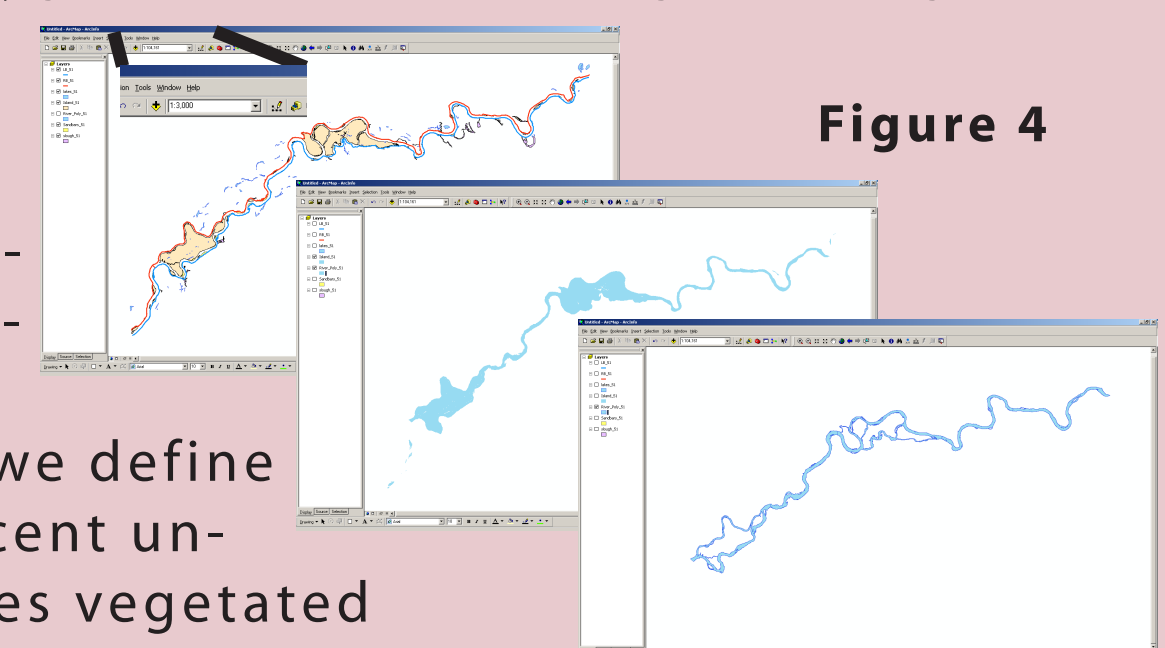
Figure 4

year using the georeferenced images as base maps in ArcMap 9.3 at a 1:3000 scale. We then created polygon files from the digitized right and left banks for each year using the Line to Polygon tool in ArcMap. The islands were then clipped out of the polygons (Figure 4). This allowed us to measure the planimetric area of the active channel for each year. (The active channel as we define it consists of the stream and adjacent unvegetated sandbars, and it excludes vegetated islands.) Lastly, the river was divided into five sections (Eau Claire, Caryville, Islands, Stretch, and Nine Mile) at easily identifiable locations along the river. The planimetric area of each section for each year could then be easily measured and compared (Figure 5).

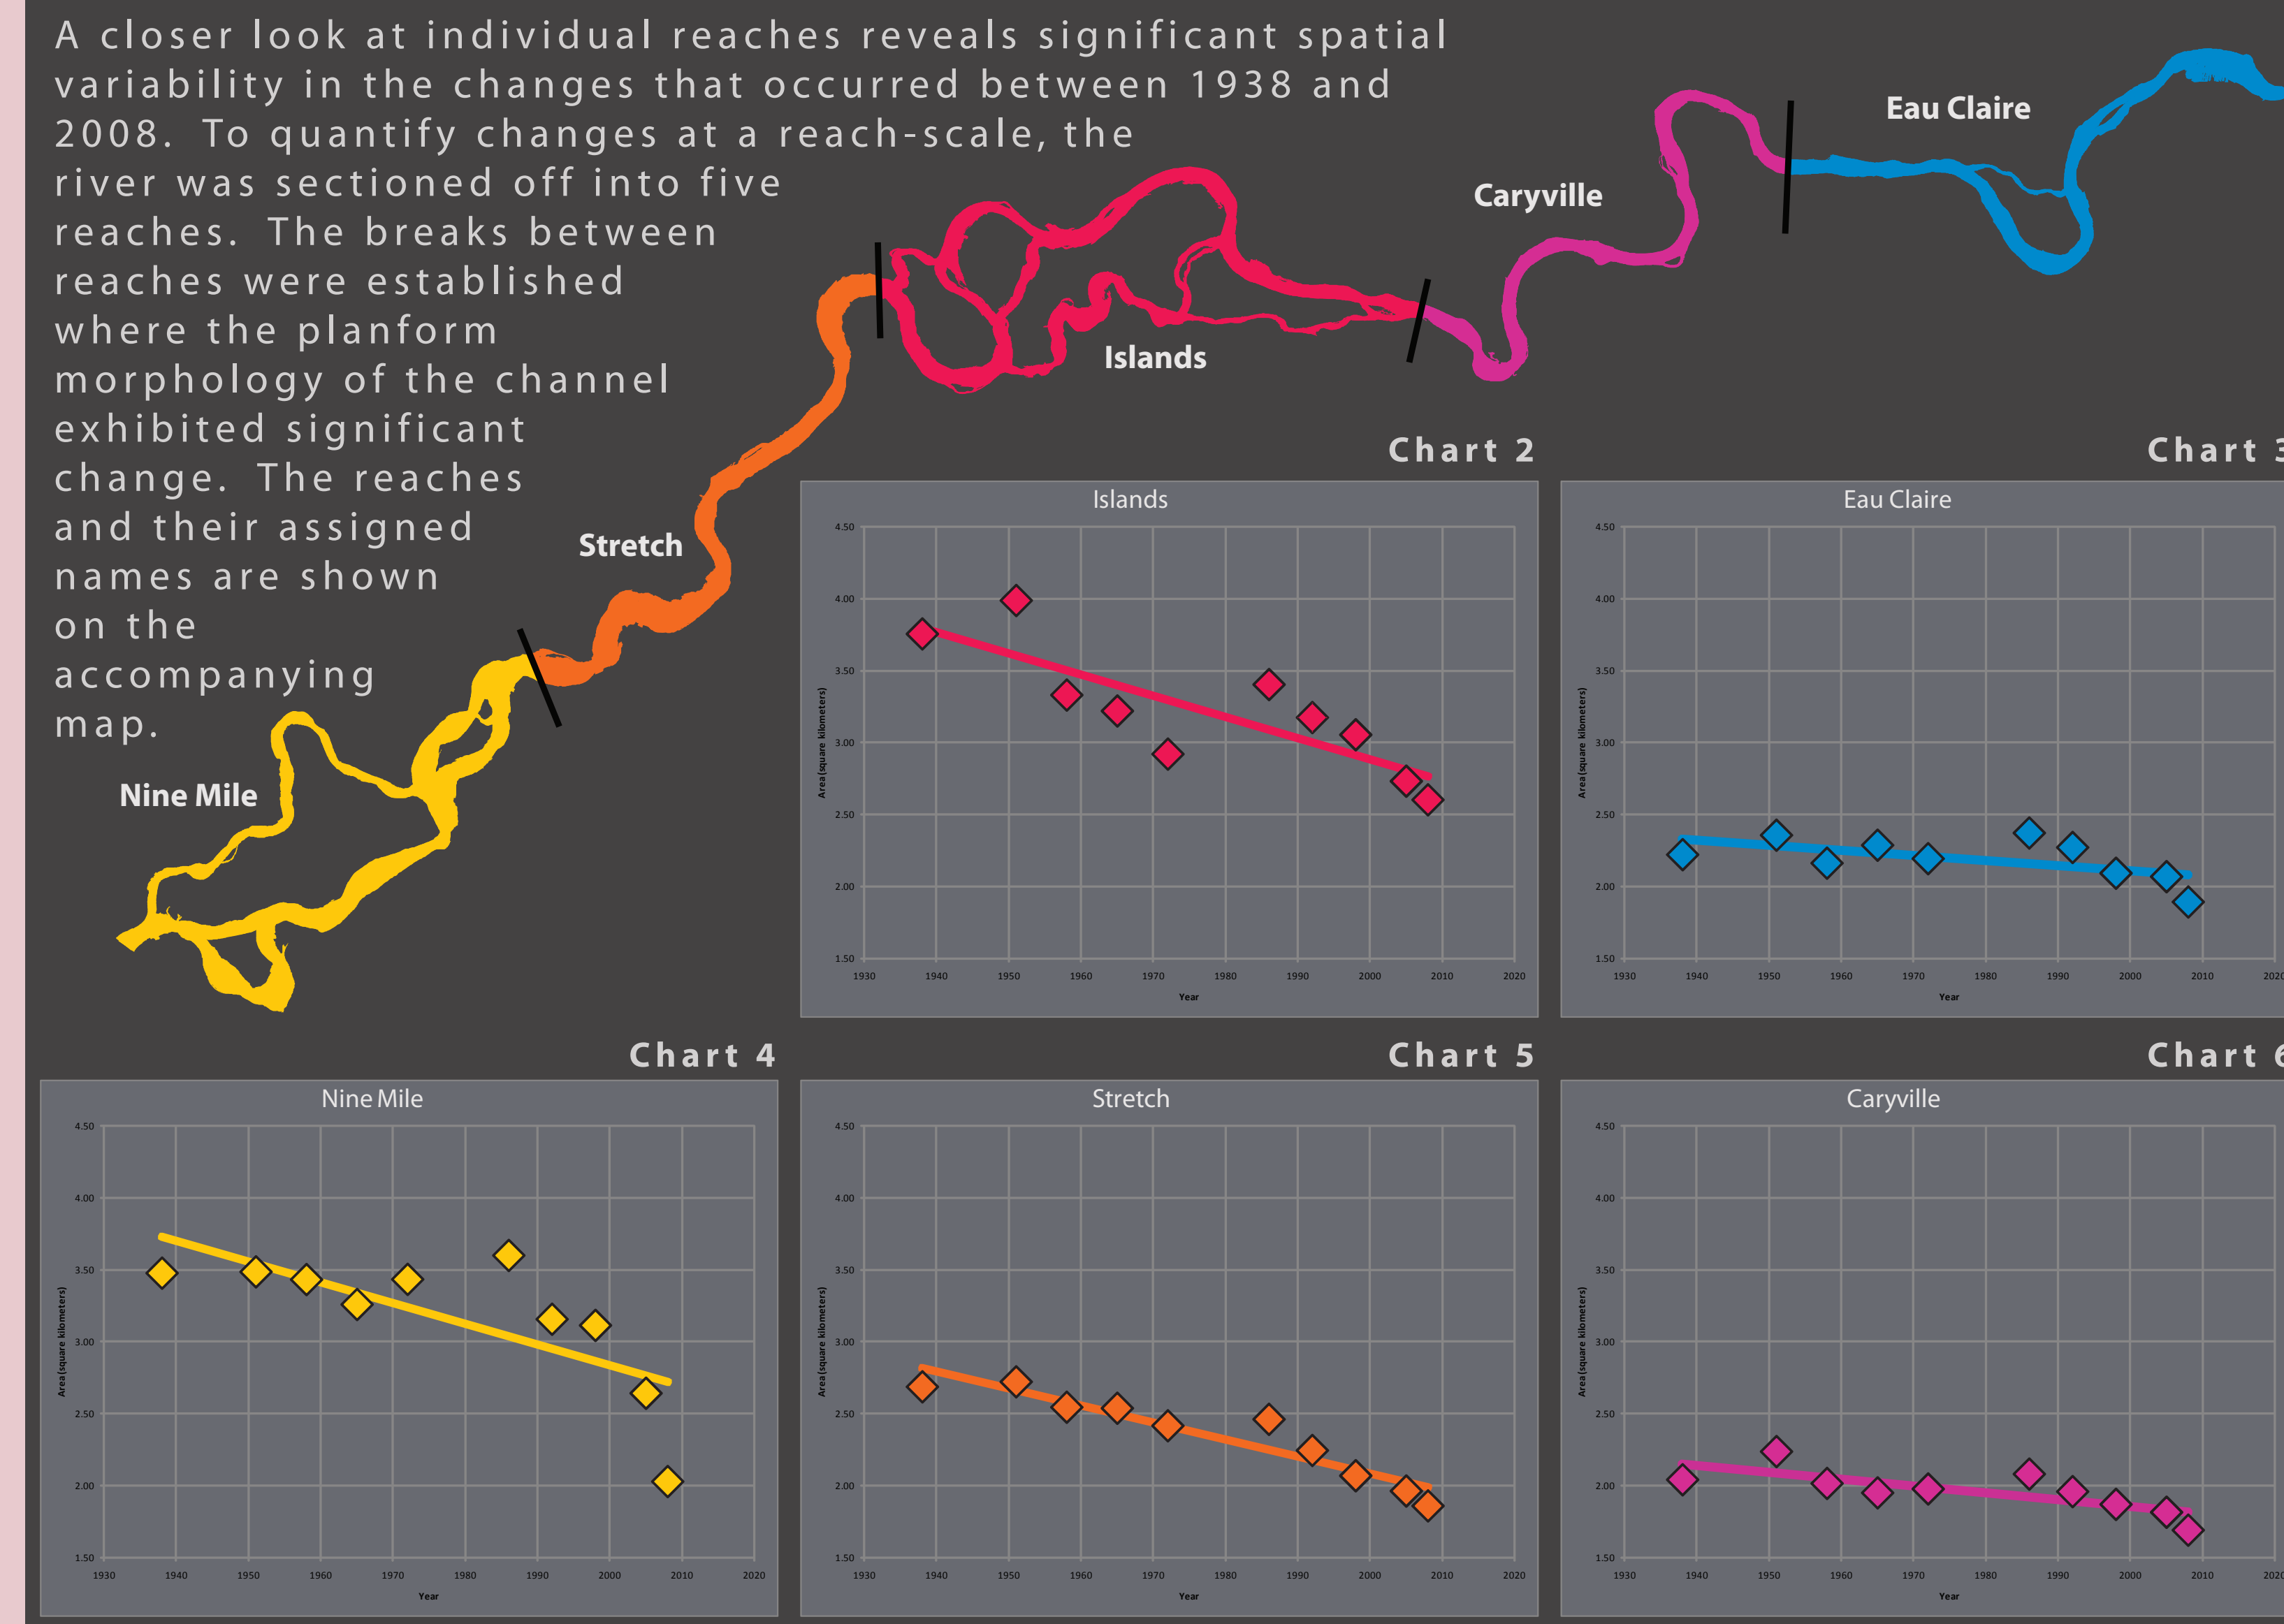
A closer look at individual reaches reveals significant spatial variability in the changes that occurred between 1938 and 2008. To quantify changes at a reach-scale, the river was sectioned off into five reaches. The breaks between reaches were established where the planform morphology of the channel exhibited significant change. The reaches and their assigned names are shown on the accompanying map.

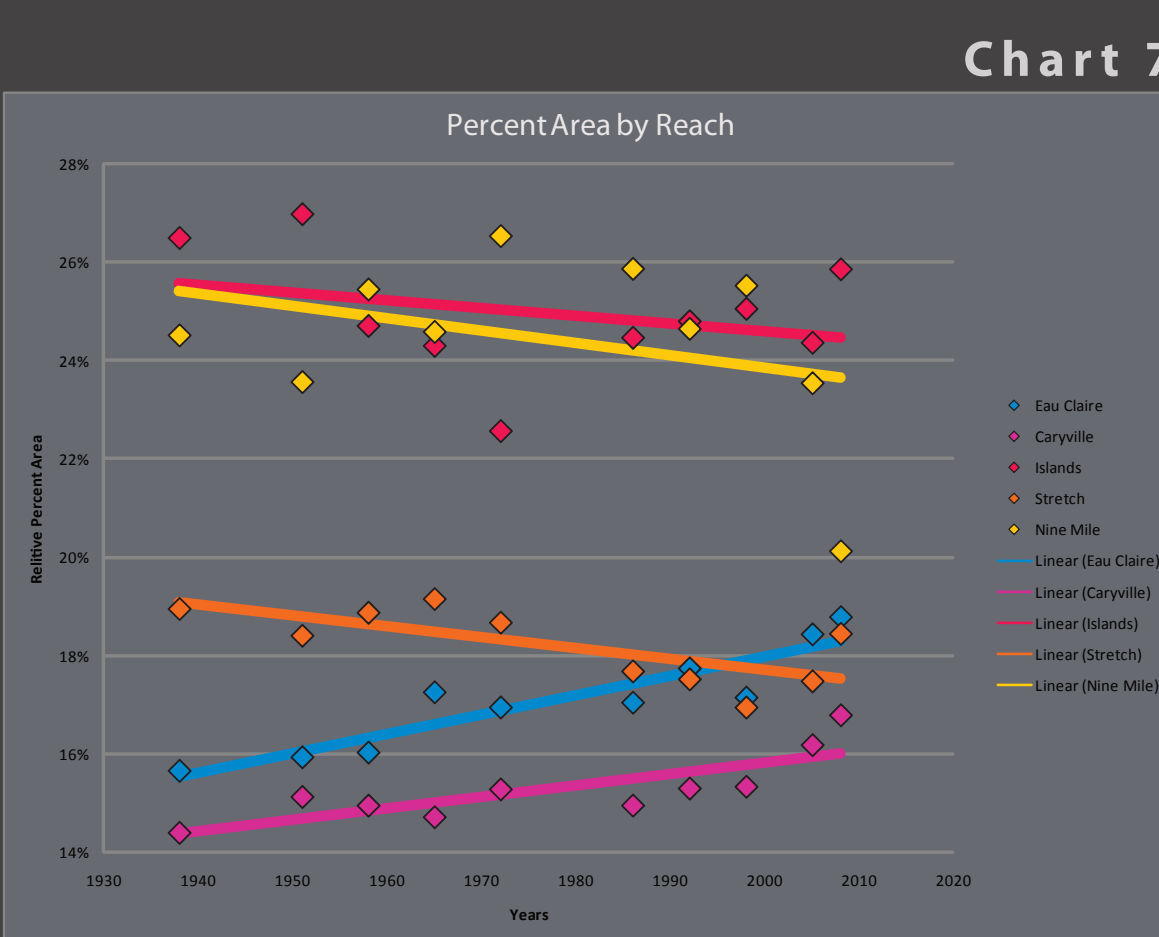
Charts 2 through 6 reveal the spatially nonuniform decline in active channel area. Between Eau Claire to the first anastomosing reach (comprising the Eau Claire and Caryville reaches) changes in area have been modest. In contrast, along downstream reaches, they have been much more remarkable, although the temporal trends along these reaches have not been the same. For example, active channel area along the Stretch reach declined fairly steadily from 1938 to 2008, while along the Islands and Nine Mile reaches, it decreased in a manner characterized by considerable year-to-year variability. And of these two, the Nine Mile reach exhibited little change in active channel area till after 1986, whereas the Islands reach began declining decades earlier. Spatially variable planimetric change has altered the relative area of active channel in each reach (as a proportion of the total active channel area) (Chart 7).
