Characterization of REBCO Superconducting Tape Damage Induced by Various Sample Preparation Methods

Nate Hartnett¹, Javier Ramirez^{1, 3}, Matthew Jewell¹, Yifei Zhang²
¹Materials Science & Engineering Program ❖ University of Wisconsin - Eau Claire
²SuperPower, Inc. ❖ Schenectady, NY
³University of Wisconsin - Fox Valley ❖ Menasha, WI

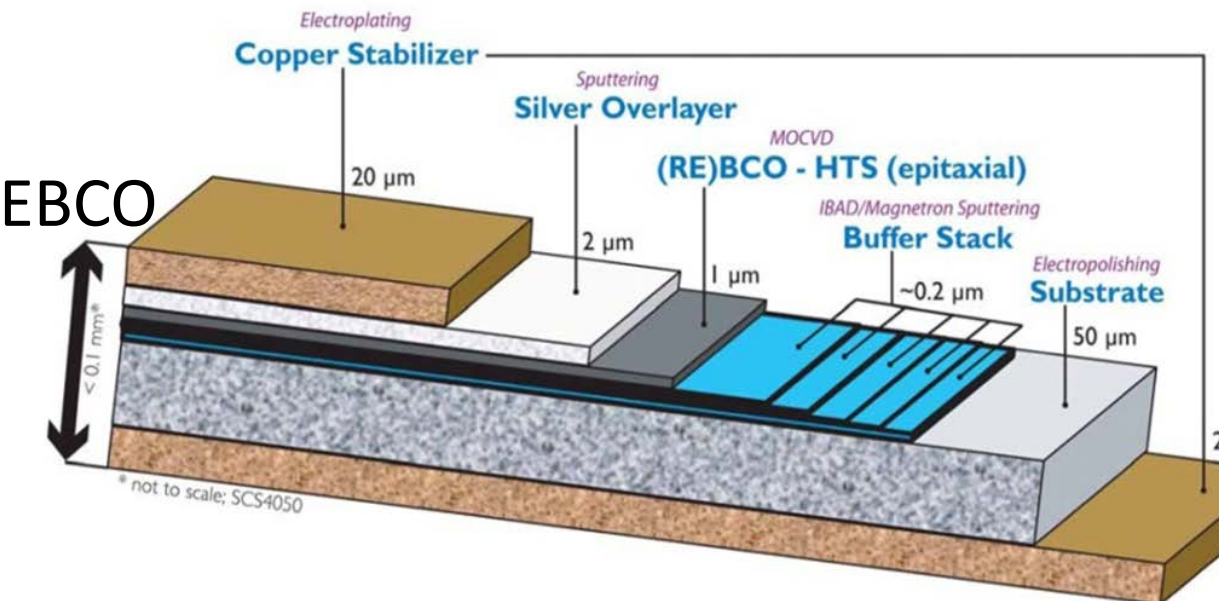
REBCO Tape

- ❖ Rare-earth barium-copper-oxide (REBCO) superconductors are high-temperature superconducting wires fabricated in a tape geometry.
- ❖ A REBCO tape has several layers consisting of:
 - Copper and silver layers for mechanical protection and electrical stability
 - REBCO superconducting layer
 - A collection of oxide buffer stacks that orient the crystal growth of the REBCO
 - A nickel-based layer (Hastelloy) for mechanical strength.

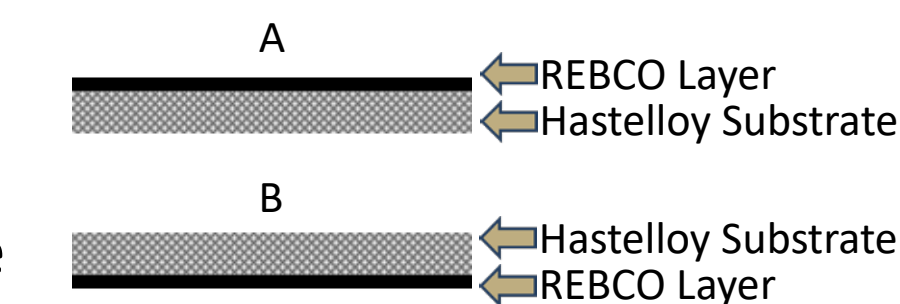
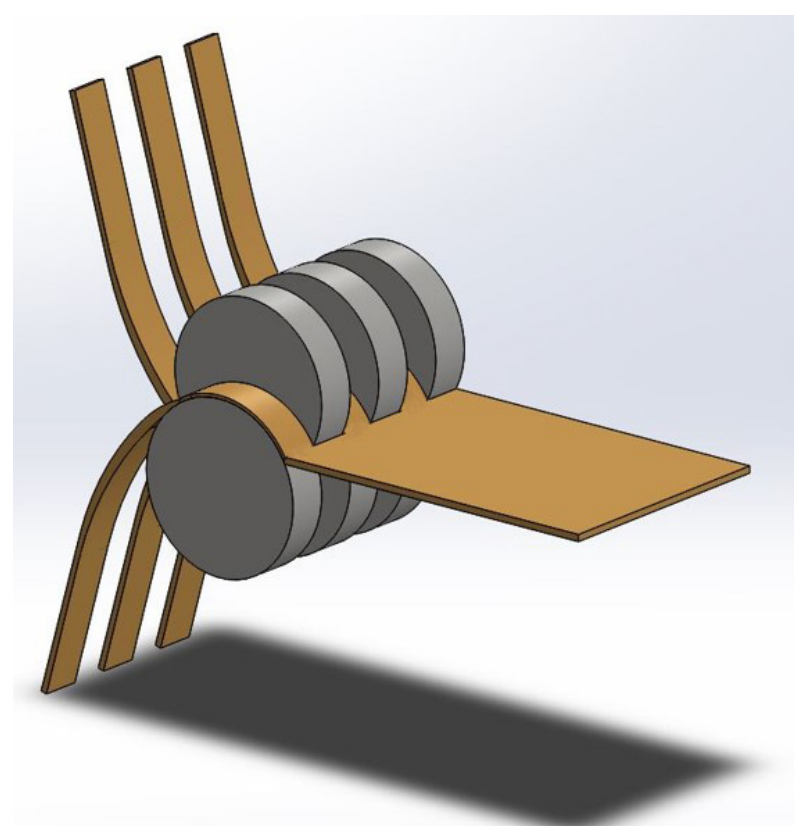
Industrial Slitting process

- ❖ The industrial slitting process consists of two sample sets being cut from a 12 mm wide tape, named as Sample A ("UP") where the REBCO layer is face-up during slitting process, and Sample B ("DOWN") where the REBCO layer is face-down during the slitting.
- ❖ Each sample is slit into 6 pieces (labeled as sample numbers 1-6) of 2 mm wide tapes with the slitter shown.
- ❖ The slitter has 6 knives, where each edge of a knife is given a code as "01, ..., "12."

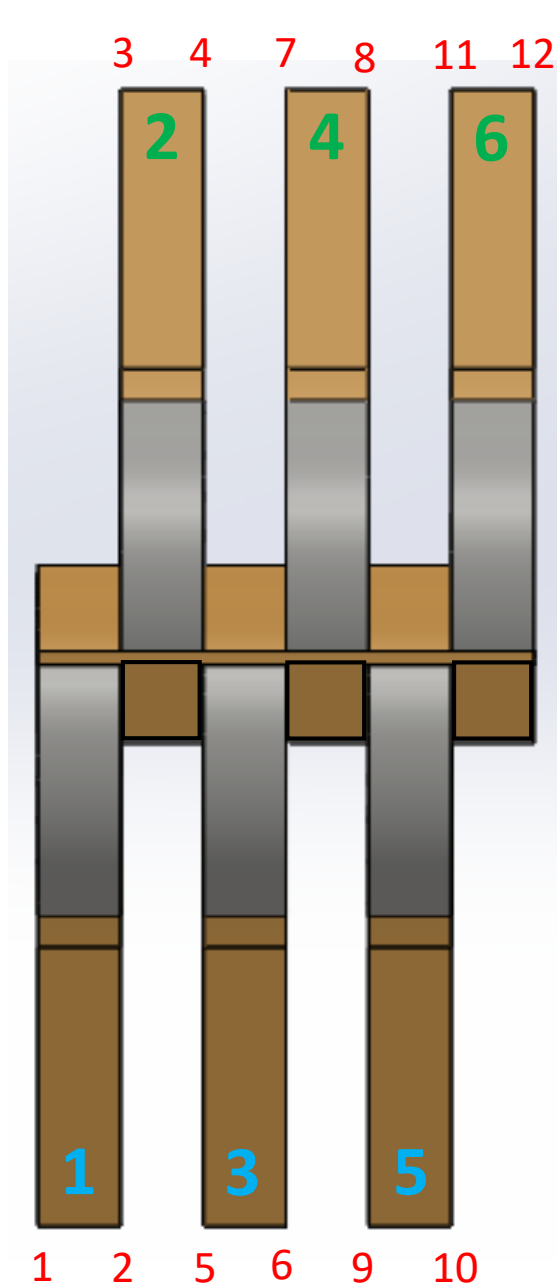
Schematic Explanation

- ❖ The Large Blue and Green numbers correspond to the sample number (1 – 6) of the slit piece.
- ❖ The small red numbers correspond to the edge number of the sample
- ❖ The schematic here is showing the relative positioning of the tape segments after they have passed through the slitting tool.

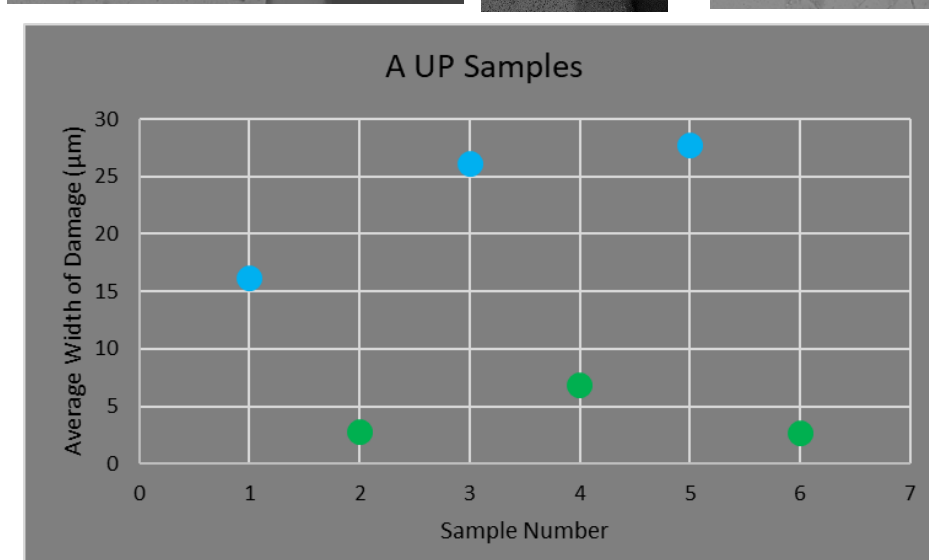
Results

- ❖ The even numbered REBCO UP samples showed less damage along the slit edge, whereas the odd numbered samples exhibited a greater severity of damage (larger area of REBCO layer missing and larger area of buffer stacks exposed). The odd REBCO DOWN Samples showed less damage along the slit edge, whereas the even numbered samples exhibited a greater severity of damage. This trend in damage relates to whether the REBCO is in tension or compression. When the REBCO is under compression the damage is minimal. When the REBCO is under tension the damage is greater.

- ❖ Compression of the REBCO Layer during the slitting process leads to minimized damage
- ❖ Tension in the REBCO layer during the slitting process leads to increased damage

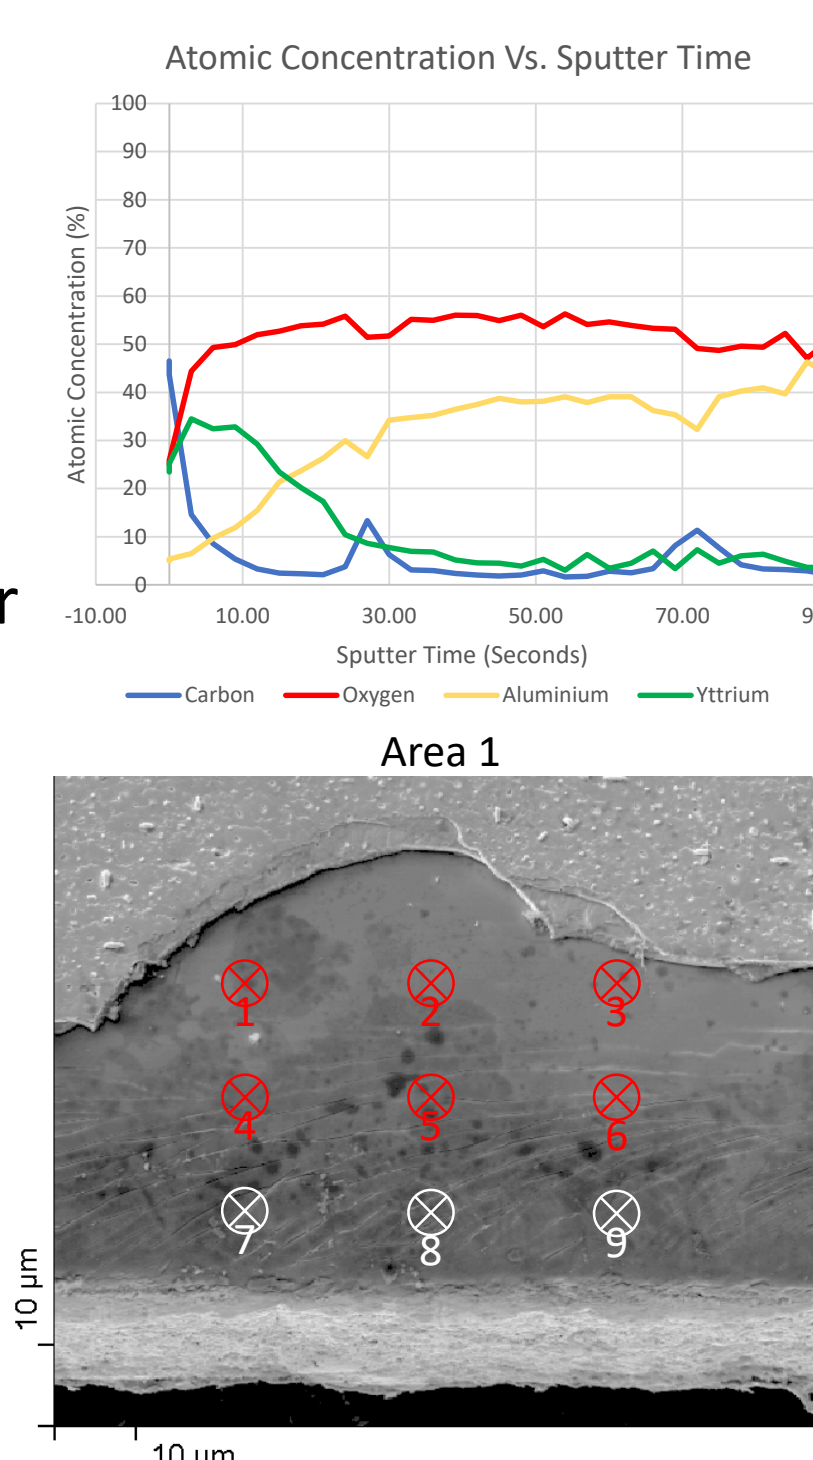
- ❖ Using Auger electron spectroscopy and incremental Argon sputtering we were able to plot elemental composition as a function of sputtering time. If we have a sample where we know the thickness of a buffer layer, we can see how long it takes to sputter that layer and then calculate a sputter rate for that specific material.
- ❖ With the sputter rate, we can calculate the thickness of buffer layer by multiplying the sputter rate by the total time it took to sputter through the buffer layer.
- ❖ This procedure was used on one REBCO UP Sample and one REBCO DOWN.
- ❖ On each sample data was collected on three different locations.
- ❖ At each location data was collected at 9 points.
- ❖ Points marked in red were chosen for data analysis.

- ❖ Error bars for the graph were calculated using a 95% confidence interval
- ❖ In both samples, the exposed buffer layer was identified to be yttria.
- ❖ The samples did not show significant differences in the average thickness of the yttria layer.
- ❖ Variance in the thickness of the yttria suggests that the fracturing occurred in the middle of the yttria layer.

- ❖ The exposed buffer layer was identified as yttria on all areas of both samples
- ❖ Due to the measured thickness of the yttria layer it can be inferred that the fracturing occurred in the middle of the yttria layer. Further tests will be conducted to confirm this.

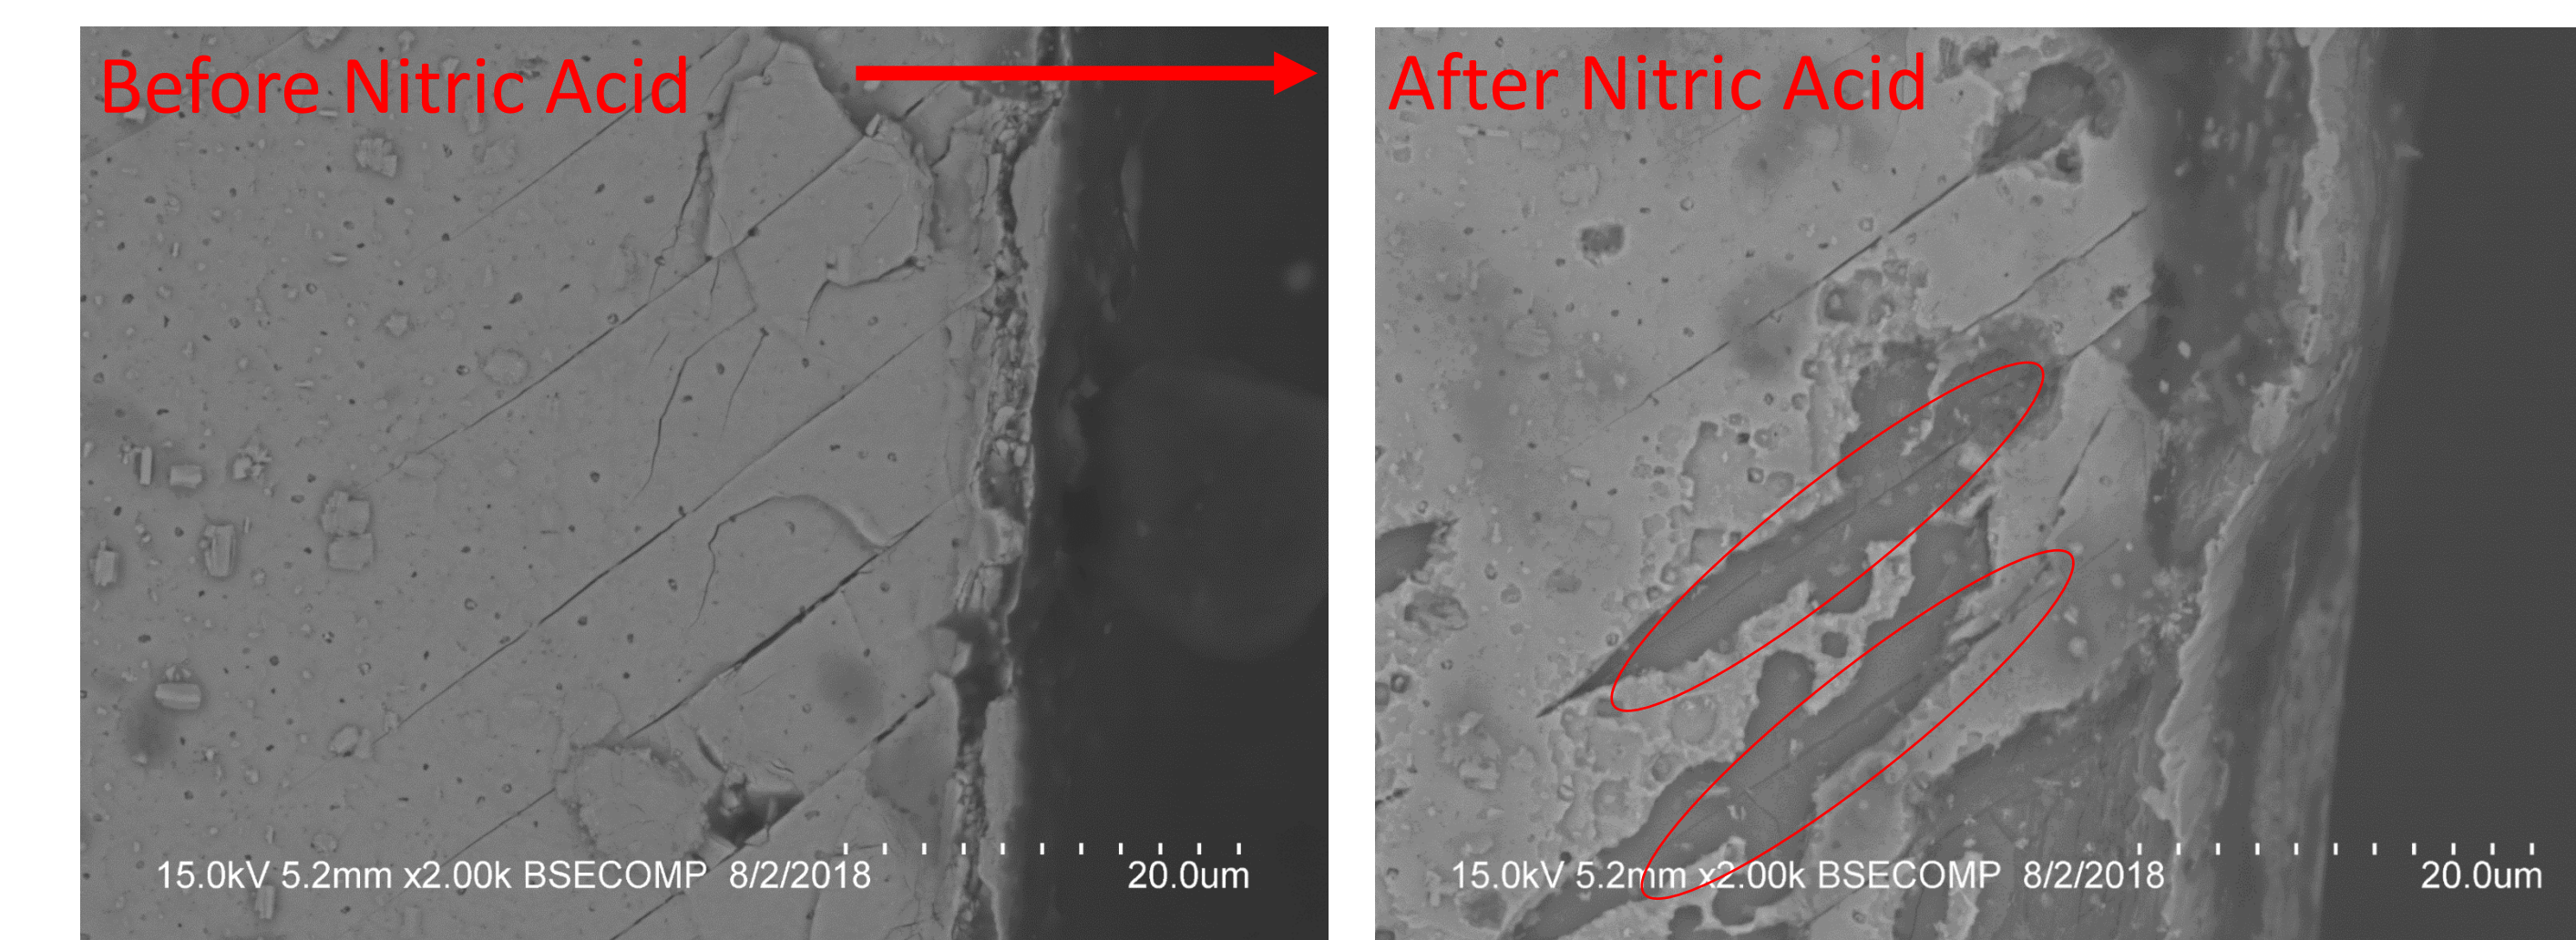
- ❖ For the industrially slit samples we wanted to see if the cracks in the buffer layers extended beneath the REBCO layer to the buffer stack, and whether the cracks in the buffer layers matched the cracks in the REBCO layer. To do this we used nitric acid to etch away the REBCO. We submerged the samples in increments of 5 seconds, imaging them in between each submergence.

- ❖ The cracks in the REBCO layer sit directly on top of similar cracks in the buffer stack.
- ❖ There is a clear propagation of the crack from one layer to the next. As the REBCO layer is thicker, we hypothesize that this layer cracks first, but we do not yet have evidence to support this.
