Planning Community Gardens: Soils and Slopes at the University of Wisconsin-Eau Claire Priory, West Central Wisconsin

Matthew Brueske, Hannah Adams, Nik Anderson, Dakota Dorn, Miles Hegg, Zach Hilgendorf, Alyssa Krantz, Cody Kroening, Sean Morrison, Patrick Thompson & Garry Running,

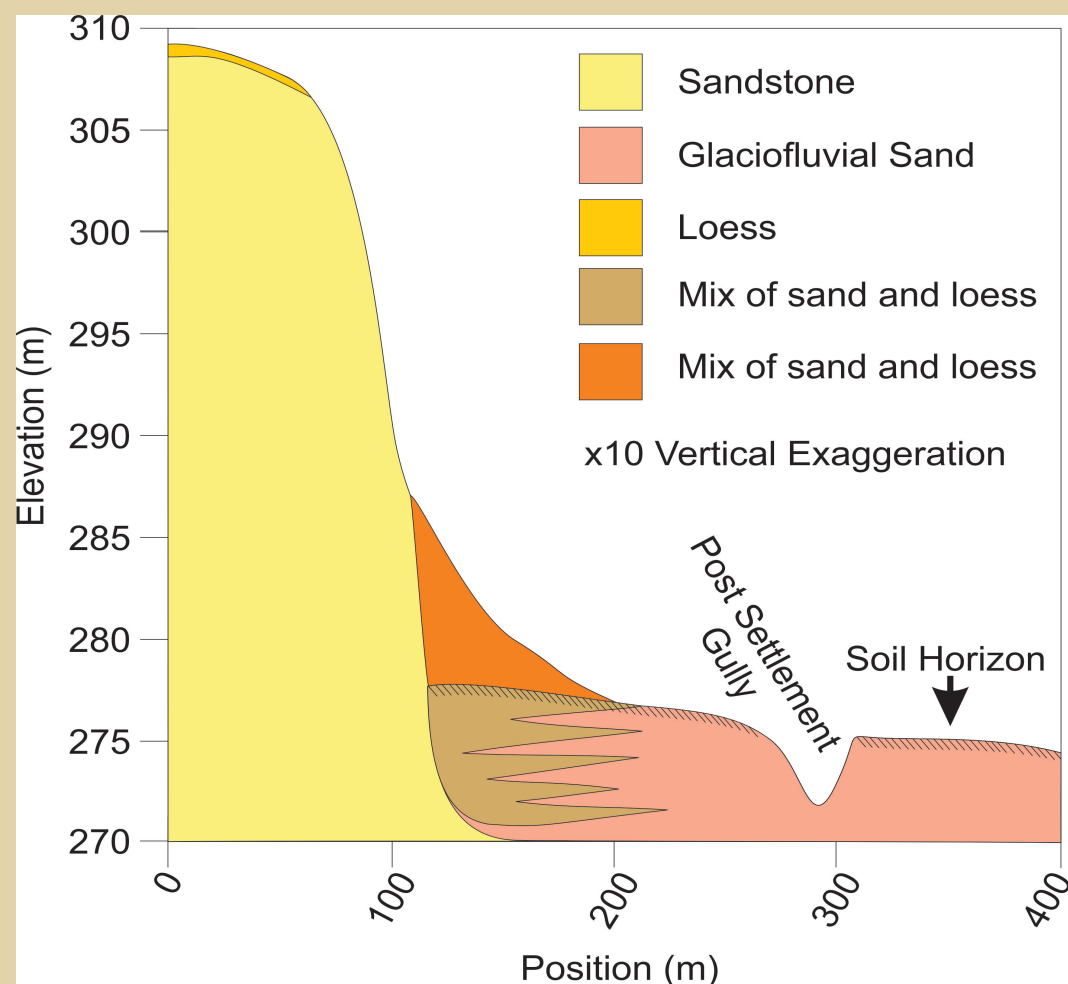
Figure 4. Bedrock in the study area is the Late Cambrian Mt. Simon Formation, a ridge forming sandstone. Sediments overlying the Mt. Simon-supported ridge include: late-Wisconsinan loess on the ridgetop, reworked loess mixed with older (late Pleistocene) reworked glacial outwash on adjacent slopes, reworked late-Wisconsinan loess and glacial outwash on lower slopes, and late-Wisconsinan glacial outwash in the valley. Valley aggradation and destabilization of ridgetops and slopes occurred simultaneously during the late-Wisconsinan. Slope stability and valley incision occurred during the Holocene until EuroAmerican agricultural practices lead to renewed slope destabilization, erosion, and redeposition of mixed colluvium along valley margins. In addition, gully formation on the valley floor occurred during the period of intense EuroAmerican agricultural landuse. Slopes have revegetated and stabilized since the 1960s when the study area was converted from farmland to a priory.

Relief in the study area is controlled by a bedrock ridge sloping to the valley bottom. There are four main parent materials present in the study area: bedrock, loess (ridgetop), colluvium (slopes adjacent to ridge), and glaciofluvial sediments (valley bottoms) (Figure 4). Soils forming on the modern surface of the Priory landscape are silty-texture (loess or loess derived) or sandy texture (glaciofluvial) (Figure 5).

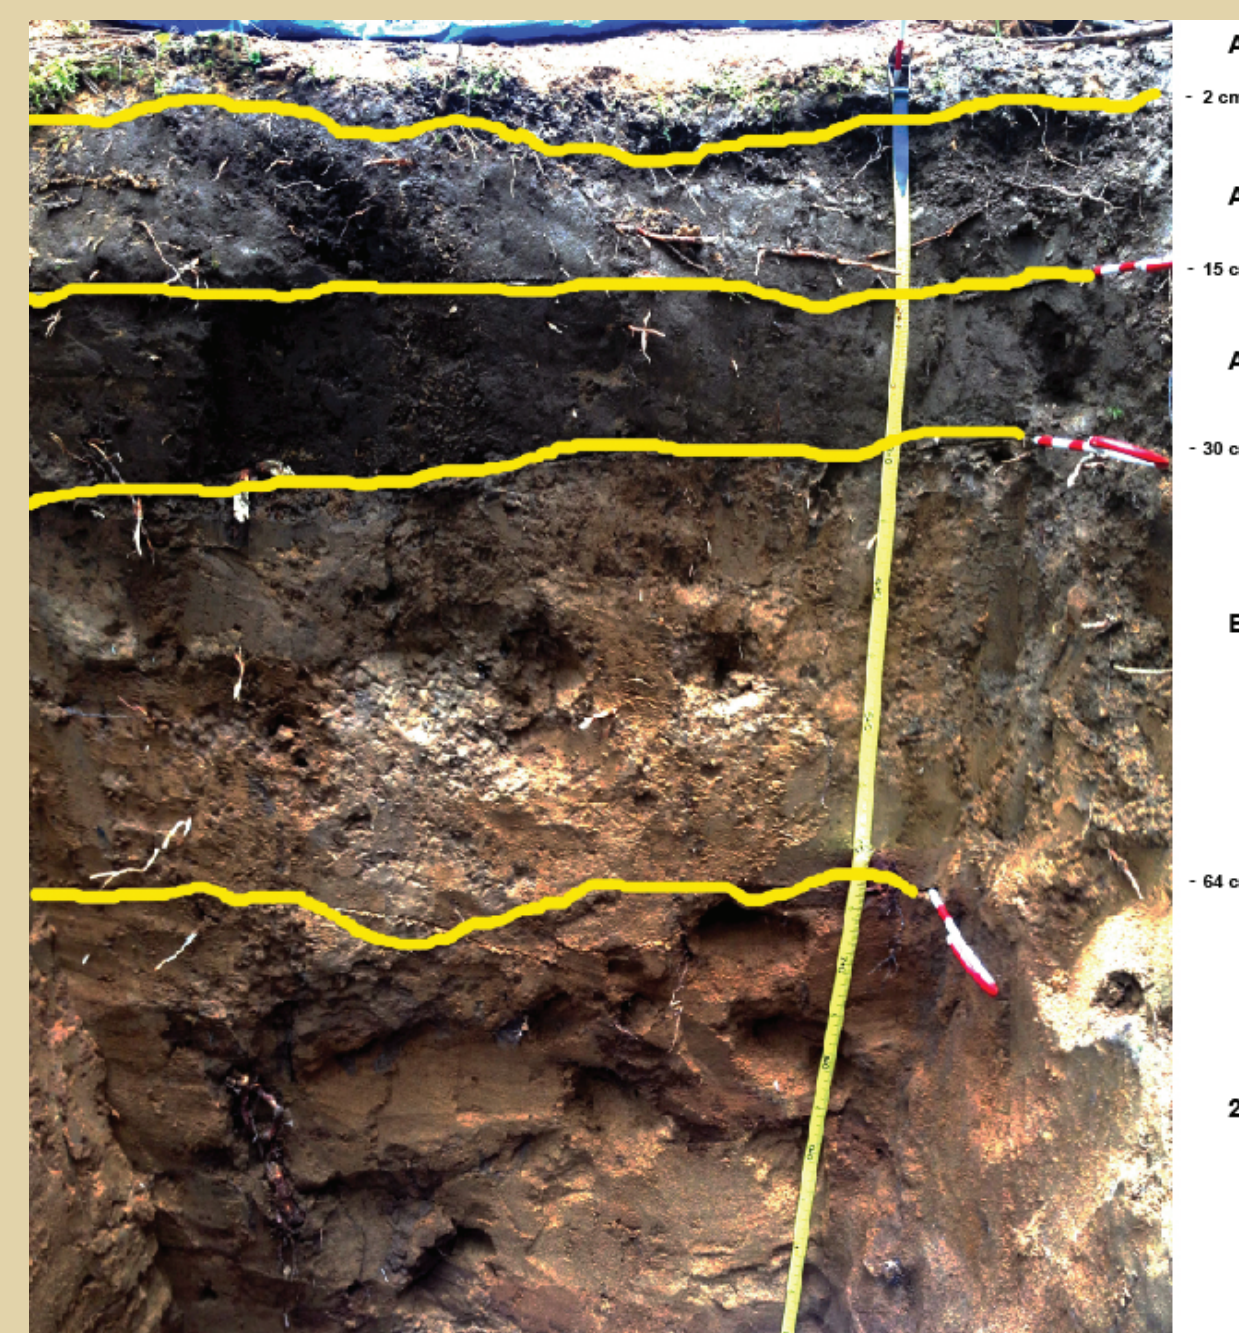
Figure 10. Photograph of soil profile 2014-3. Approximate horizon boundaries are shown by the yellow line. Horizon designations are on the right. This photo is a composite of two photos stitched at roughly 60 cm deep (Photograph by Matthew Brueske).

Table 3. Description of the soil profile exposed in soil pit 2014-3 (44.7646°N, 91.5080°W).

Horizon	Depth (cm)	Color	Texture	Structure, Consistence, Inclusions, Boundary
Ap1	0-2	10YR 3/2, Very Dark Grayish Brown	Silty Clay Loam	Moderate, fine, platy, very friable, non-sticky, moderately plastic; roots: fine, vertical, common; abrupt smooth
Ap2	2-15	10YR 3/2, Very Dark Grayish Brown	Silty Clay Loam	Moderate, fine, platy, very friable, non-sticky, moderately plastic; roots: medium, vertical, common; abrupt smooth
Ap3	15-30	10YR 3/2, Very Dark Grayish Brown	Silty Clay Loam	Moderate, fine, platy, very friable, non-sticky, moderately plastic; roots: fine, vertical, few; abrupt smooth
Bt	30-64	10YR 4/4, Dark Yellowish Brown	Sandy Clay Loam	Moderate, coarse, fine sub-angular blocky; very firm, non-sticky, non-plastic; roots: fine, vertical, few; clear smooth
2Cb	64-140	10YR 5/5, Yellowish Brown	Loamy Sand	Weak, fine, granular, friable, slightly sticky, non-plastic; roots: medium, vertical

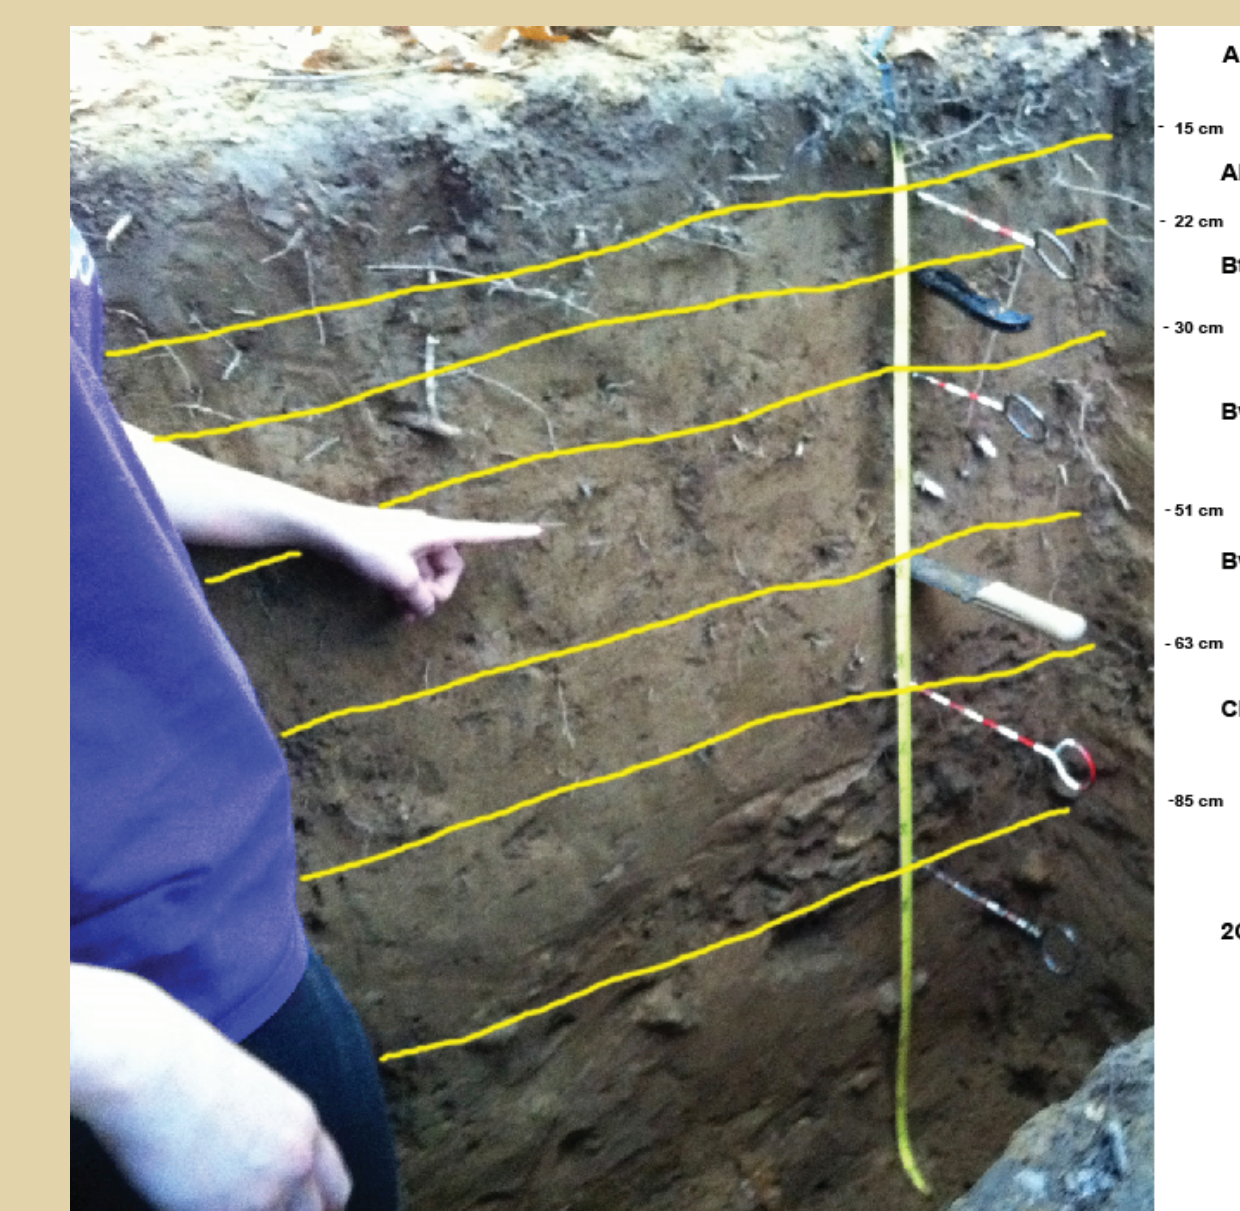
Figure 12. Photograph of soil profile 2014-4. Approximate horizon boundaries are shown by the yellow line. Horizon designations are on the right. (Photograph by Zach Hilgendorf).

Table 4. Description of the soil profile exposed in soil pit 2014-4 (44.7649°N, 91.5087°W).

Horizon	Depth (cm)	Color	Texture	Structure, Consistence, Inclusions, Boundary
A	0-15	10YR 4/2, Dark Grayish Brown	Sandy Clay Loam	Moderate, fine, sub-angular blocky; friable, non-sticky, moderately plastic; roots: very fine to fine, vertical, many; clear smooth
AE	15-22	10YR 4/3, Brown	Sandy Clay Loam	Moderate, fine, sub-angular blocky; friable, non-sticky, moderately plastic; roots: very fine to medium, vertical, common; clear smooth
Bt1	22-30	10YR 4/4, Dark Yellowish Brown	Sandy Clay Loam	Strong, fine to medium, sub-angular blocky; firm, non-sticky, very plastic; roots: fine, vertical, few; gradual smooth
Bw1	30-51	10YR 5/4, Dark Yellowish Brown	Sandy Clay	Strong, medium, sub-angular blocky; firm, non-sticky, very plastic; roots: medium, horizontal, few; gradual smooth
Bw2	51-63	10YR 4/6, Dark Yellowish Brown	Sandy Clay Loam	Strong, very fine, angular blocky; firm, non-sticky, very plastic; roots: fine to medium, no orientation, few; clear smooth

Cb	63-85	10YR 4/4, Dark Yellowish Brown	Sand	Weak, fine to medium, sub-angular blocky; friable, non-sticky, non-plastic; clastic quartz arenite, channels, sub-horizontal, many; clear smooth
2Cb	85-130+	10YR 5/5, Yellowish Brown	Sand	Weak, fine to medium, sub-angular blocky to massive, very friable, non-sticky, non-plastic; clastic quartz arenite, equiaxial; pebbles, no orientation, few
