**Rapid Strengthening  
of Reinforced  
Concrete Bridges**

**Lawrence C. Bank, Michael G. Oliva,  
Dushyant Arora and David T. Borowicz  
University of Wisconsin - Madison  
Department of Civil and Environmental Engineering**

October, 2003

WHRP 03-06

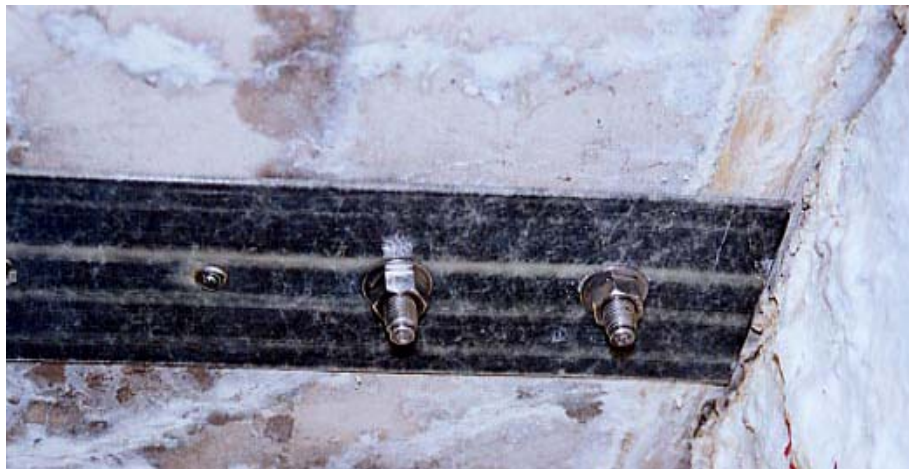
Figure 4.24. Installed end anchor next to the abutment

The strips were predrilled at the locations of the anchor bolts using the rotary hammer drill with the nominal diameter of the anchor bolt. The hole was then cleaned before the anchors bolts were inserted. Once the anchor was inserted in the drilled hole, the anchors were hammered into place (taking care not to damage the FRP strip). The anchor bolts were then tightened using a socket wrench. Figure 4.24 shows the installed end anchors near the support ends.

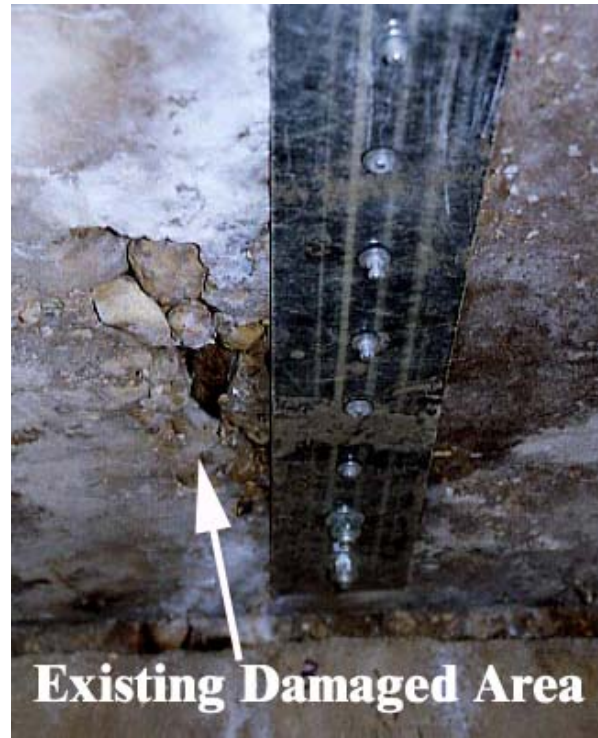
Figure 4.29. Relocated FRP strip near existing local damaged area

In a situation where the row of fasteners was anticipated to achieve improper embedment the FRP strip was slightly re-positioned. Figure 4.29 shows the position of the FRP strip in close proximity to a local damaged area. The strip was moved a few inches to avoid the damaged area.

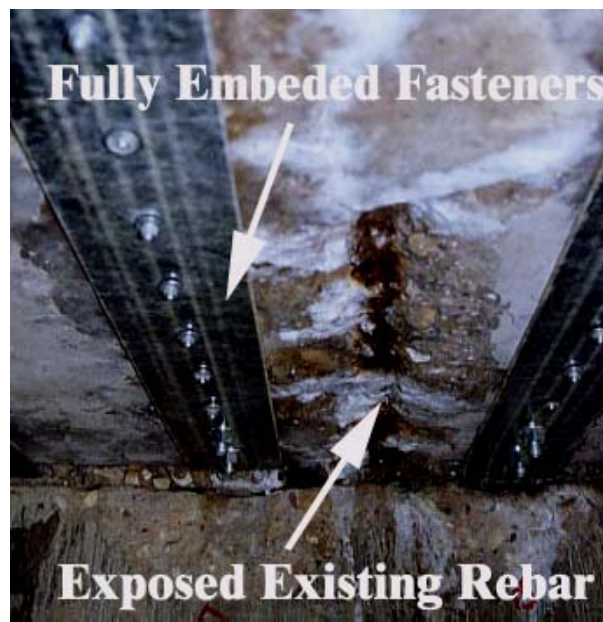
Figure 4.30. Existing damaged area in the bridge with the exposed steel reinforcement

Local damage in the existing concrete substrate did not cause a problem with the fastening of the FRP strip. Figure 4.30 shows an existing damaged area in the bridge with the exposed steel reinforcement.

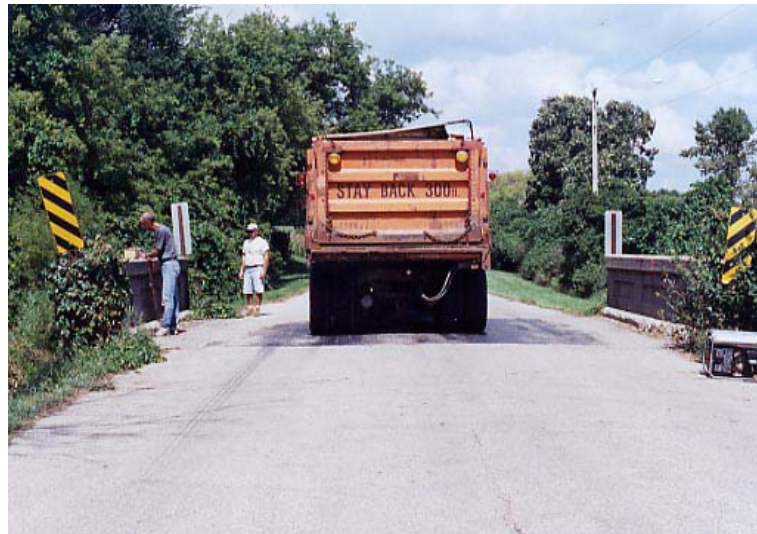
Figure 4.36. Load Case I on bridge P-53-702

The load cases were considered to represent the most extreme loading conditions possible. Because of the transverse symmetry of the structure, only one lane was tested. Figure 4.36 shows Load Case I on the bridge after strengthening.

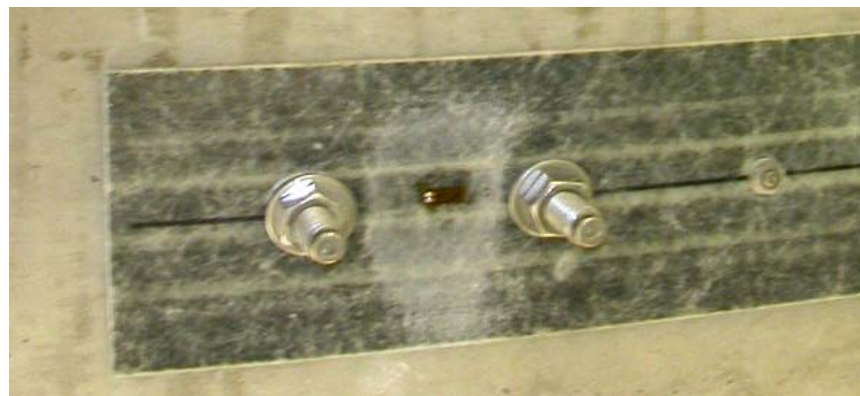
Figure 5.7. End anchor bolts and end fastener for FRP2 SS

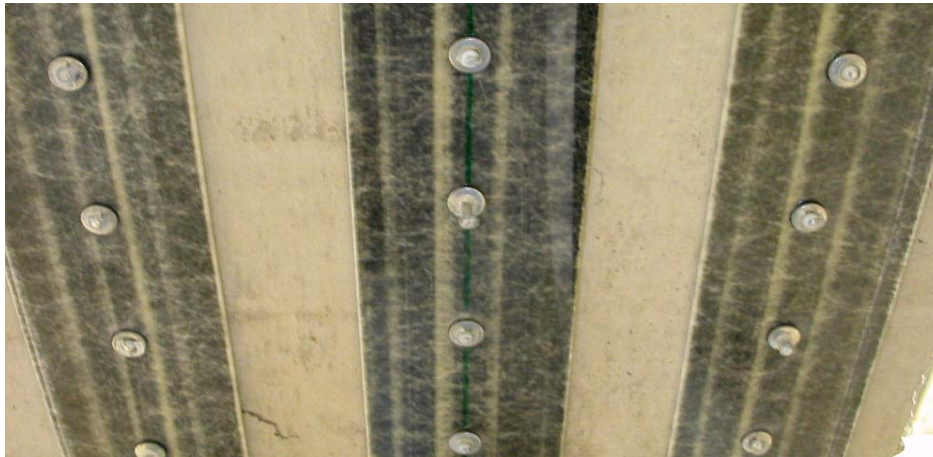
Figure 5.8. FRP 3 beam strengthened with three FRP strips

Figure 5.8 shows the relative positions of the FRP strips for beam FRP 3 strengthened with three FRP strips.

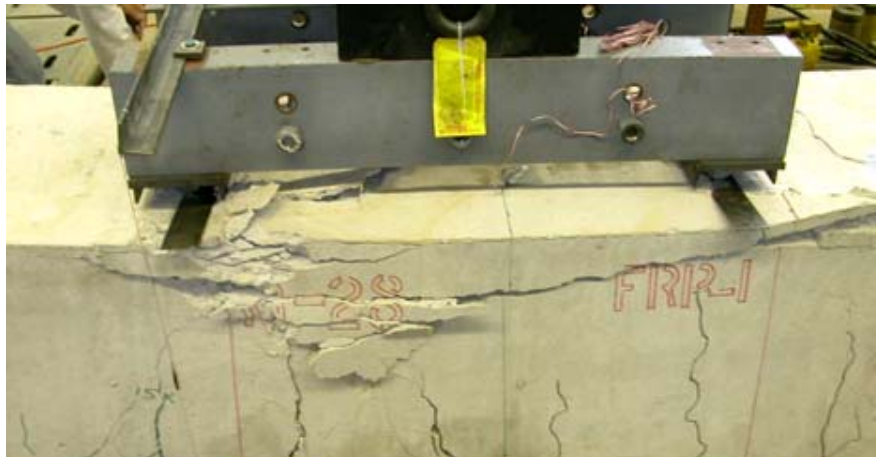
Figure 5.22. Concrete compression failure of FRP1

During the initial loading of the strengthened beam flexural cracks, which traveled upwards as the loading increased, were seen in the moment span. At the point of yield, the cracks in the moment span were visibly larger. Beyond the yielding of the concrete, the beam continued to gain strength until concrete compression failure occurred near one of the load points. At first, local crushing was observed which eventually developed into the entire top of the beam failing due to concrete compression. A load drop was seen at this point. Figure 5.22 shows the concrete compression failure in the moment span.

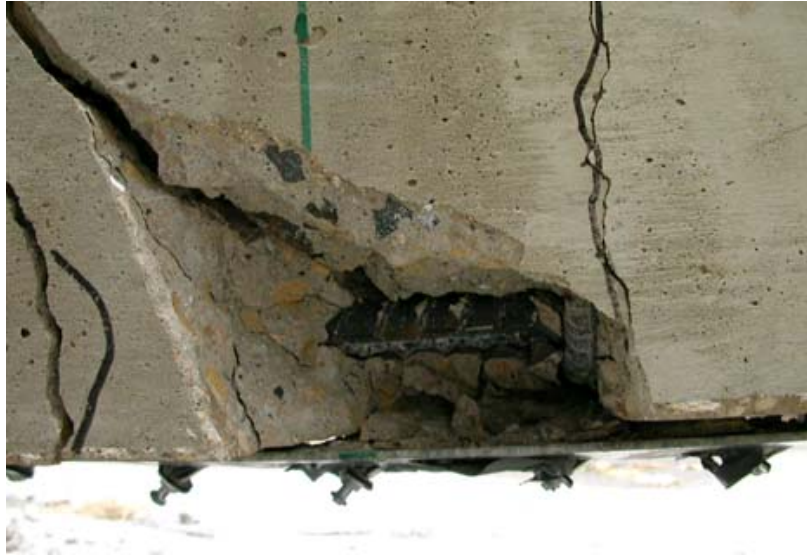
Figure 5.26. Secondary failure mode of beam FRP 1 due to fastener pullout

This bearing failure was seen to decrease towards the center of the beam. A shear-out failure of the FRP strips at one of the ends of the beams was seen. In the middle of the span, under one of the load points, fastener failure due to pullout was seen. A concrete “tooth” failure was also noted. Figure 5.26 shows this failure.

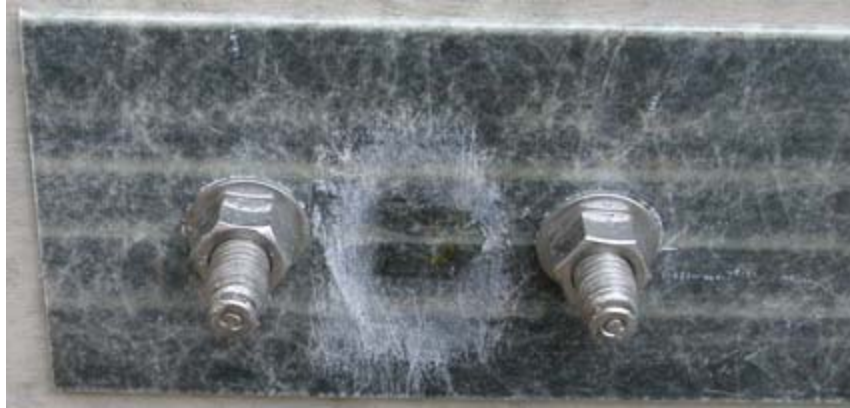
Figure 5.33. FRP strip at the end for beam FRP 2SS (post failure)

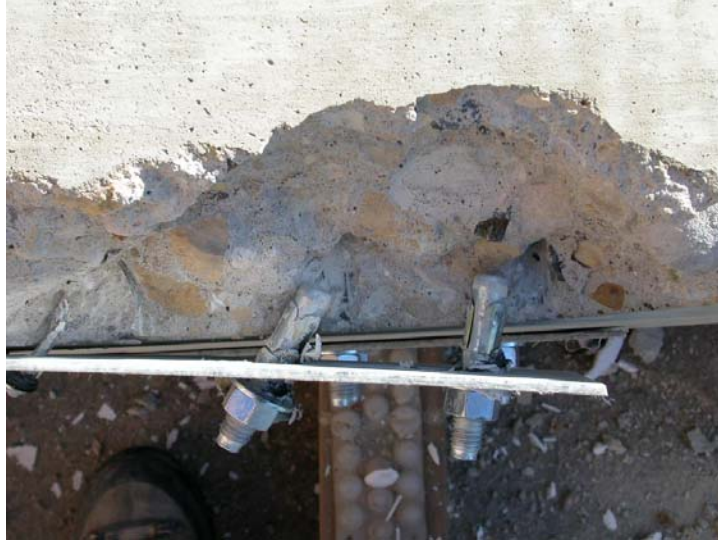
Figure 5.49. Final end-anchor pullout failure in beam FRP 3

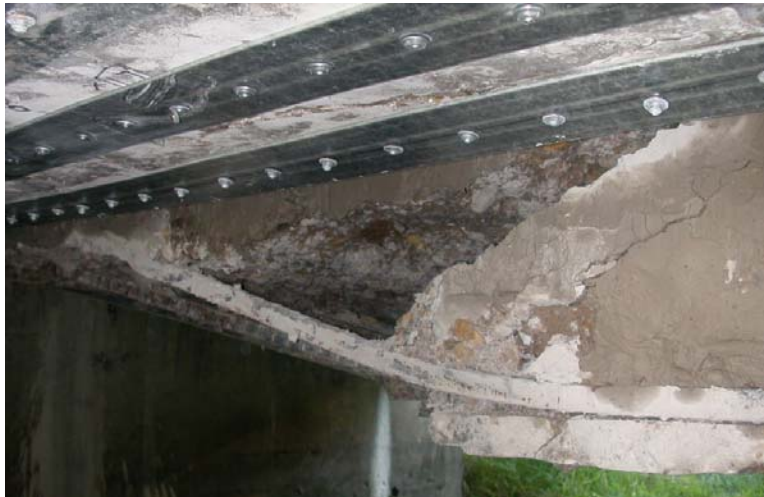
Figure 6.19. Shear failure and spalling along southeast portion of west section

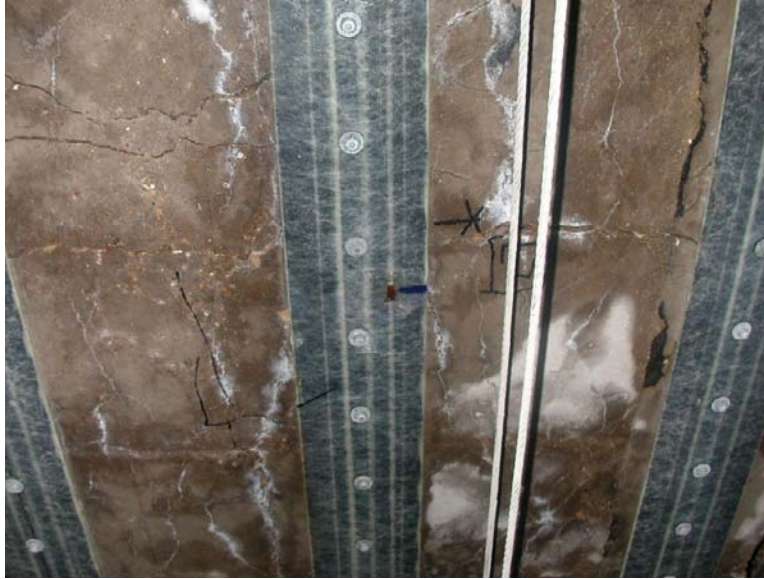
Figure 6.20. Flexural cracks at midspan of west section (during test)

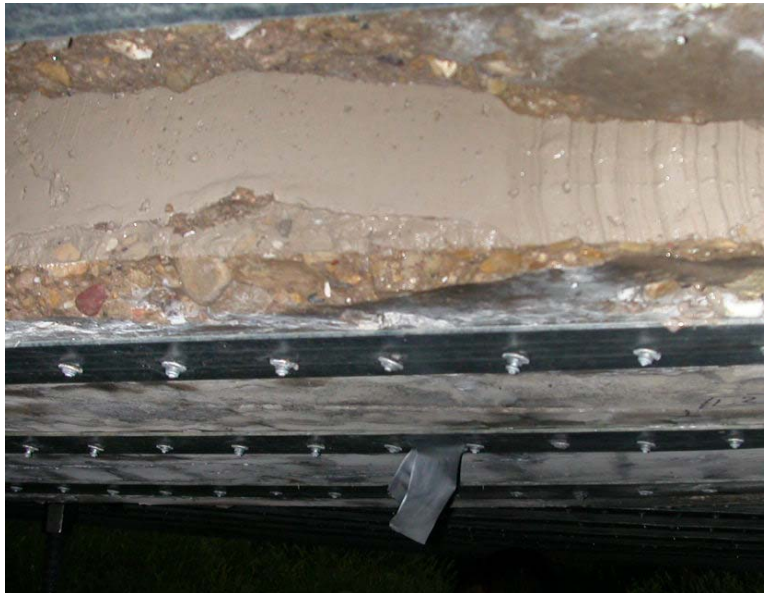
Figure 6.21. View of rotated fasteners along length of west section

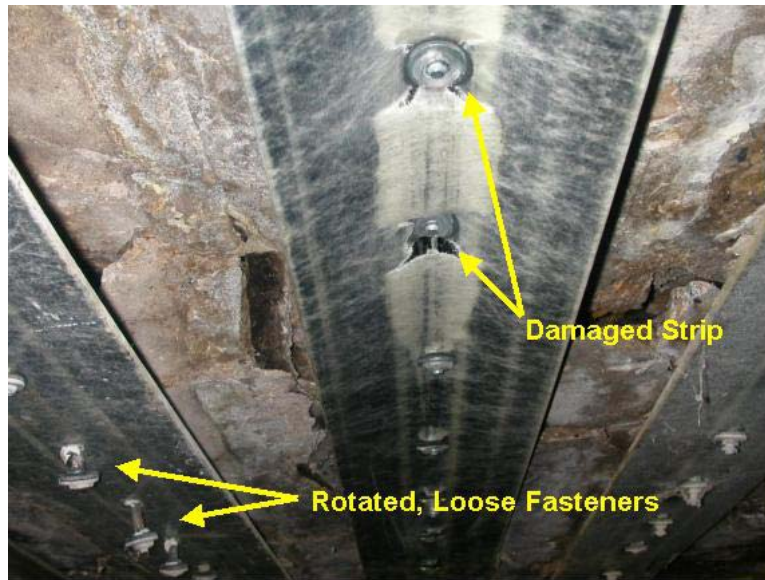
Figure 6.24. View of strips on east section after test completion

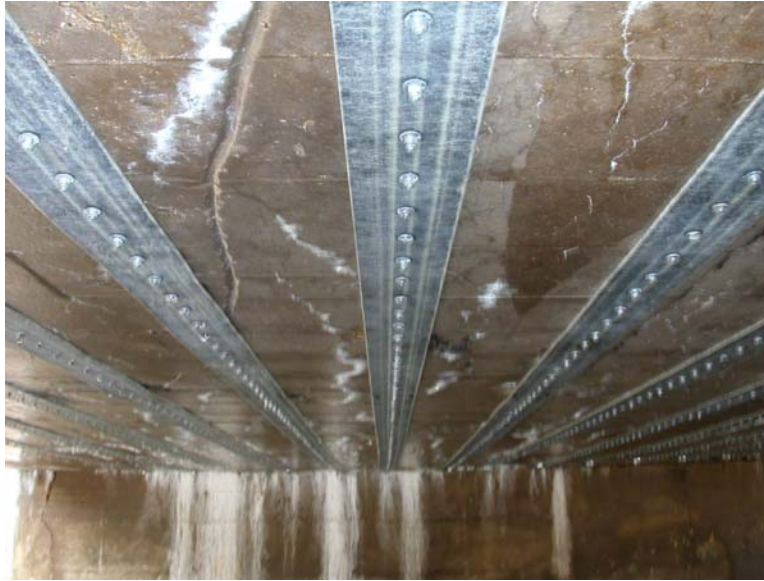
Figure 6.36 Overall view of the retrofitted bridge deck after ten months

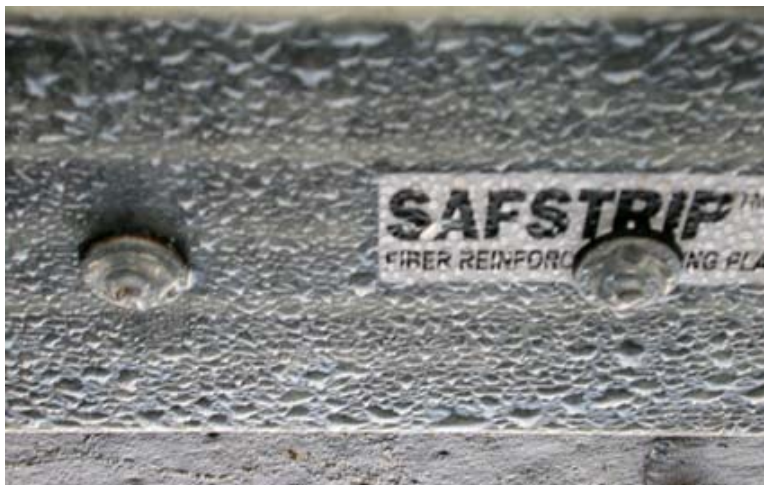
Figure 6.37. FRP strips covered with moisture (spring, 2003)

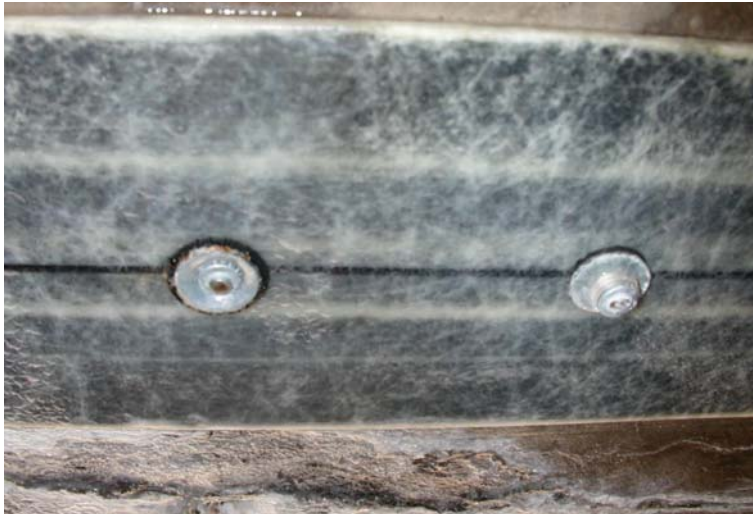
Figure 6.38. Small amount of corrosion seen at the southern end

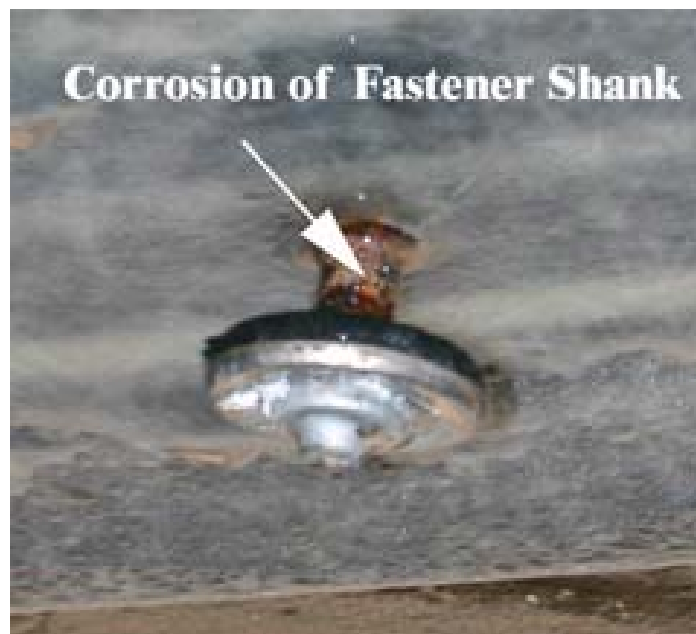
Figure 6.42. Corrosion of ALH fastener shank with incomplete embedment

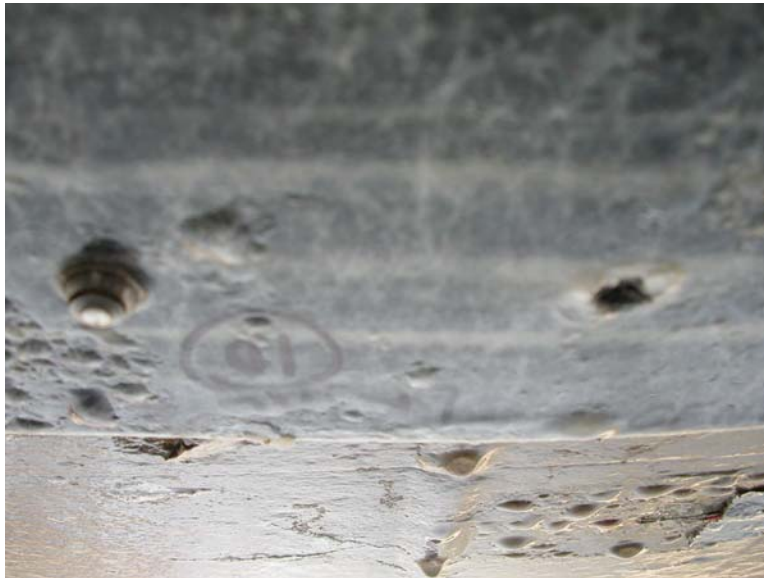
Figure 6.44. Deterioration of FRP strip at location of missing fastener

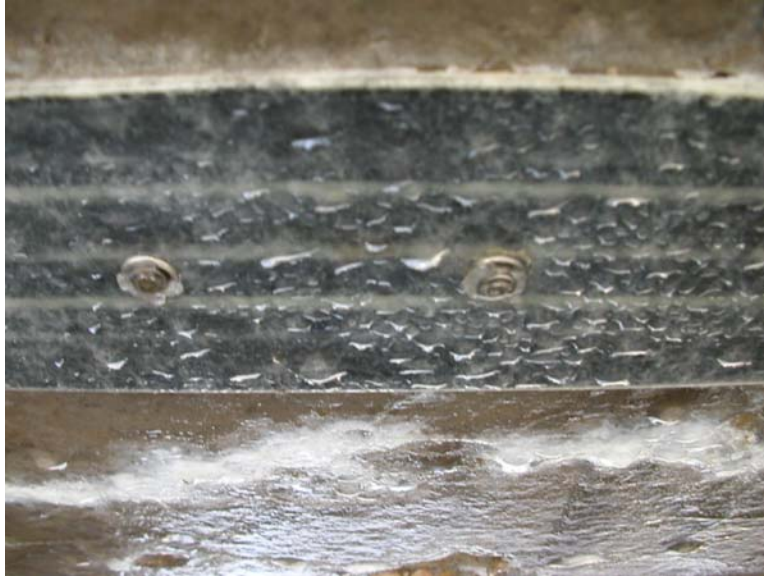
Figure 6.45. Edge of FRP strips covered with water

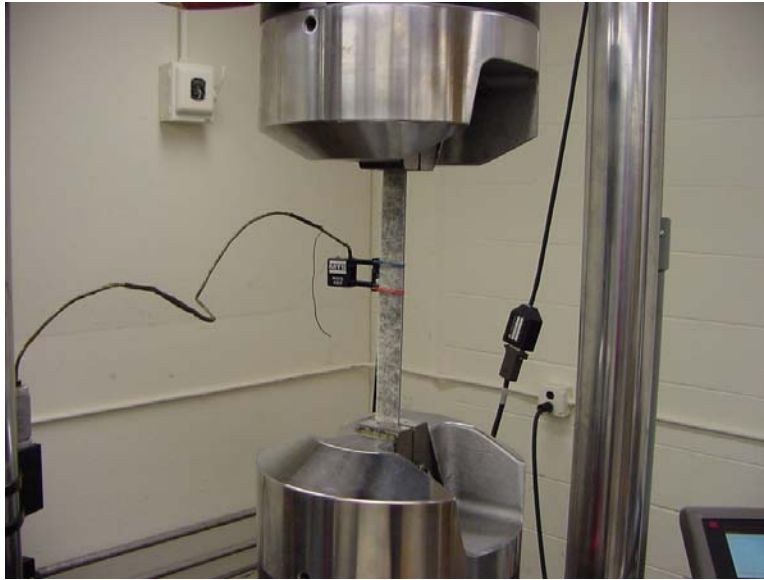
Figure 6.46. Testing a coupon of recovered material (no hole)
