**Concrete Cracking in
New Bridge Decks
and Overlays**

SPR # 0092-09-06

**Baolin Wan, Ph.D, Christopher Foley, Ph.D, P.E., and Jordan Komp
Transportation Research Center
Department of Civil and Environmental Engineering
Marquette University
March 2010**

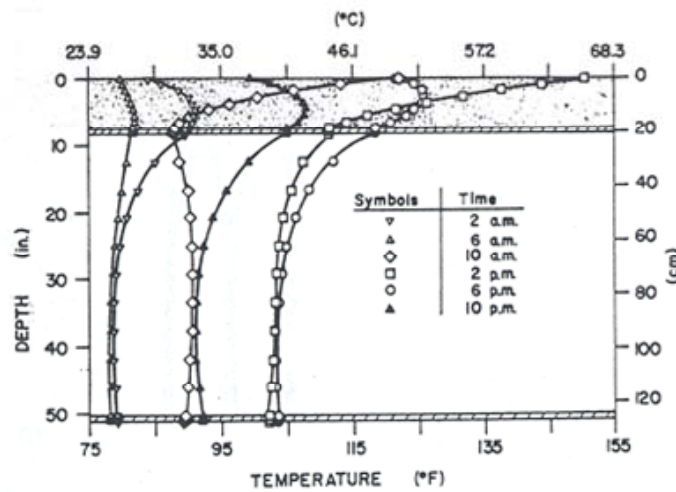
Figure 2.3 Thermal Gradient (Saadeghvaziri and Hadidi 2002).

Indirect loading can also be caused by internal restraint, including unequal shrinkage caused by differing rates of moisture loss through a bridge deck thickness and temperature gradients throughout the thickness of the concrete bridge deck. In cases of unequal restraint through the height of the concrete deck, it is common for tensile stresses to develop near the surfaces of the deck, while compressive stresses develop in the inner portions of the deck thickness (PCA 1970).

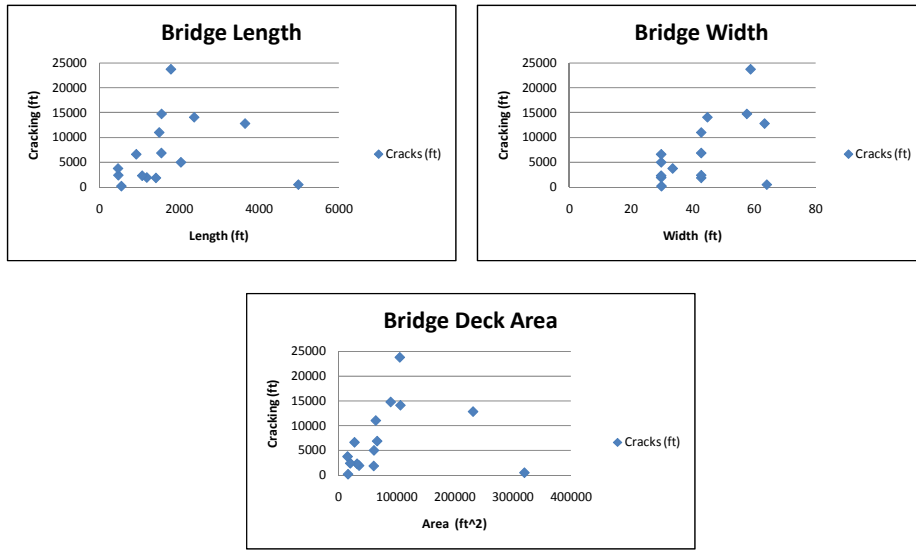
Figure 3.3 Cracking Based on Length, Width, and Area.

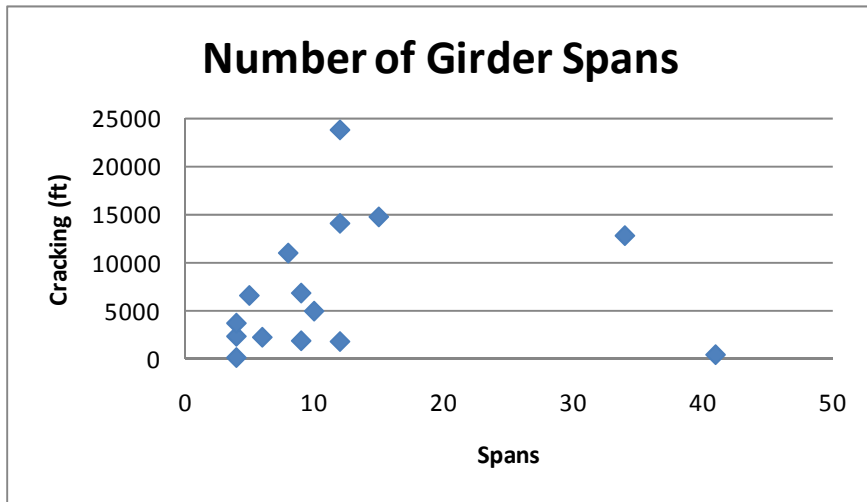
Figure 3.5 Cracking vs. Number of Superstructure Spans.

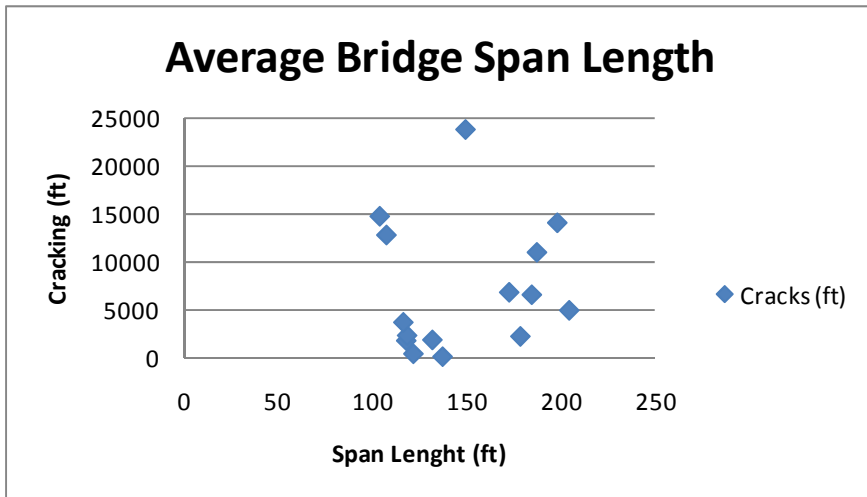
Figure 3.6 Cracking vs. Average Span Length.

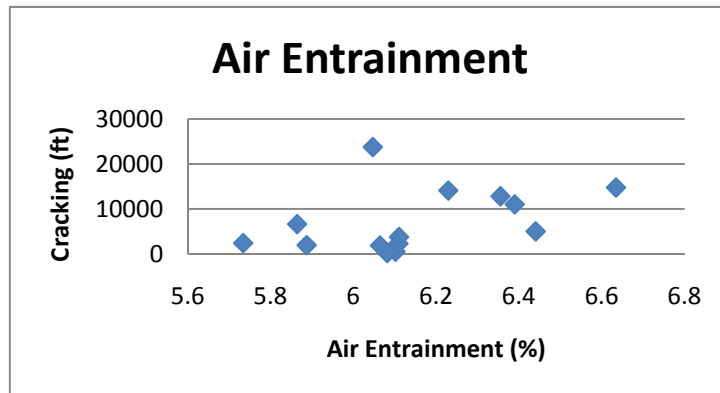
Figure 3.8 Cracking vs. Air Entrainment.

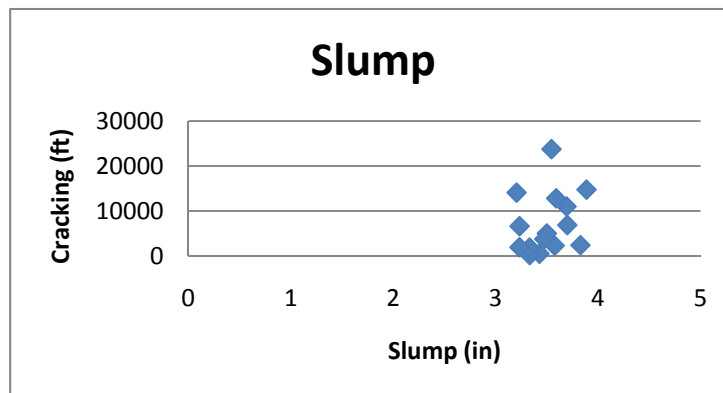
Figure 3.9 Cracking vs. Slump.

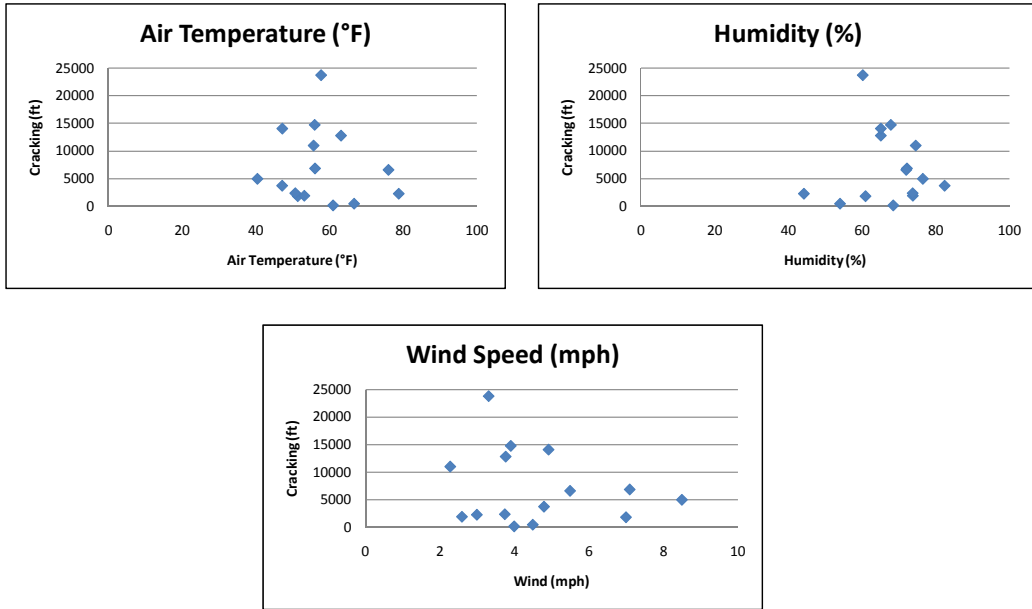
Figure 3.10 Cracking vs. Air Temperature, Humidity, and Wind.

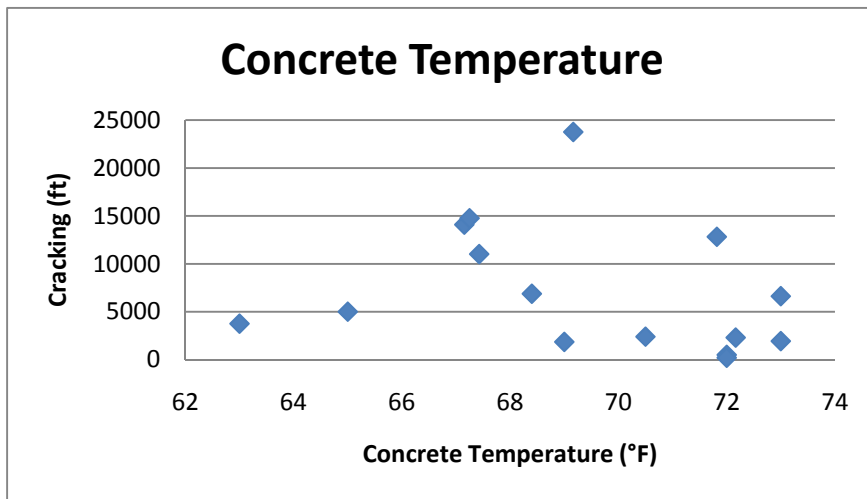
Figure 3.11 Cracking vs. Concrete Temperature.

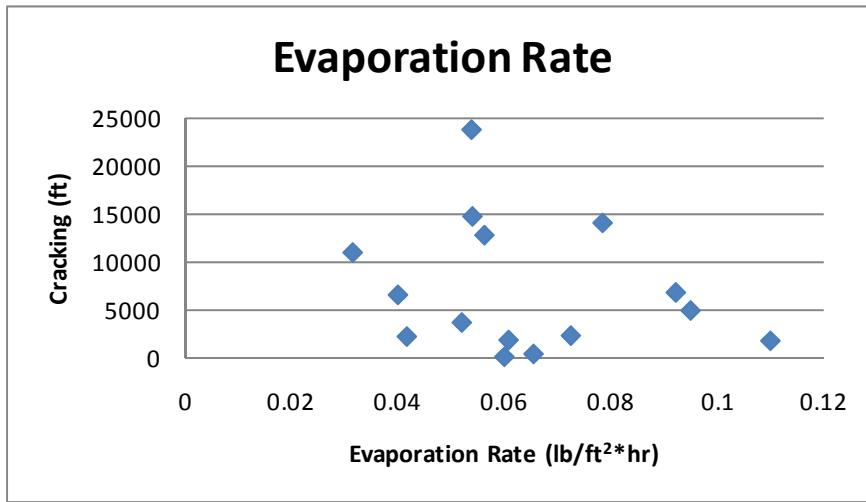
Figure 3.12 Cracking vs. Evaporation Rate.

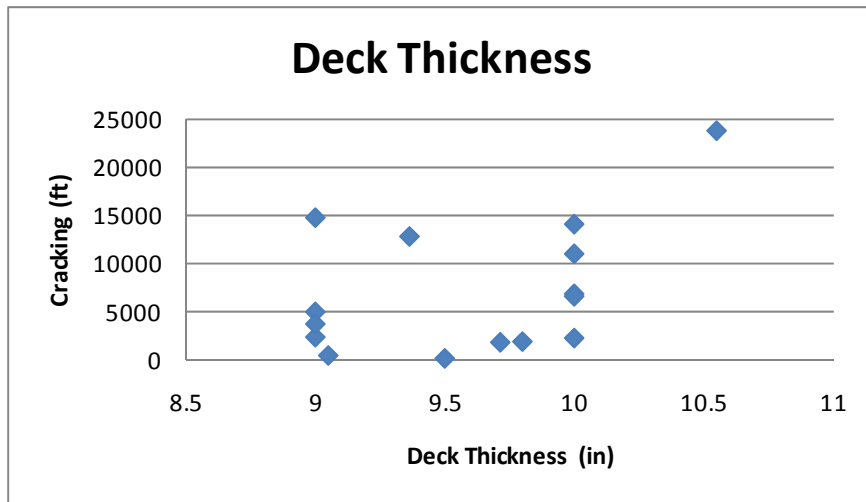
Figure 3.13 Cracking vs. Deck Thickness.

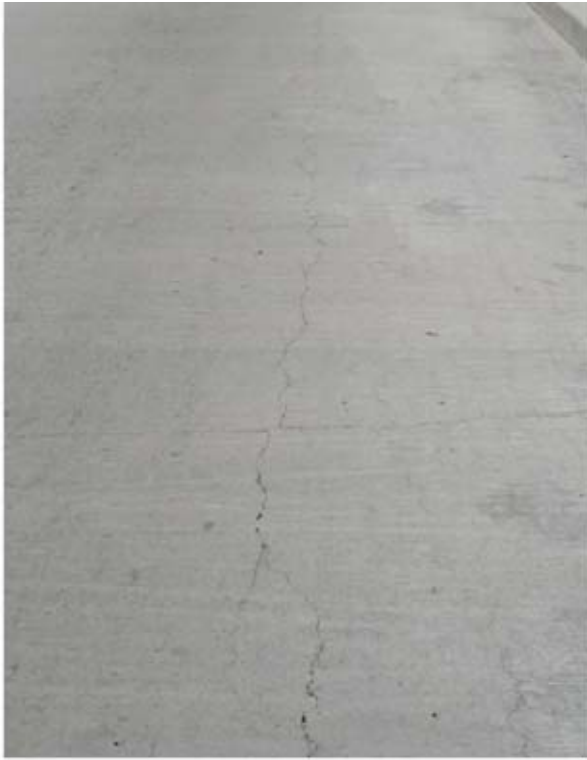
(a) B-40-692 Longitudinal Cracks

Figure 4.2 Bridge B-40-692 Deck Cracking.

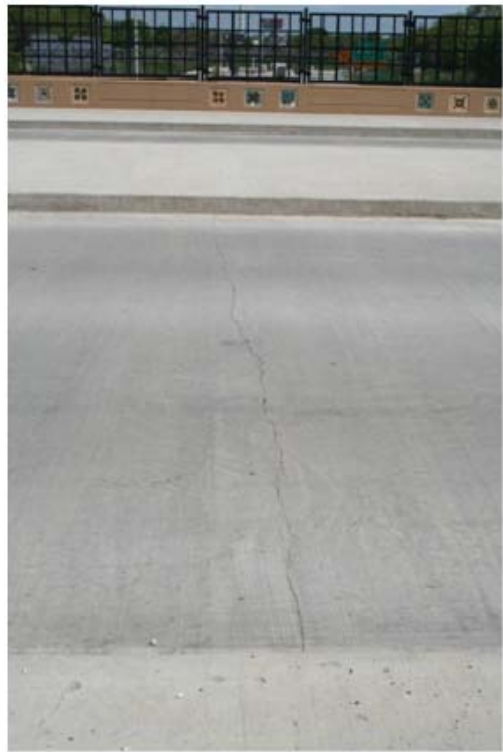
(b) B-40-692 Transverse Cracks

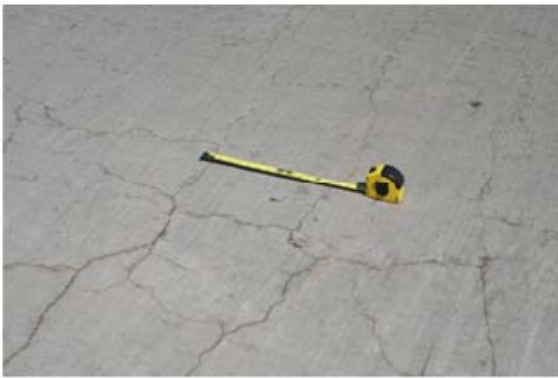
(c) B-40-692 Map Cracks

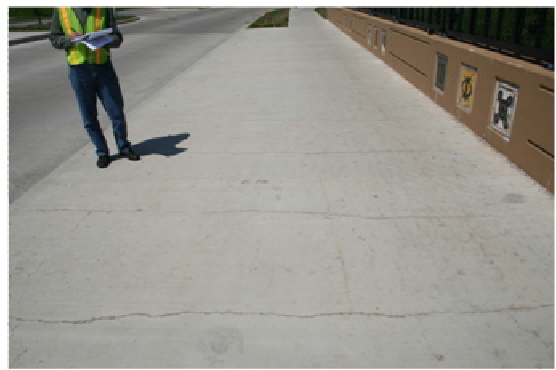
(d) B-40-692 Cracks in Sidewalk

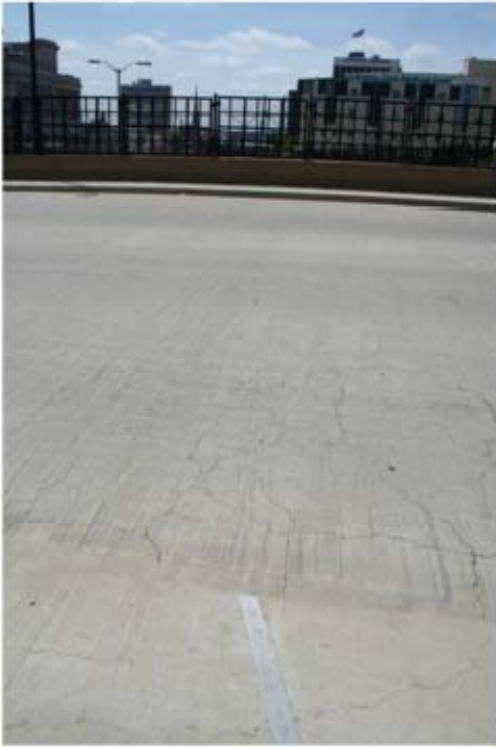
(a) B-40-686 Map Cracks

Figure 4.4 Bridge B-40-686 Deck Cracking.

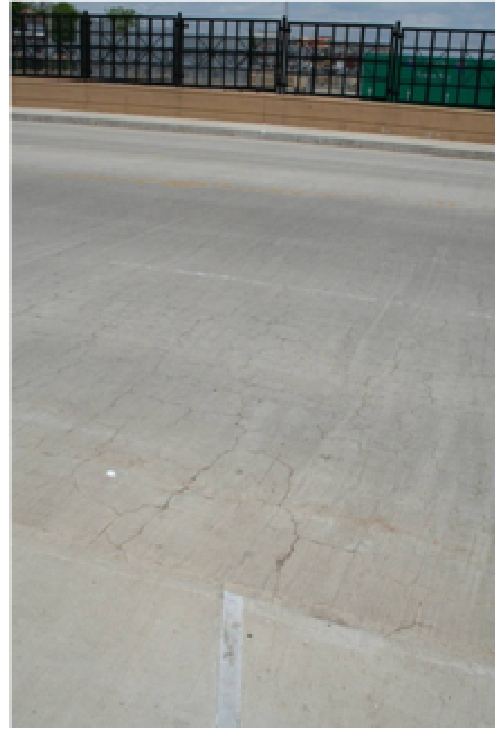
(b) B-40-686 Transverse Cracks

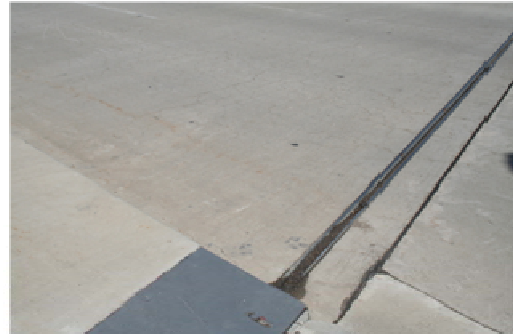
(d) B-40-686 East Support (No Cracks)

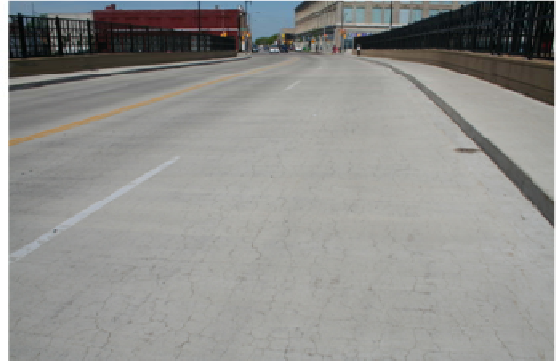
(b) B-40-689 Longitudinal Cracks

Figure 4.6 Bridge B-40-689 Deck Cracking.

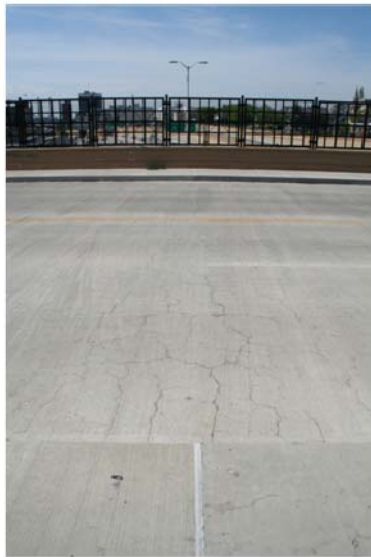
(c) B-40-689 Map Cracks

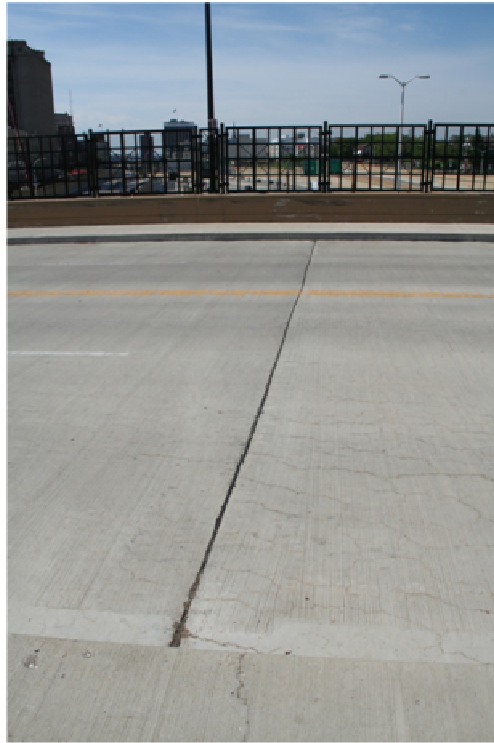
Figure 4.7 Bridge B-40-689: Longitudinal Cracks at the Construction Joint.

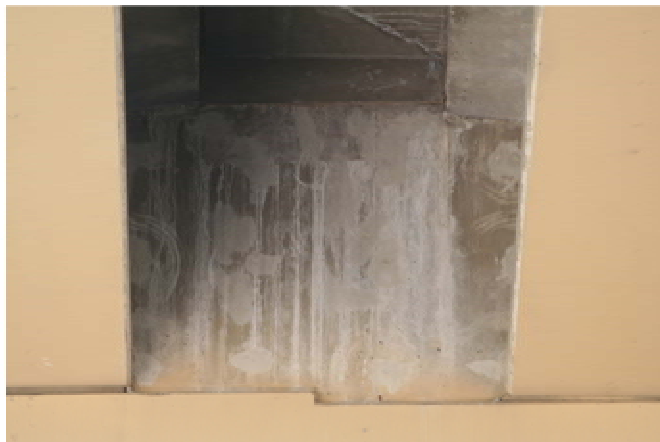
Figure 4.8 Bridge B-40-689: Diagonal Cracks at the piers.

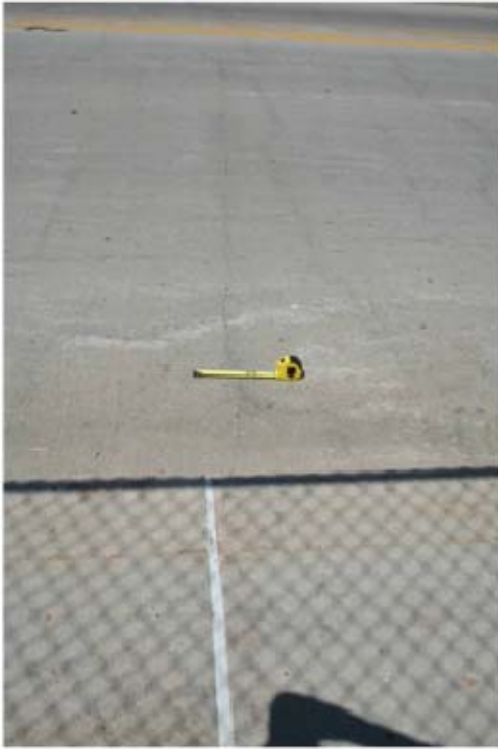
(a) B-40-429 Transverse Cracks on Top

Figure 4.10 B-40-429 Deck Cracking.

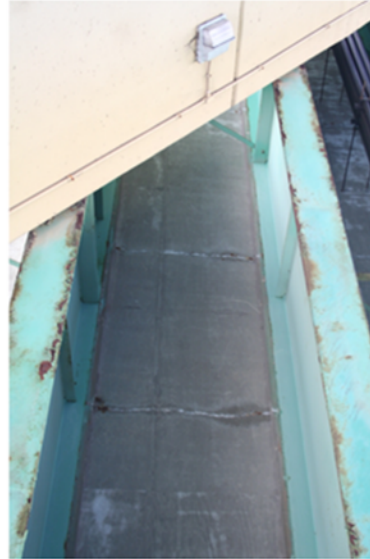
(b) B-40-429 Transverse Cracks on Bottom

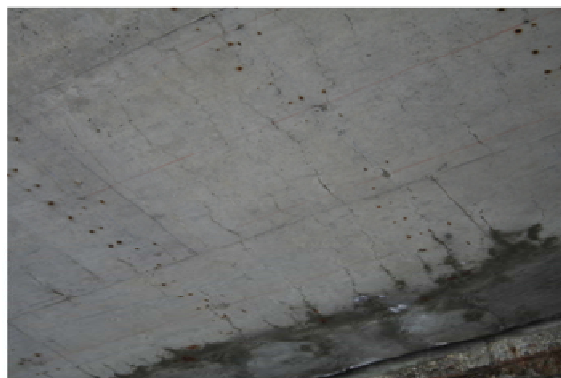
(b) B-67-293/294 Transverse Cracks

Figure 4.12 Bridge B-67-293/294 Deck Cracking.

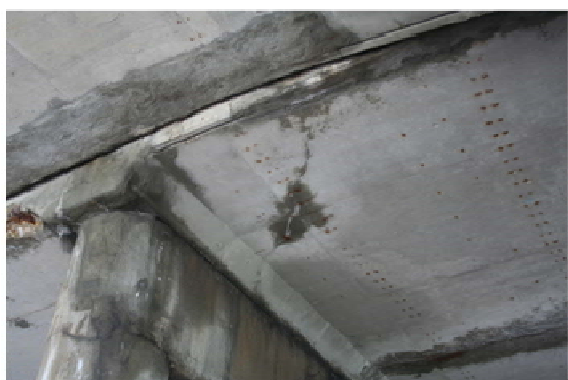
(c) B-67-293/294 Diagonal Cracks

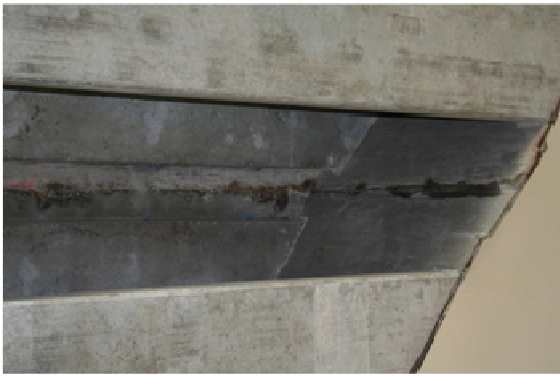
(a) B-67-296/297 Longitudinal Cracks

Figure 4.14 Bridge B-67-296/297 Deck Cracking.

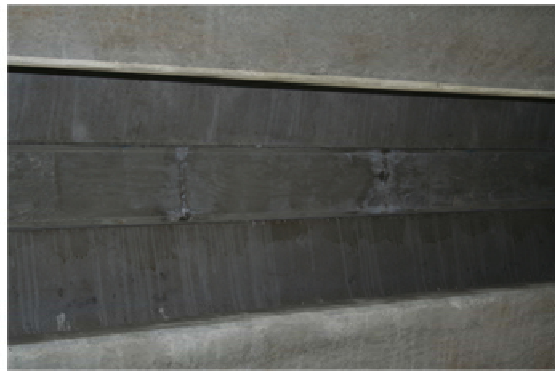
(b) B-67-296/297 Transverse Cracks

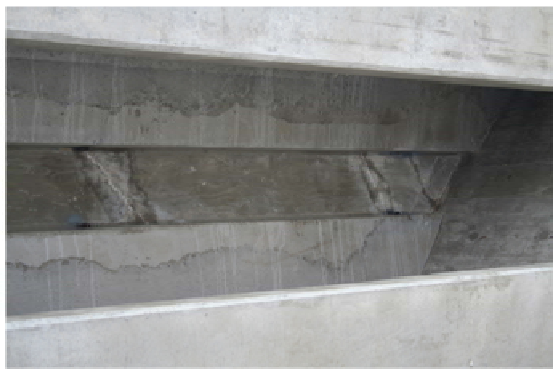
(c) B-67-296/297 Diagonal Cracks

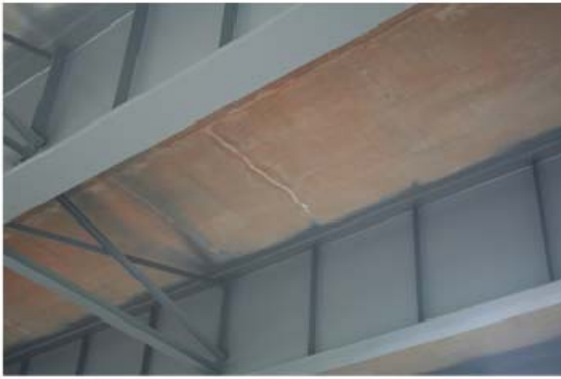
(a) B-67-134/135 Transverse Cracks

Figure 4.16 Bridge B-67-134/135 Deck Cracking.

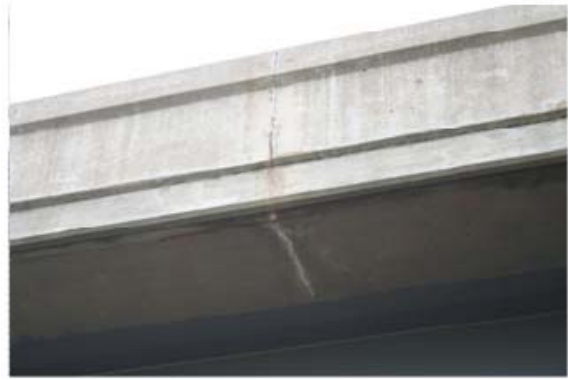
(b) B-67-134/135 Transverse Cracks at Barriers

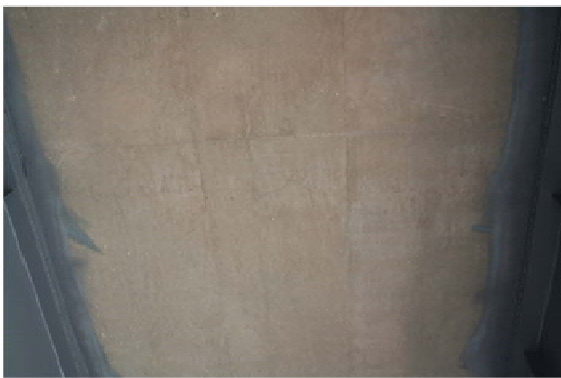
(c) B-67-134/135 Longitudinal Cracks

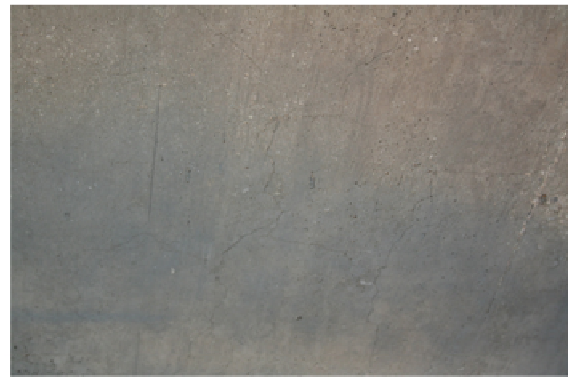
(c) B-67-134/135 Map Cracks

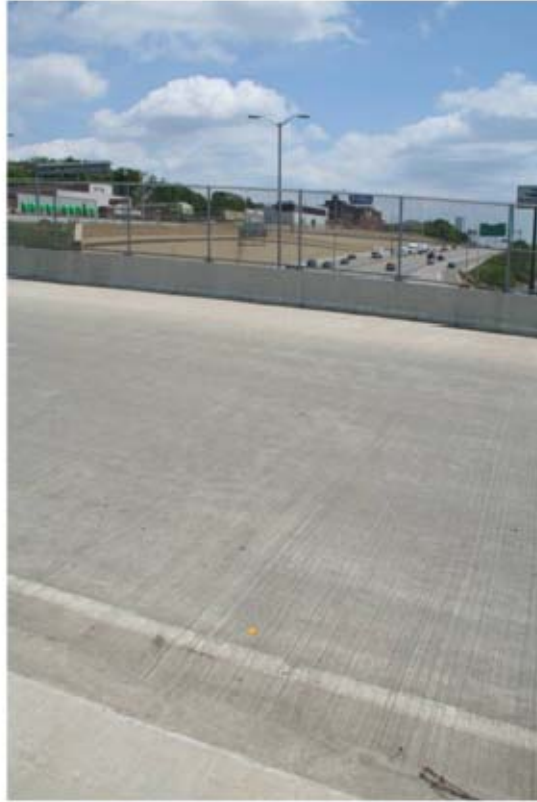
Figure 4.19 Bridge B-40-34 Deck Cracking (Transverse Cracks).

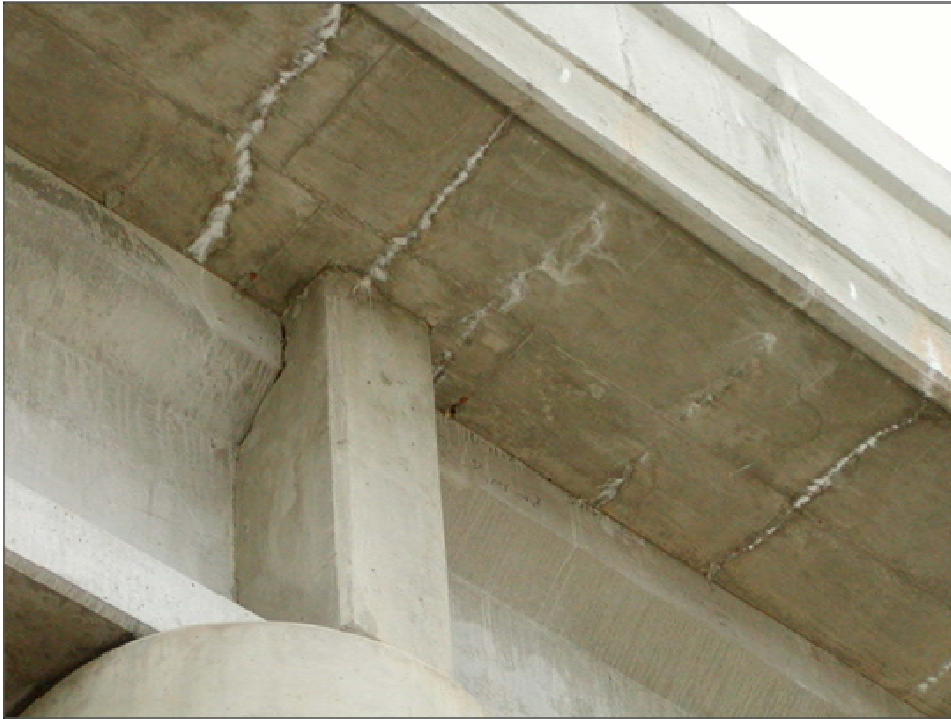
Figure 5.3 Cracking with Efflorescence (South Side of B-20-133 above Central Pier).

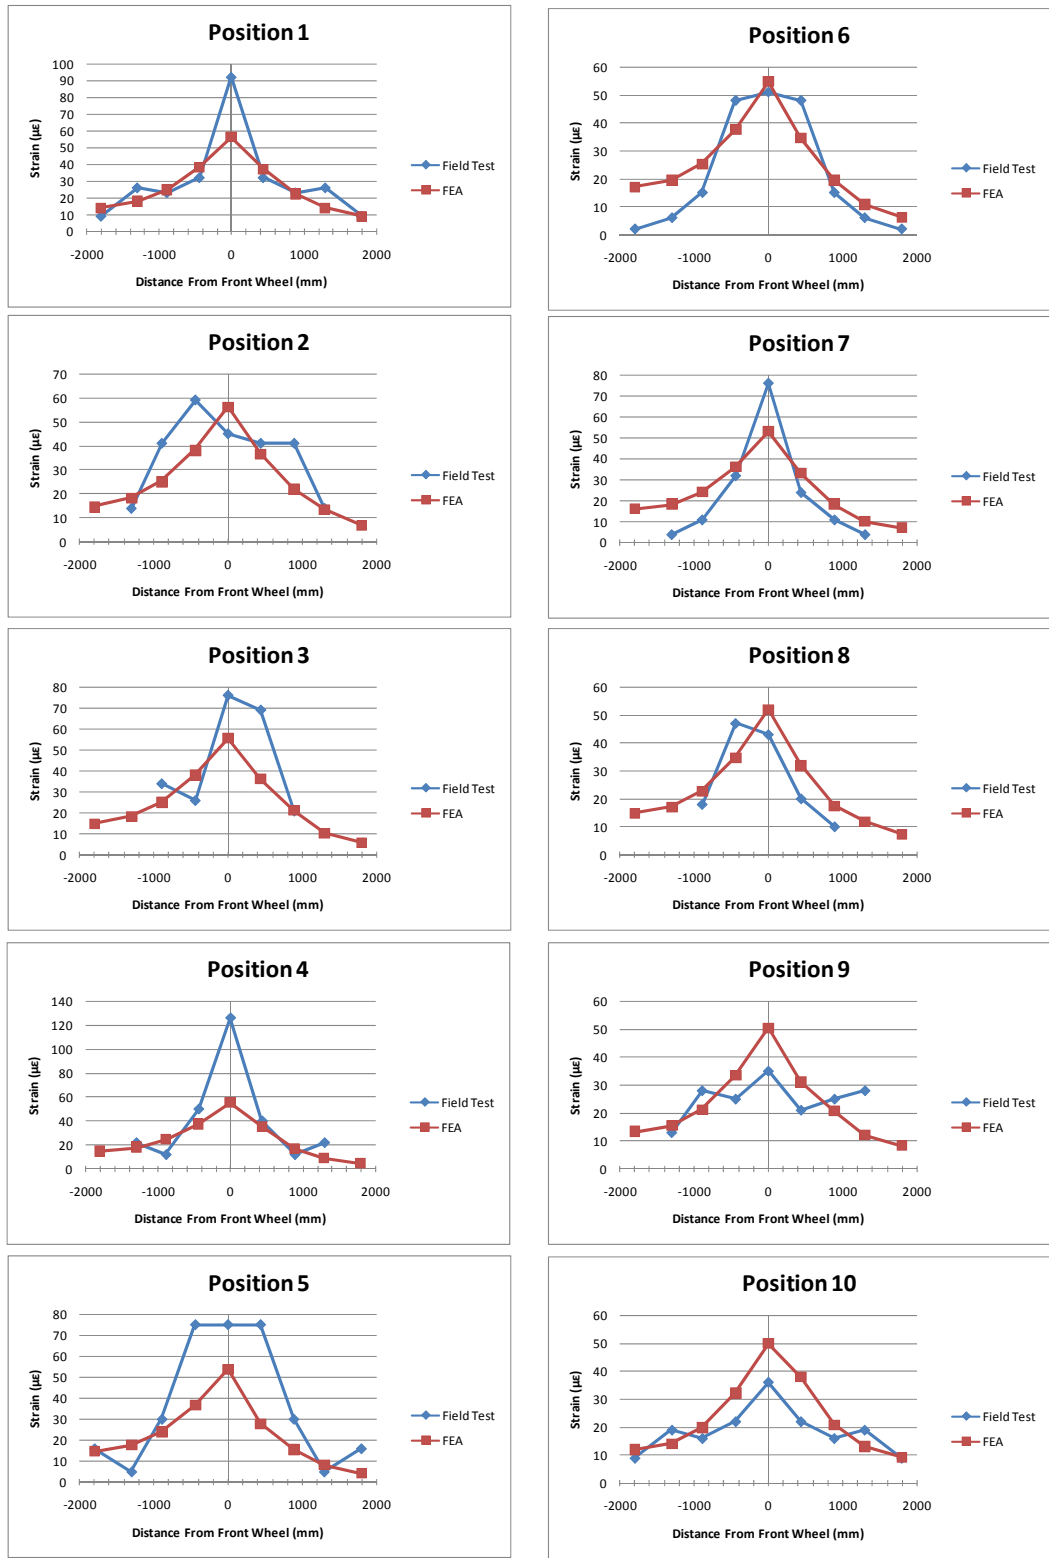
Figure 5.15 Transverse Deck Strains obtained from finite element analysis and field load test.

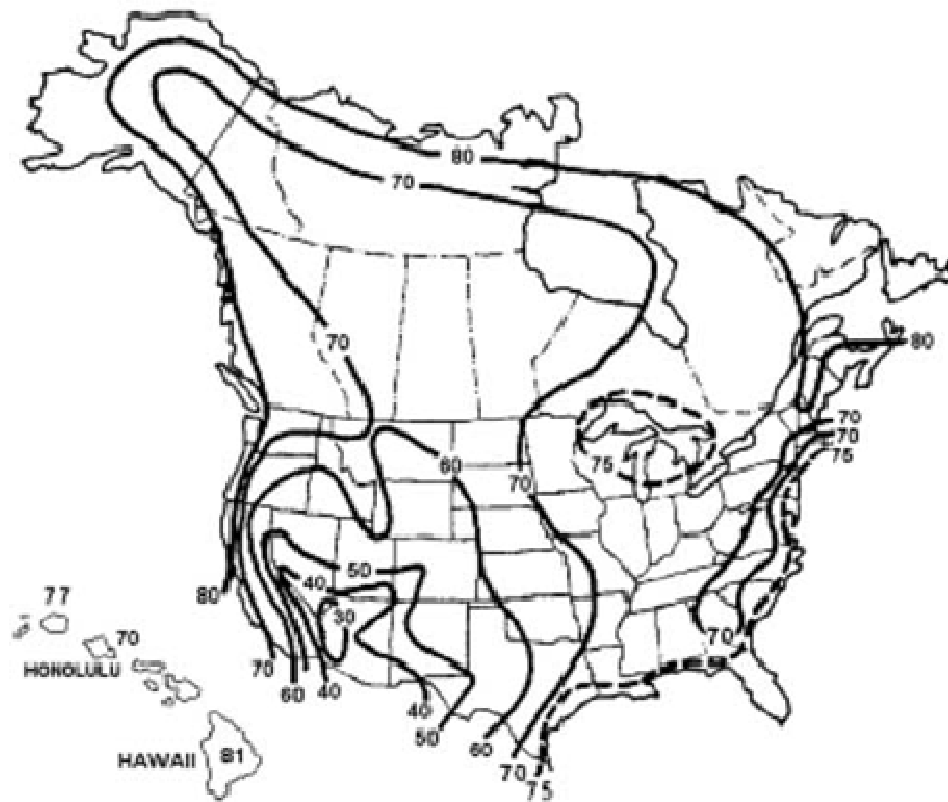
Figure 5.25 Topographic Map of United States Humidity (Tadros and Al-Omaishi 2003).

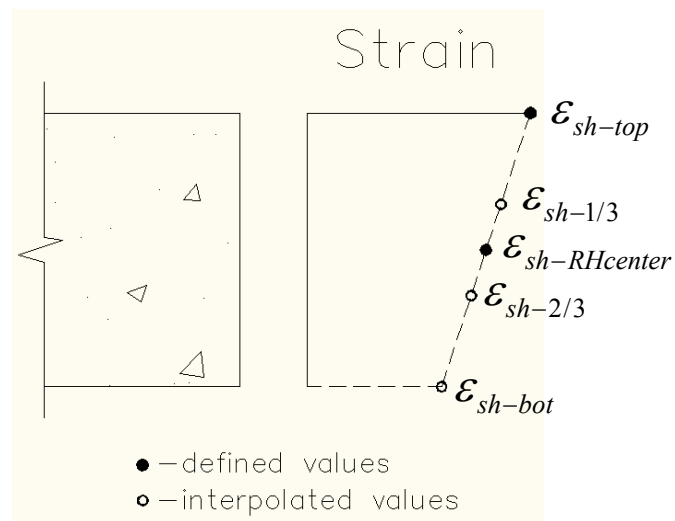
Figure 5.26 Shrinkage Strain Distribution throughout the Deck.

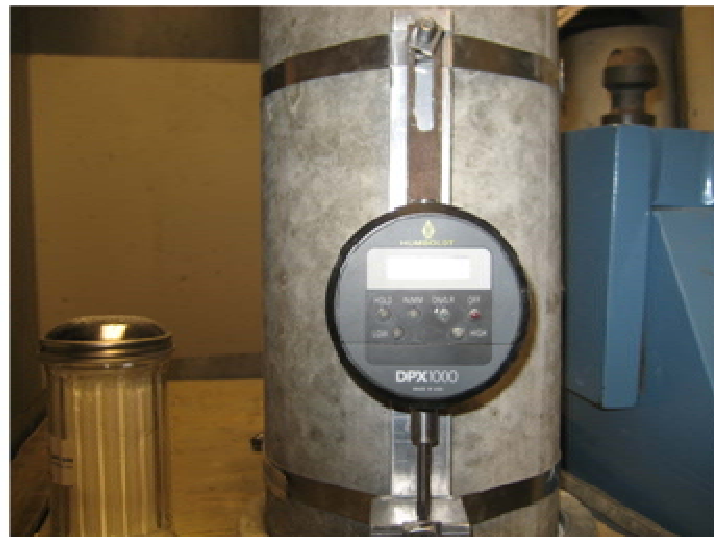
Figure 6.4 Modulus of Elasticity Test Setup.

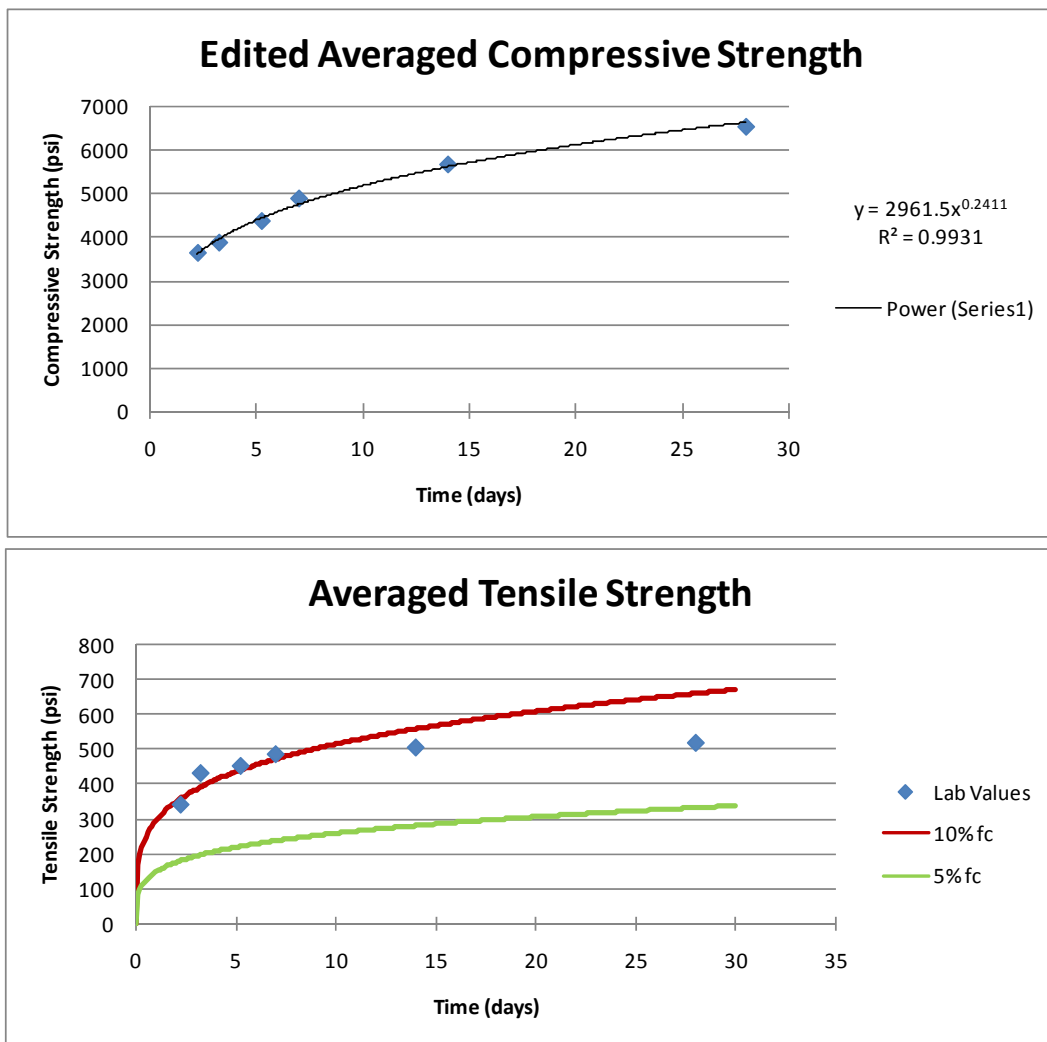
Figure 6.10 Tensile Strength vs. 10% and 5% of Compressive Strength.
