**ASSESSMENTS OF CONCRETE INTERNAL DAMAGE CAUSED  
BY FREEZE-THAW CYCLES AND MECHANICAL LOADING**

A Thesis Submitted in  
Partial Fulfillment of the  
Requirements for the Degree of

Master of Science  
in Engineering

at  
The University of Wisconsin-Milwaukee

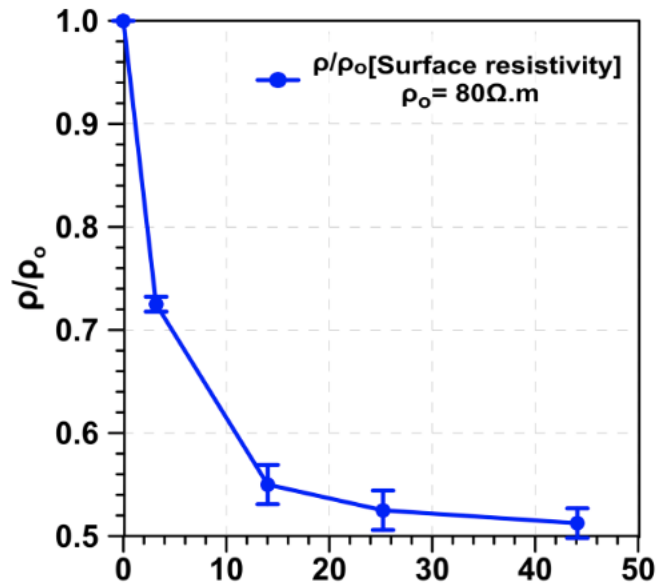
Figure 2.2: The surface resistivity of specimens with different degrees of damage.

In resistivity test, resistivity decrease with high rate of damage due to the freeze-thaw cycles in concrete. With further increase of damage the electrical resistivity decreases with a lower rates

as shown in Figure 2.3. It indicates that electrical resistivity might only be sensitive to low damage levels.

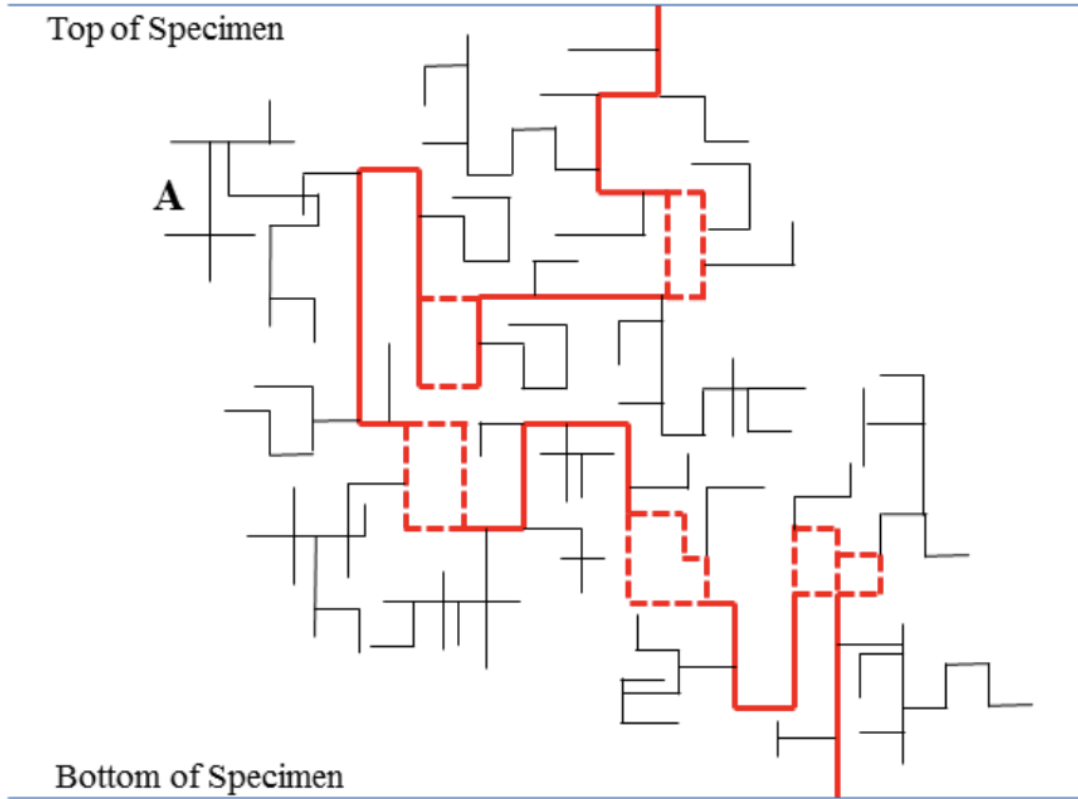
Figure 2.3: The schematic of a possible microcracks network in concrete specimens (Ghasezahsomin, et al., 2016)

Cement paste is the most conductive phase in concrete and the pore solution is the main contributor to the electrical conductivity of the cement paste. “Due to the contribution of the cement paste to electrical conductivity, the contribution of the microcracks to electrical conductivity is less pronounced as compared to the contribution of the cracks to saturated hydraulic conductivity.”

The authors concluded that the hydraulic conductivity cannot represent the microcracks with dangling ends in the concrete. However, the hydraulic conductivity of a crack increases linearly with an increase in these microcracks.

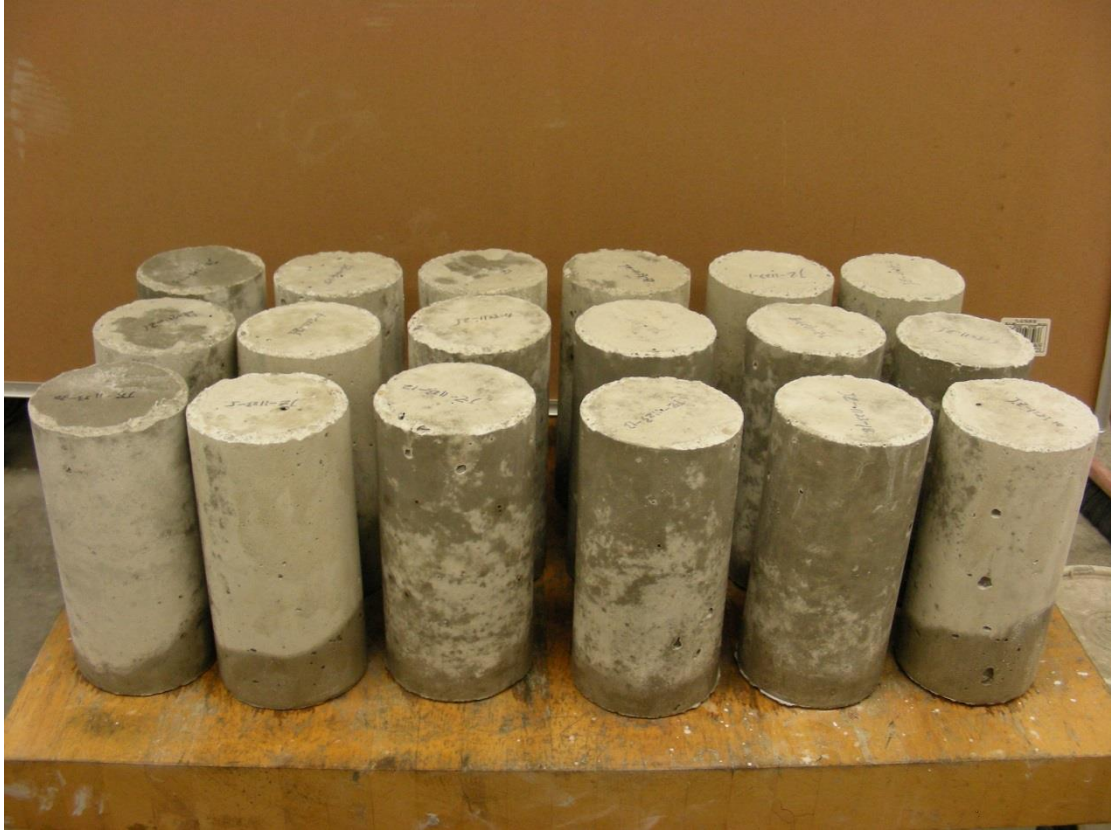
Figure 3.1: The cylinders were subjected to freeze-thaw cycles or combination of freeze-thaw cycles and compressive stress.

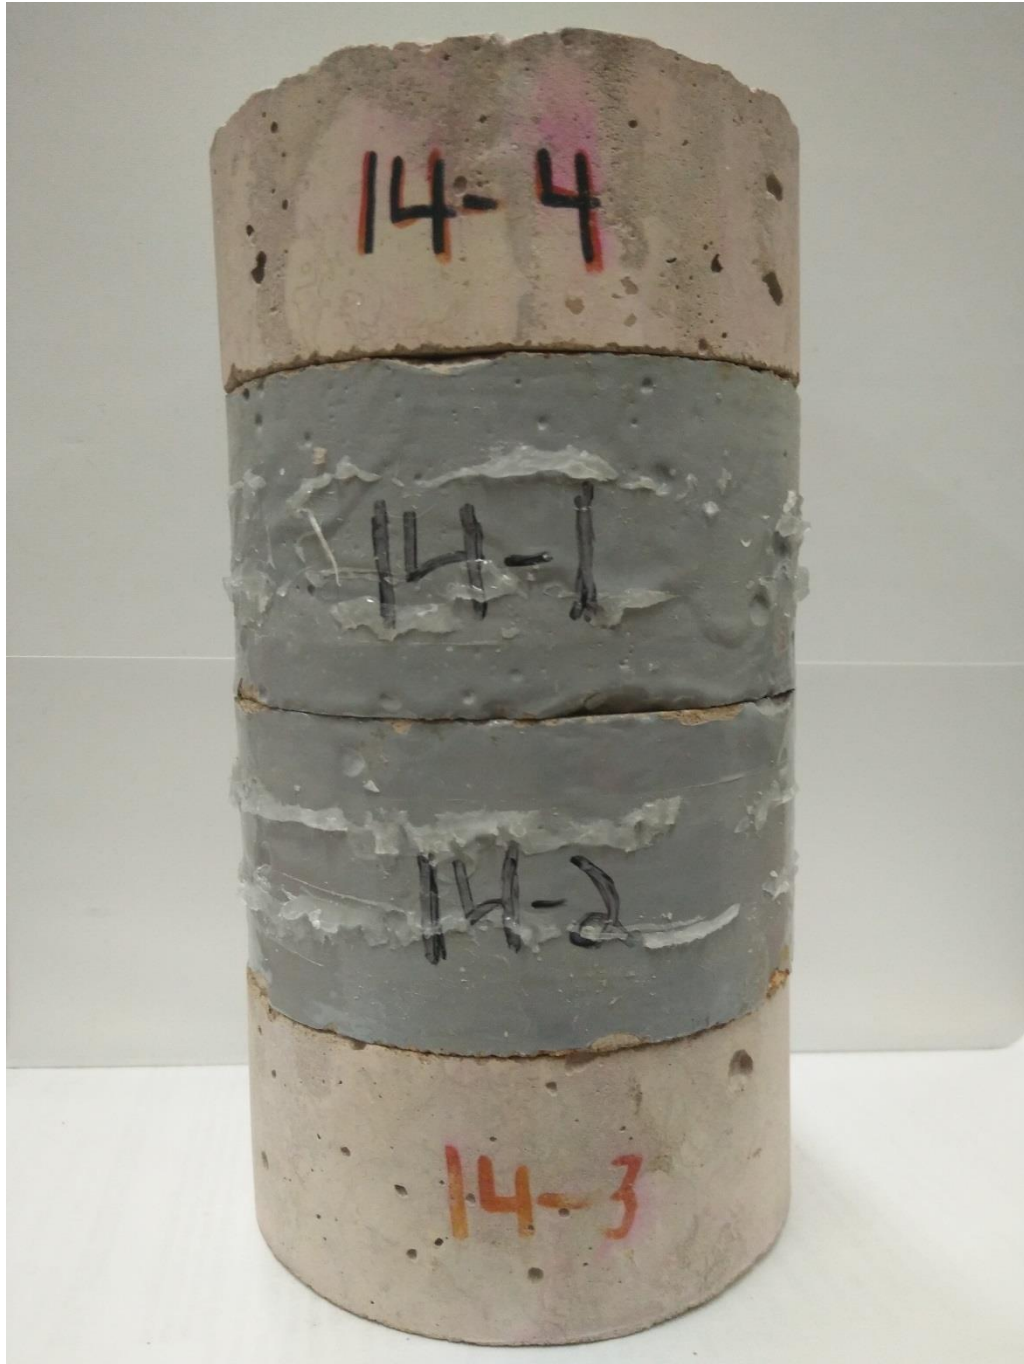
Figure 3.2: The samples for RCIP tests are from middle of cylinders.

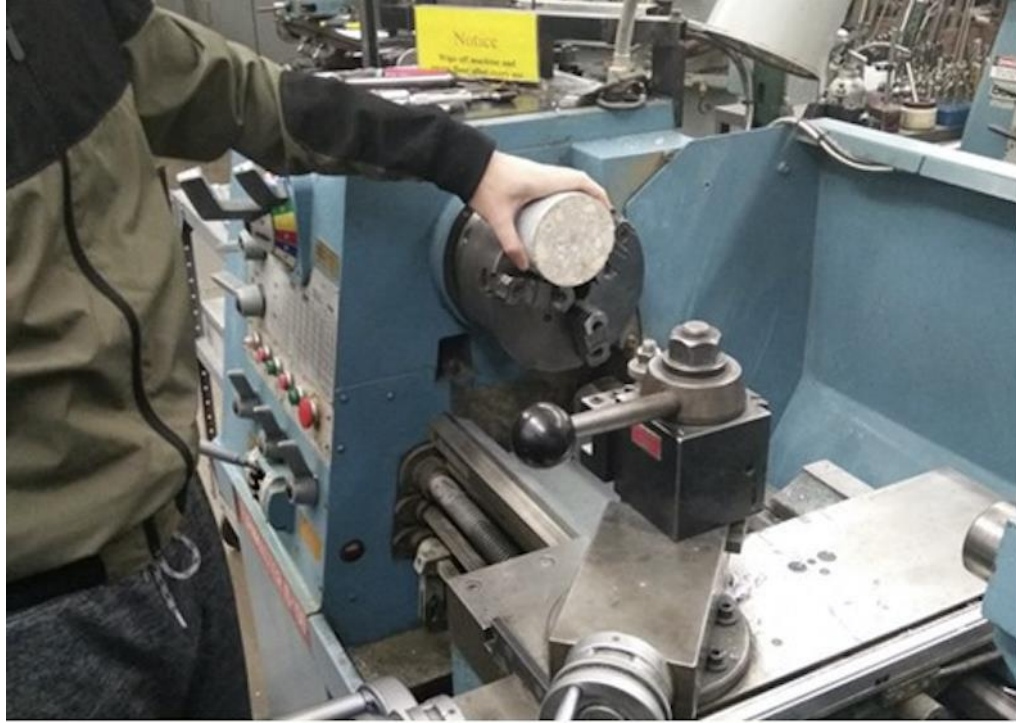
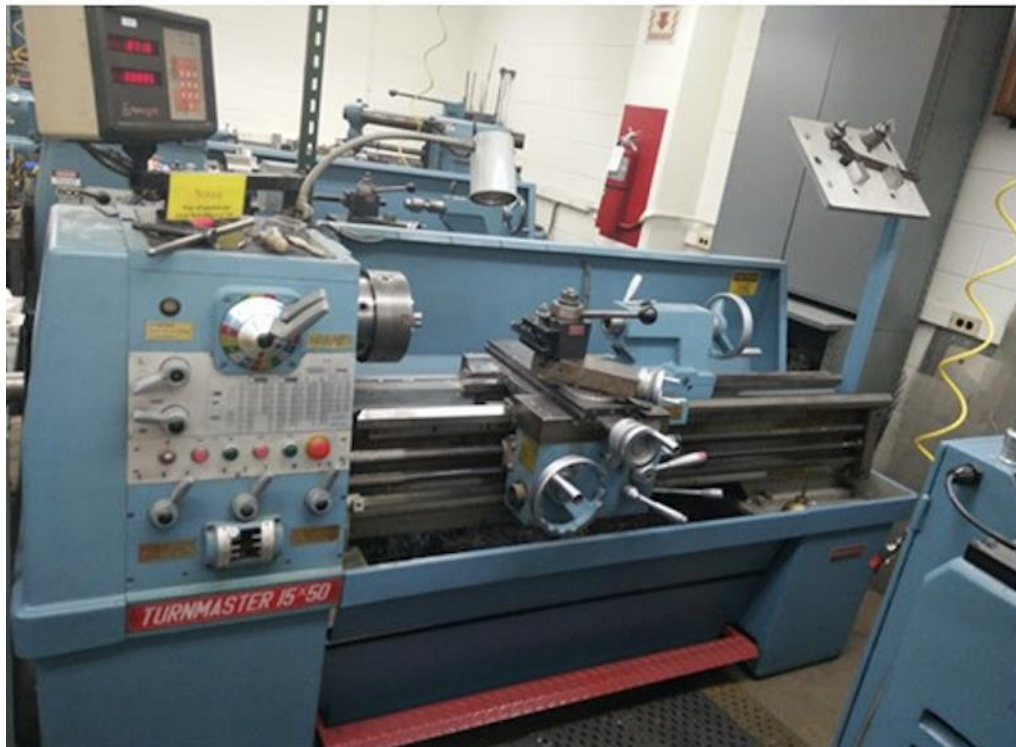
Figure 3.5: Milling sample surfaces using AMERICA TURNMASTER 1525 Engine Lathe

The surface of samples was stained with epoxy residue during the specimen preparation. As shown in the Figure 3.5, there is epoxy residues on the surface of samples. In this case, Chloride ions cannot pass through the specimens. Hence the surface of the samples surface was milled to remove the epoxy residue. A AMERICA TURNMASTER 1525 Engine Lathes with diamond drill was used for cutting epoxy off the surface of samples, as shown in Figure 3.6. It is deemed that the milling process also removed the carbonation on the disc surfaces.

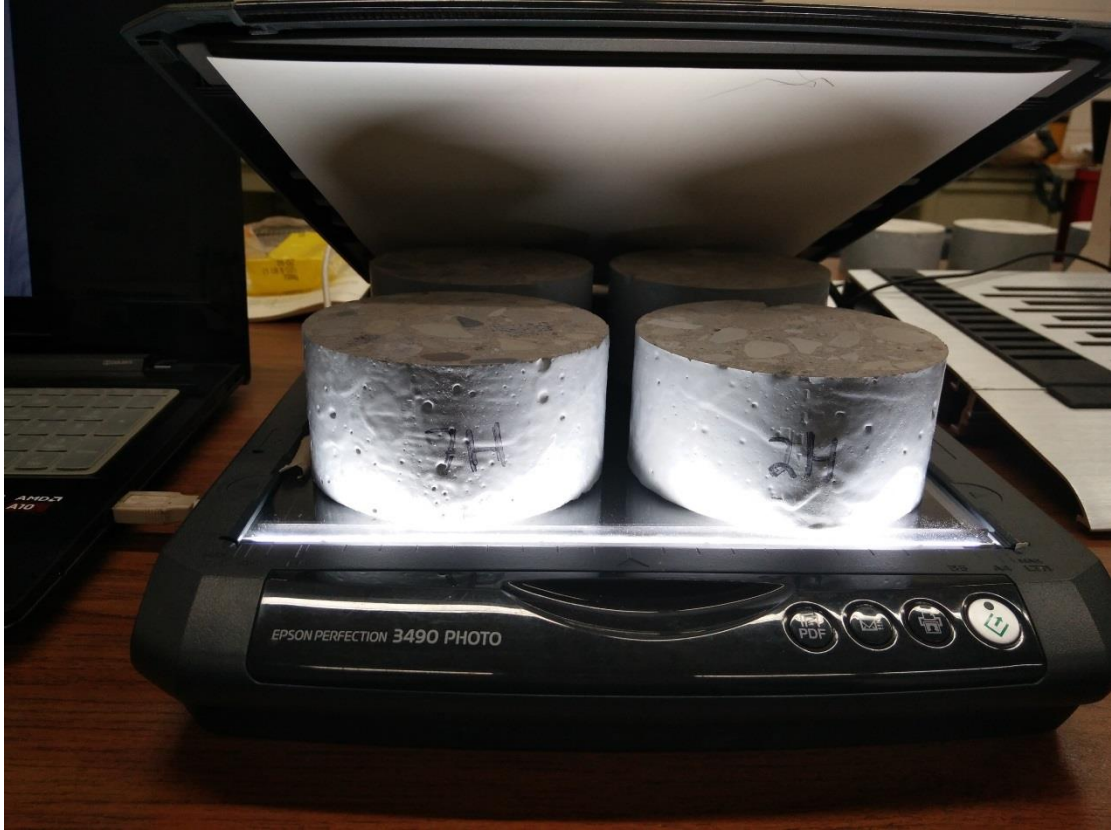
Figure 3.9: The EPSON scanner used for scanning the specimens.

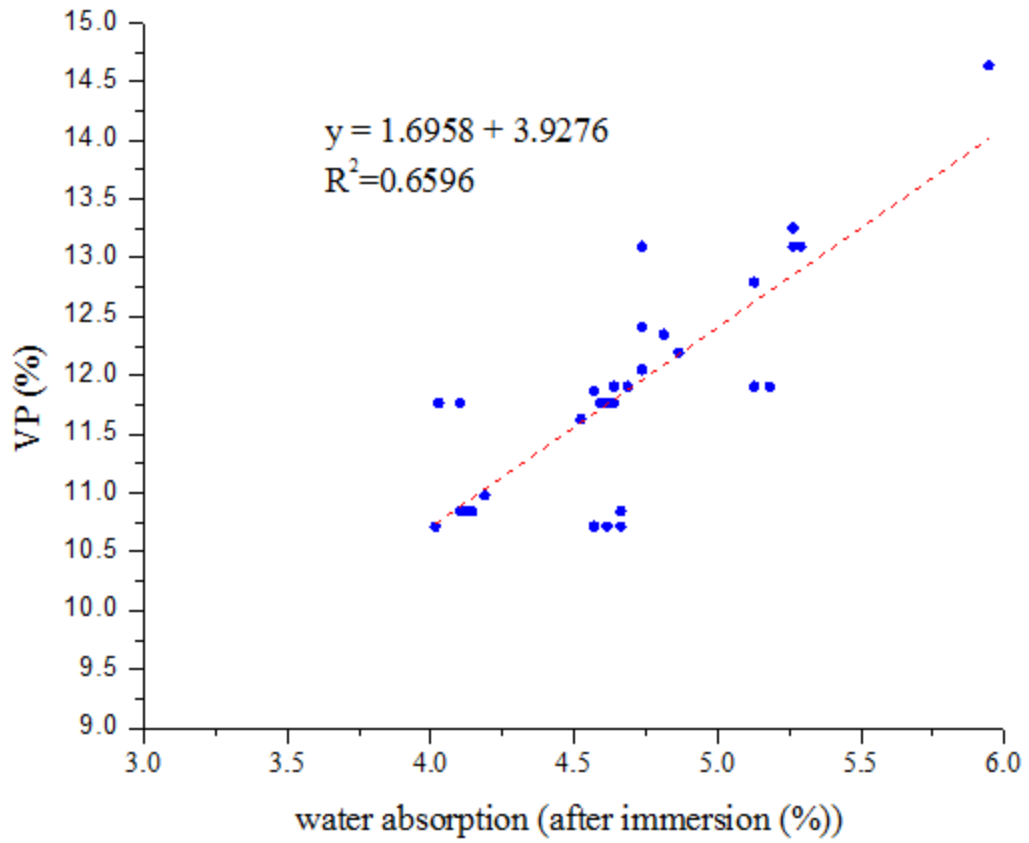
Figure 4.3: Relationship between VP and water absorption (after immersion (%))

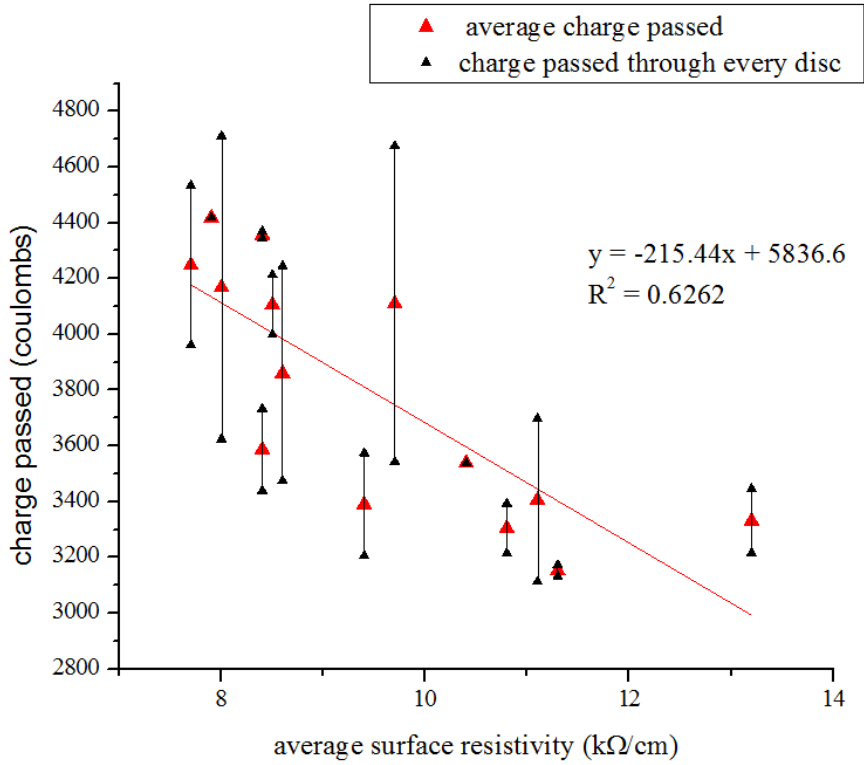
Figure 4.4: Relationship between average charge passed and average surface resistivity.

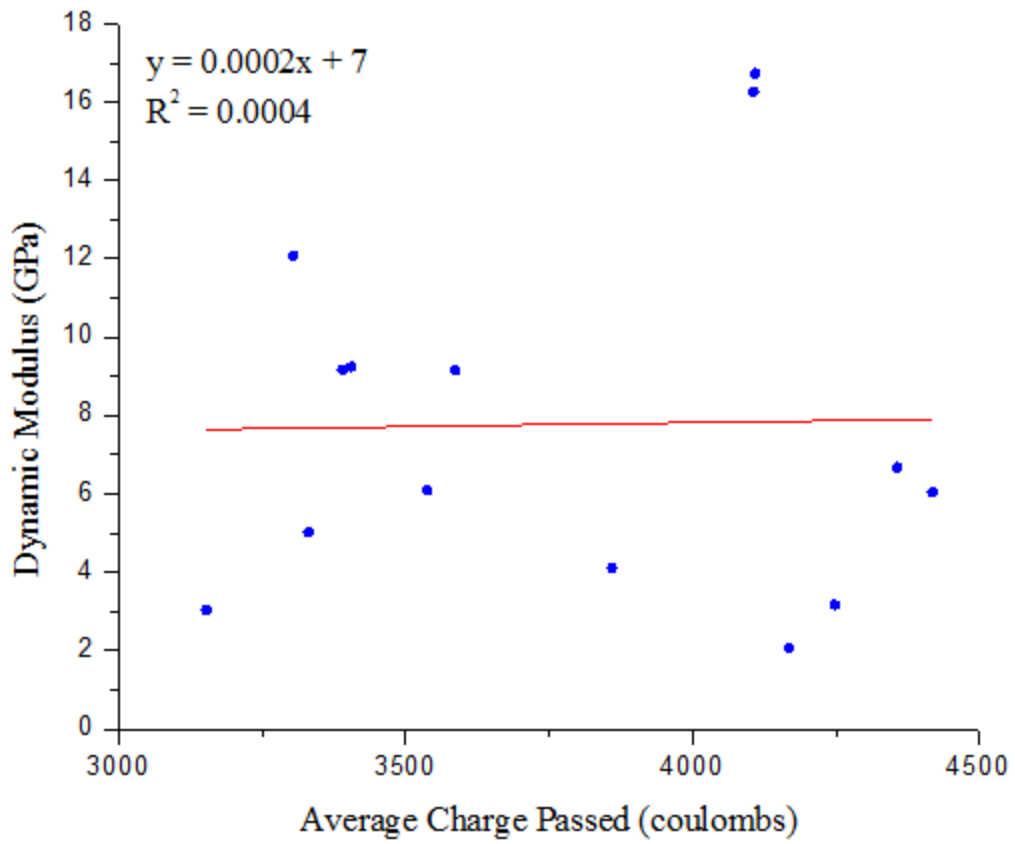
Figure 4.16: The relationship between dynamic modulus and average charge passed.

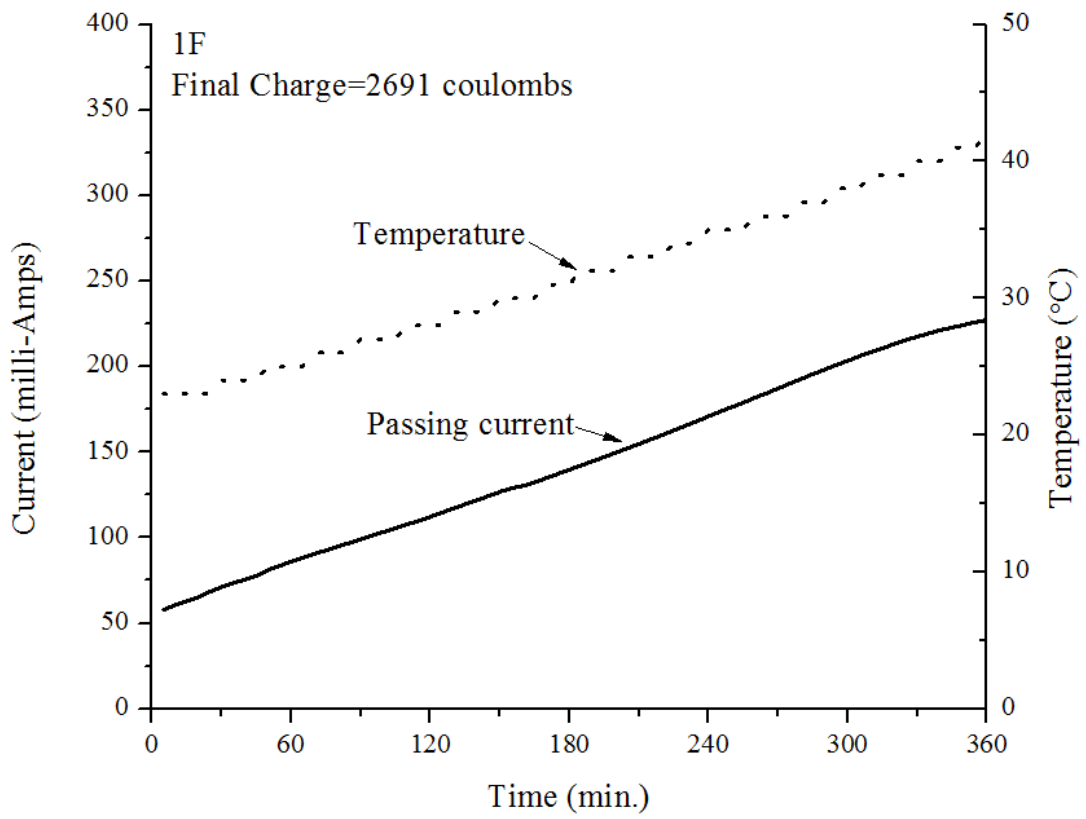
Figure A.2: The picture and graph of passing current/temperature vs. time for sample 1F.
