**Performance Evaluation of  
Open Graded Base Course with  
Doweled and Non-Doweled  
Transverse Joints on  
USH 18/151, STH 29,  
and USH 151**

SPR # 0092-09-03

September 2010

WHRP 10-10

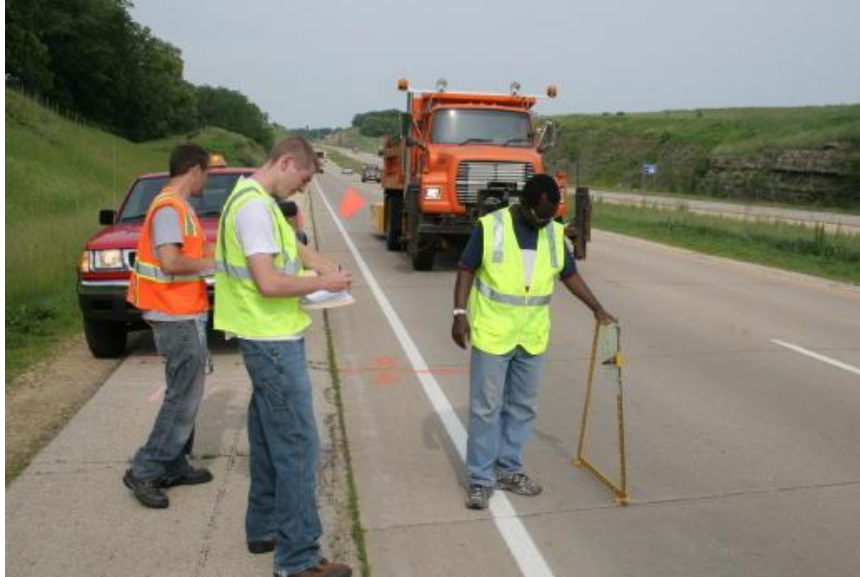
**Figure 4.1 Transverse Joint Fault Measurement on USH 18/151**

Pavement condition was manually measured for PDI. Trained UW-Platteville civil engineering students collected the manual data under faculty supervision. Prior to project data collection, the students completed a course in pavement design and pavement rehabilitation at UW-Platteville, and conducted practice measurements on actual concrete segments. Figures 4.1 and 4.2 illustrate pavement condition measurement during the study.

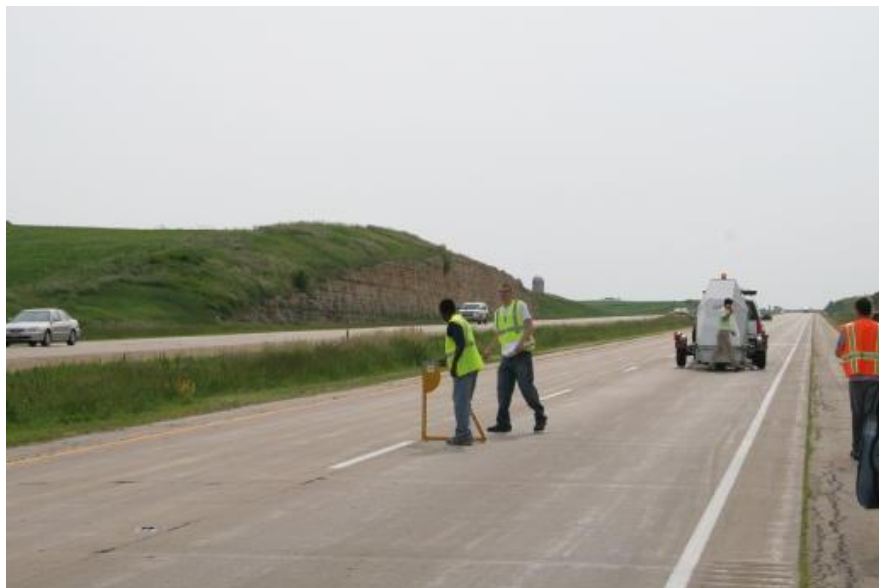
**Figure 4.2 Longitudinal Fault Measurement on USH 18/151**

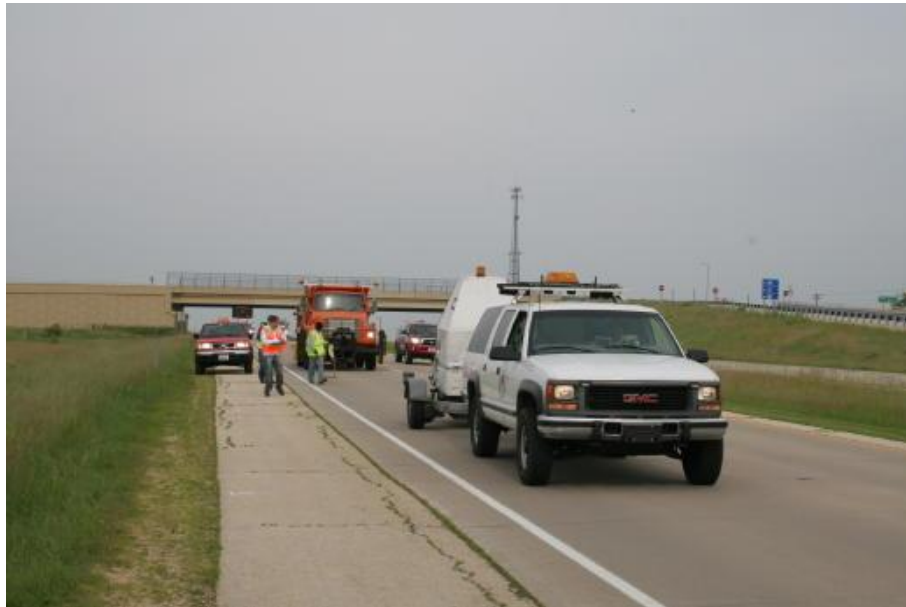
**Figure 4.3 FWD Testing on USH 18/151 at Barneveld Interchange**

Falling Weight Deflectometer (FWD) testing was performed using WisDOT's Kuab 2-m FWD. FWD testing was utilized to provide fundamental measures of transverse joint load transfer capacity, subgrade strength and uniformity of slab support. A traditional two-layer analysis procedure, using FWD deflections measured at various load levels, was used to determine the in-place stiffness of the constructed pavement (all layers combined) and the dynamic  $k$  value of the subgrade. Effective PCC slab thicknesses were estimated based on assumed pavement moduli values based on the PCC pavement deflection analysis procedure outlined in the 1998 supplement to the AASHTO guide. Namely, an AREA-based solution was employed to estimate the pavement's radius of relative stiffness, with corrections applied to account for in-place slab dimensions (length and width). Figure 4.3 illustrates FWD testing on the USH 18/151 project.

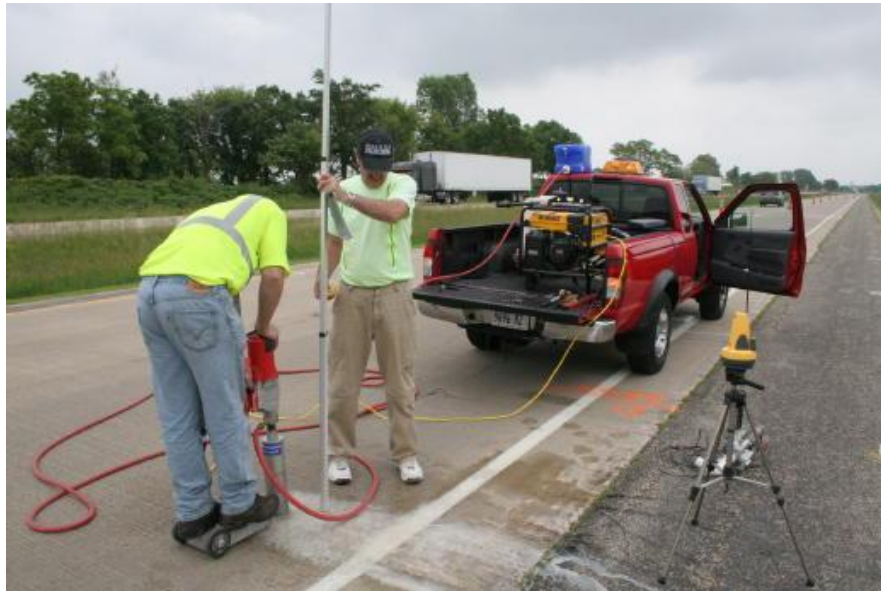
**Figure 4.6 Drilling Corehole and Recording Elevations (USH 18/151)**

Permeability and drainage capacity were measured within each of the OGBC test sections. Full-depth cores were cut through the PCC pavement, then water from a county highway truck was pumped into the drainage layer to allow subsurface flow towards the longitudinal collector edgedrain pipe and ultimately out the transverse edgedrain outlet. (FWD testing preceded water permeability testing so that the flow of water in the pavement base did not alter the FWD reading). A flow meter measured and displayed the rate of water inflow, in gallons per minute, and the total volume of infiltrated water, in gallons. Inflow rates ranged from 0 to 8 gallons per minute. The permeability of the drainage layer, in feet per day, was then estimated using standard permeability and flow calculations. Target permeability from the FDM is recommended at 1,000 feet per day (WisDOT 2008). In several test sections, no water flow was observed after 100 gallons of water were added to the corehole. If water was observed at the outlet, tracer dye was added at the corehole to then measure the time to flow through the drainage system. Figures 4.6 through 4.12 capture permeability testing.

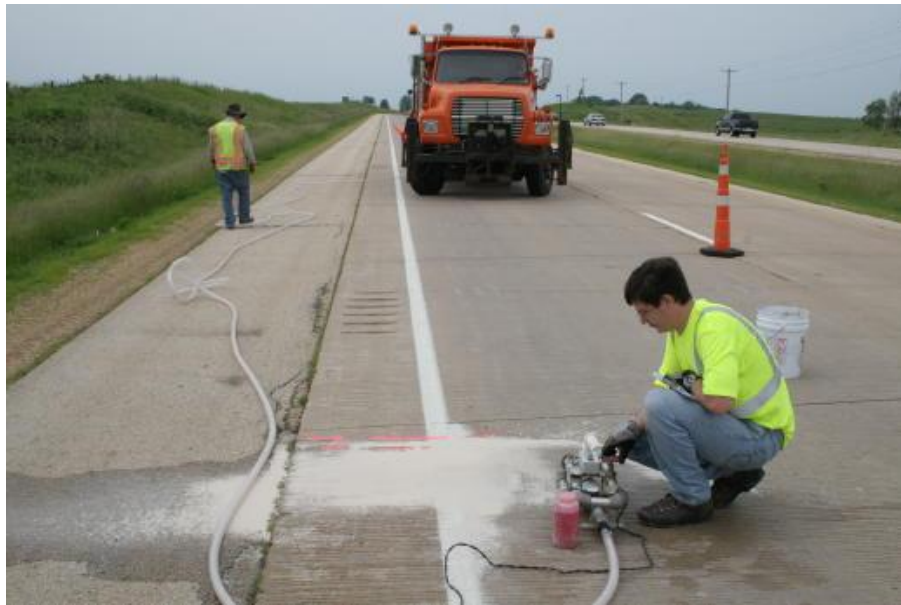
**Figure 4.7 Water Inflow at Corehole and Recording Rate and Total Volume (USH 18/151)**

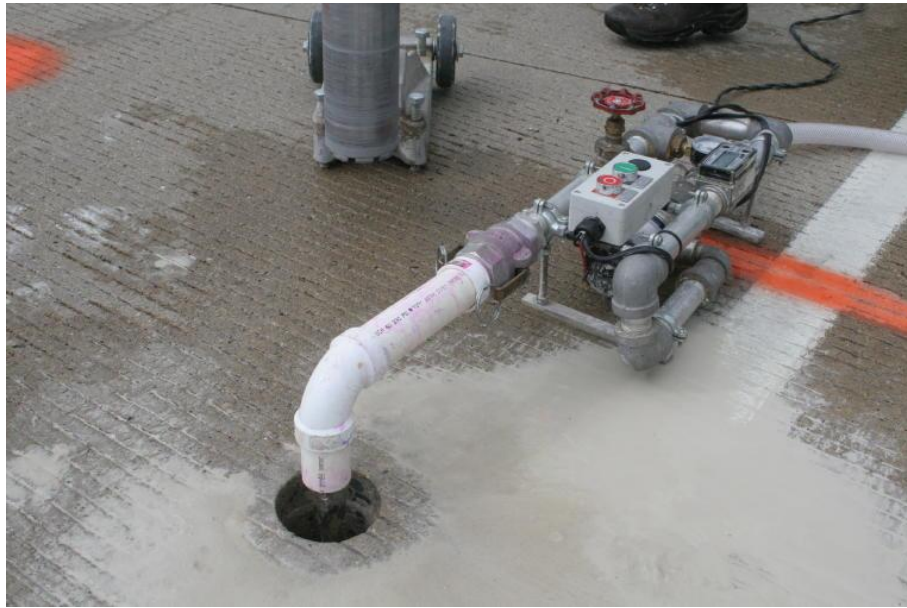
**Figure 4.8 Water Flow Meter (USH 18/151)**

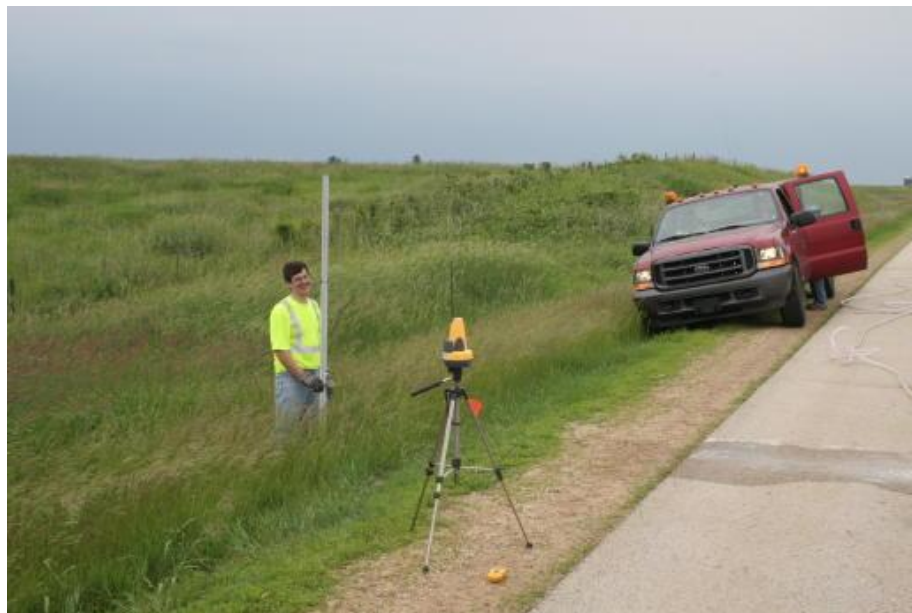
**Figure 4.9 Recording Elevation at Outflow Drainpipe (USH 18/151)**

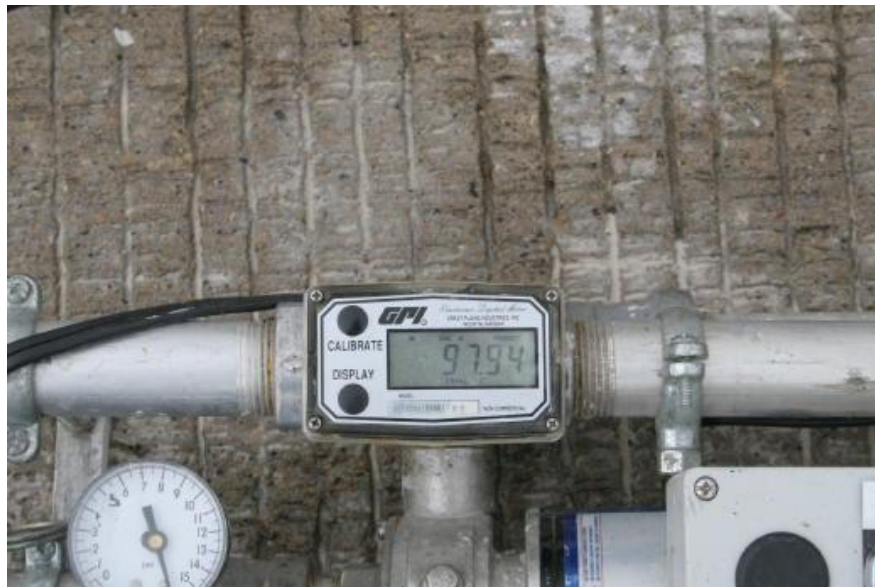
**Figure 4.10 Flow Meter measuring 97.94 Gallons of Water into Corehole (STH 29)**

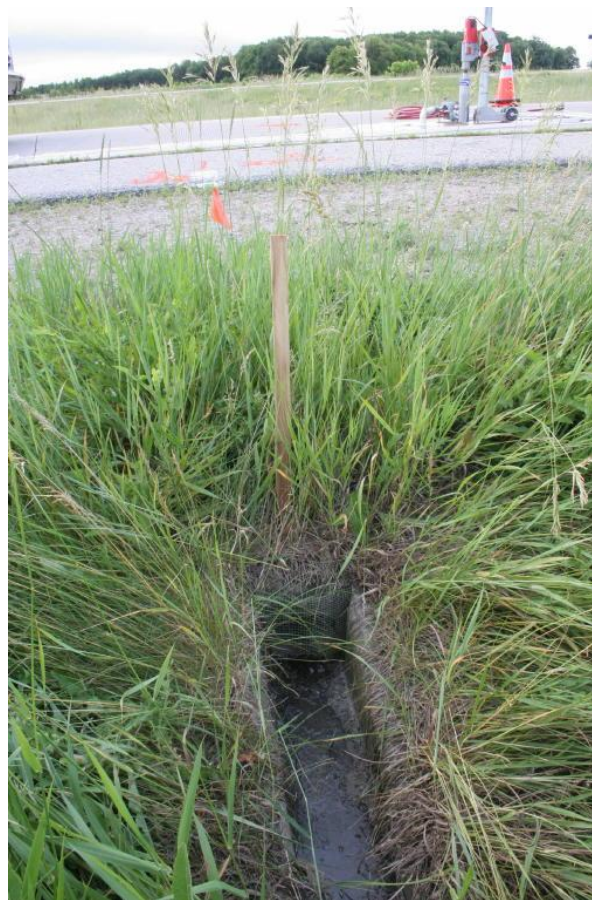
**Figure 4.11 Water flowing out Edgedrain Pipe and Apron Endwall (STH 29)**

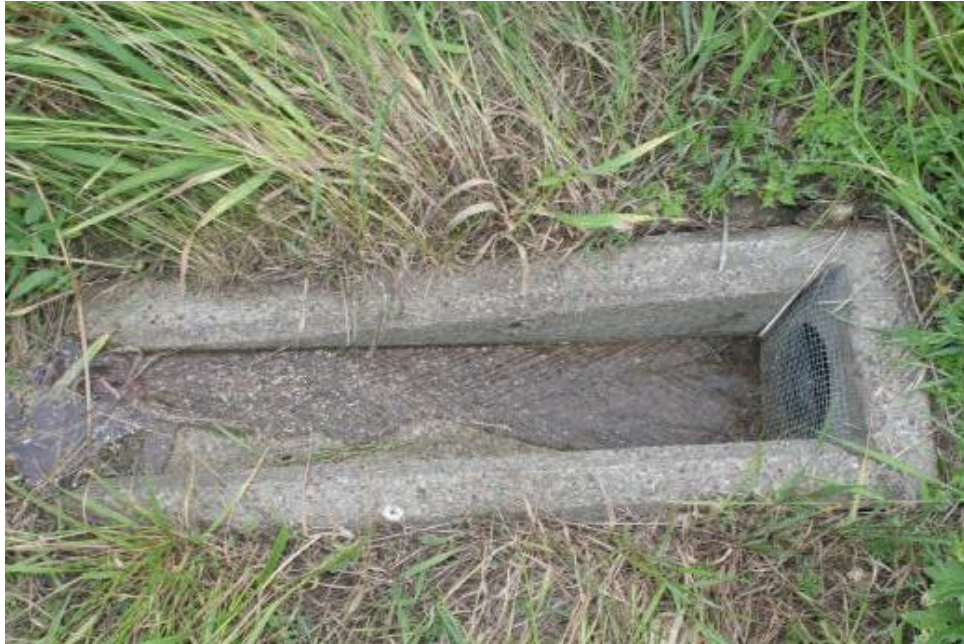
**Figure 4.12 Water with Tracer Dye flowing out Edgedrain Pipe and Apron Endwall (STH 29)**

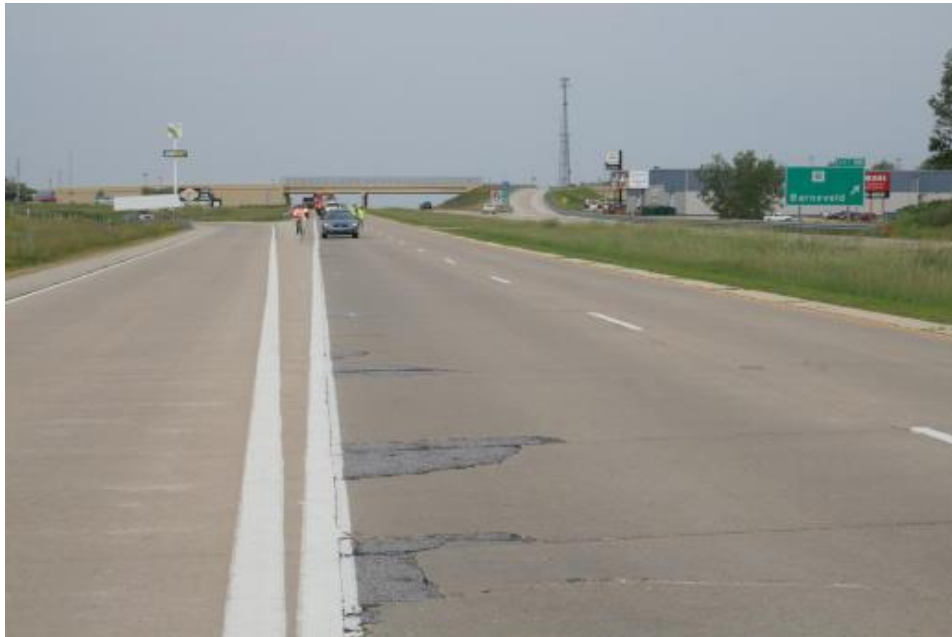
**Figure 5.1 Patching in TIC Section Adjacent to New On-Ramp**

Measured performance data from the three highway segments are shown in Tables 5.2 through 5.4. The third TIC section on USH 18/151 was omitted from the analysis since patching and distressed joints/cracks appeared to be the result of a removed right-side longitudinal pipe when a new eastbound entry ramp was constructed in 2004. Figure 5.1 illustrates the extent of patching in this TIC section adjacent to the new on-ramp.

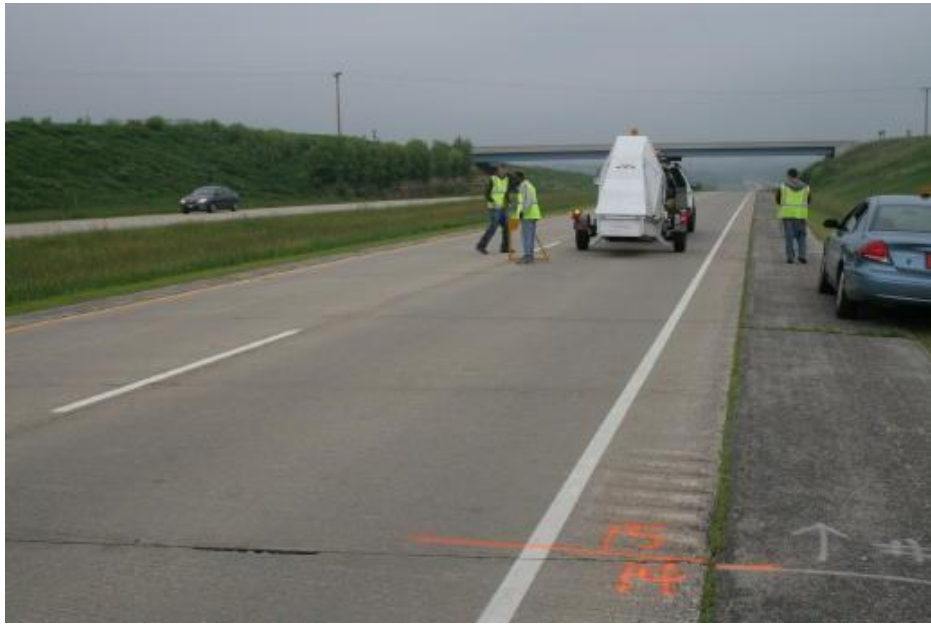
The effect of sealant was further investigated by comparing adjacent sealed and unsealed sections on doweled USH 18/151 dense graded sections, and a combination of doweled and non-doweled sections on STH 29. First, the two sections on USH 18/151 were analyzed. These adjacent sections both had doweled JPCP with 6-inch thick dense graded base, with the only difference being Section #14 without sealant (WisDOT standard) and Section #15 with sealant. Traffic levels were assumed equal, however the 528-foot PDI segment was just beyond an exit ramp for STH 78 on the west side of Mount Horeb (Figure 5.11).

**Figure 5.11 Location of USH 18/151 Test Section east of STH 78 Exit Ramp**

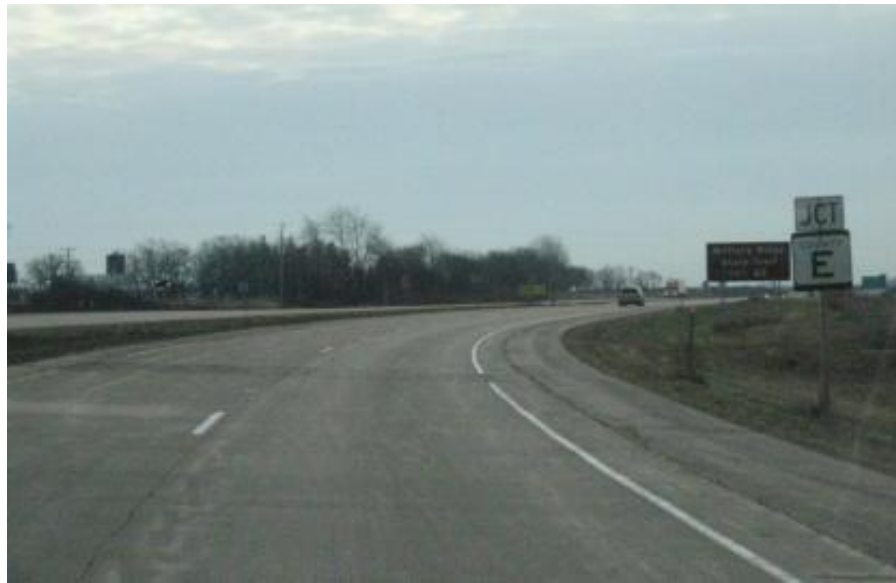
**Figure 7.5 Patching on Doweled Dense-Graded Test Section #14 on USH 18/151**
