**The Vegetation and Hydrology of Impoundments after Dam Removal in
Southern Wisconsin**

CHRISTIAN FRANCIS LENHART

A thesis submitted in partial fulfillment of
the requirements for the degree of

UNIVERSITY OF WISCONSIN-MADISON

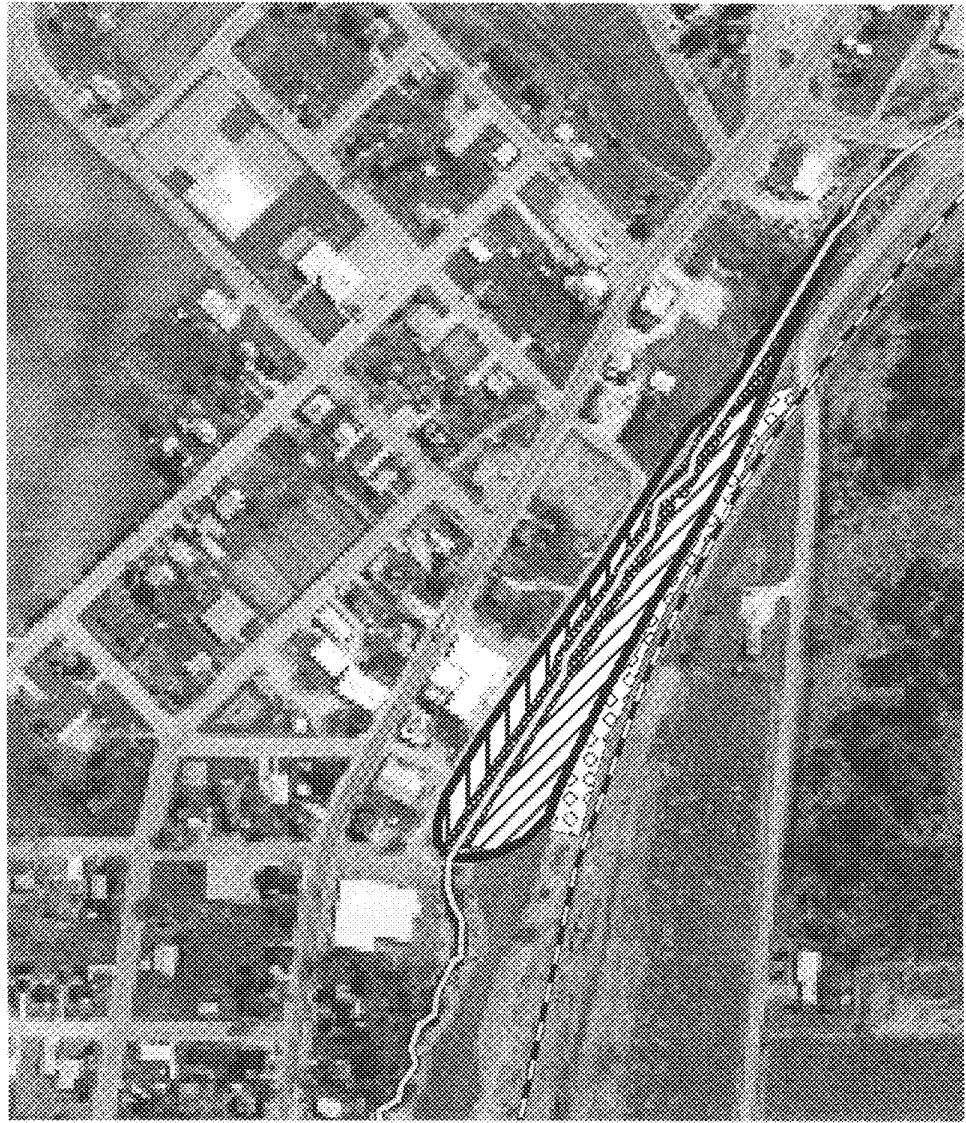
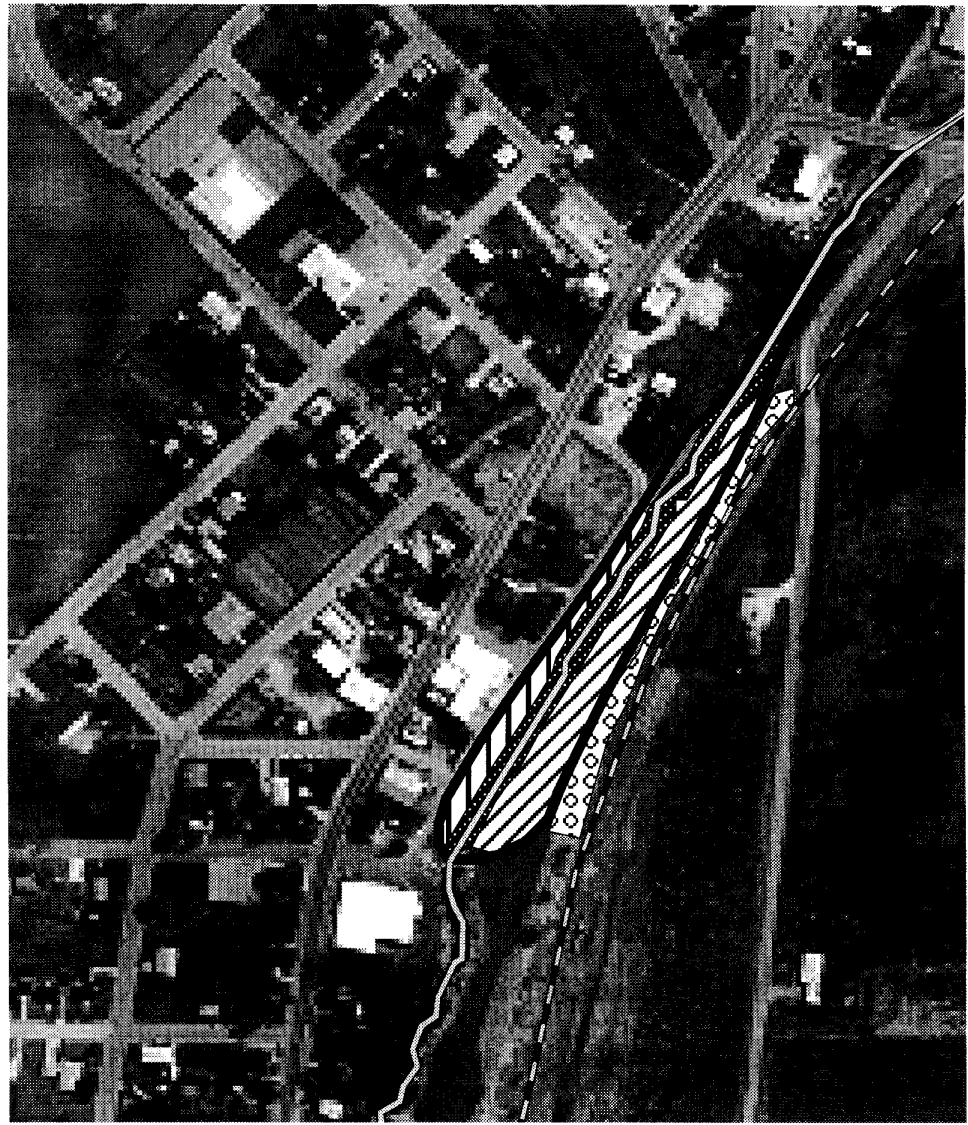
Figure 2b: Map showing location of plant communities at the former Cross Plains millpond on Black Earth Creek (B.E.C.), Dane County, WI

- Black earth creek
- Bec pond boundary
- Railroad tracks
- Reed canary/willows/forbs
- Prairie remnant
- Grasses/prairie species
- Road/lawn

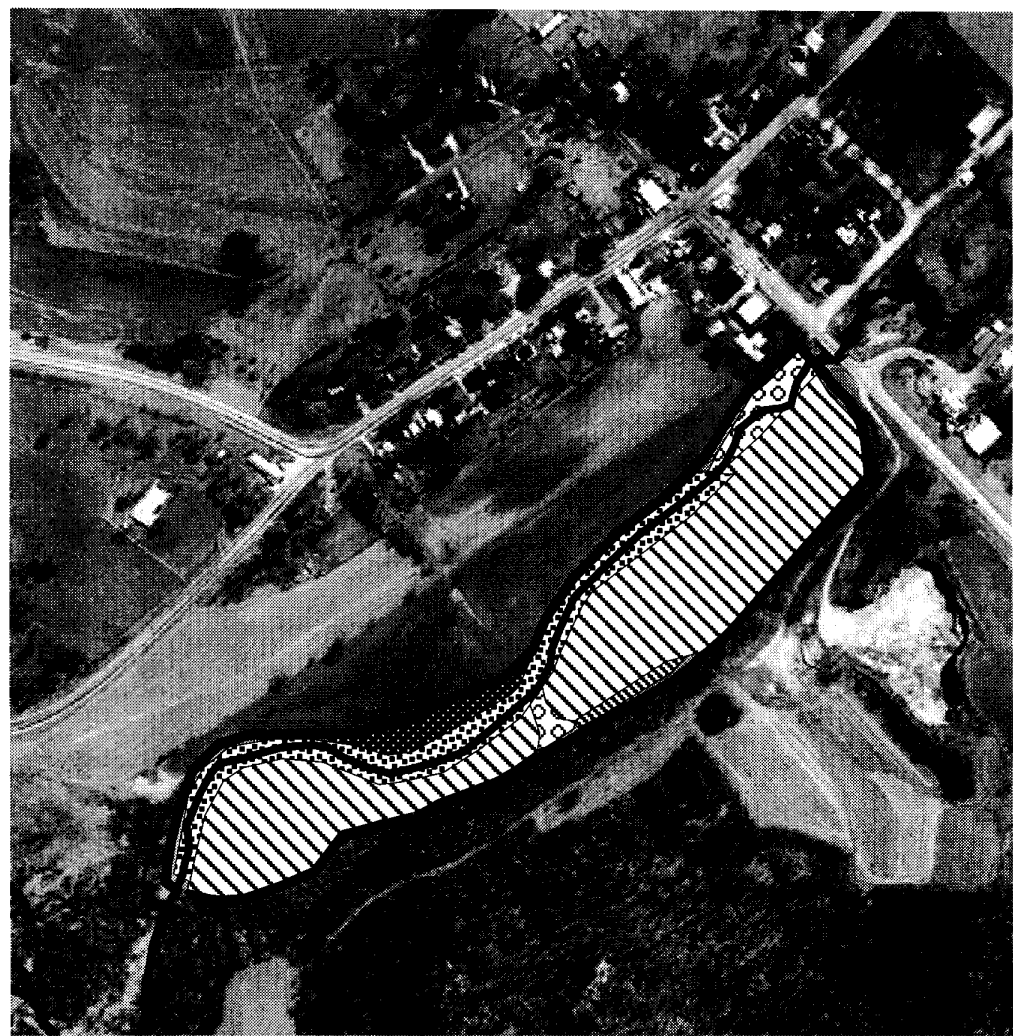
Figure 3b: Map of plant communities at former Mt. Vernon millpond on Mt. Vernon Creek, Dane County, Wisconsin

- Mt. Vernon Creek
- Mt. Vernon pond boundary
- Reed canary grass
- Hay field
- Boxelder
- Sedges
- Brome/pasture grasses

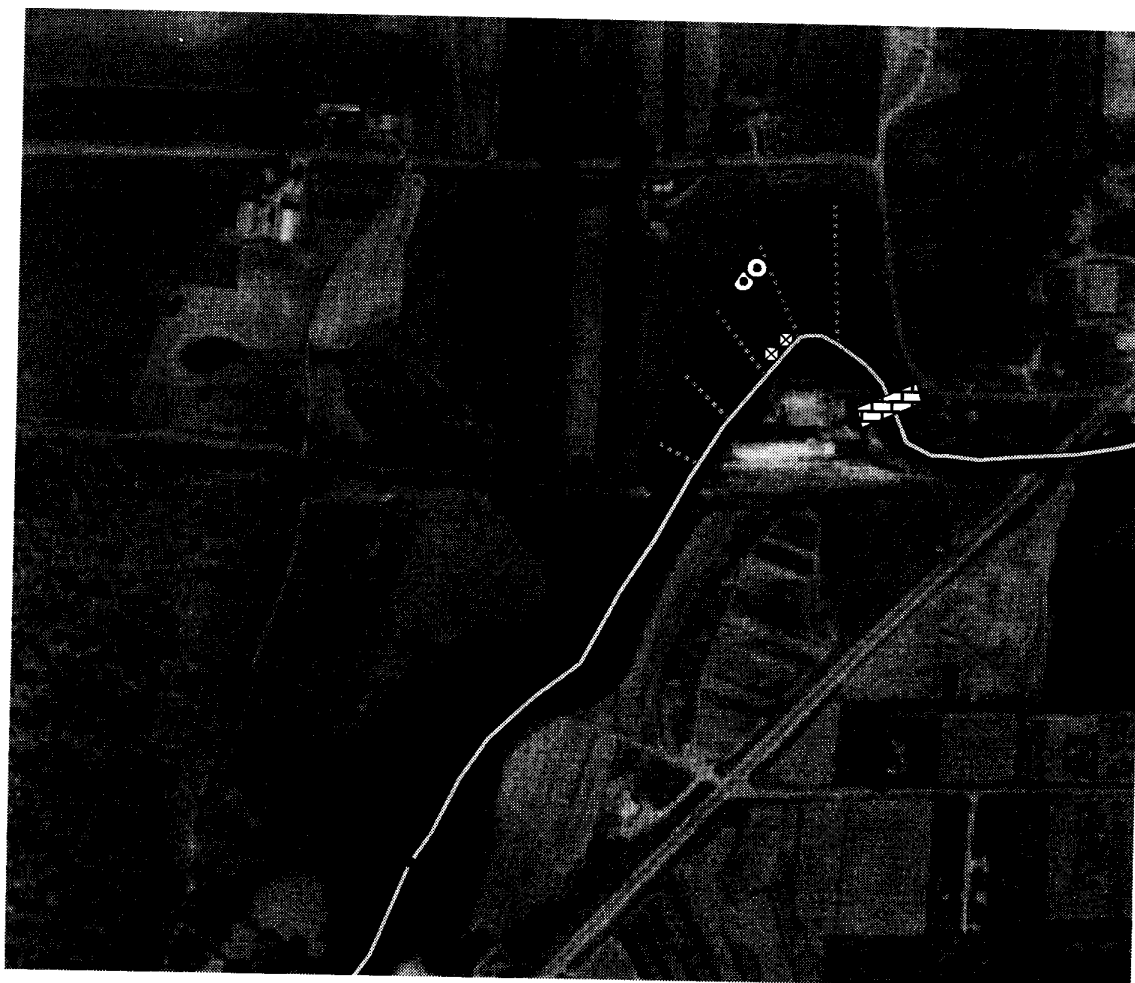
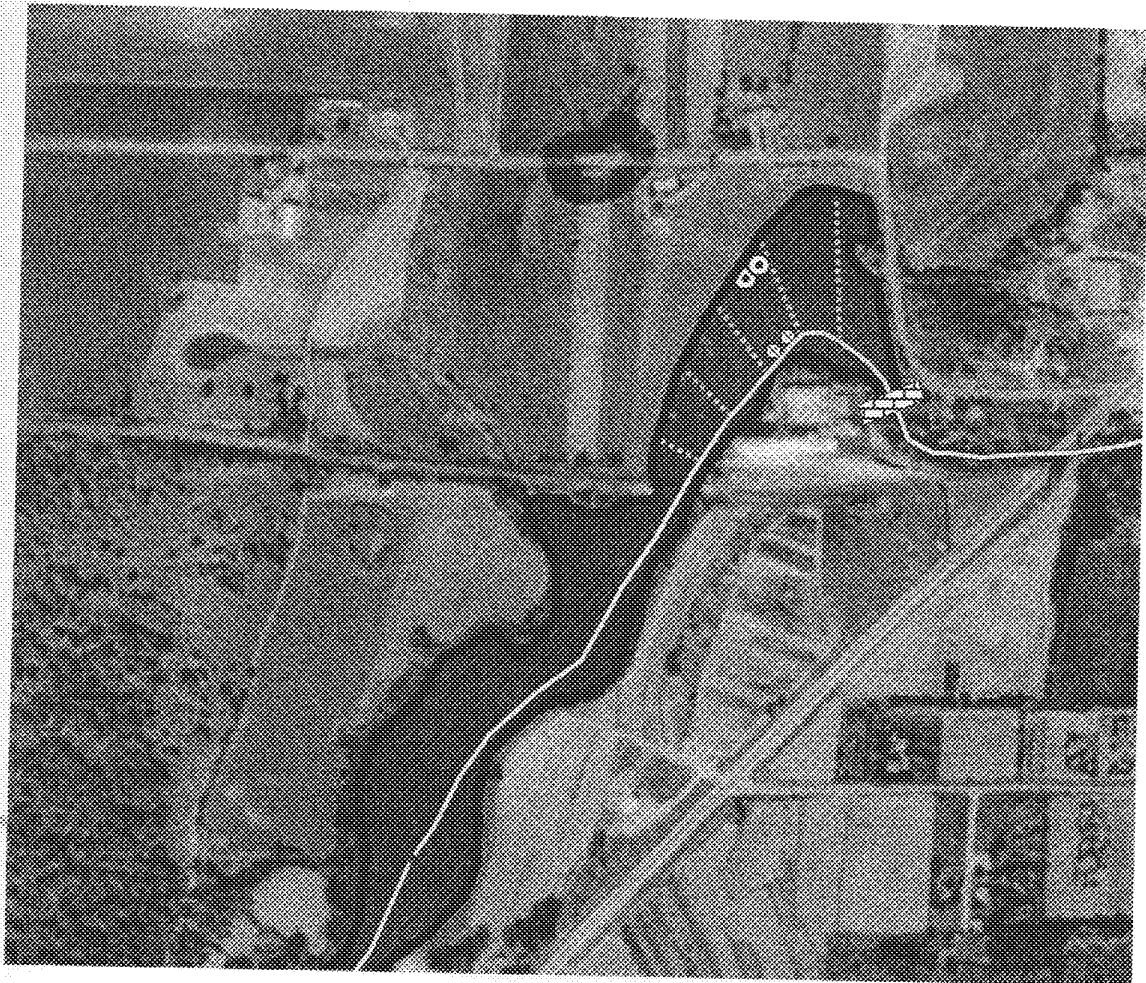
Figure 4a: Map showing location of transects and wells at the former Waterloo millpond along the Maunsha River, Jefferson County, WI

Note: not to scale
Waterloo Pond was 81 acres
(Source: 1979 Aerial photograph)

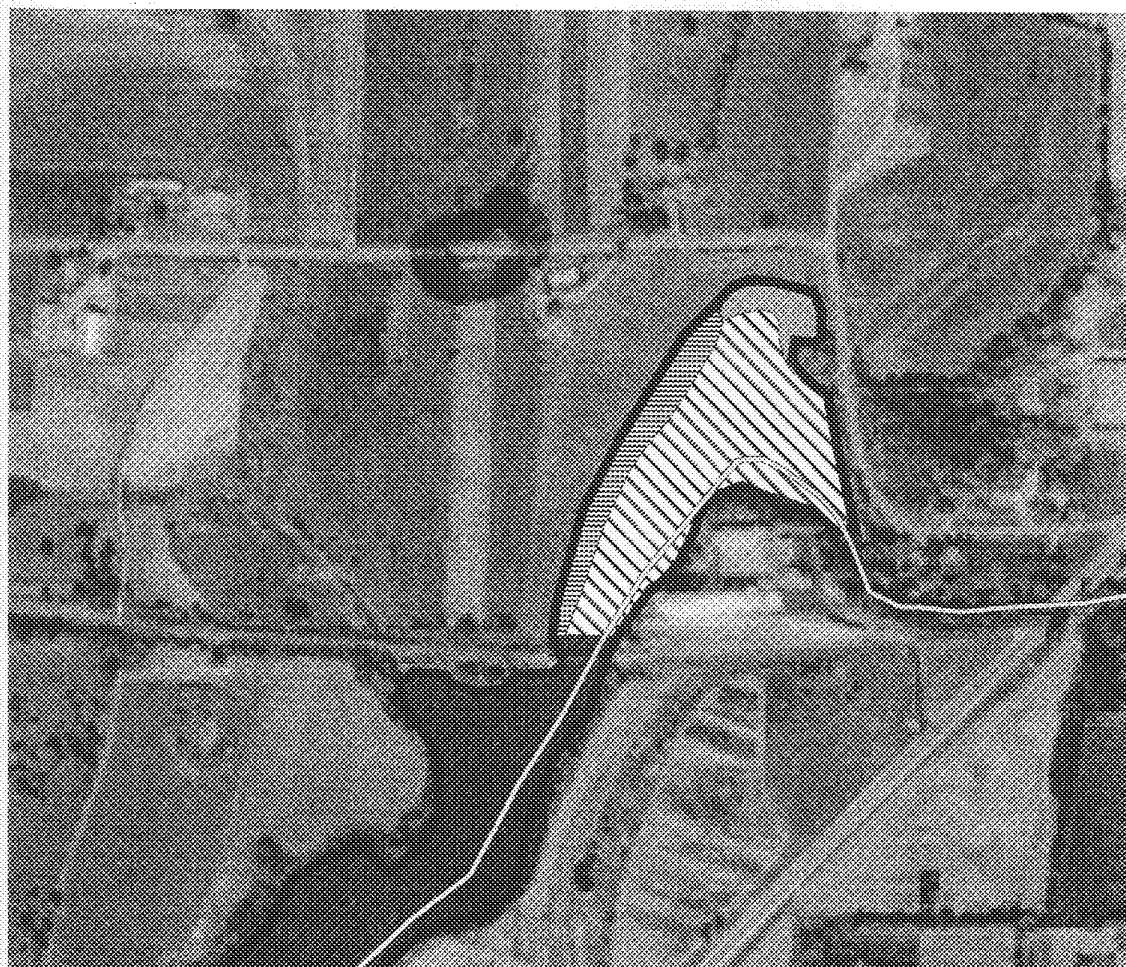
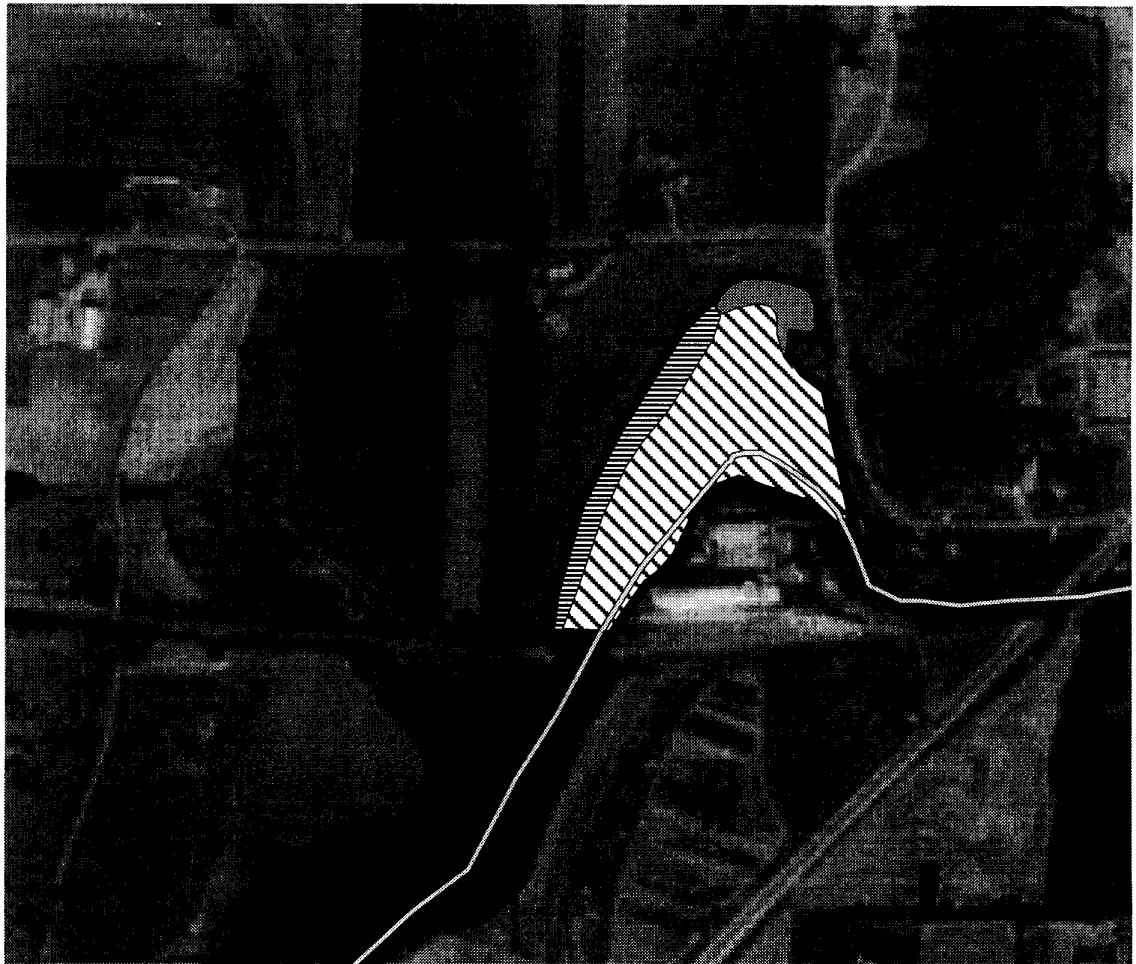
Figure 4b: Map of plant communities at the former Waterloo millpond on the Maunasha River, Jefferson County, WI

Note: not to scale
Waterloo Pond was 81 acres
(Source: 1979 Aerial photograph)

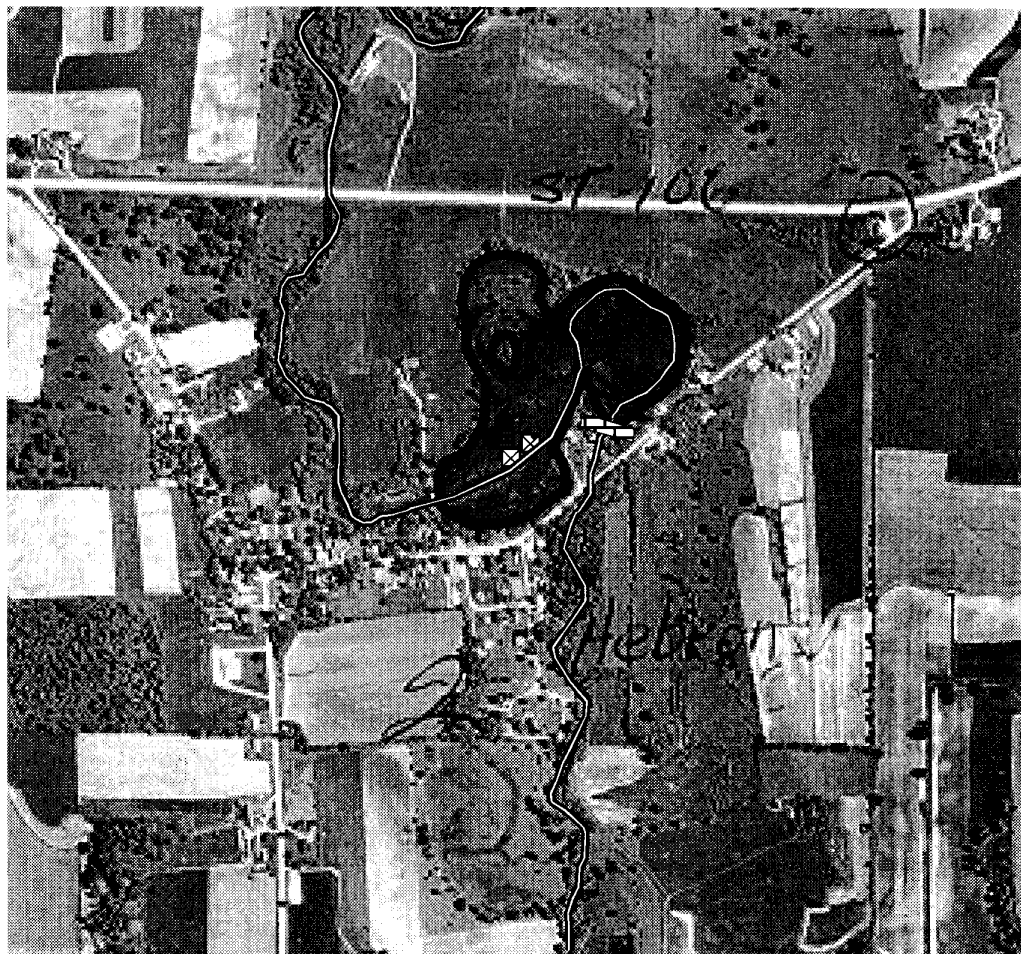
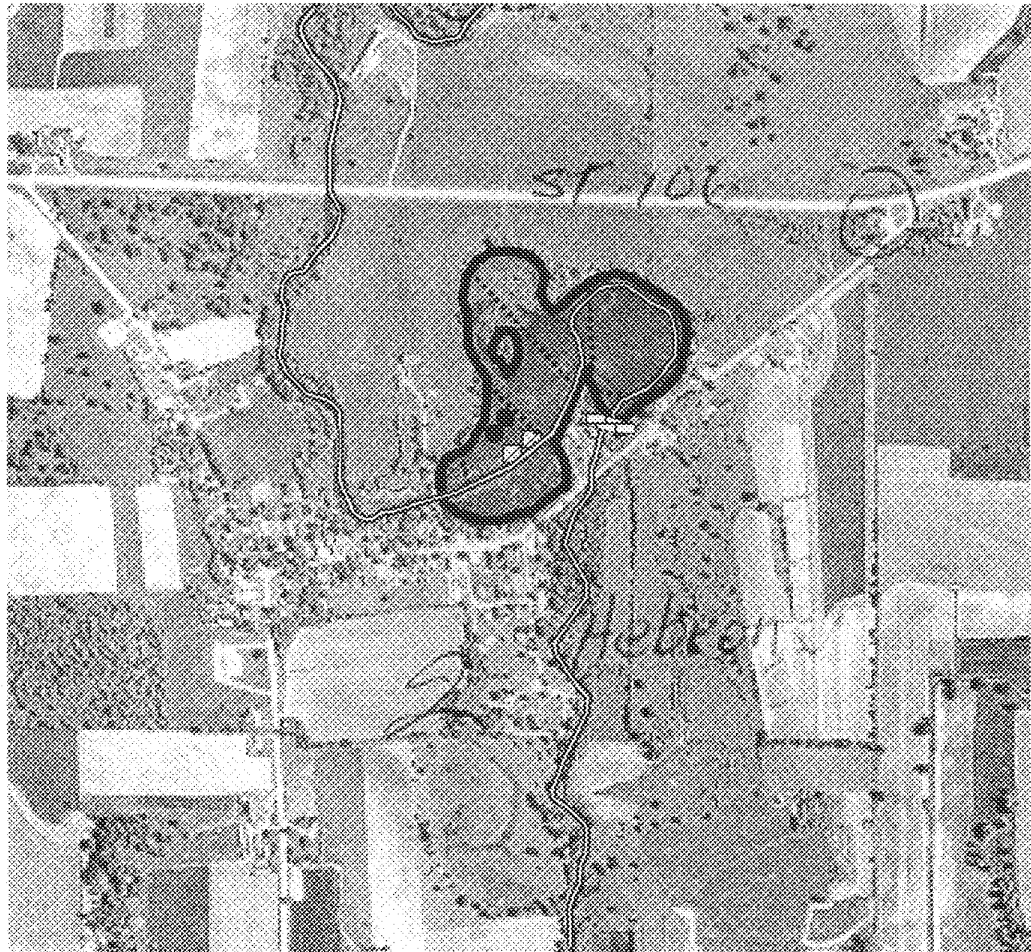
Figure 5a: Map showing location of transects and wells at former Hebron millpond on the Bark River, Jefferson County, WI

Note: not to scale
 Hebron pond was 28 acres
 (Source: 1969 Aerial photograph)

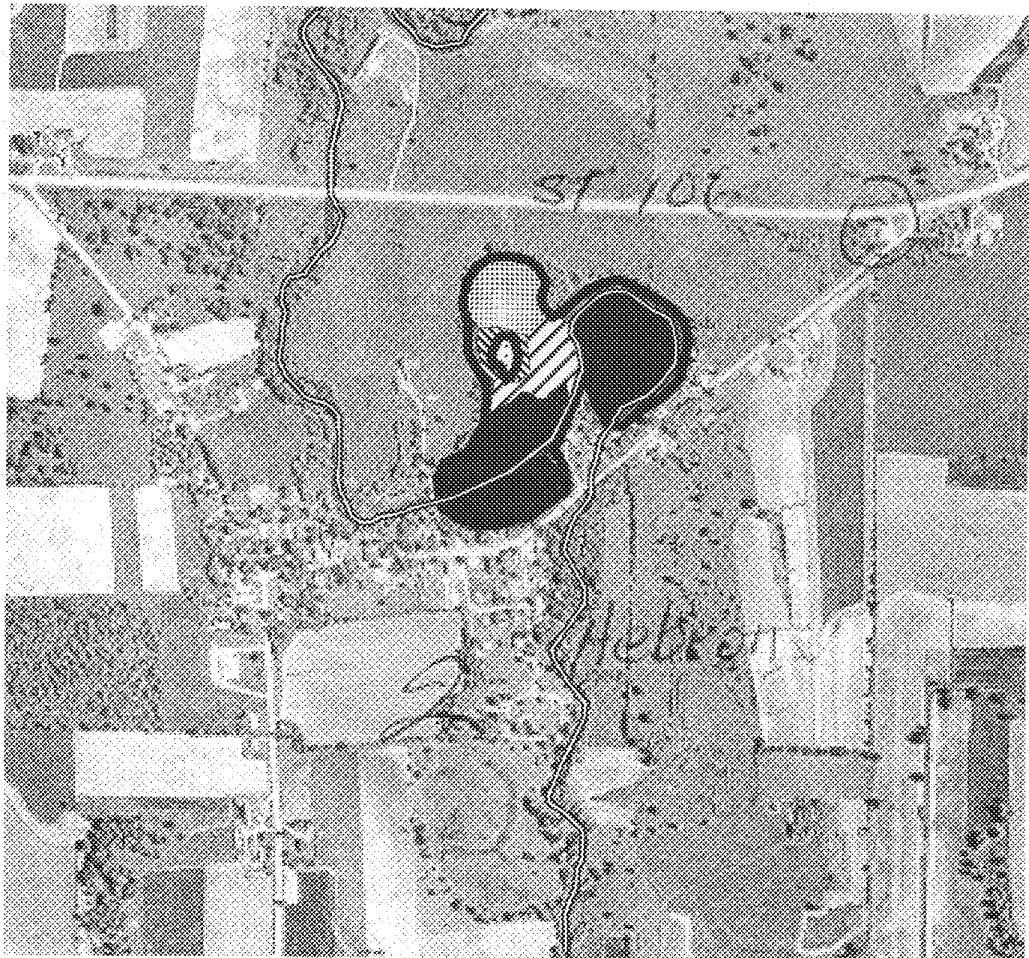
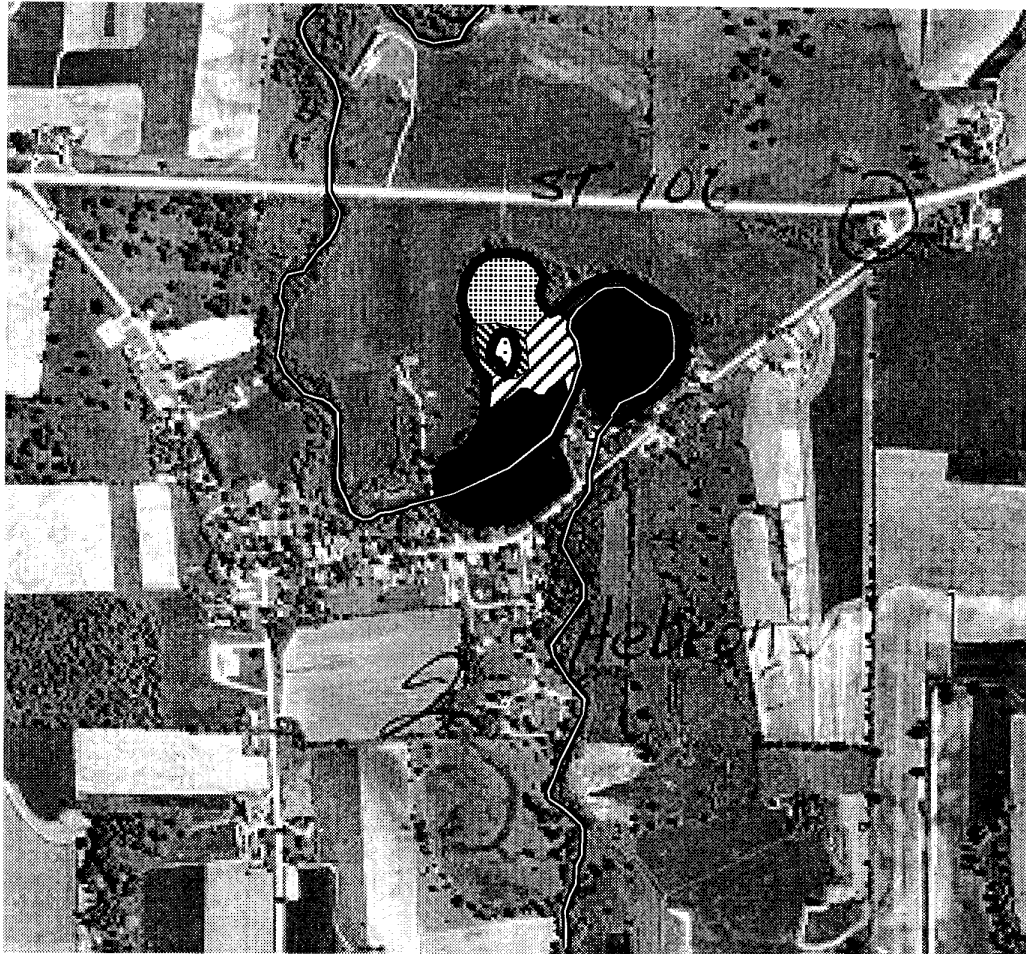
Figure 5b: Map of plant communities at former Hebron millpond on the Bark River, Jefferson County, WI

Note: not to scale
 Hebron pond was 28 acres
 (Source: 1969 Aerial photograph)

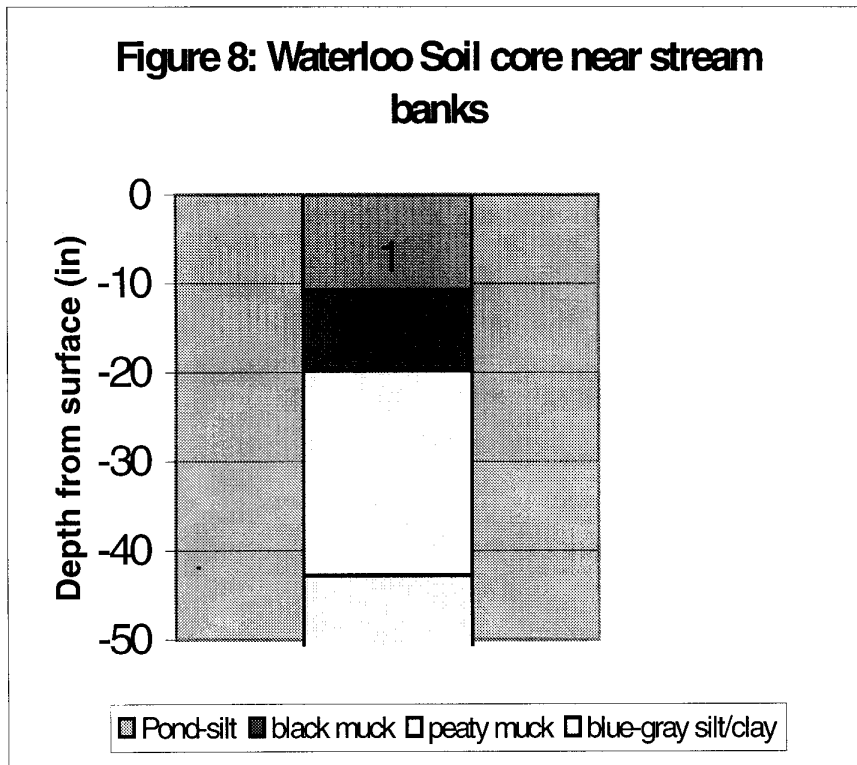
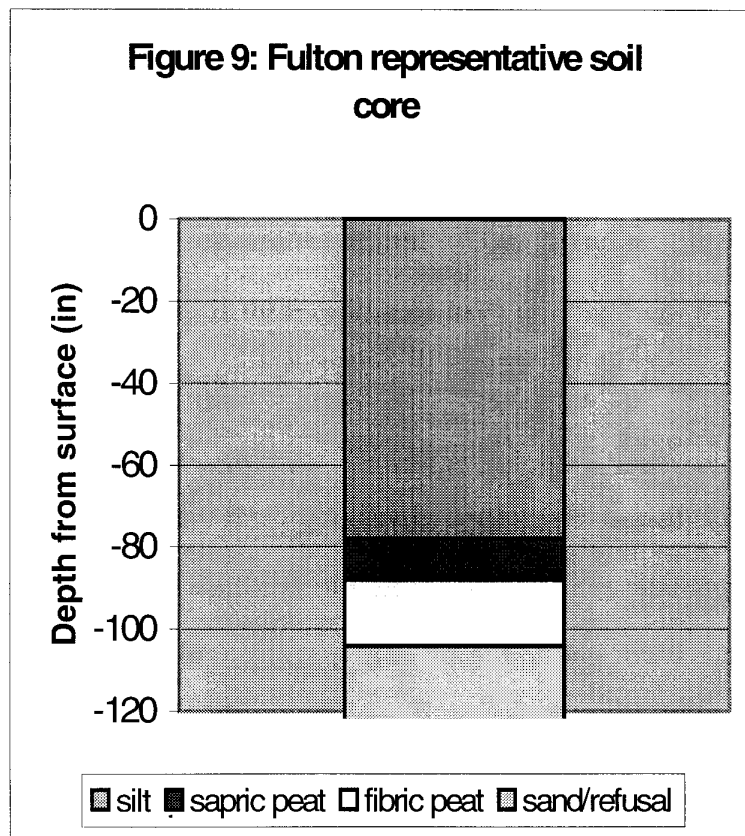
soils (Table 5). Fulton and Waterloo had the most extensive peat deposits with much undecayed woody plant material characteristic of fibric peat (Figures 8 and 9).

The peat was often patchy, varying in depth from a 2 - 20 inches and was often found lying on top of tightly compressed blue-gray silt or clay. In other areas, black muck (with more decomposed plant material than the peat) and silt loam were found on top of the old floodplain. The overtopping of organic soils with mineral soils at many of these sites has important ecological consequences, effecting hydraulic conductivity, porosity, and other factors that affect plant community composition. The presence of peat and black muck on the original floodplain indicate that these sites supported at least some area of wetland

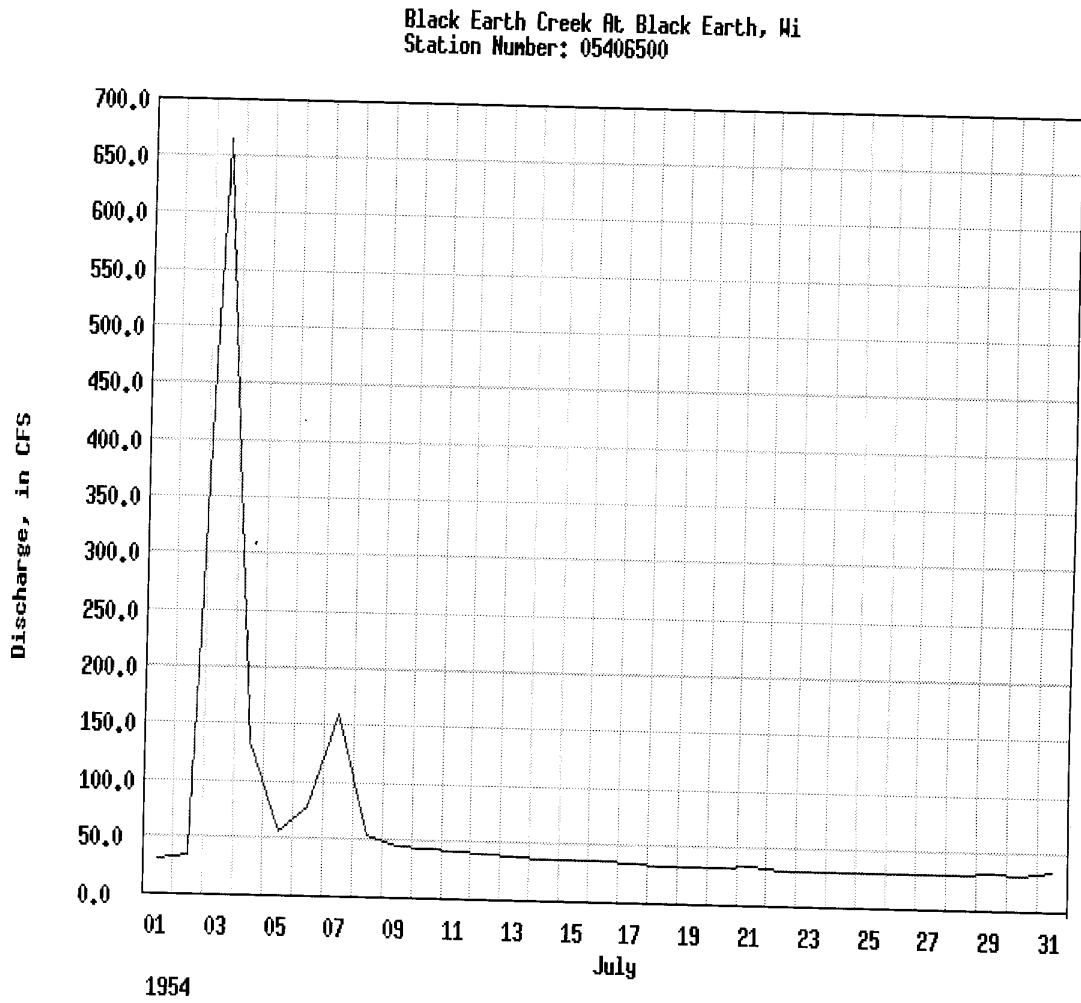
Figure 12: Hydrograph for Black Earth Creek at Black Earth, Wisconsin,
July 1954 (USGS, 1999)

Legend: — Discharge, in CFS
— Estimated Discharge, in CFS

Other peaks that exceeded the estimated pond flooding flow occurred in 1978 (2870 cfs), 1981 (3040 cfs) and 1994 (2730 cfs). The daily hydrograph records for these days do not even reach the recorded instantaneous peaks indicating that the peak flow must have only lasted for a period of minutes. On these smaller flood events, the river could have only potentially overtopped the floodplain for a period of one hour or less, the smallest time period measurable on the daily hydrographs.

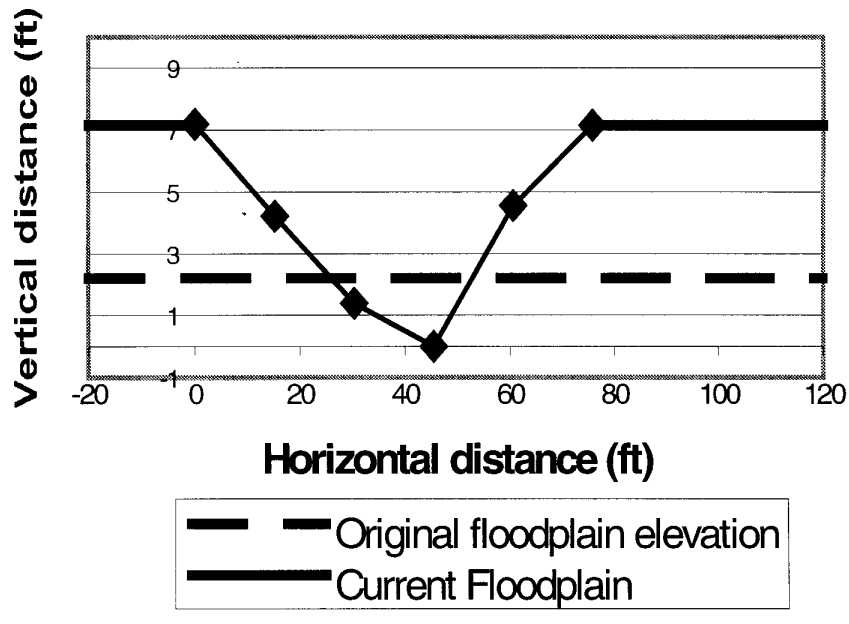
**Figure 13: Stream Cross Section at Mt. Vernon
Creek, WI
March 1999**

Streams with greater amounts of deposited sediment, such as Mt. Vernon and Fulton tend to become more deeply entrenched than streams with less sediment, such as Waterloo, because these streams have further to downgrade to coarse material.

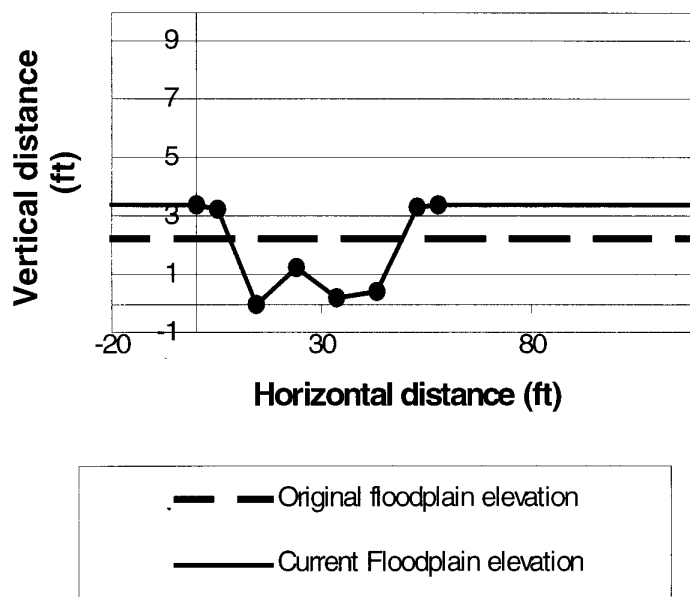
Figure 14: Maunesha River Cross Section, at Waterloo, February 1999

Streams at 8 of 10 cross-sections had cut beneath the pond-deposited sediment. At these locations the elevation of the stream bottom lay beneath the elevation of the pond-deposited sediment. The only site where the stream bottom still lied on the pond sediments was at Hebron, where the elevation of the stream bottom was 1-2 feet above the lower elevation of pond sediments. These two cross sections were taken about 400-600 yards from the old dam

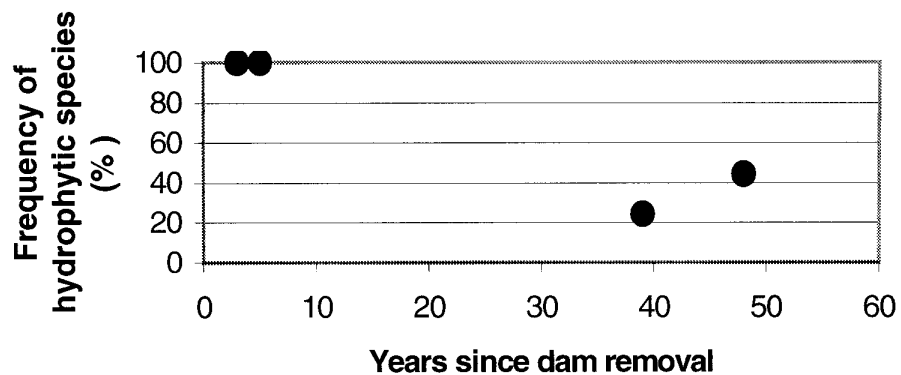
Figure 15: Frequency of hydrophytic species vs. time since dam removal

Categorization of plants using USFWS hydrophytic indicator scores (USFWS, 1998), showed quantitatively that the older sites supported less wetland vegetation and more facultative to upland species than the sites of recent dam removal (Figures 15-17). In contrast, the recently removed sites were dominated by wetland plants, both obligate (OBL) and facultative wetland (FACW) species (Table 12).

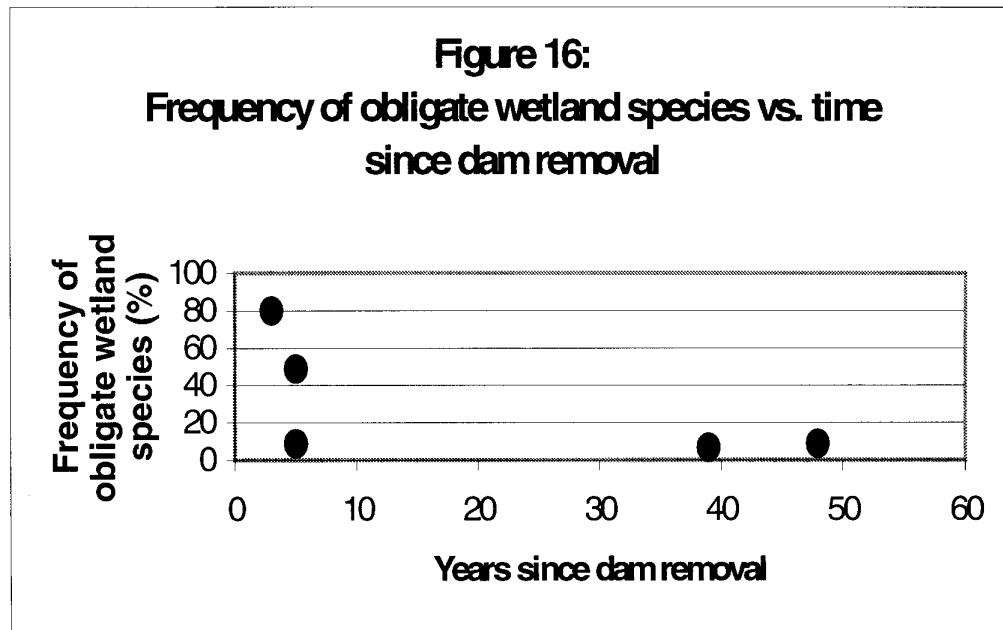
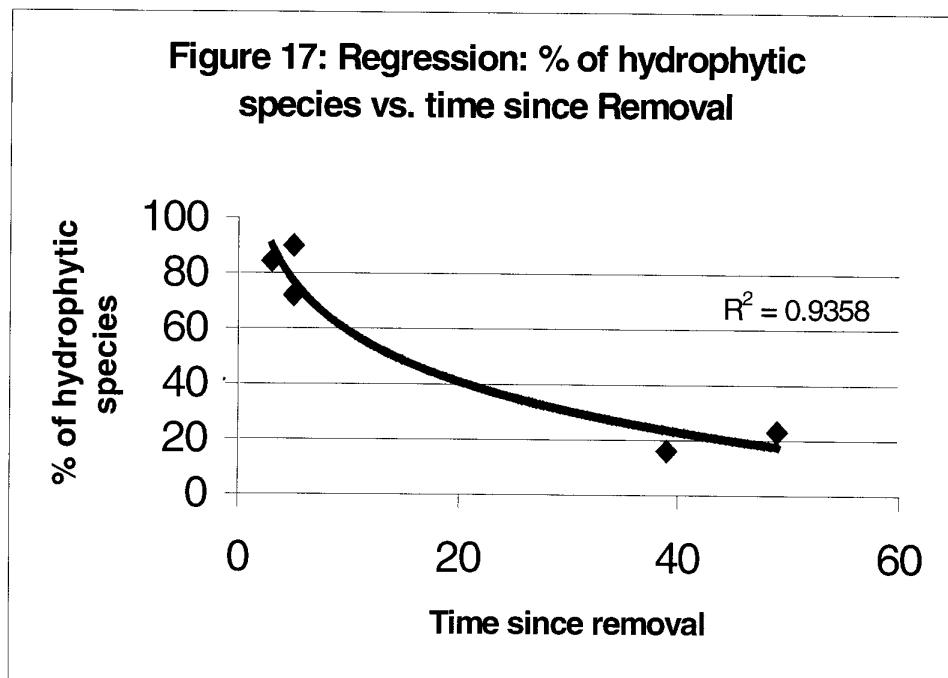
which are defined as species found in wetlands 99% or more of the time, were common at the newer sites and very rare at the older sites (Figure 16). Obligate species represented only 6.3% of species found at Black Earth Creek and 10.3% of species found at Mt. Vernon. (Black Earth Creek had no obligate species if streambank samples are excluded.) At the younger sites, obligates accounted for 21.7-61.5% of the total species. (Table 12). Hebron had by far the highest percentage of obligate species with 61%, followed by Waterloo with 32.4%.
