# **Staged Concrete Bridge Deck Pours Adjacent to Live Traffic**

A thesis submitted in partial fulfillment of the requirements for the degree of

**UNIVERSITY OF WISCONSIN – MADISON**

**2017**

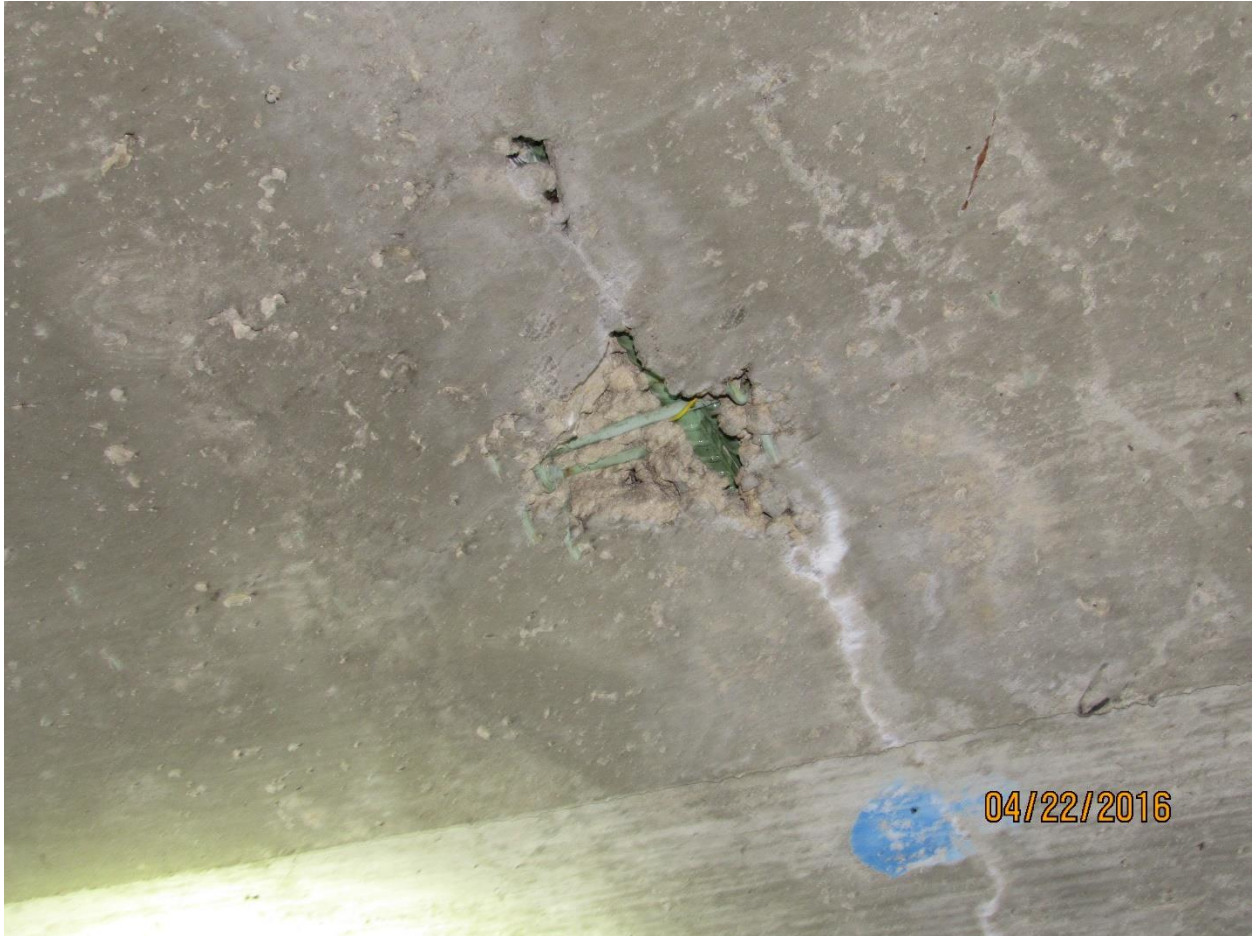
*Figure 4.2- Inadequate concrete consolidation exposing reinforcement in the longitudinal joint region. (B-40-216 – Dowel bar splicer; detail B per Figure 4.1)*

Visual inspections did not prove one detail to be preferable over the others. Bridge decks with each detail were seen that were free of defects and performing well. One issue often encountered was under-consolidated concrete in the longitudinal joint region. The presence of spliced bars and shear keys in this region results in more congestion, which often makes it more difficult to properly consolidate concrete into these tight areas. Couple this with the medium slump concrete that is required for bridge decks and underconsolidation in this area becomes common. An example of inadequate consolidation can be seen in Figure 4.2. To prevent this, workers should use extra effort to ensure the concrete in the longitudinal joint region is properly consolidated by internal vibration. Alternatively, using one-piece bar couplers (Figure 4.1– Detail C) will result in the least amount of congestion and should improve this issue.

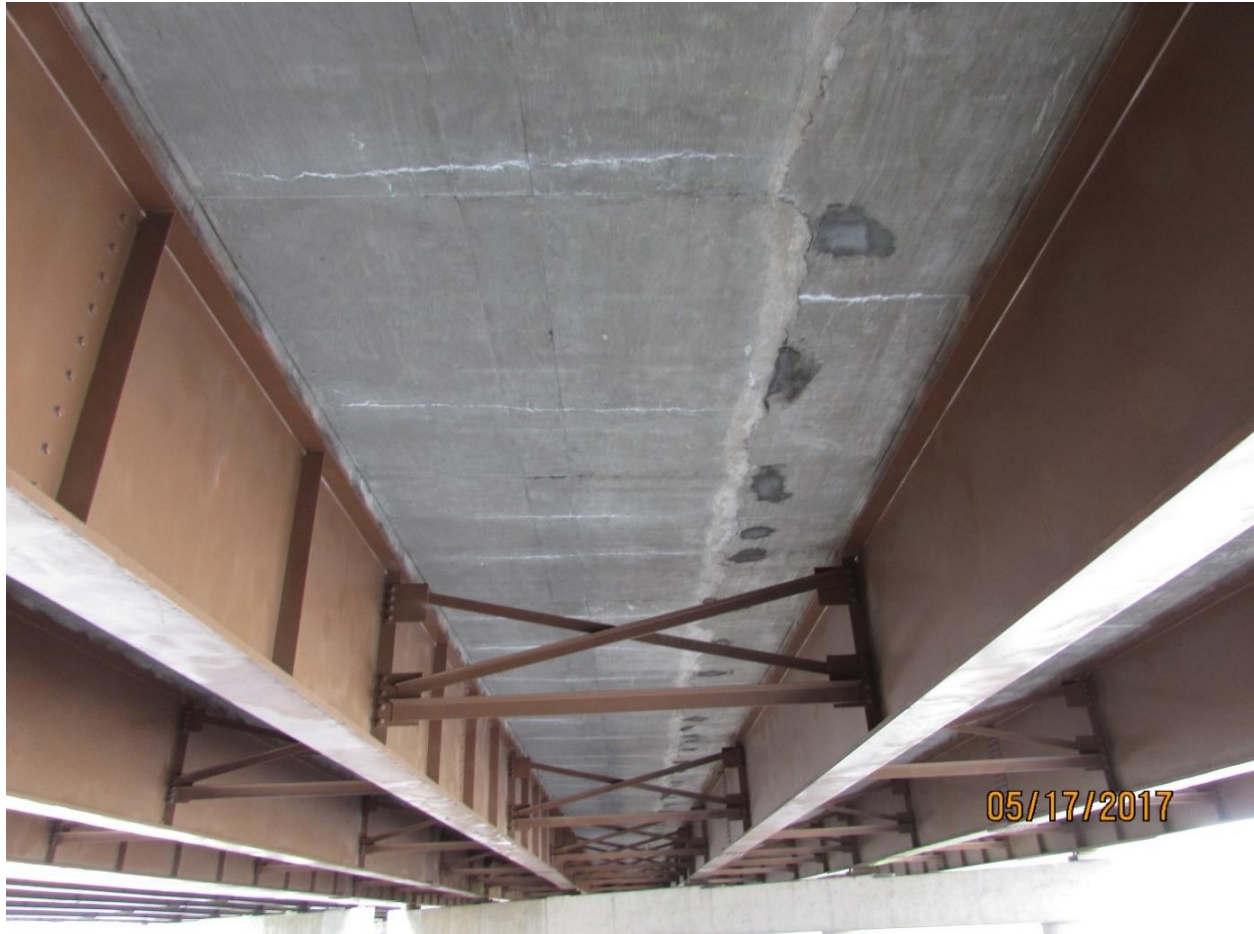
*Figure 4.3- Typical regularly spaced transverse cracks with efflorescence (B-70-176)*

Nearly every bridge exhibited transverse cracking with efflorescence to some extent. These cracks were typically widely spaced in the midspan region, and were most likely flexural cracks. In some cases, these transverse cracks were concentrated more in one side of the deck (i.e. Stage 1 or Stage 2) but there was no evidence to suggest they were related to differential deflections during construction. If differential movement between concrete and reinforcement were to cause transverse cracking, it would be expected to be more closely spaced, at approximately the same spacing as the transverse reinforcement. Typical transverse flexural cracks with efflorescence can be seen in Figure 4.3.

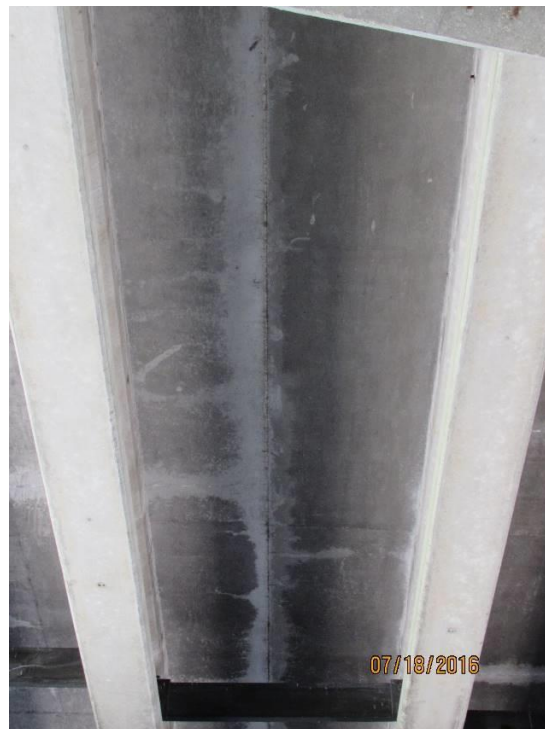
*Figure 4.4 - Typical leakage through a longitudinal construction joint (B-53-083)*

Signs of leakage through the longitudinal construction joint were also commonly observed. This should be avoided; if water, deicing chemicals, road salt and other corrosive agents can seep through the construction joint and reach the reinforcement, the steel crossing the construction joint will be vulnerable to premature degradation. A typical leaking construction joint can be seen in Figure 4.4. This was typical for many of the inspected bridges. The Wisconsin DOT has a standard detail (Figure 4.5) to prevent this type of leakage, in which the top of the construction joint is saw-cut and sealed after construction of both adjoining decks. It is possible that this was not performed on the bridges that showed leakage through the joint. Bridges that utilized this sealant showed minimal signs of leakage through the joint, suggesting that this detail is adequate when used.

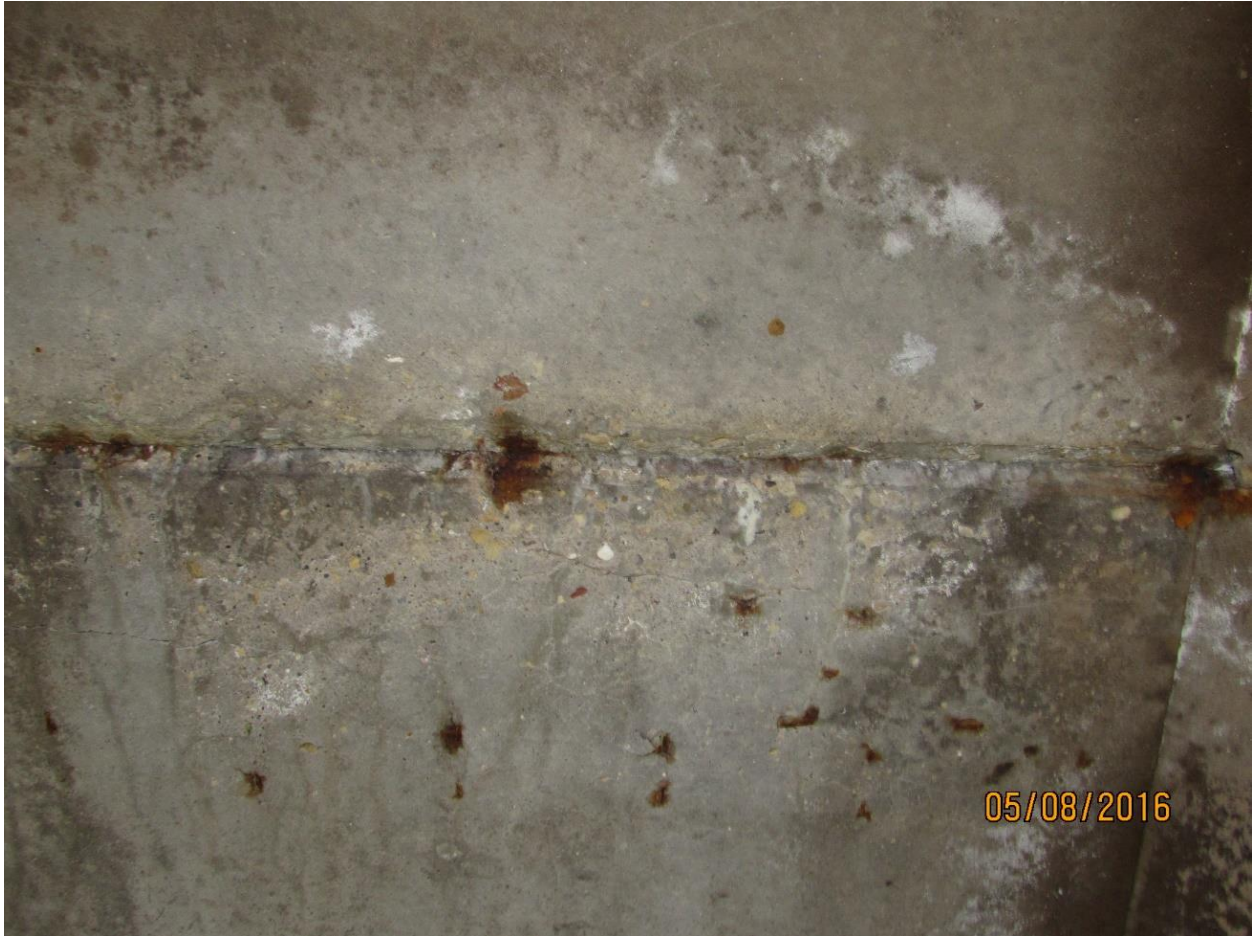
*Figure 4.6 - Typical spots of corrosion on the underside of the longitudinal construction joint (B-56-022)*

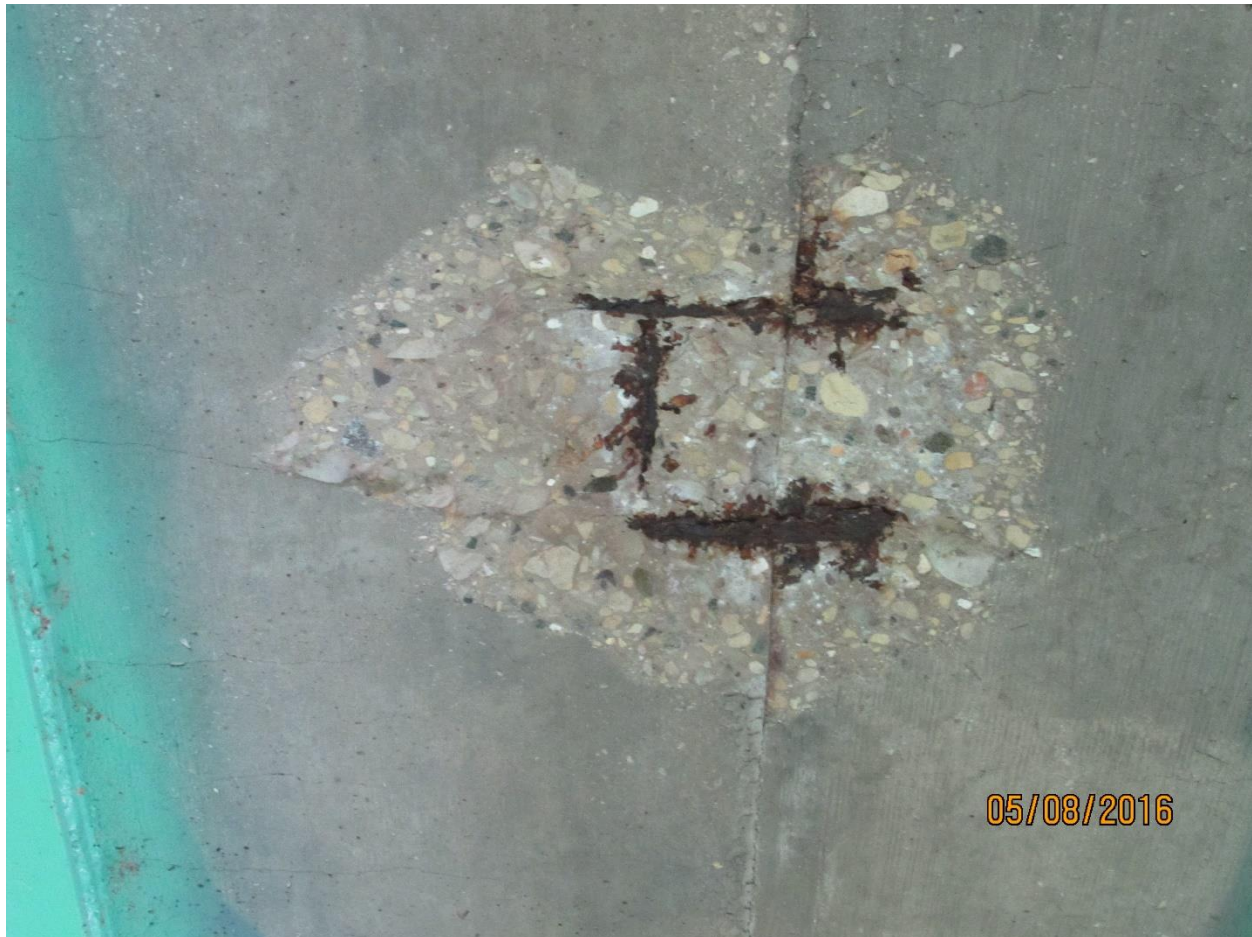
*Figure 4.7- Spalled concrete and corroded reinforcement. Transverse cracking at approx. same spacing as transverse reinforcement (B-13-593)*

One specific bridge deck constructed in stages that was determined to be in poor condition was on bridge B-13-593. This Dane County bridge was on State Highway 19 over Halfway Prairie Creek. This single-span, 58.9 ft simply-supported steel girder bridge was built in 1939, and then had a deck replacement in stages in 1989. Extensive transverse cracking at approximately the same spacing as the transverse reinforcement was seen in this bridge, extending from both sides of the construction joint. There were also delaminations in the longitudinal joint region, and two locations with spalled concrete exposing corroded reinforcing bars (Figure 4.7). The integrated wearing surface was in decent condition, with a few transverse cracks that had been recently sealed. The staged construction joint also appeared to have been sealed recently.

The only known design details for this bridge that may have contributed to this degradation were that the concrete deck was thin (only 7 in.), and the bottom layer of reinforcement in the slab was not epoxy coated. The plain steel bars are more susceptible to corrosion, which would then lead to the spalled patches of concrete seen in the underside of the deck. Although the deterioration in this bridge seems compelling, it is difficult to definitively attribute it to staged construction practices. At the time of the inspection, this bridge deck was 27 years old and approaching the end of its service life. It is therefore difficult to classify this damage as premature, which is the main concern of this research.

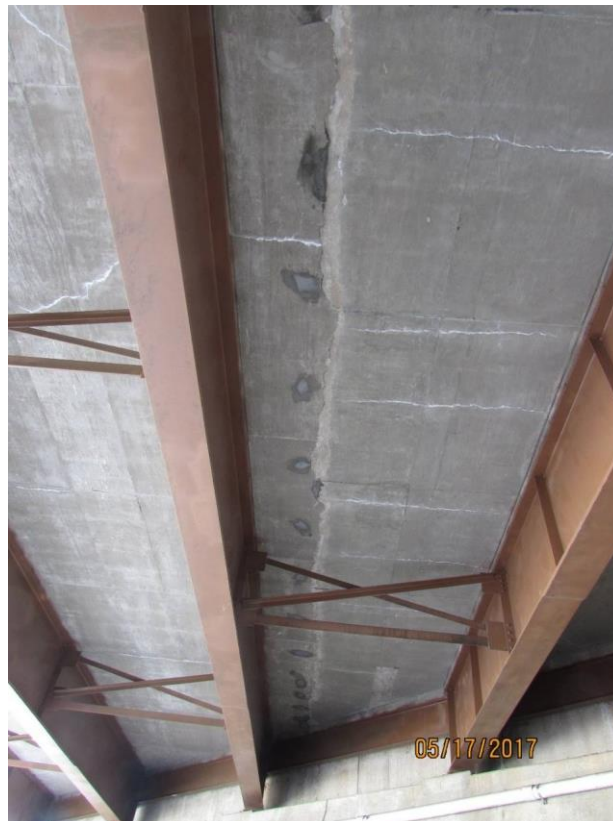
*Figure 4.8- Transverse cracks extending to abutment in Stage 2 deck (right side). Transverse cracks in Stage 1 deck (left side) only near midspan region. (B-70-176)*

widened deck portion. However, the widened portion of the deck had regularly spaced transverse cracks with light efflorescence throughout the length of the bridge, where the existing deck only had similar cracks in the midspan regions (see Figure 4.8). The transverse cracks in the widened portion of the bridge deck are likely shrinkage cracks. The two deck portions were constructed 16 years apart, so they were likely subjected to different environmental conditions during curing and would therefore have varying distributions of shrinkage cracks. Additionally, these transverse cracks were mainly observed in the widened portion of the deck directly adjacent to the longitudinal construction joint. Shrinkage cracks would be more prevalent in this area because the hardened deck adjacent to the curing concrete provided some restraint against shrinkage. The adjacent bridge (B-70-177), which was identical, was chosen to be a subject for the analytical modeling portion of this research as discussed in Section 6.4.

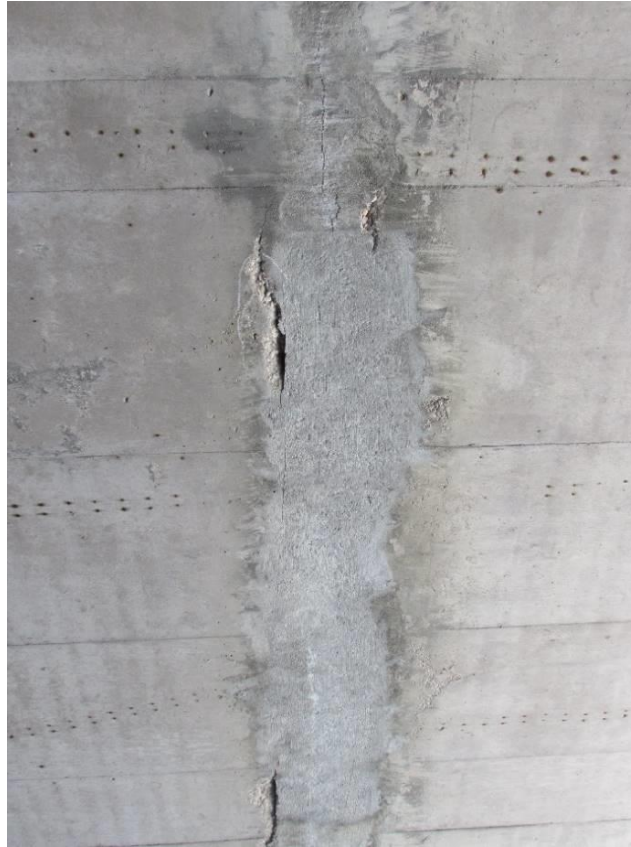
*Figure 4.9- Patching of previously spalled concrete at longitudinal construction joint in haunched slab bridge. (B-30-026)*

In 1970, when these bridges were widened, epoxy coated steel reinforcement was not being used in Wisconsin, which explains why such severe corrosion of the reinforcement was seen. Due to the overlays in place, the original wearing surface could not be inspected, but based on the condition of the underside of the slab, it may be inferred that cracks and other defects in the longitudinal construction joint region allowed for the corrosion of the underlying steel reinforcement, resulting in the eventual defects seen in this region.

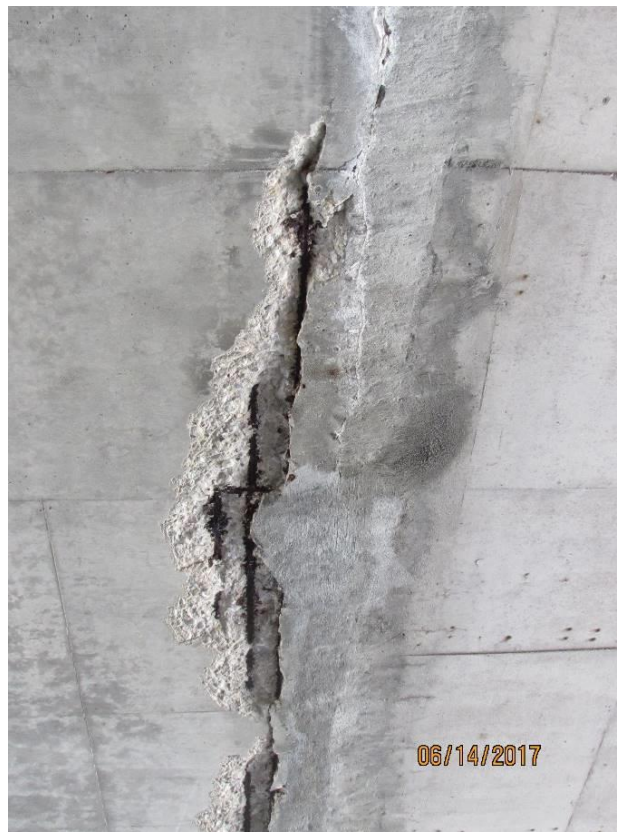
*Figure 4.10- Spalled concrete at longitudinal construction joint exposing corroded reinforcement. (B-30-014)*

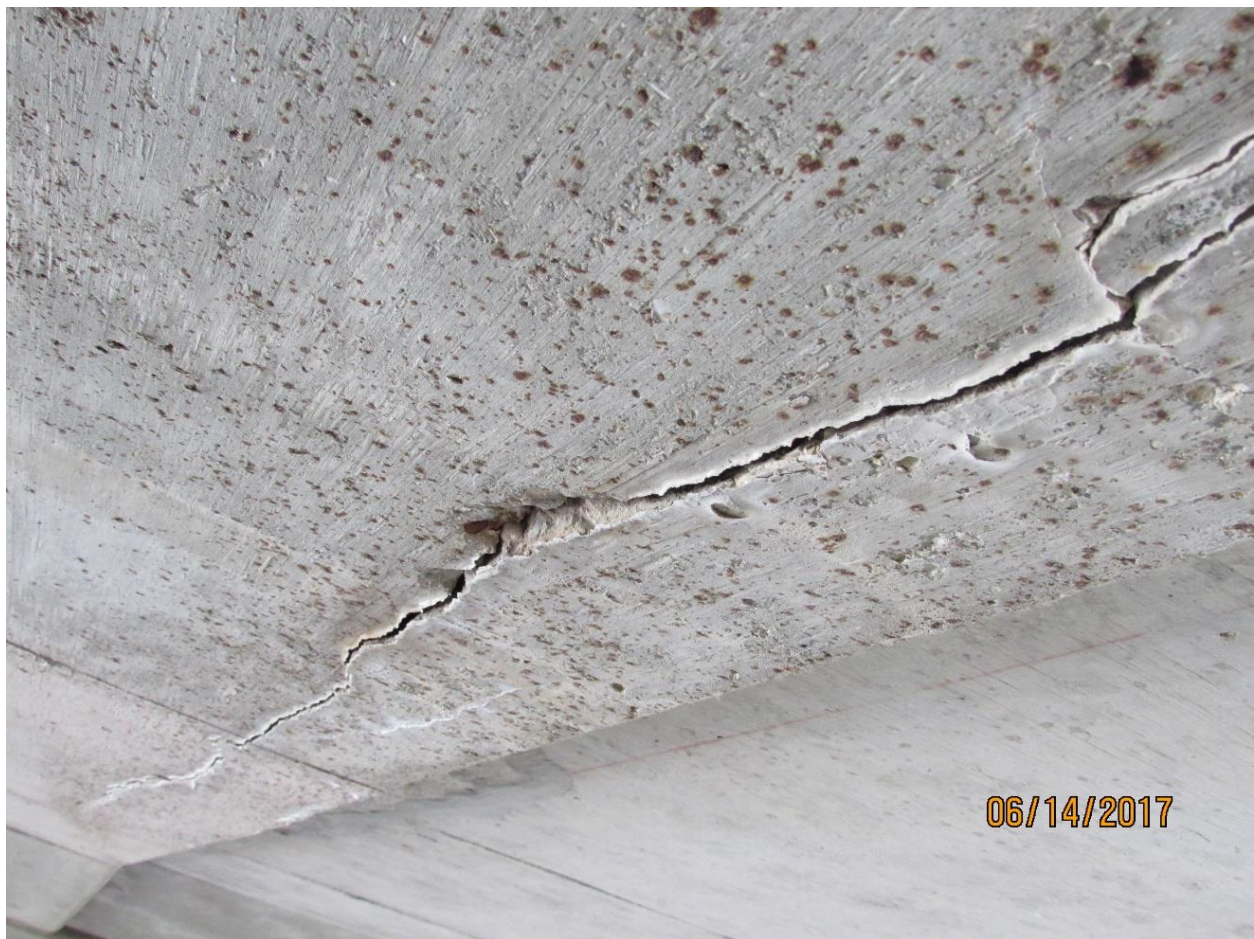
*Figure 4.11- Large longitudinal crack adjacent to construction joint. (B-51-017)*

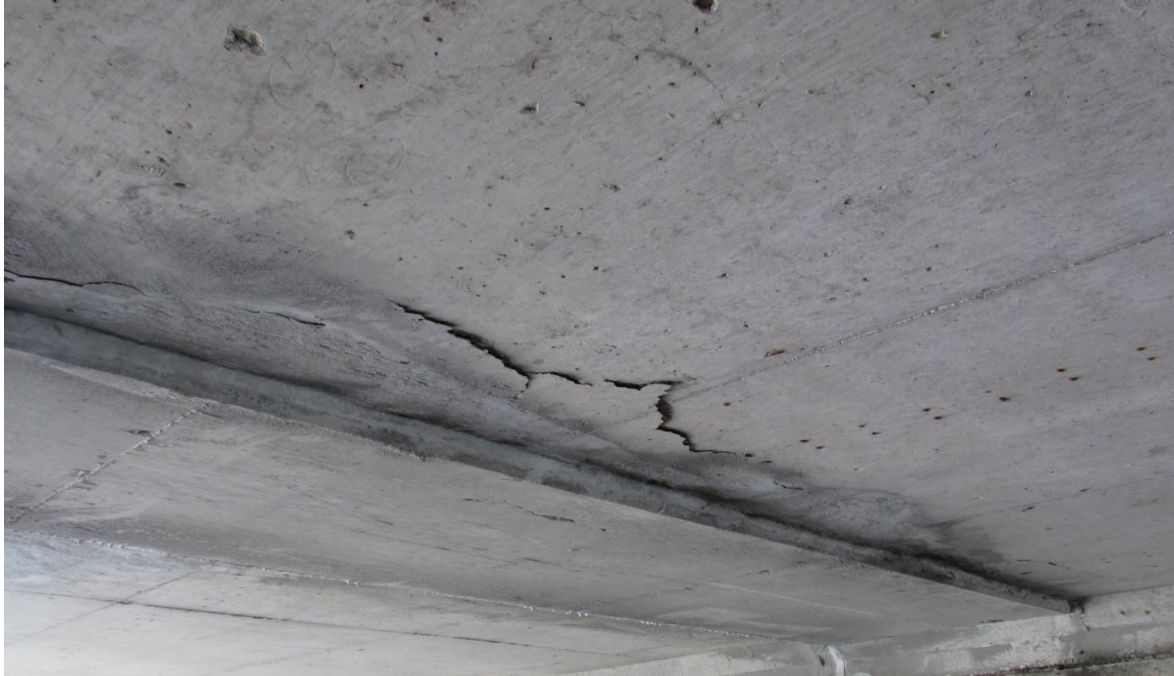
*Figure 4.12 - Delaminated area adjacent to longitudinal construction joint in widened portion of deck. (B-30-014)*

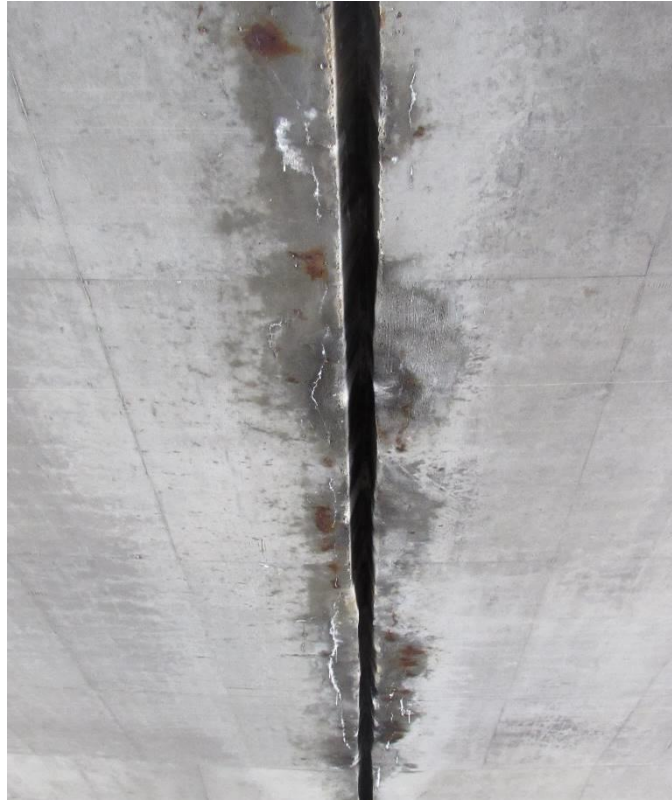
*Figure 4.13 - Efflorescence and corrosion due to retained moisture at waterstop joint between adjacent bridges. (B-30-025/026)*

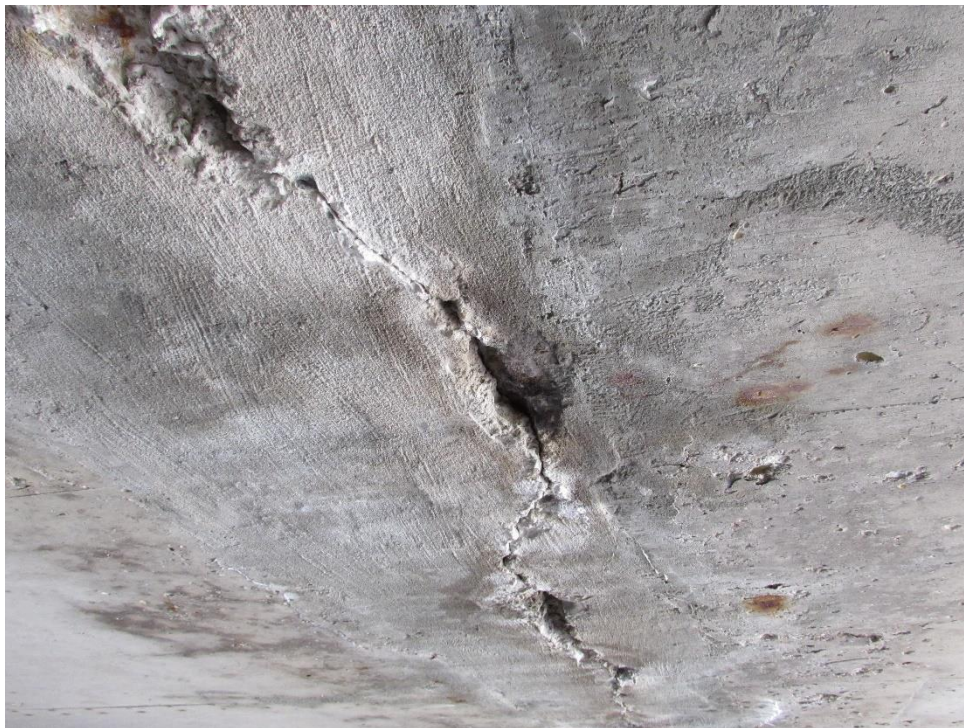
*Figure 4.14 - Large longitudinal crack opening approximately 1/4" during the passage of large trucks. (B-30-015)*

opened under traffic loading. This differential movement at the construction joint was measured to be approximately  $\frac{1}{4}$  in., and occurred in the construction joint from the original 1959 construction (Figure 4.14). This repeated opening and closing of large cracks was slowly wearing away the concrete, which was piling up on the embankment underneath. Visible differential movement at the longitudinal construction joint verified that the continuity across the joint had been severely degraded. This likely meant the concrete-rebar bond across the joint had been compromised, possibly due to corrosion of the steel, damage to the surrounding concrete, or other factors.

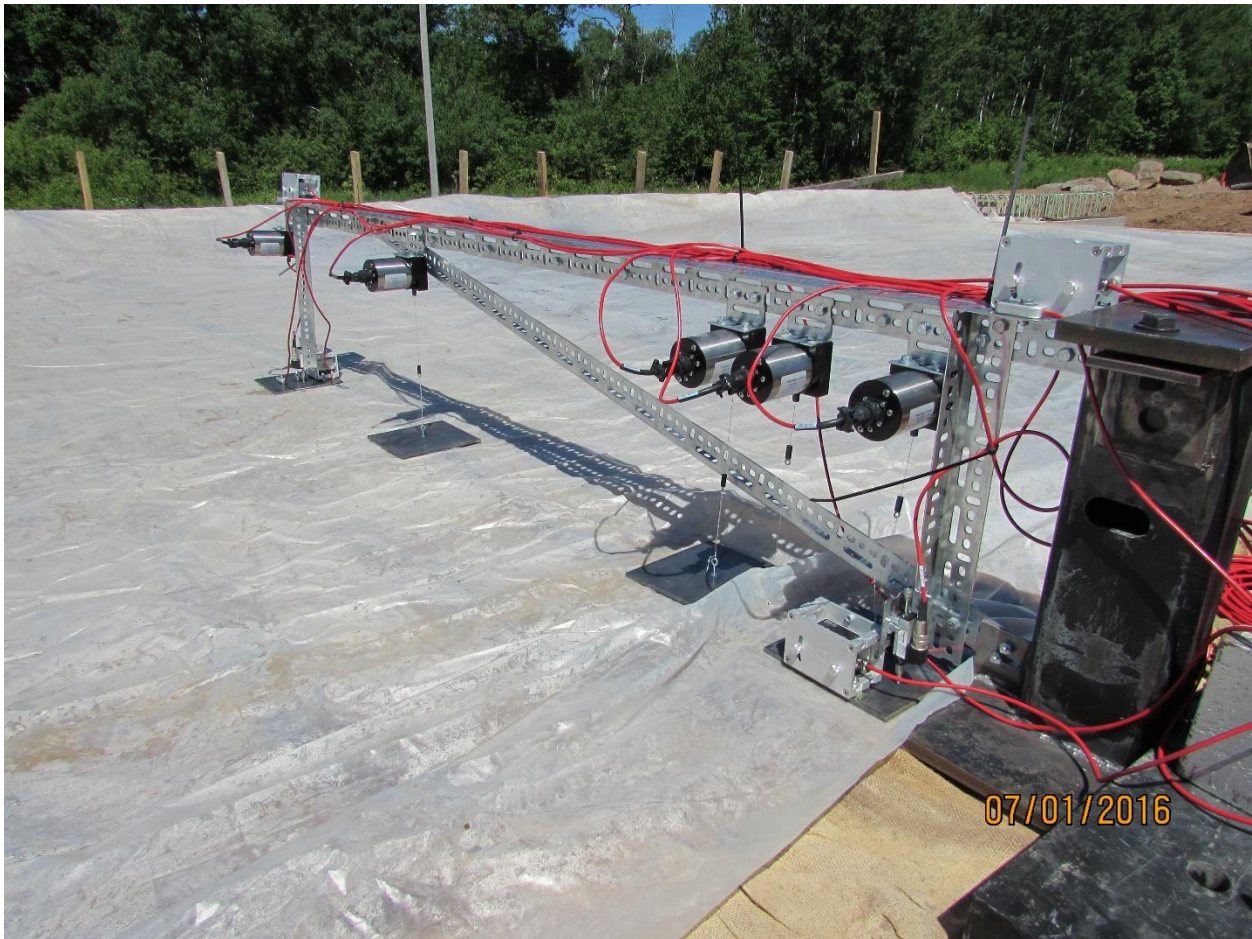
*Figure 5.2- Field monitoring instrumentation setup after casting of Stage 2 deck (B-16-136)*

These sensors measured displacements at points on the fresh concrete surface as well as on the instrumentation arm itself, which then allowed for the calculation of differential deflections between the two adjacent girders. Two different methods were used to compute differential deflections. They are discussed further in Sections 5.1.3 and 5.1.4. A collection frequency of 100 Hz was used for all field monitoring.

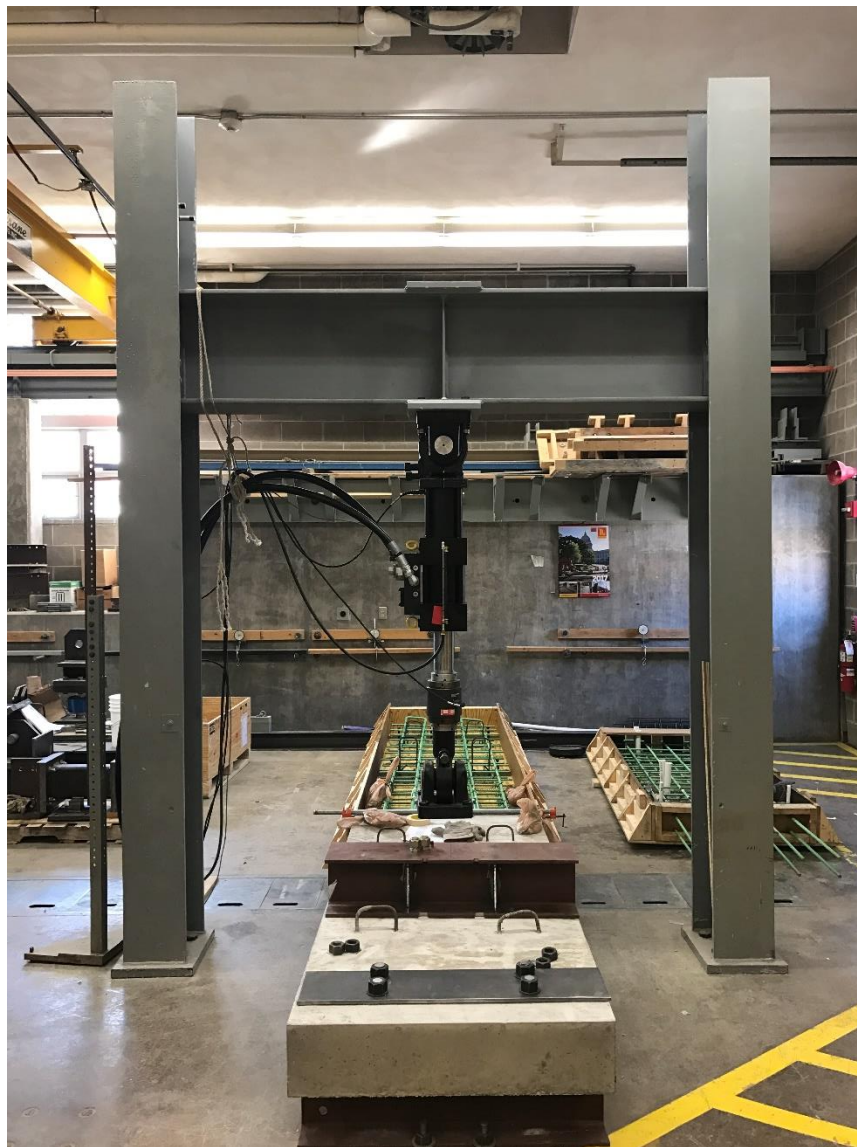
*Figure 7.2 - Specimen in place underneath loading frame prior to casting of Stage 2 portion.*

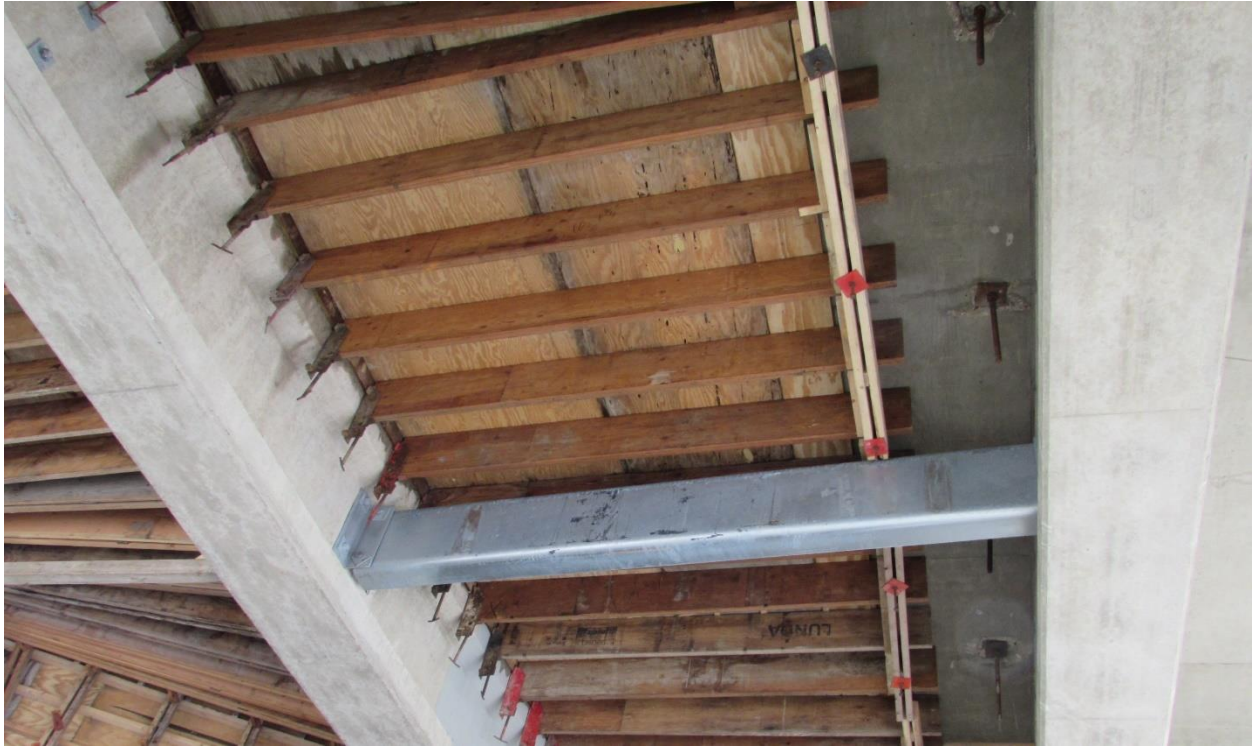
*Figure 7.9 - Formwork system as seen in staged construction of bridge B-64-123. Wood beams are supported by top flange of left girder and rods are drilled through Stage 1 hardened deck on right side.*

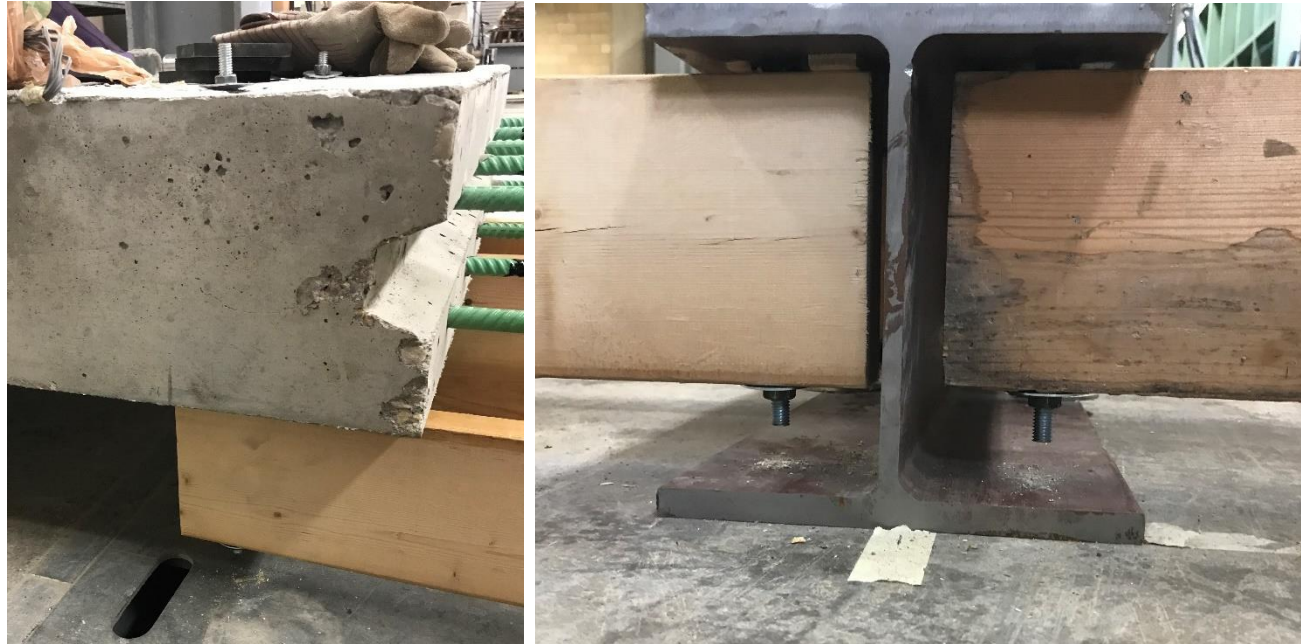
*Figure 7.12 - Formwork supporting system connections. Left: steel rod passing through hardened slab. Right: steel rod threaded into nut welded to steel supporting beam.*

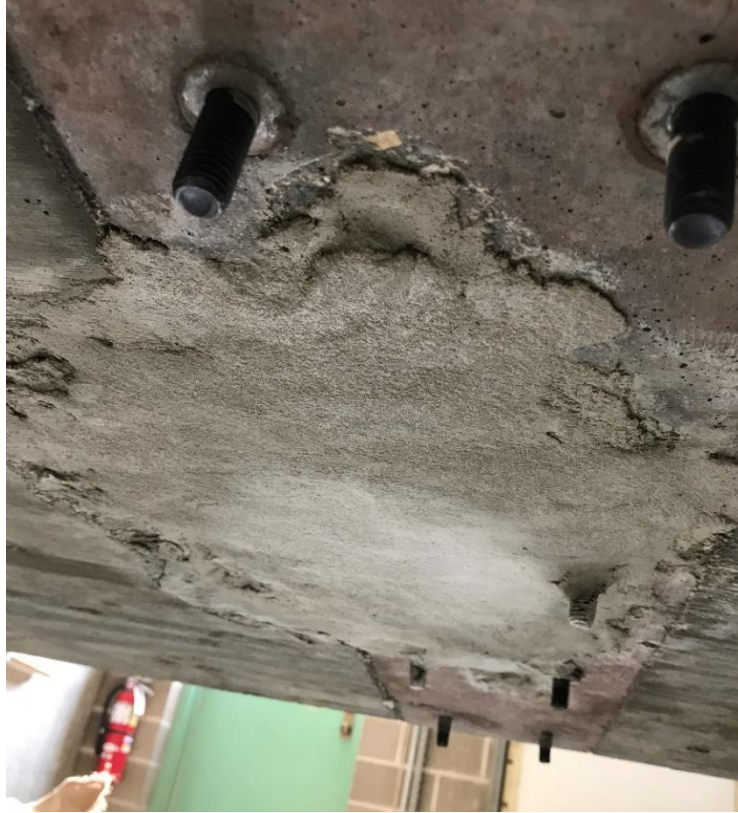
*Figure 7.28 - High strength grout repair patch where a shear connector had accidentally been pulled from the underside of the specimen.*

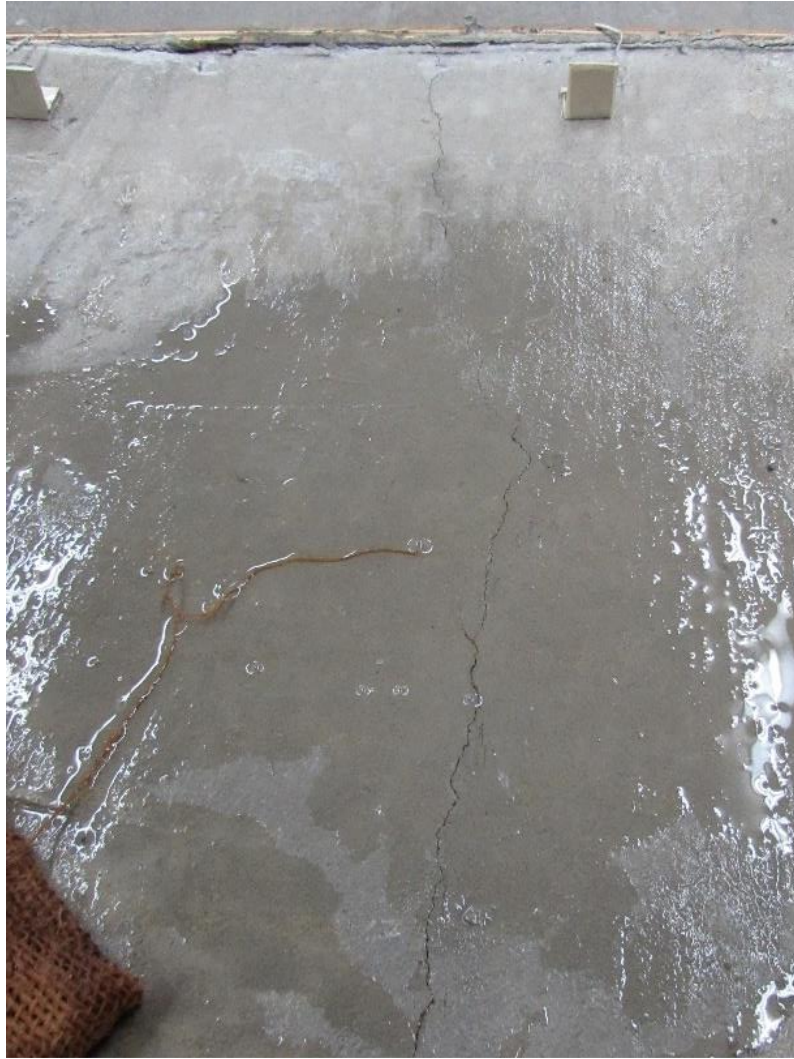
*Figure 7.29 - Flexural crack resulting from deflections applied during curing of Stage 2 segment.*

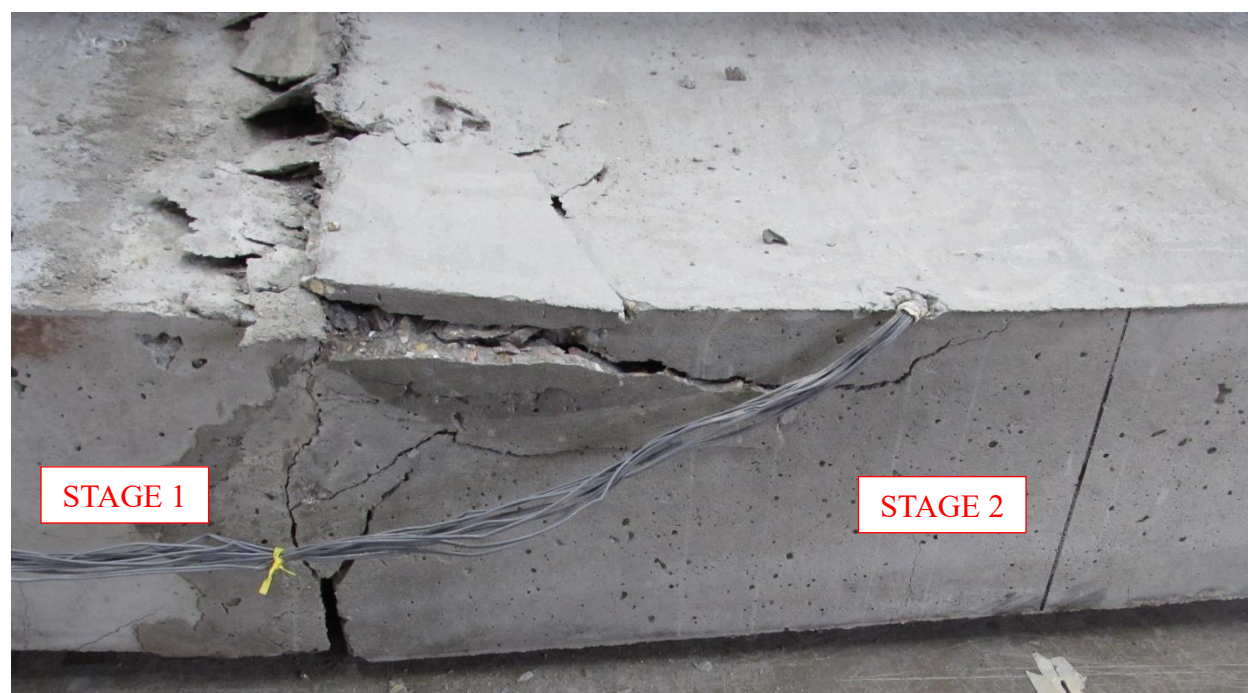
*Figure 7.31 - Specimen 2 compression block failure at construction joint.*
