LONG-TERM PERFORMANCE OF RADON BARRIERS
IN LIMITING RADON FLUX FROM FOUR URANIUM
MILL TAILINGS CONTAINMENT FACILITIES

A Thesis submitted in partial fulfillment of
the requirements for the degree of

Master of Science

UNIVERSITY OF WISCONSIN-MADISON

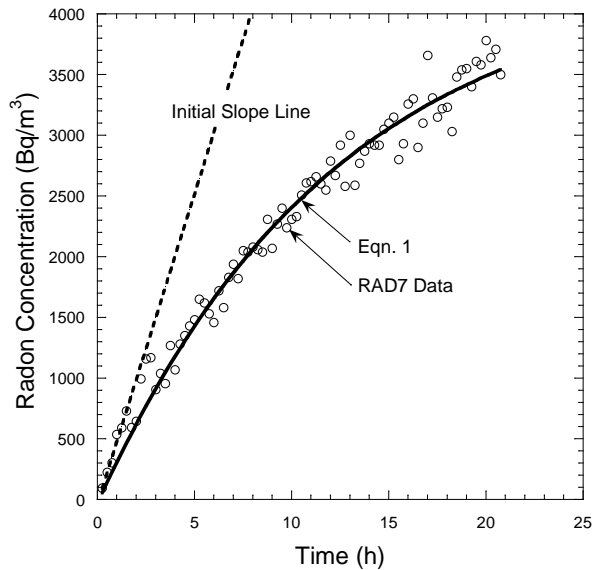
Figure 4.5 – Example of a Rn buildup curve from RAD7 data, fit with Eqn. 1.

Using the method of least-squares regression, the Rn flux, J_o is determined (see **Figure 4.5** for curve fit example from field data). The initial flux emanating from a material or surface can also be calculated considering only the initial, linear portion of the Rn buildup curve. In this initial region of Rn buildup, flux is independent of back diffusion and decay and so can easily be

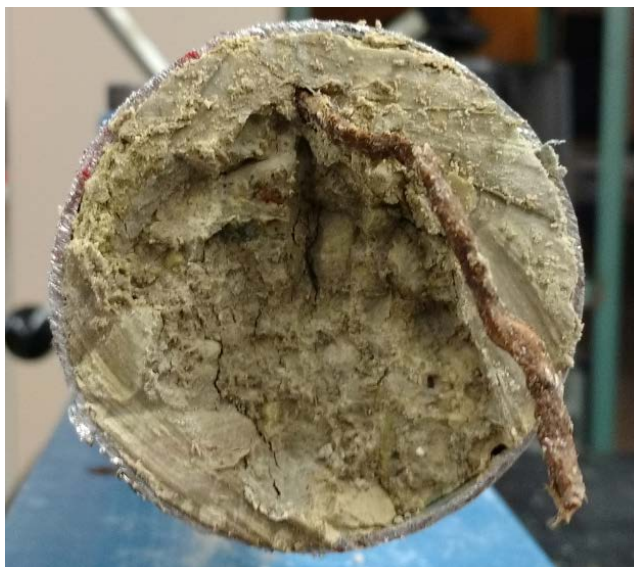
Figure 5.1.11 – A large root protruding from a thin-walled Shelby tube sample from TP-3 from Falls City, TX.

The average flux measured from test pit 3 (Mesquite Brush) was more than seven times greater than the adjacent test pit 4 (control) and was very close to the UMTRCA limit of 0.74 Bq/m²s, which is consistent with the hypothesis. Furthermore, the thicknesses of the two pits were comparable. However, the flux measured from the tailings beneath the mesquite pit was greater than that measured beneath the control pit, which may have contributed to the elevated fluxes measured from the mesquite pit. The water content did not appear to be lowered in test pit 3 due to the presence of the Mesquite Tree and was found to have a greater water content compared to the control. The elevated fluxes measured at the surface at test pit 3 may also be due to the pathways created from the root structure. **Figure 5.1.2** (below) shows an example of a large root found in the thin-wall Shelby tube during lab sampling.

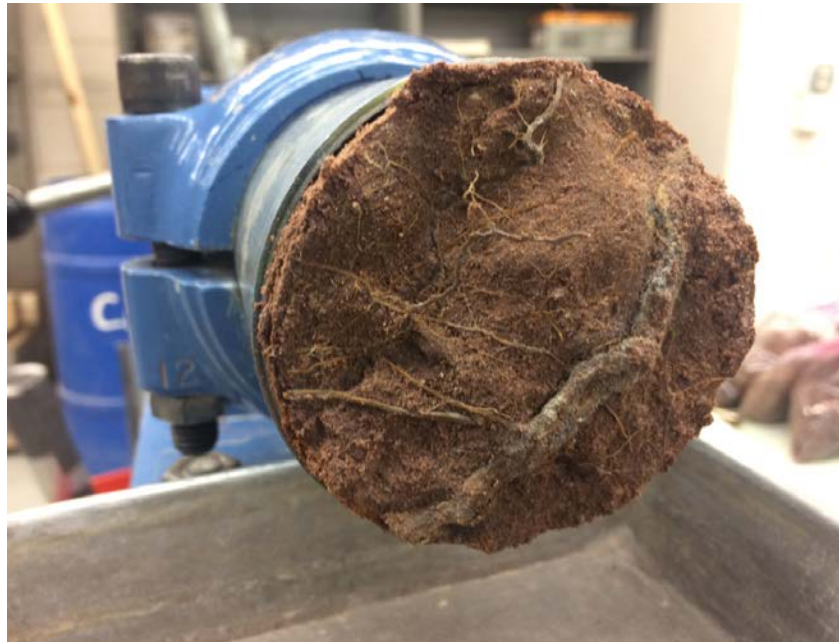
Figure 5.1.13 – Large root in 70 mm diameter Shelby tube sample from Bluewater, NM test pit 5.

The average flux measured from test pit 5 (saltbush colony) was greater than sixty times the average flux measured from test pit 4 (control). The average water content in test pit 5 was approximately 33% lower than the control test pit and multiple roots were observed in 70 mm diameter Shelby tube samples obtained from test pit 5 (**Figures 5.1.3 and 5.1.4**). Both of these characteristics likely served to increase the Rn diffusion coefficient of the Rn barrier beneath test pit 5 and are likely the main reasons why elevated fluxes were measured. The thickness of the barrier at each of the test pits was comparable. Furthermore, the flux from the tailings beneath test pit 5 (saltbush colony) were much less than the tailings flux measured from test pit 4 (control), strengthening the hypothesis that the saltbush colony was the main cause of the elevated flux measurements.

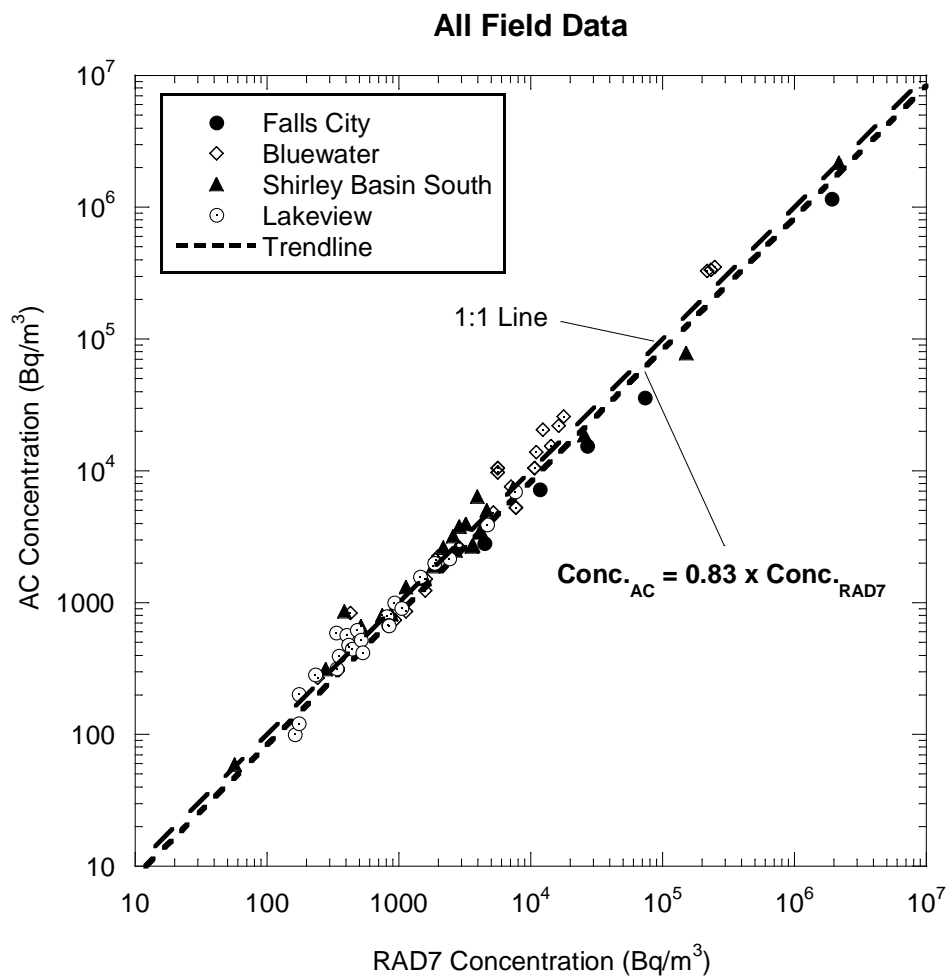
Figure 5.3.3 – Comparison of the AC and RAD7 methods in determining Rn concentration (all field data points included). n = 76, R² = 0.94

A line was fit to the data points using a best-fit linear-regression for each dataset. A line with a 1:1 slope was also shown in each plot as a reference. If the two methods were in perfect agreement for each test, the points would fall on this 1:1 line.

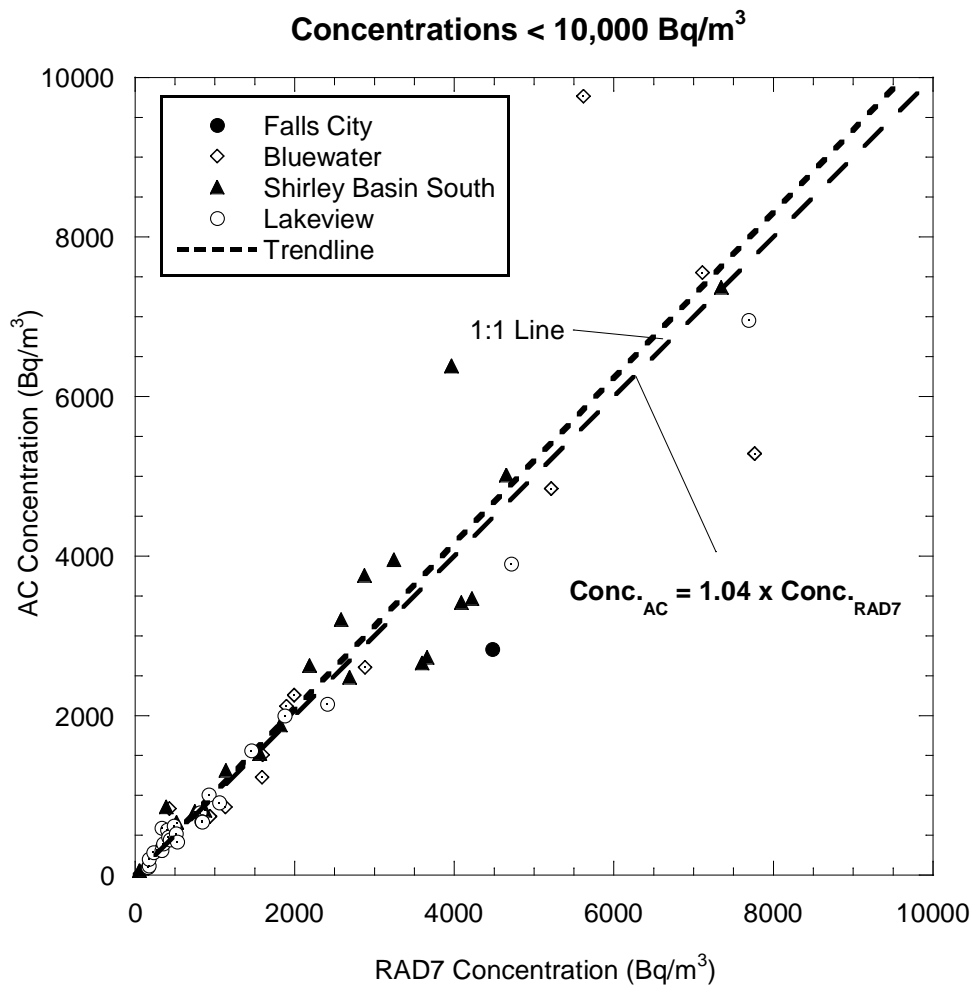
Figure 5.3.4 - Comparison of the AC and RAD7 methods in determining Rn concentration (Rn concentrations below 10,000 Bq/m³). n = 60, R² = 0.82

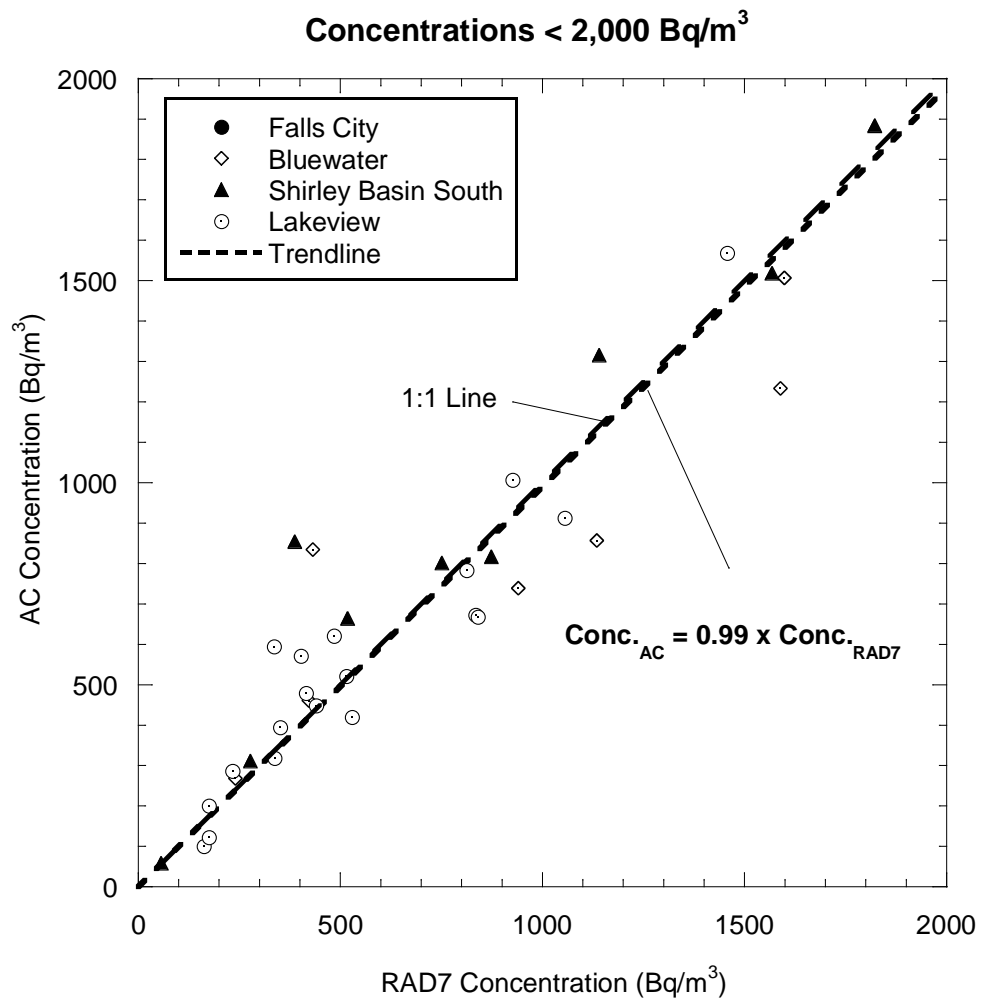
Figure 5.3.5 - Comparison of the AC and RAD7 methods in determining Rn concentration (Rn concentrations below 2,000 Bq/m³). n = 35, R² = 0.86

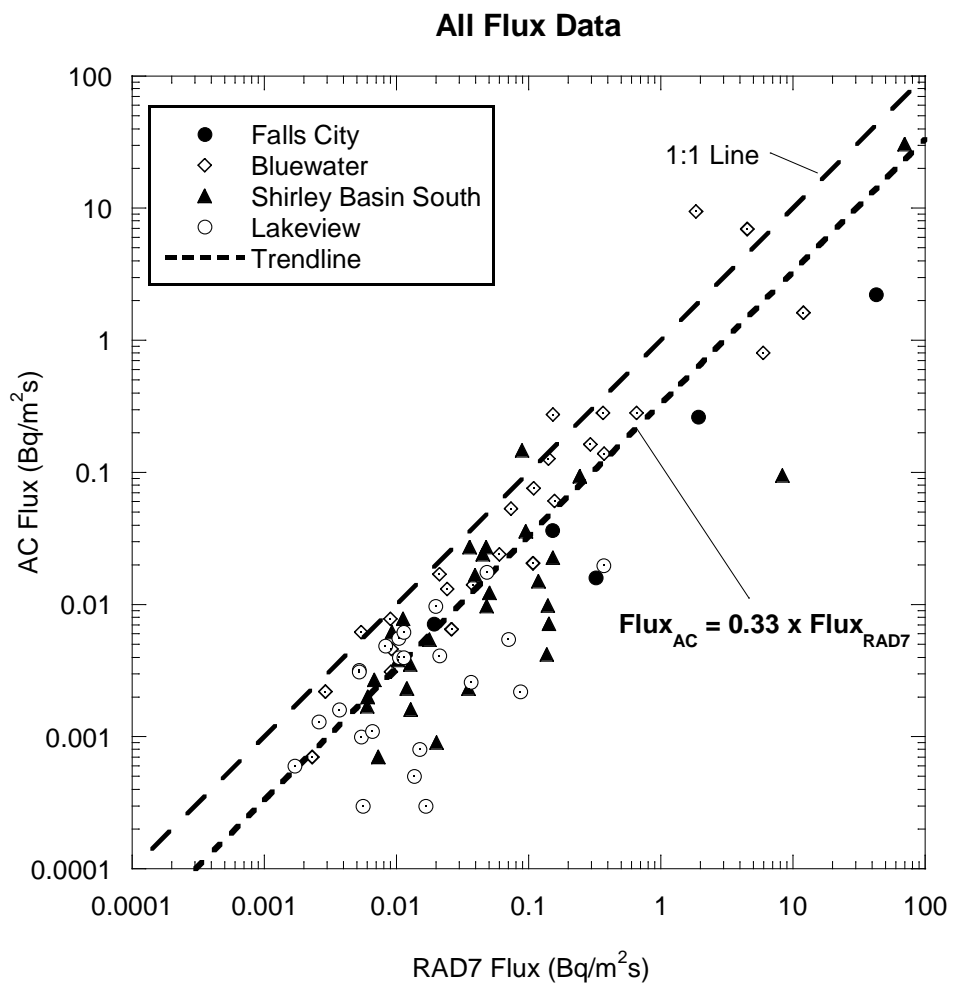
Figure 5.3.6 - Comparison of the AC and RAD7 methods in determining Rn flux (All Rn flux data included). $n = 81$, $R^2 = 0.75$

The same method was used to analyze the agreement of RAD7 and AC methods in determining Rn flux. **Figures 5.3.6 through 5.3.8** show fluxes calculated using RAD7 on the x-axis versus the corresponding fluxes calculated using the AC method on the y-axis. **Figure 5.3.6** shows all field data points on a log-log scale so that extreme values can be shown. **Figures 5.3.7 and 5.3.8** show data points below concentrations of 1.0 Bq/m²s and 0.1 Bq/m²s, respectively, so that this relationship could be observed for all data points. The majority of flux magnitudes for field measurements taken from the surface of the Rn barrier were below the UMTRCA limit of 0.74 Bq/m²s and so particular emphasis is placed on **Figure 5.3.7** with values below 1.0 Bq/m²s.

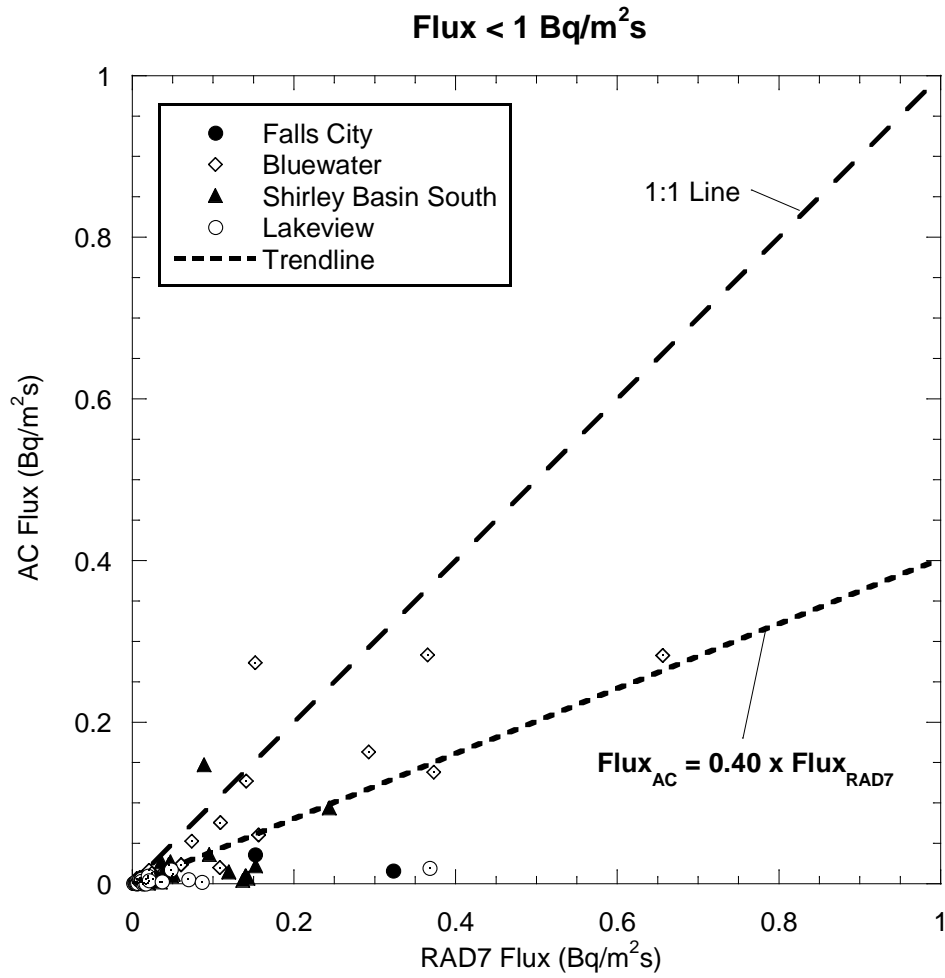
Figure 5.3.7 - Comparison of the AC and RAD7 methods in determining Rn flux (Rn fluxes below 1 Bq/m²s). n = 74, R² = 0.54

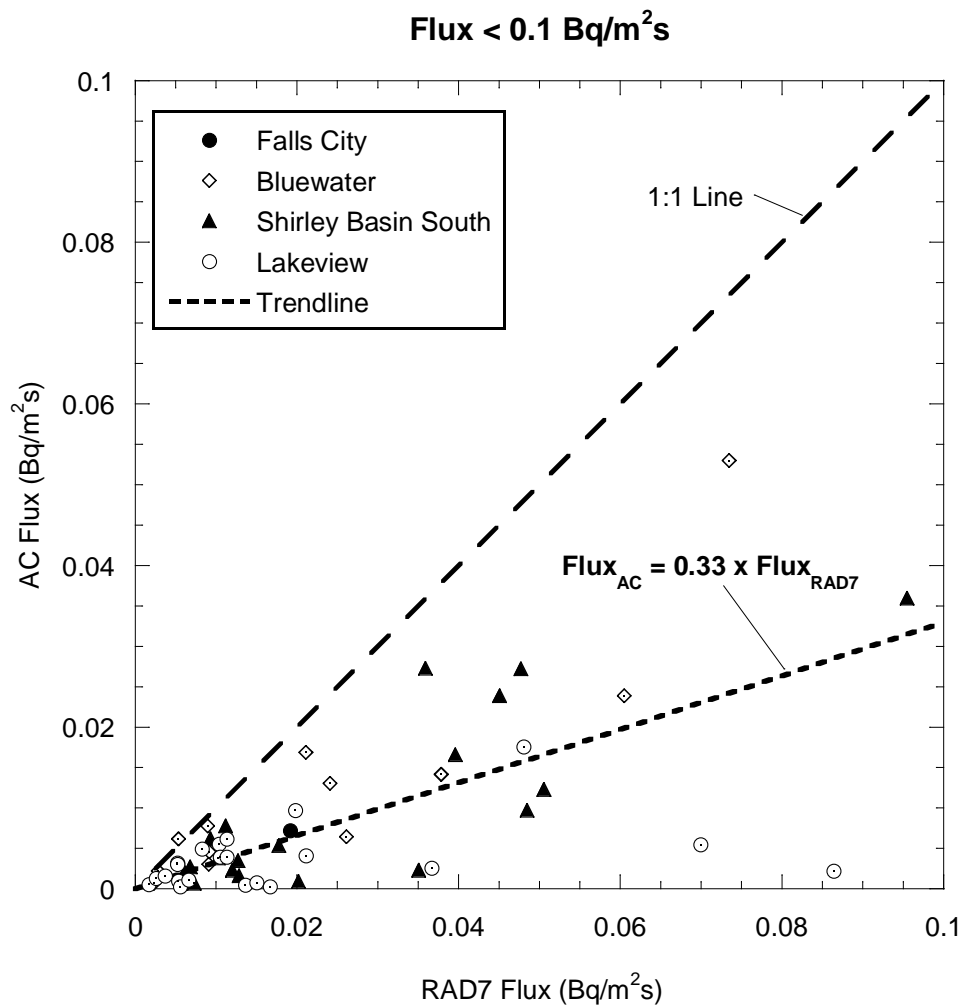
Figure 5.3.8 - Comparison of the AC and RAD7 methods in determining Rn flux (Rn fluxes below 1 Bq/m²s). n = 54, R² = 0.39

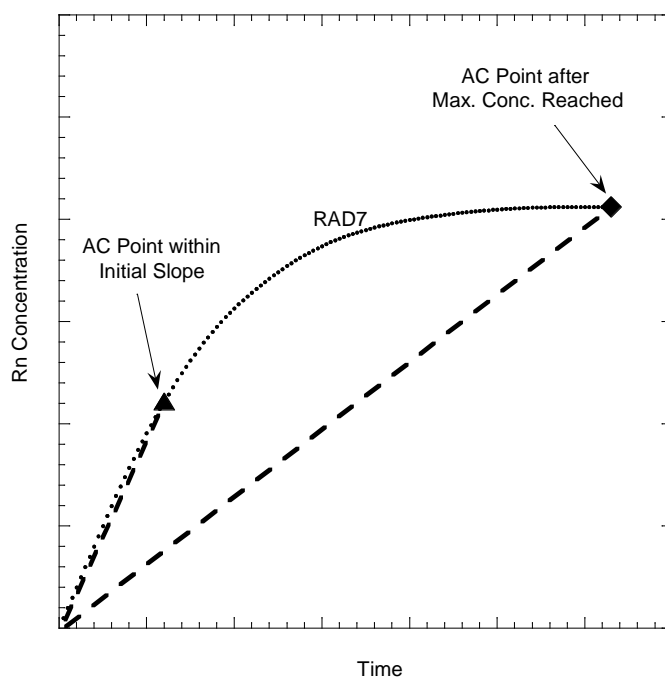
Figure 5.3.9 – An idealized depiction of Rn concentration buildup within a flux chamber.

that the concentration within the chamber will have reached a maximum, steady value (typical of smaller chambers). The slope of the Rn buildup to that single concentration point will be less than the maximum slope of Rn buildup in the initial concentration buildup portion of the curve. **Figure 5.3.9**, below, depicts this phenomenon under idealized conditions.

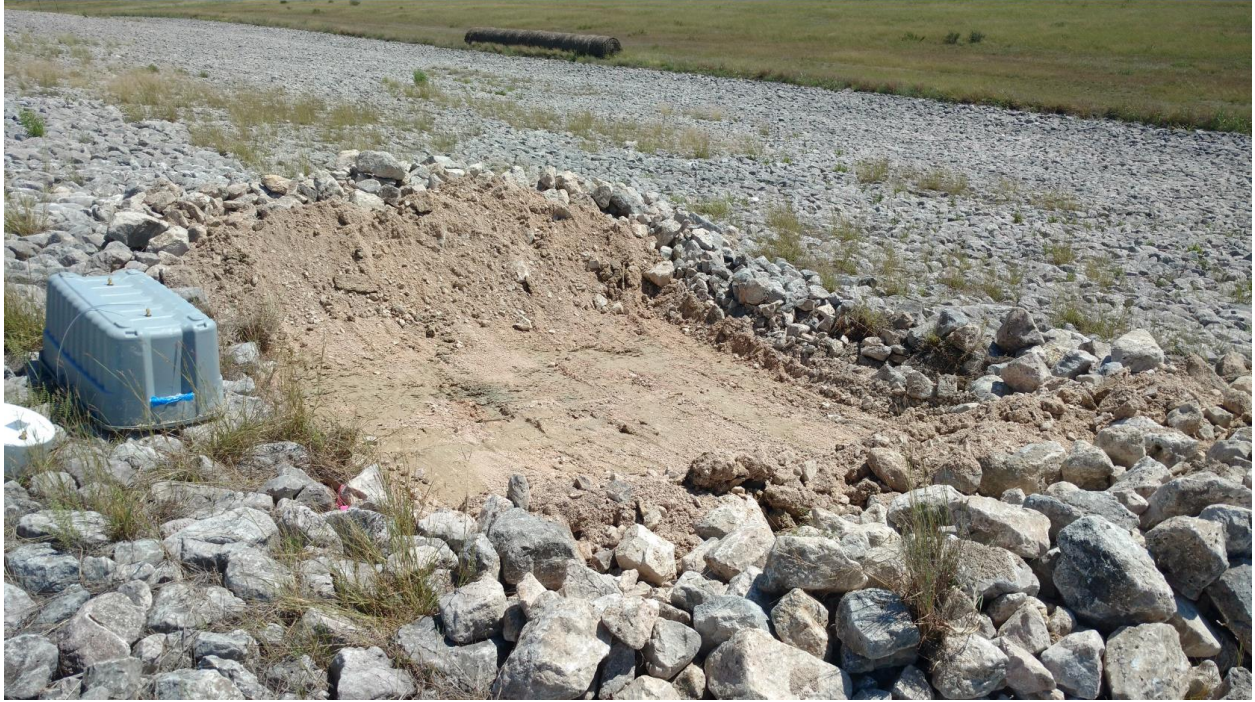
Figure 11 – Test pit with rip-rap layer removed to expose Rn barrier.

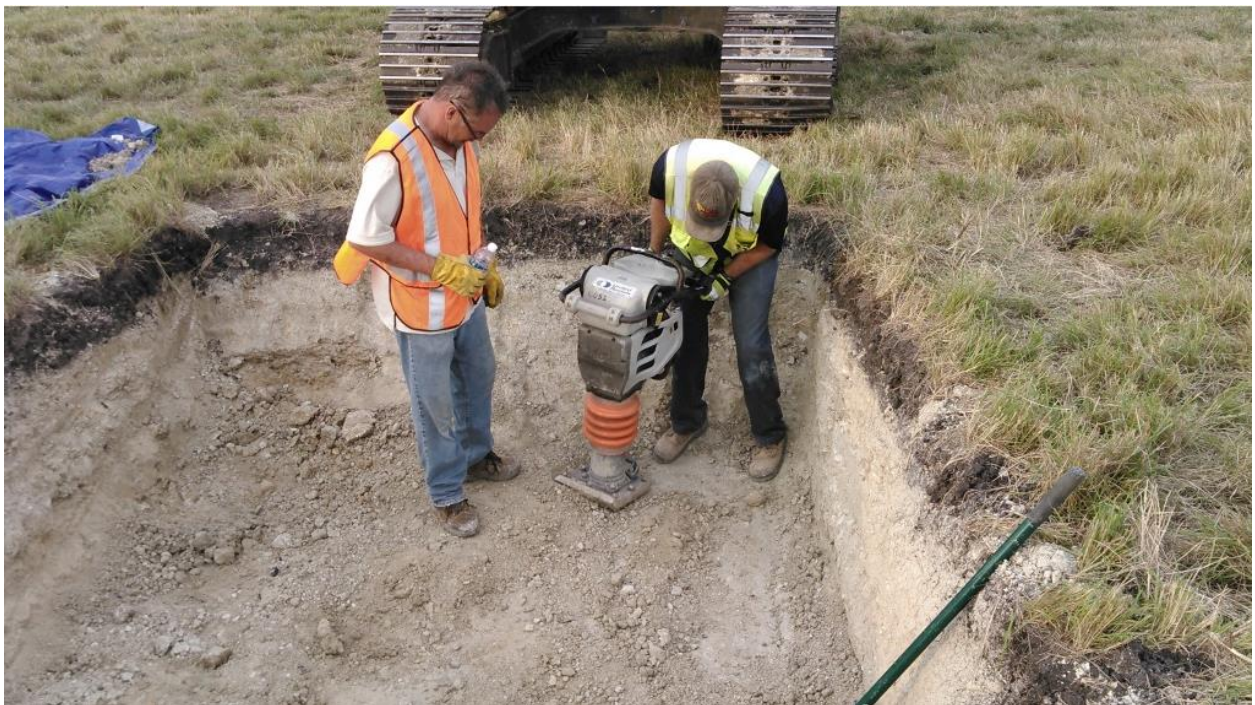
Figure 12 – Replacement and compaction of Rn barrier material.

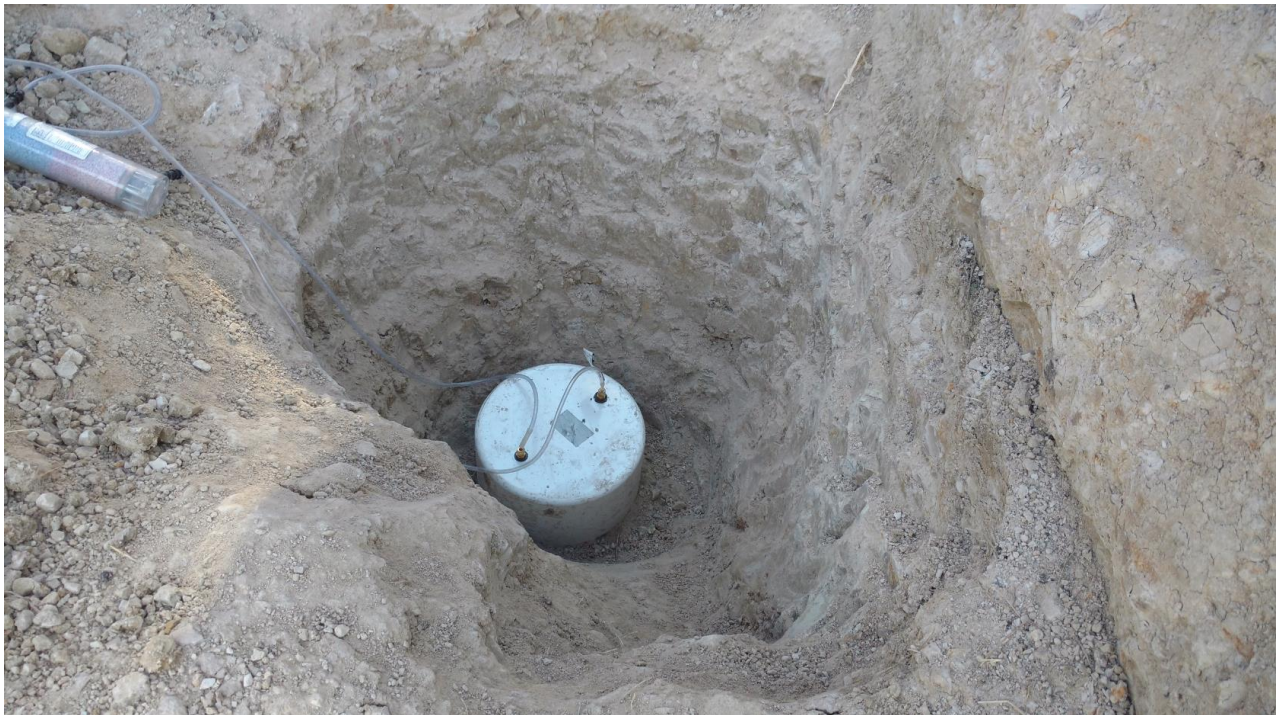
Figure 14 – Small flux chamber placed directly on tailings.

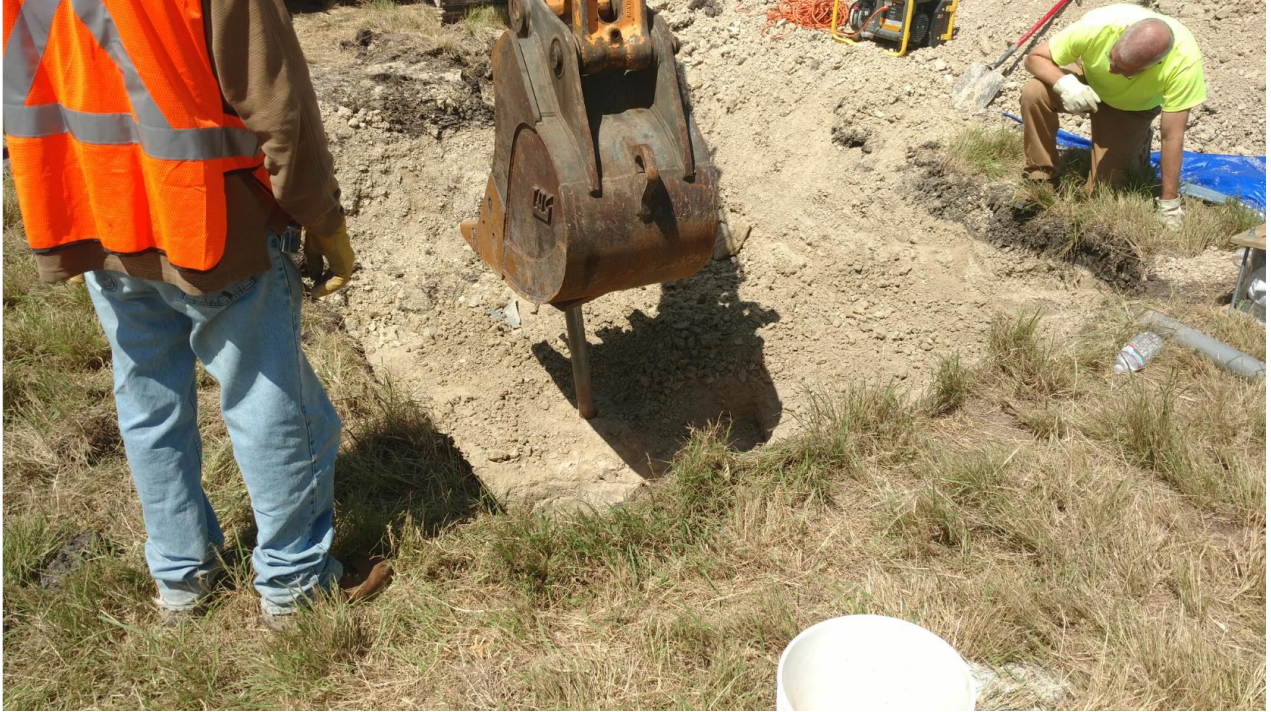
Figure 15 – Pushing a thin-walled tube sample through the Rn barrier with an excavator bucket.

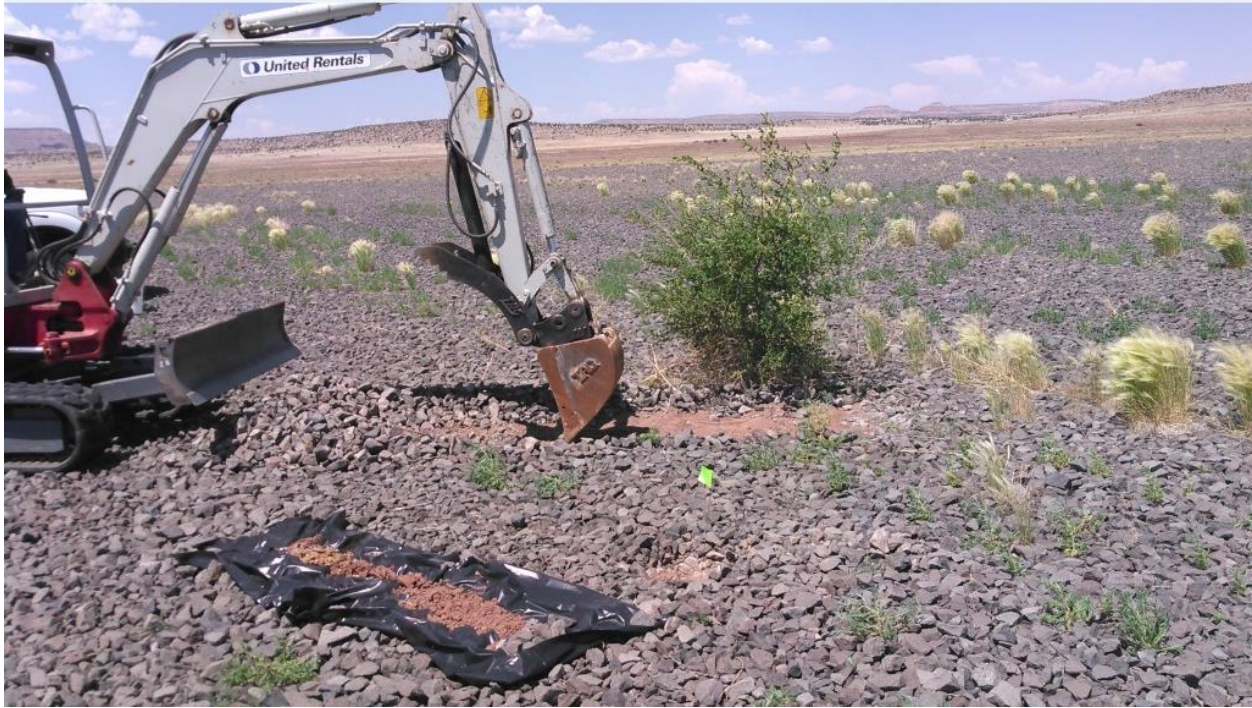
Figure 46 – Removal of the rip-rap layer to expose the top of the Rn barrier.

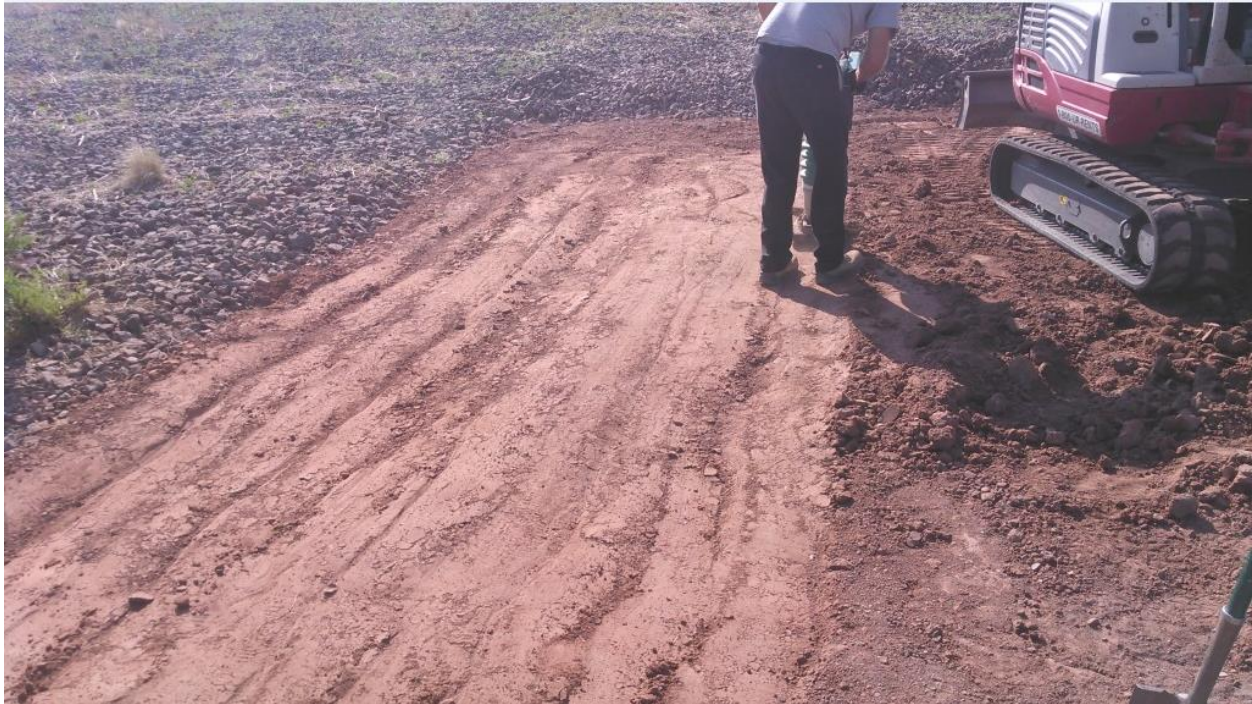
Figure 47 – Repair and compaction of the Rn barrier soil.

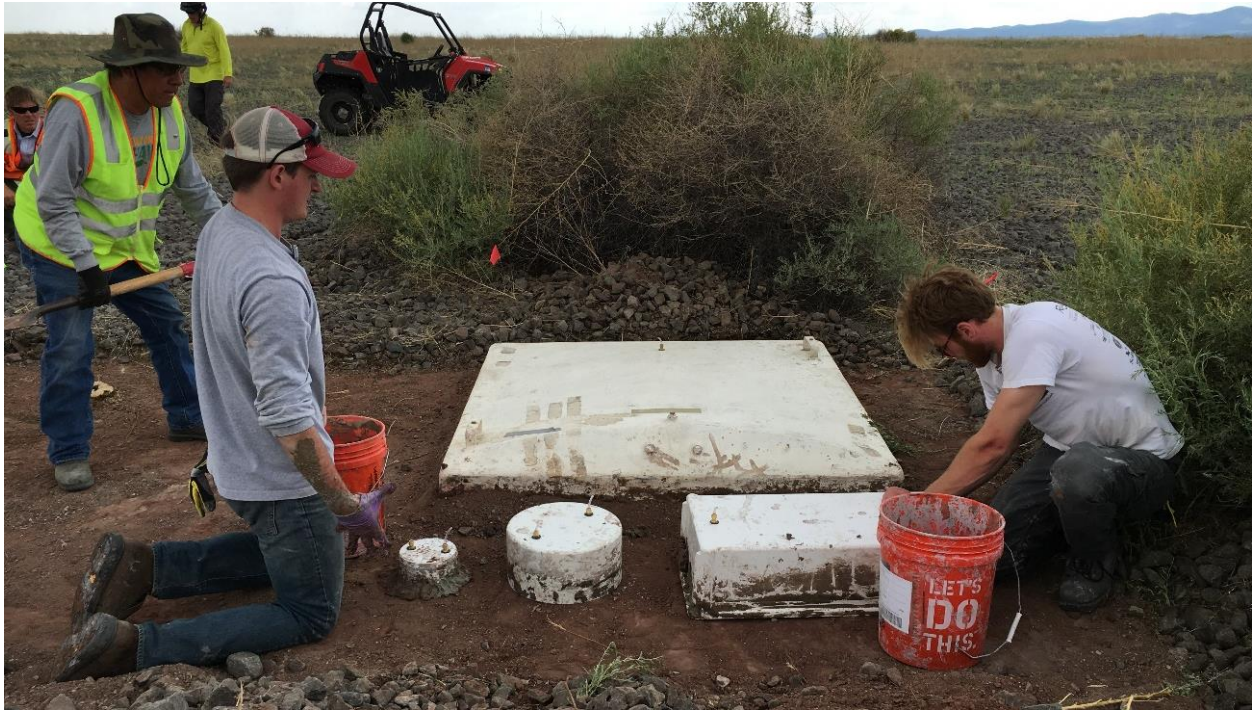
Figure 48 – Installation of flux chambers on the surface of the Rn barrier.

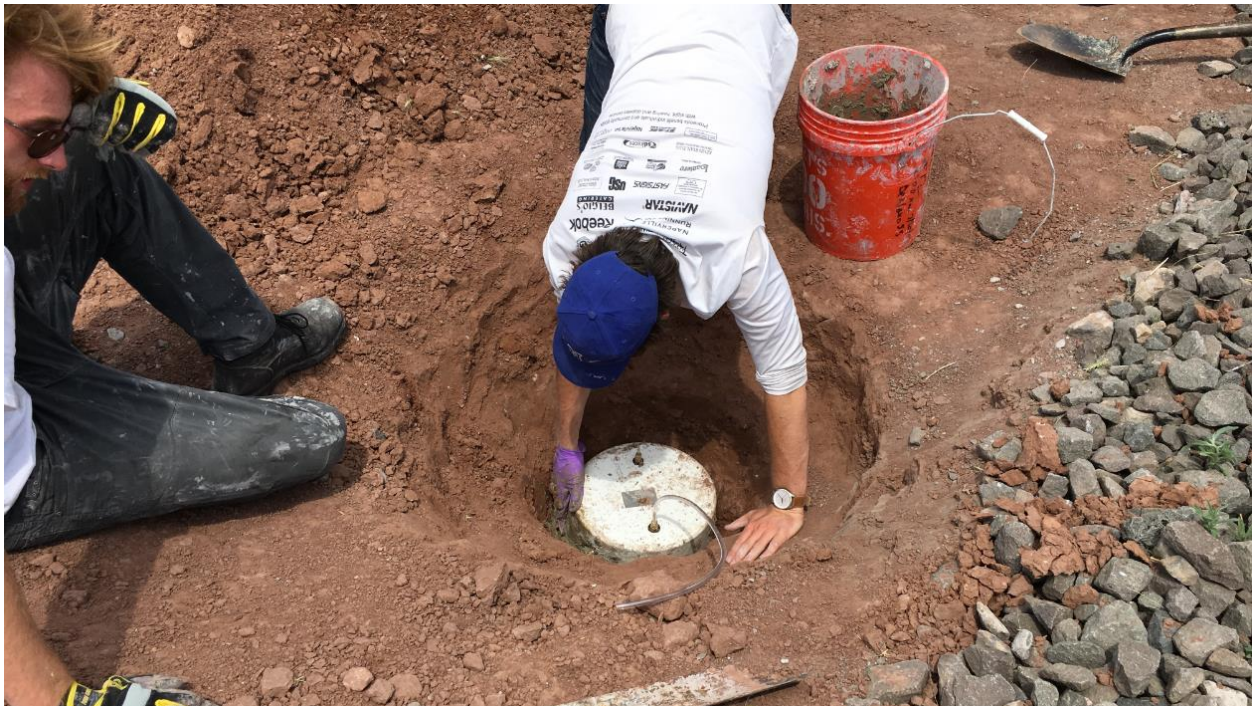
Figure 49 – Installation of a small flux chamber on the exposed tailings.

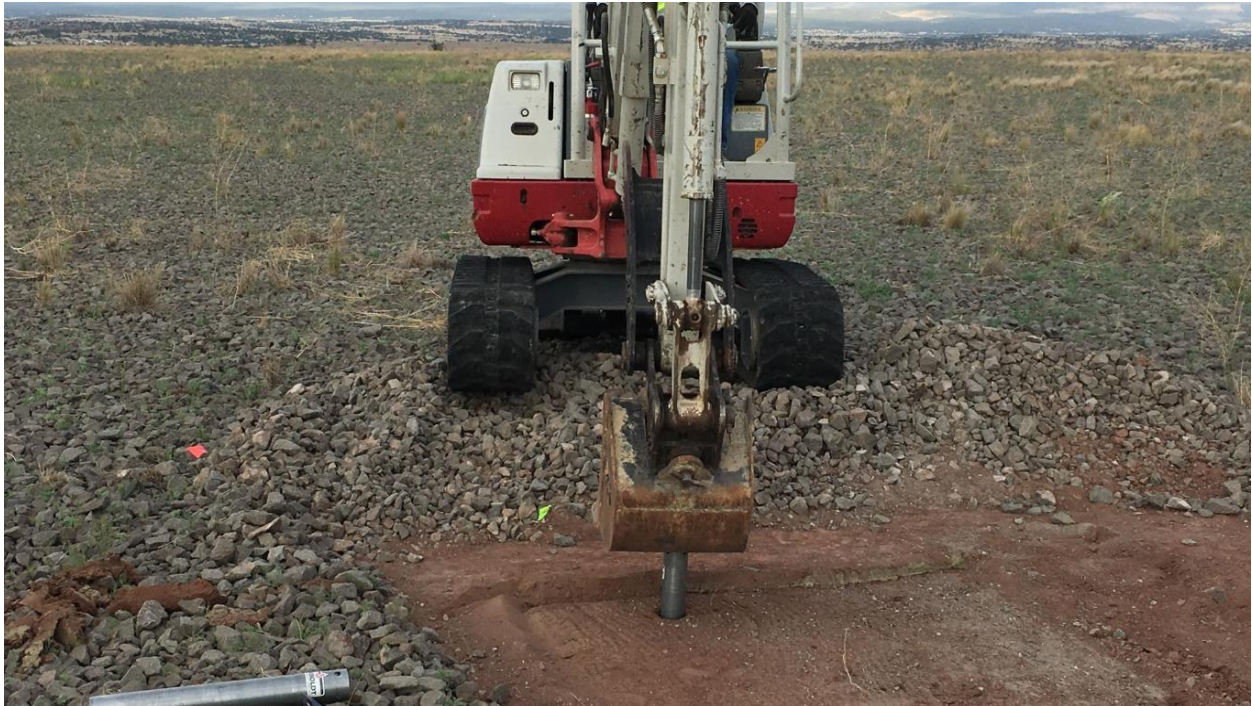
Figure 50 – Obtaining a thin-walled tube sample of Rn barrier soil.

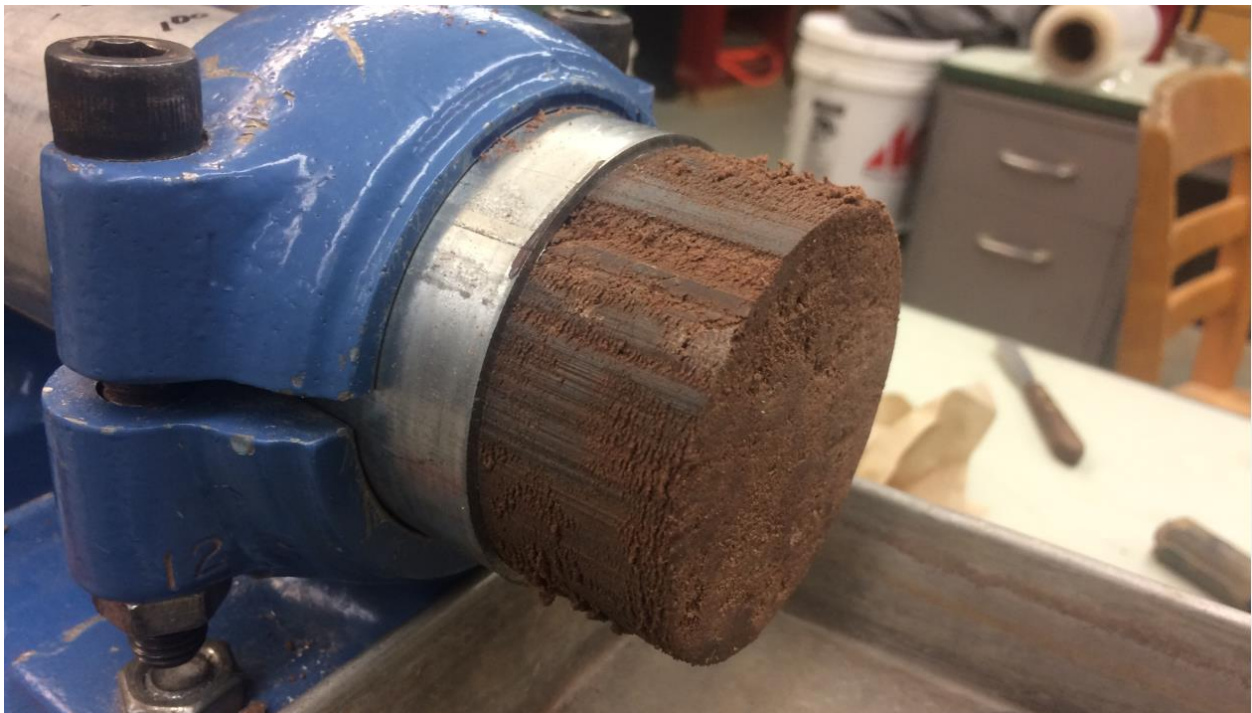
Figure 51 – Extraction of a 70 mm diameter (Shelby) tube sample in the lab.

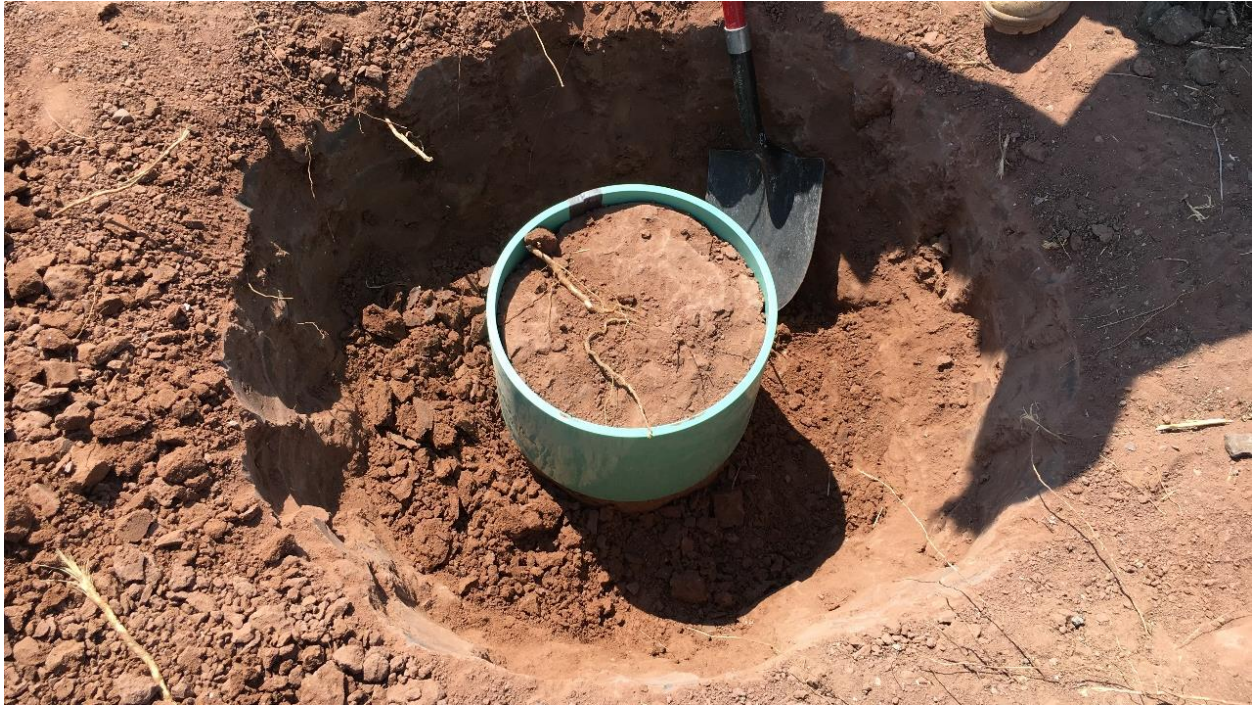
Figure 53 – Excavating a 350 mm diameter block sample from the Rn barrier with a shovel.

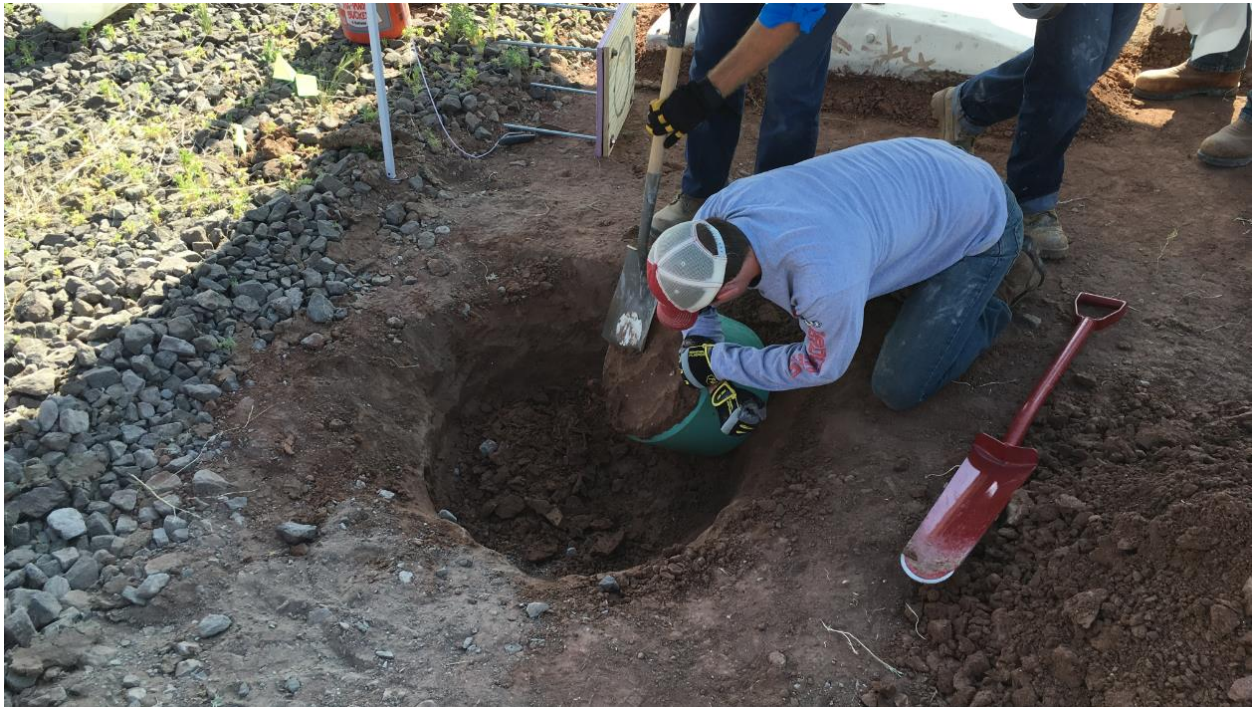
Figure 54 – Removal of a 350 mm diameter block sample from the Rn barrier.

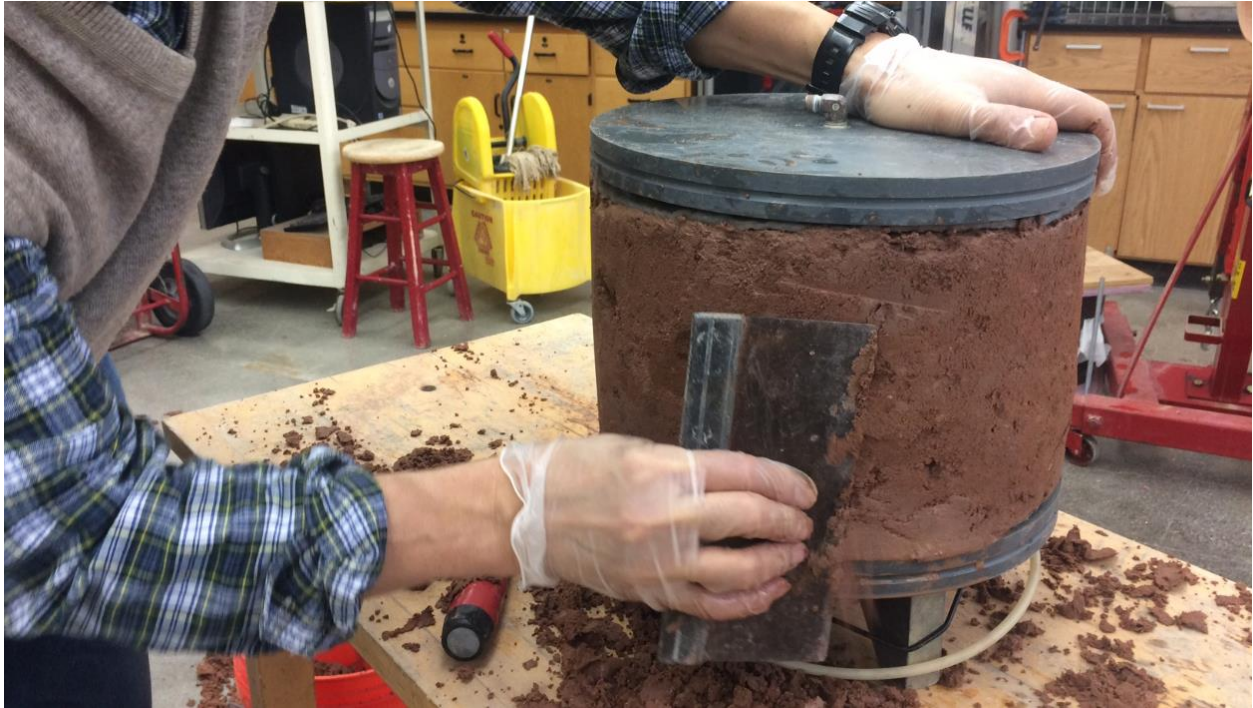
Figure 55 – Trimming 350 mm diameter block sample for saturated hydraulic conductivity test.

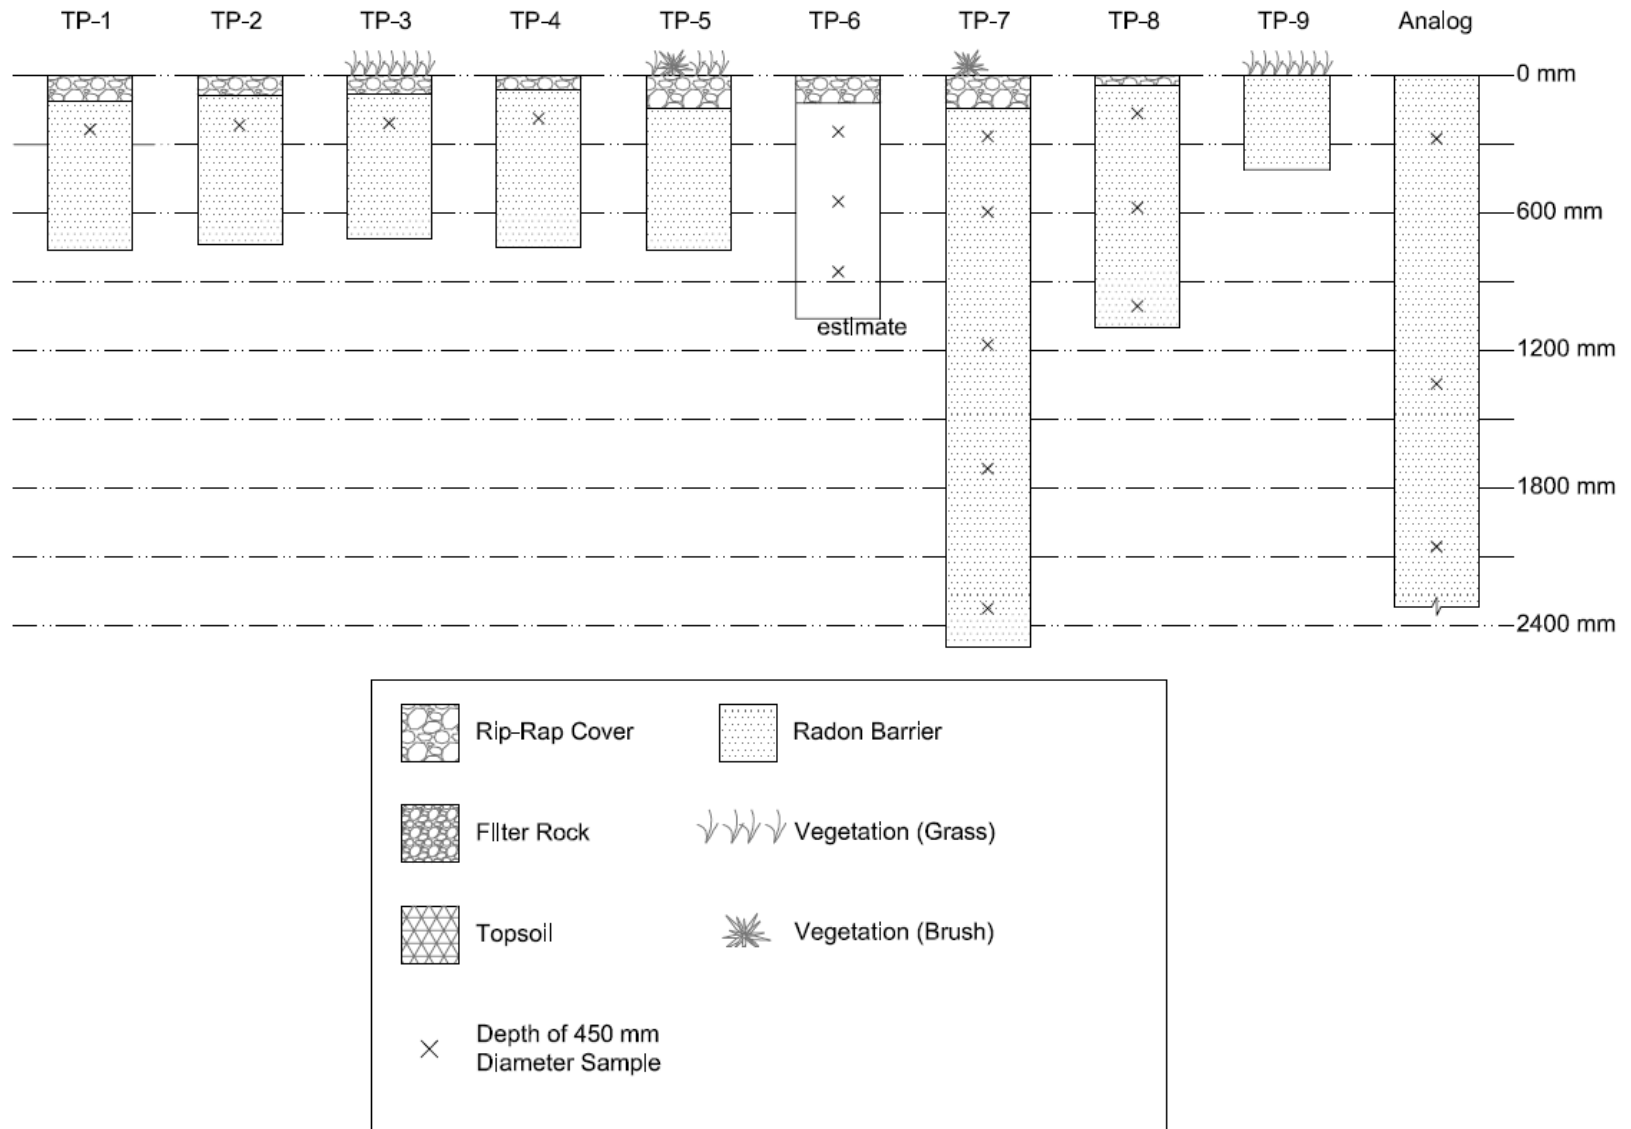
Figure 57 – Cover profiles at each test pit excavated at the Bluewater, NM site in 2016.
