LONG-TERM PERFORMANCE OF RADON BARRIERS
IN LIMITING RADON FLUX FROM FOUR URANIUM
MILL TAILINGS CONTAINMENT FACILITIES

A Thesis submitted in partial fulfillment of
the requirements for the degree of

Master of Science

UNIVERSITY OF WISCONSIN-MADISON

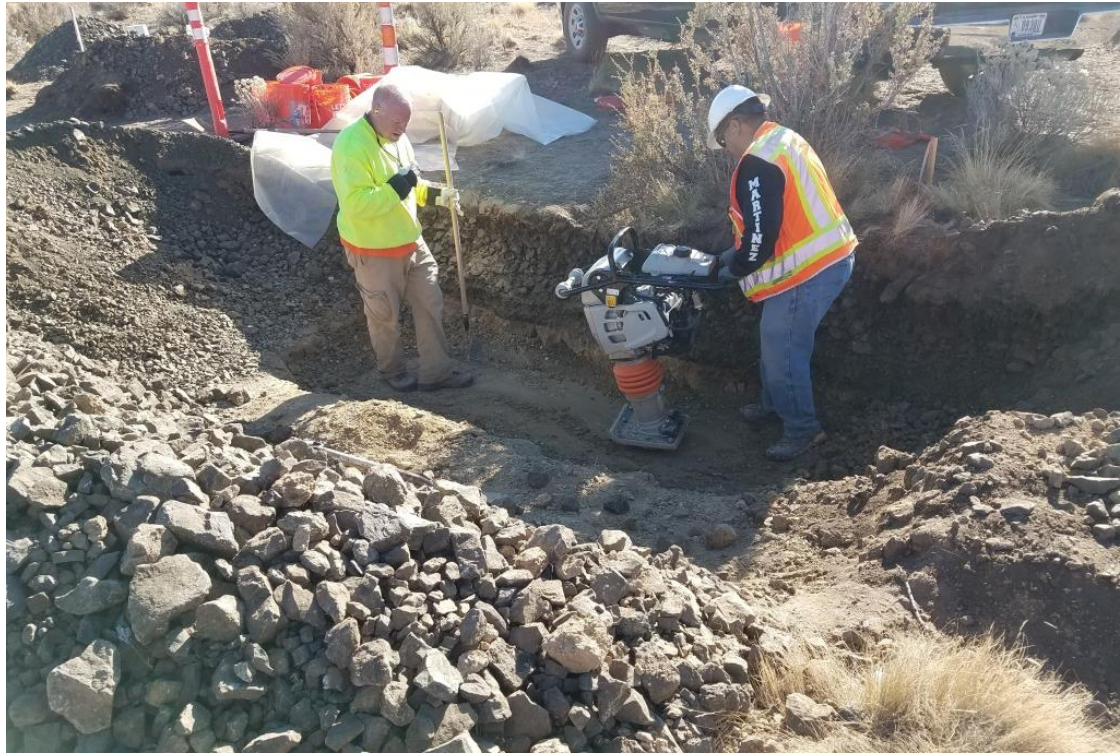
Figure 133 – Replacement and compaction of the Rn barrier soil using a hand operated compactor.

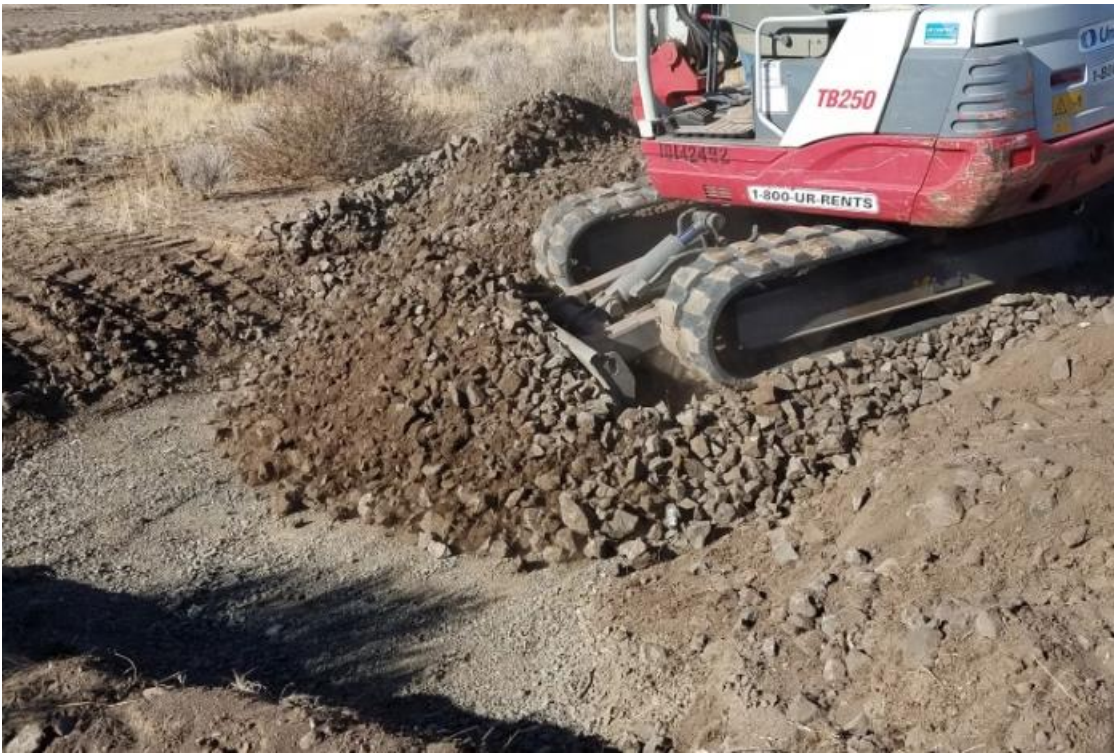
Figure 134 – Replacement of the protective layers using an excavator.

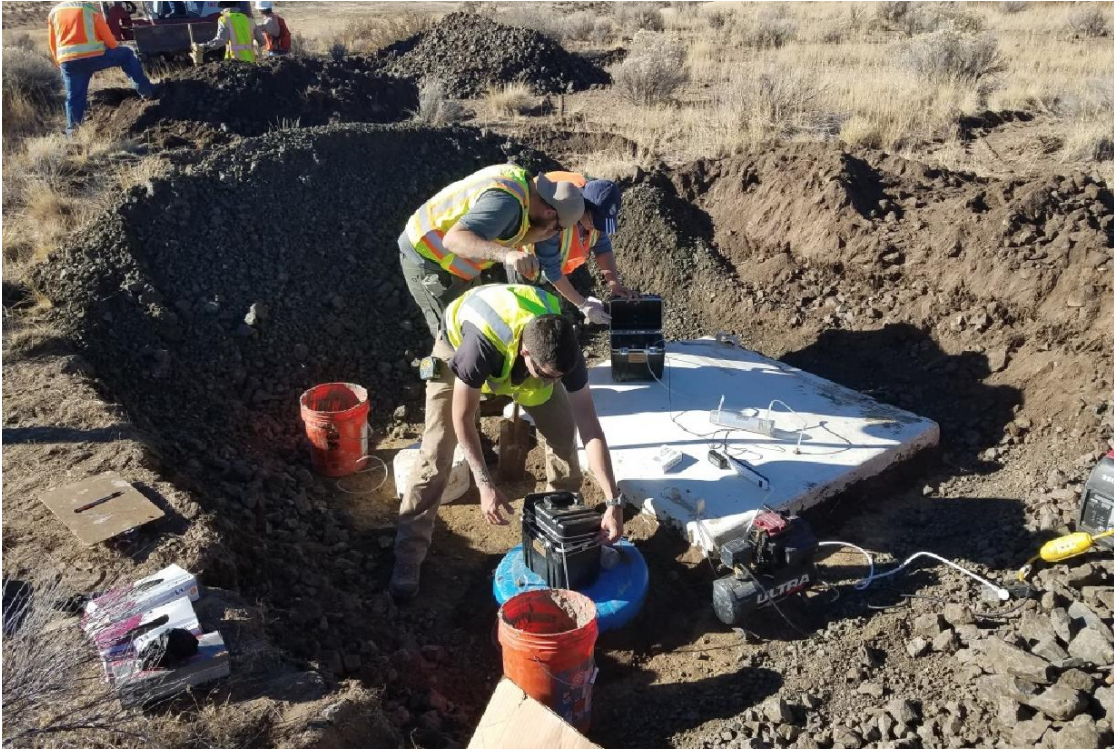
Figure 135 – Installation of flux chambers on the surface of the Rn barrier.

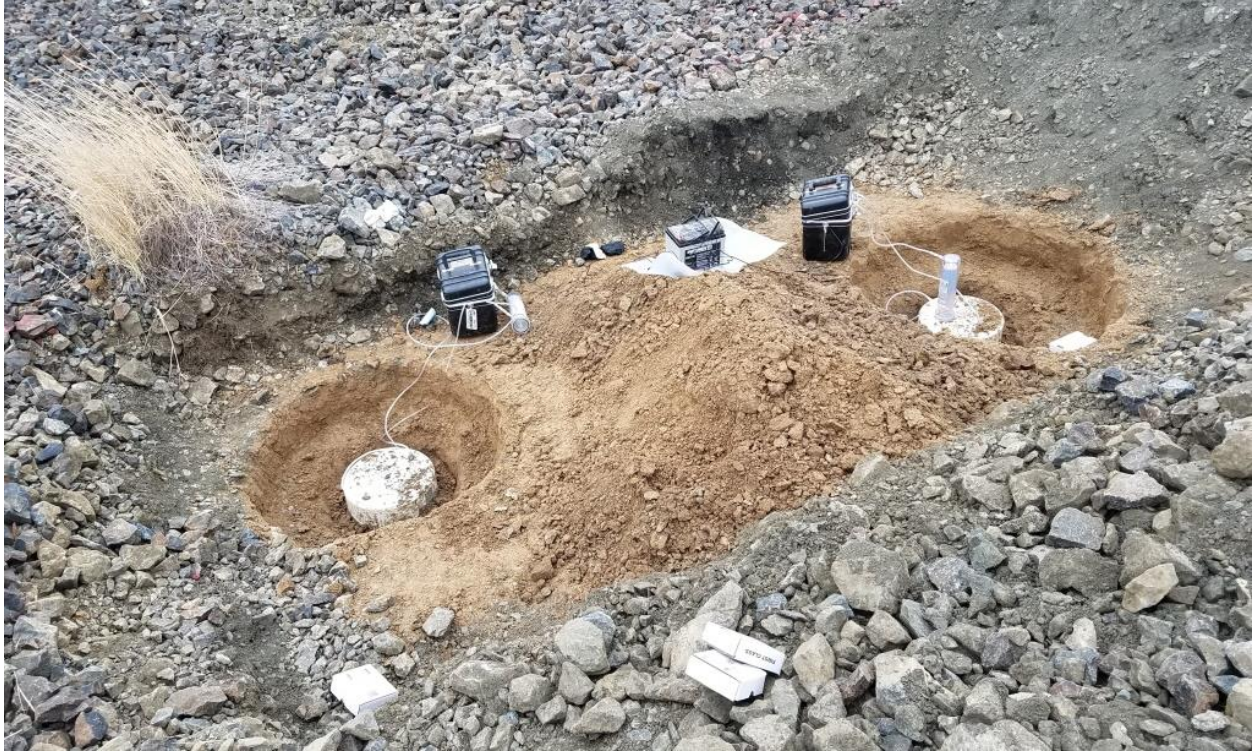
Figure 137 – Flux chambers installed on exposed tailings.
