CHARACTERIZATION AND COMPOSITION OF CORROSION SCALES IN DRINKING WATER  
DISTRIBUTION SYSTEMS

A Thesis Submitted in  
Partial Fulfillment of the  
Requirements for the Degree of

The University of Wisconsin-Milwaukee

**December 2022**

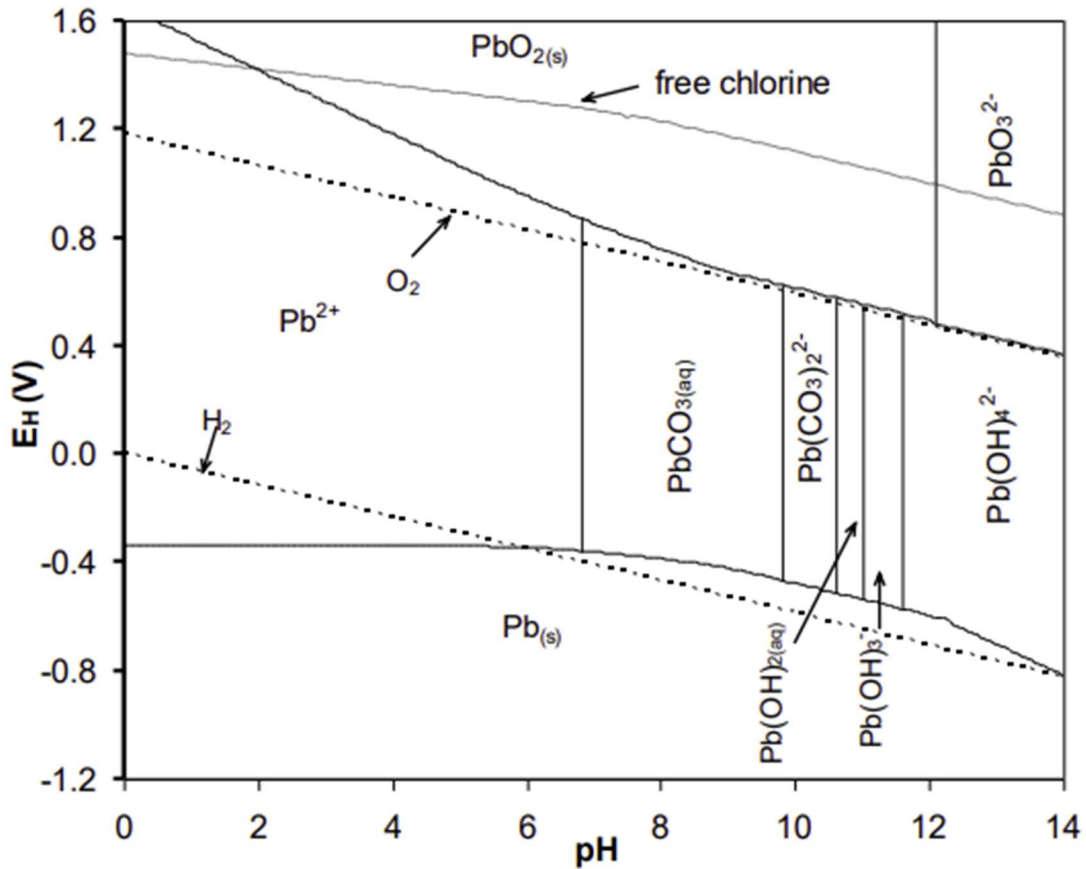
**Figure 2-2.** Pourbaix diagram of lead at 25° C. In between the dotted lines represents the conditions where water is stable. Common drinking water conditions would be in the range of 7 – 8.5 pH and a voltage of 0.25 – 1.0 V (Wang, 2012).

Pourbaix diagrams are often used to predict corrosion behavior of metals in environments exposed to water. Figure 2-2 is the standard Pourbaix diagram for lead with dissolved inorganic carbon (DIC) at 25°C. Above the two dotted lines represents the region where oxygen evolution will occur in the system, and this occurs at higher potentials which are oxidizing conditions. Across a wide range of pH values the high potential system creates the lead dioxide mineral with the lead chemical state at +4. Between the dotted lines is the region where water is stable. Within this area lead is found mostly in the +2-oxidation state forming complexes with a singular oxygen molecule, or higher oxides with hydrogens. Other relevant minerals such as lead carbonates and phosphates may form in this region. In most drinking water distribution systems, the conditions fall in the pH range of 7 – 8.5 and have a potential between 0.25 and 1.0 V (Lyon, 2010). This puts the lead oxidation in the +2 state with the ability to form many minerals. Below the bottom dashed line is the hydrogen evolution region where reducing conditions are present and lead is mainly in the elemental (base metallic) form.

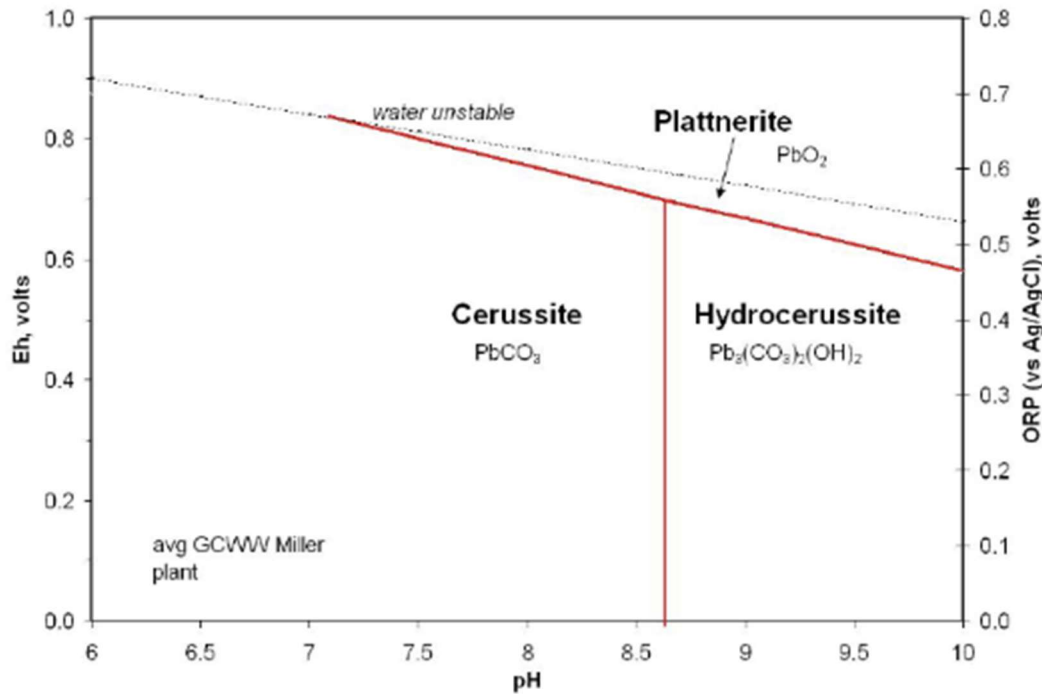
**Figure 2-6.** pH relationship between cerussite, hydrocerussite and plattnerite transformation in high redox conditions (Maynard, 2008).

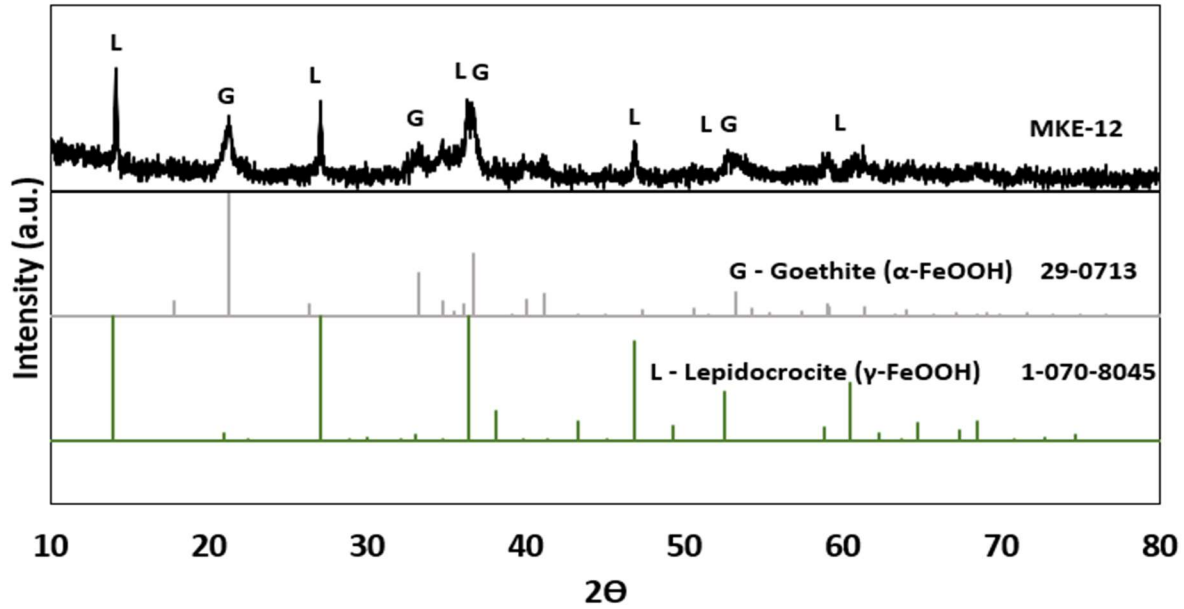
**Figure 4-1.** XRD pattern of a cast iron drinking water main harvested from Milwaukee. The reference XRD patterns for Goethite (JCPDS 00-029-0713) and Lepidocrocite (JCPDS 01-070-8045) were shown for comparison.

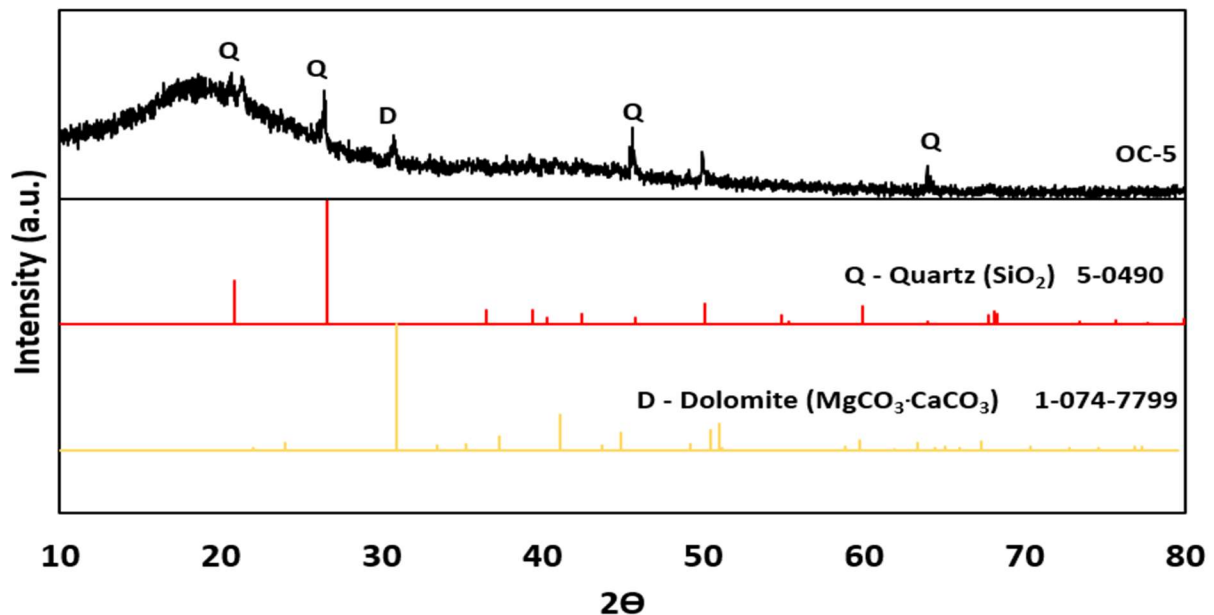
**Figure 4-2.** XRD pattern of a ductile iron drinking water main harvested from Oak Creek. The reference XRD patterns for Goethite (JCPDS 00-029-0713), Dolomite (JCPDS 01-074-7799), and Quartz (JCPDS 00-005-0490) were shown for comparison. The broad peak centered at 17° may indicate the presence of a possible amorphous phase.

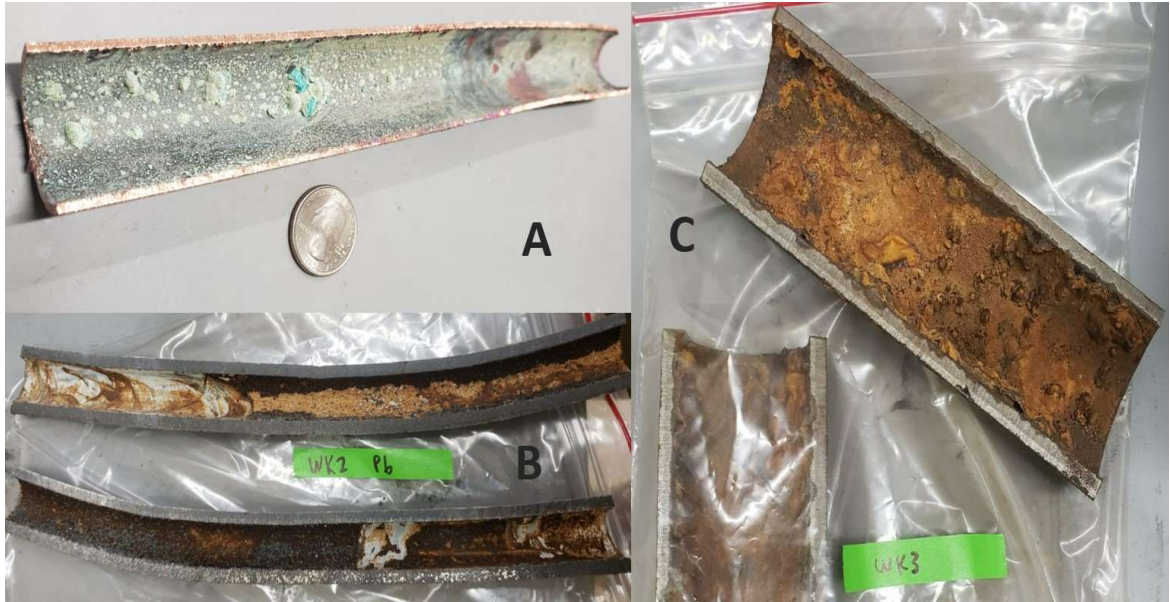
**Figure 4-5.** Longitudinal cross sections displaying corrosion scales from copper (A), lead (B), and iron (C) pipes.

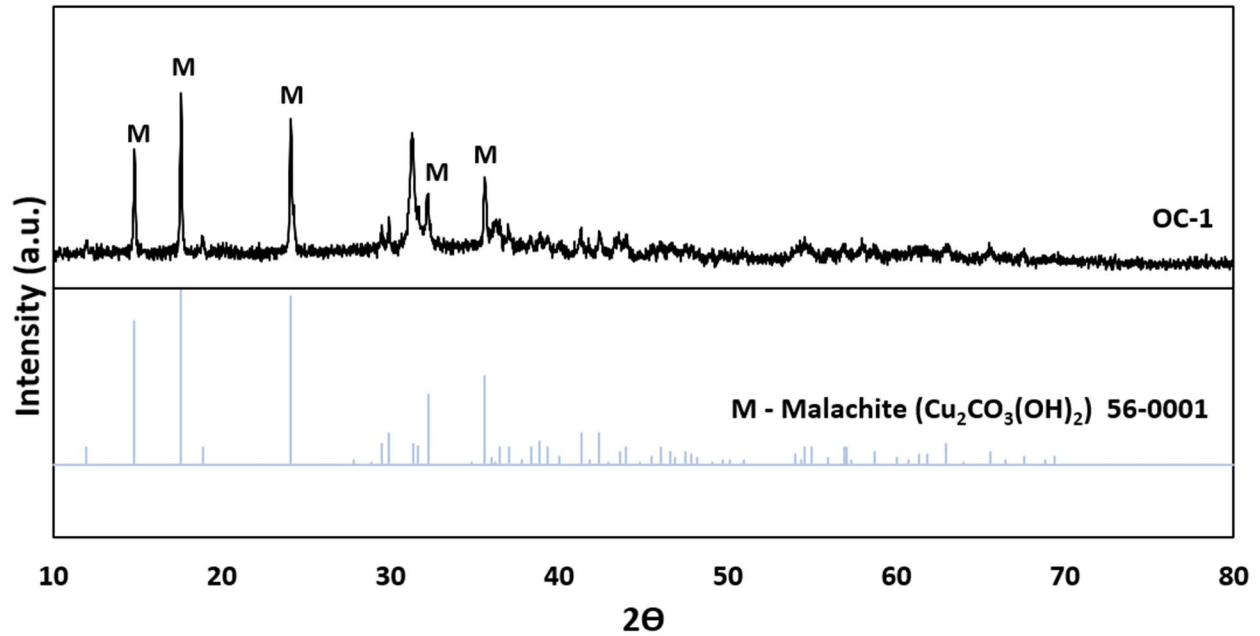
**Figure 4-6.** XRD spectra for Oak Creek copper lateral OC-1. Malachite is the primary mineral in this corrosion scale and its reference pattern is shown (JCPDS 00-056-0001).

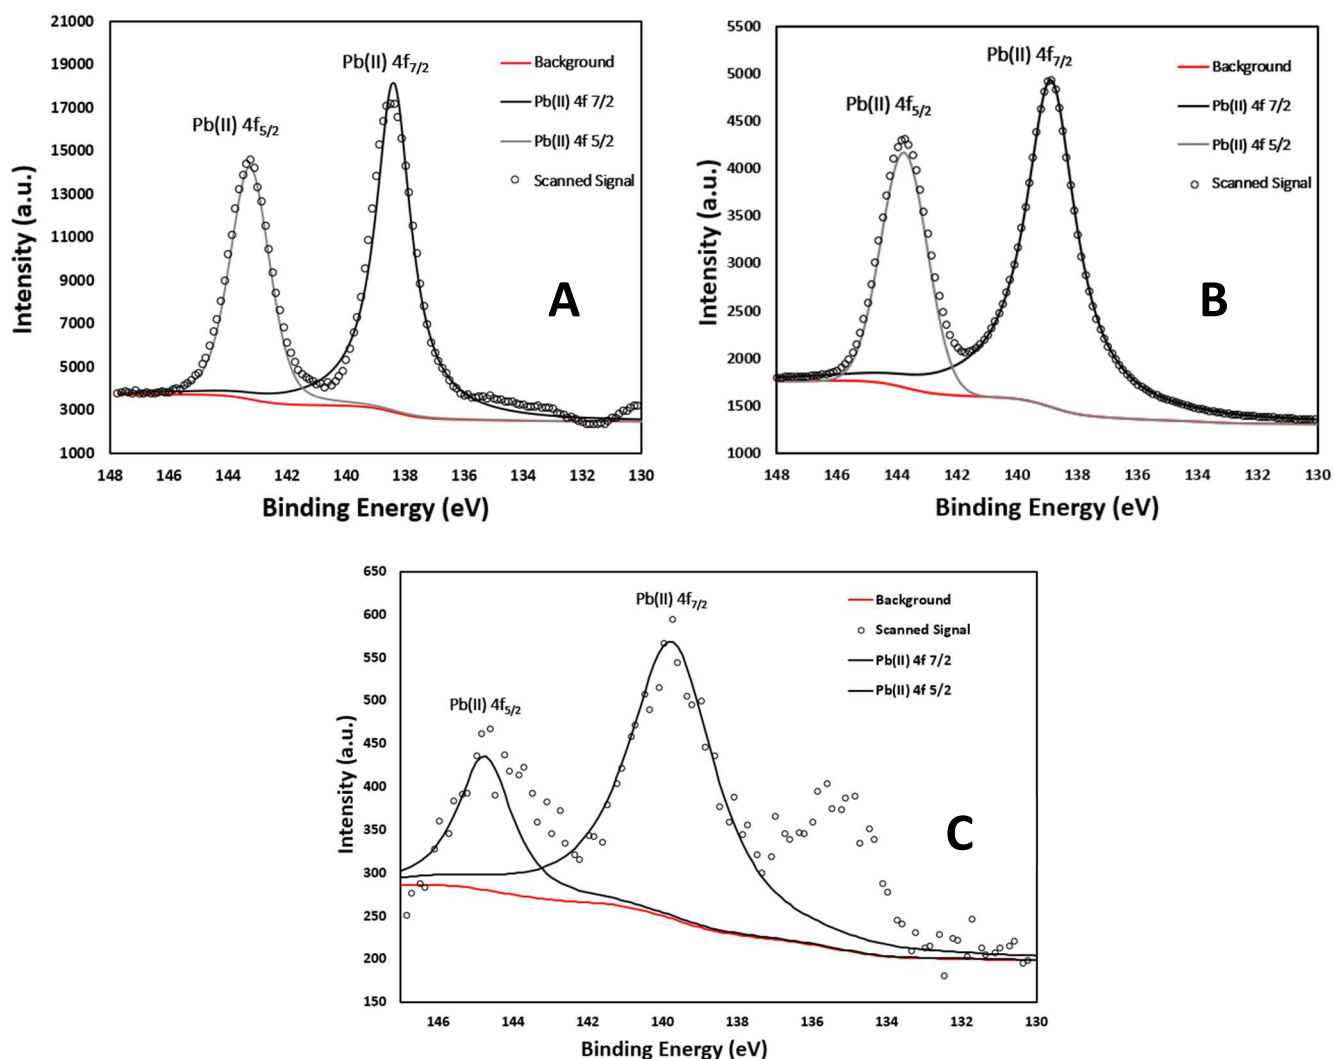
**Figure 4-8.** XPS peak matching for MKE-2 (A), MKE-6 (B) and MKE-9 (C) lead pipes. Scanned signals are represented by the open circles indicate the presence of Pb(II) oxidation states.

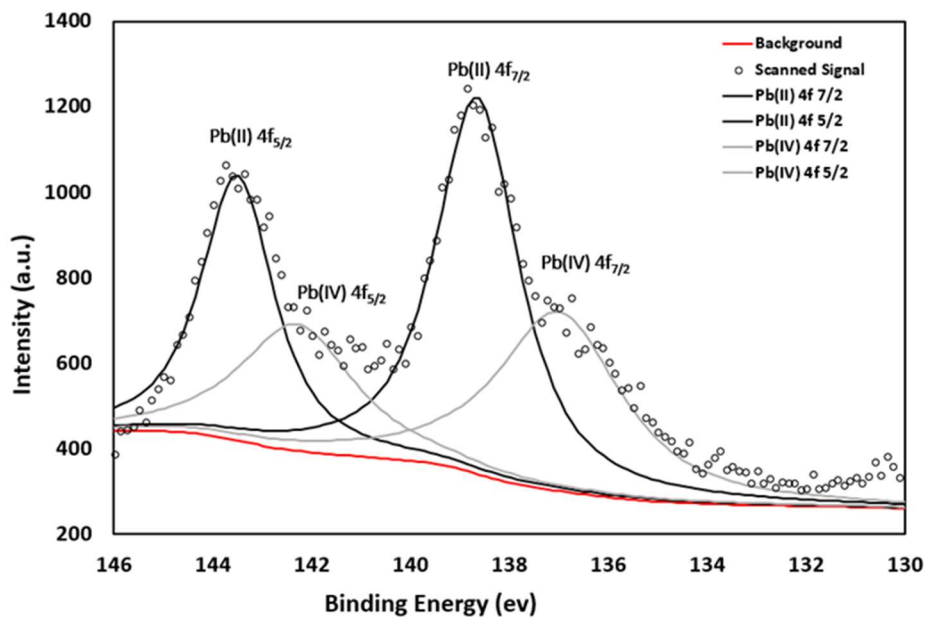
**Figure 4-9.** XPS spectra for WK-2 Pb sample from Waukesha. The extended shoulder at the offset from the center, rather than a smooth gradient, means the inclusion of both chemical states are present.

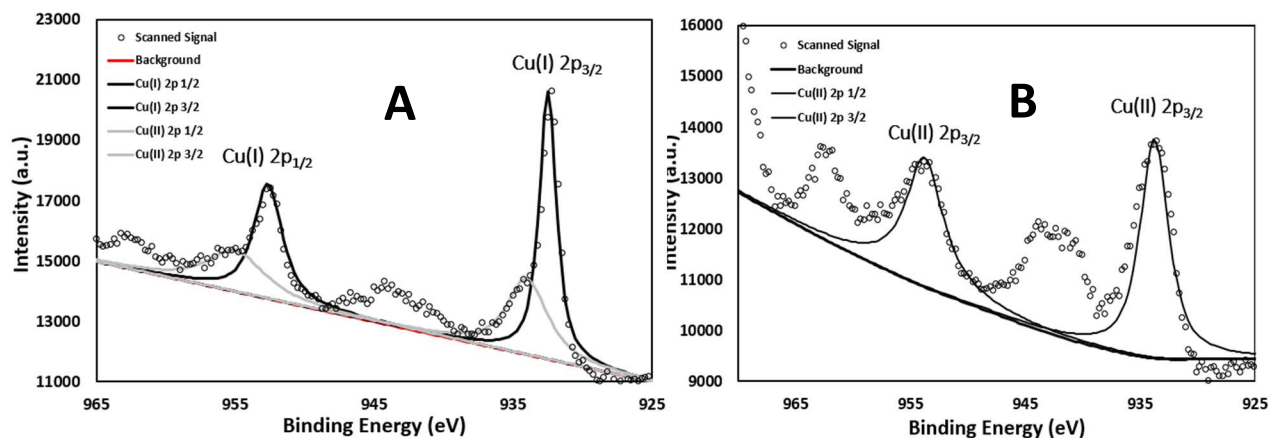
**Figure 4-14.** Reference peaks for commercially purchased cupric and cuprous oxides to display Cu(I) (image A) and Cu(II) (image B) peaks.

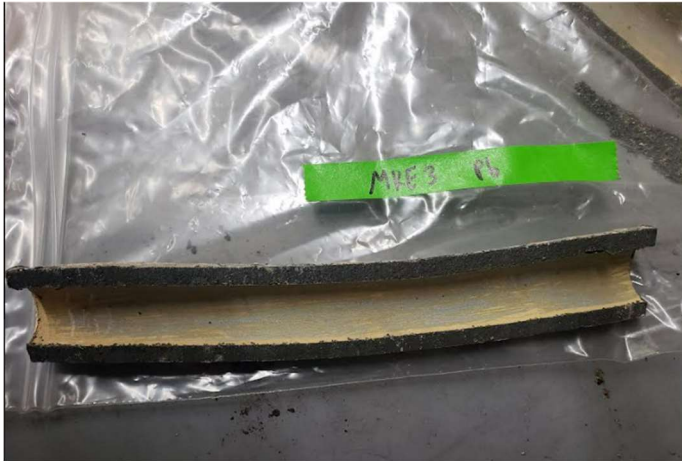
**Figure A-6.** Longitudinal cross section of MKE-3 lead pipe. Inner walls of the pipe were a tan color, characteristic of lead carbonate minerals.

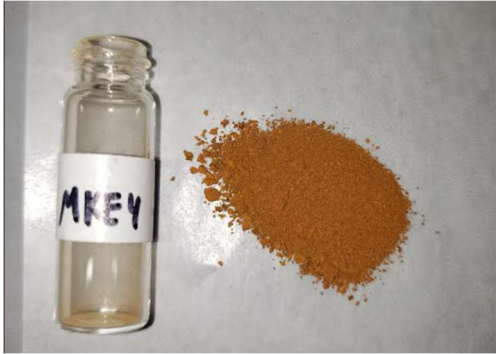
Figure A-8. MKE-4 powder sample scraped from a cast iron corrosion scale on a Milwaukee drinking water pipe.

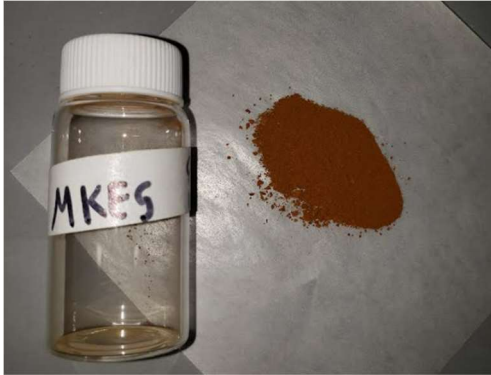
Figure A-10. MKE-5 powder sample scraped from a cast iron drinking water pipe in Milwaukee.

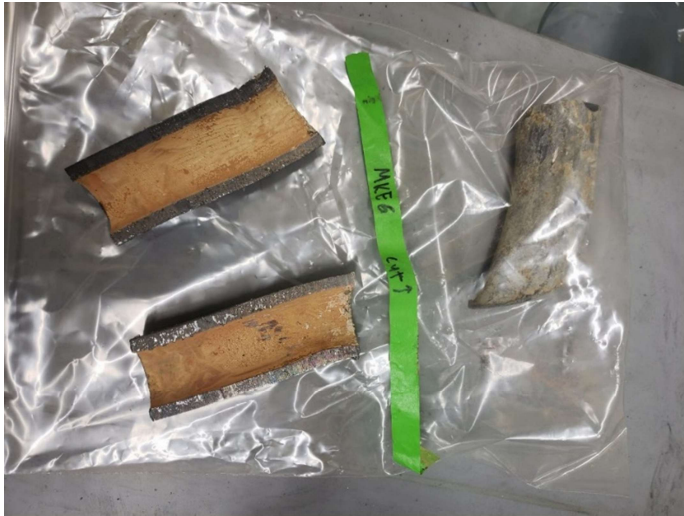
**Figure A-12.** Longitudinal cross section of a lead pipe harvested from Milwaukee. The tan color of the corrosion scale is characteristic of lead carbonate minerals.

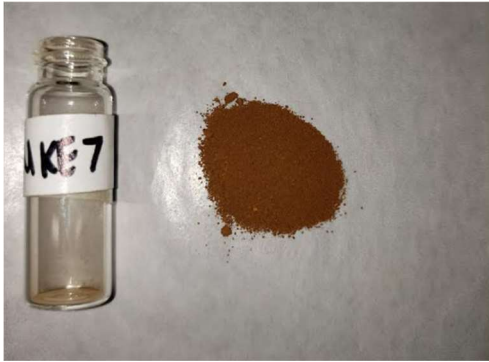
**Figure A-15.** MKE-7 powder sample scraping from a scale in a cast iron drinking water pipe from Milwaukee.

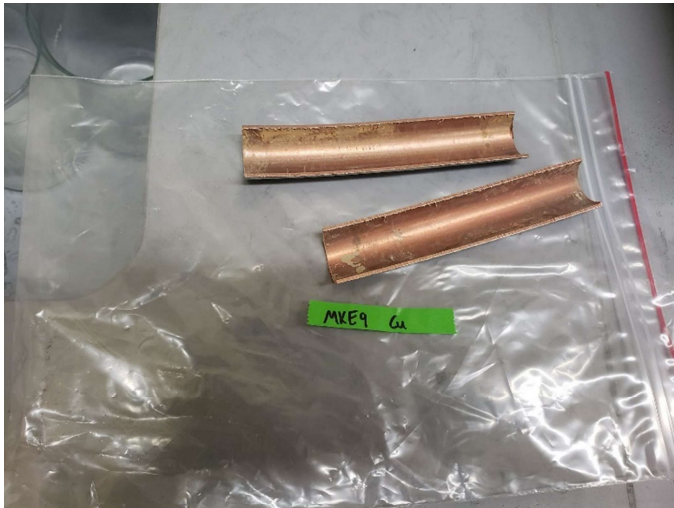
**Figure A-17.** Longitudinal cross-section of a copper drinking water pipe from Milwaukee displaying minimal corrosion scaling.

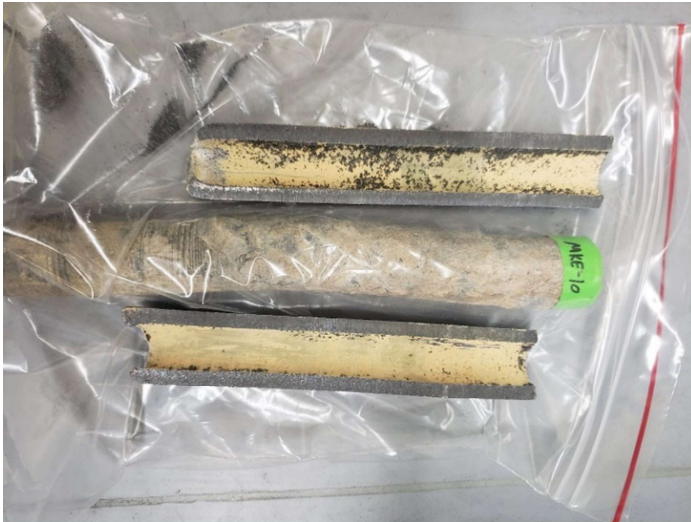
**Figure A-22.** Longitudinal cross-section of MKE-10 lead lateral pipe displaying tan colored corrosion scales on the inner pipe wall, which are common within lead carbonate minerals.

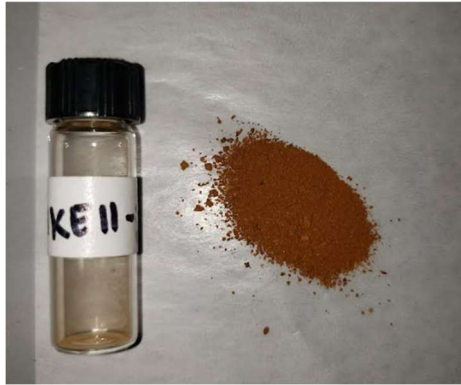
Figure A-24. Corrosion scale powder from a cast iron drinking water main in Milwaukee.

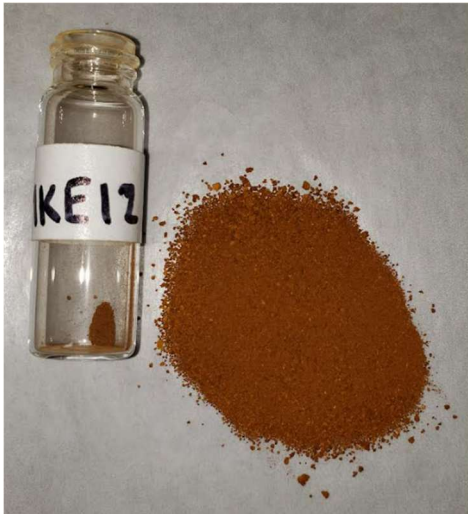
**Figure A-26.** Corrosion scale powder scraped from the inside pipe wall of a cast iron drinking water main in Milwaukee.

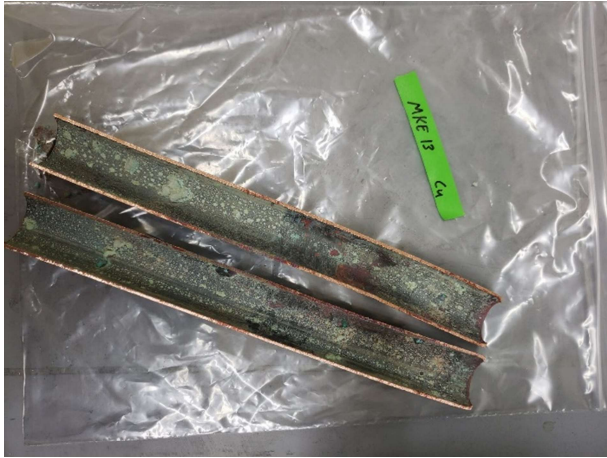
**Figure A-28.** Longitudinal cross section of a copper lateral harvested from Milwaukee. Corrosion accumulation is shown as green-blue buildup on the inside of the pipe walls.

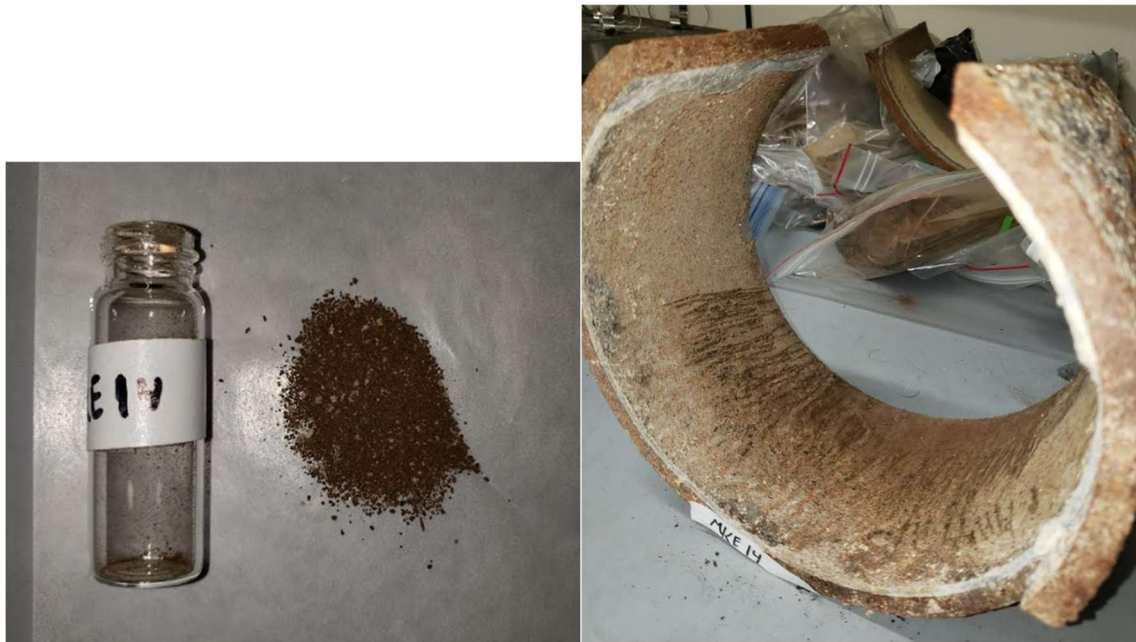
**Figure A-31.** Powderized corrosion scale scraped from the inside of a ductile iron drinking water lateral harvested from Milwaukee.

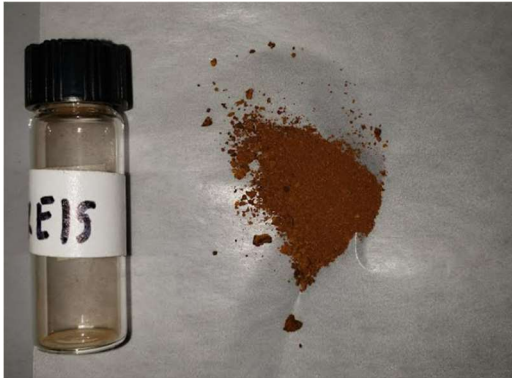
Figure A-33. Powderized corrosion scale scraped from the inside of a cast iron main in Milwaukee.

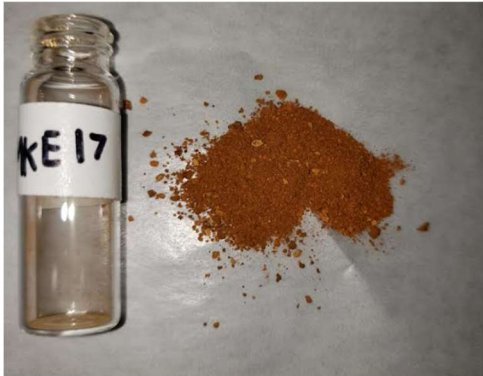
**Figure A-35.** Powder obtained from scraping the corrosion scale from a cast iron main in Milwaukee.

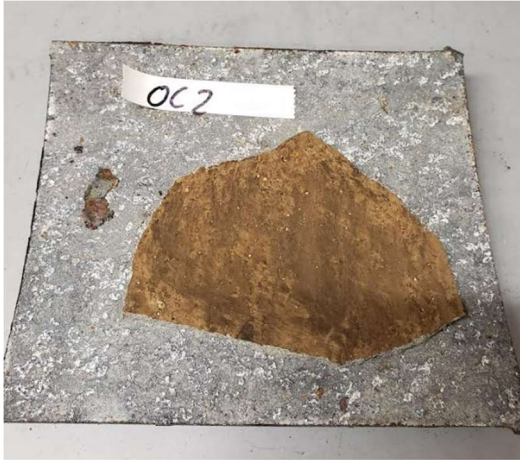
**Figure A-42.** Inside of a large ductile iron main obtained from Oak Creek. Minimal corrosion was observed on the exposed brown pipe wall.

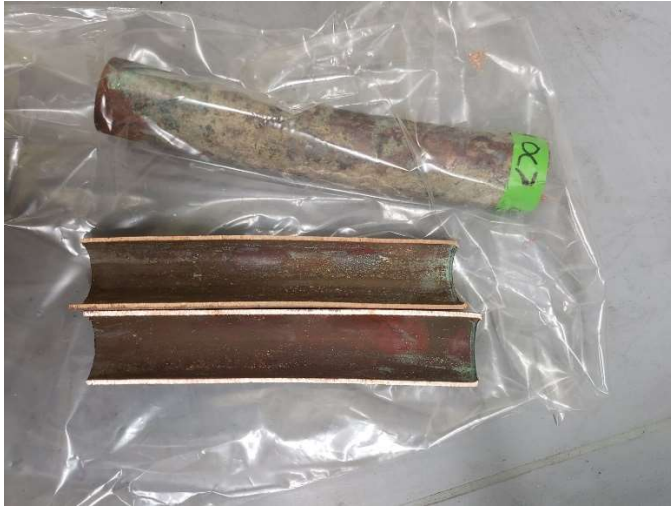
Figure A-50. Cross-section of a ductile iron pipe cut longitudinally from Oak Creek.

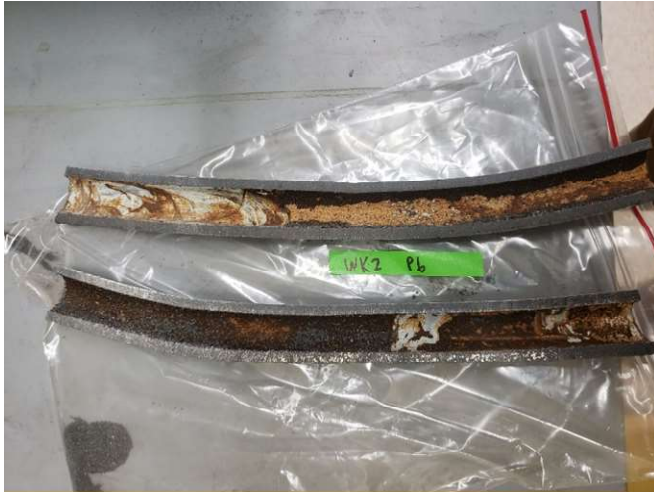
**Figure A-52.** Cross-section of a lead-lateral obtained from Waukesha displaying corrosion discoloration.
