**Hydraulic and Geomorphic Impacts of Dam Removal on the  
Upper Baraboo River, Wisconsin**

**A thesis submitted in partial fulfillment of the requirements**

**Master of Science**

**UNIVERSITY OF WISCONSIN-MADISON**

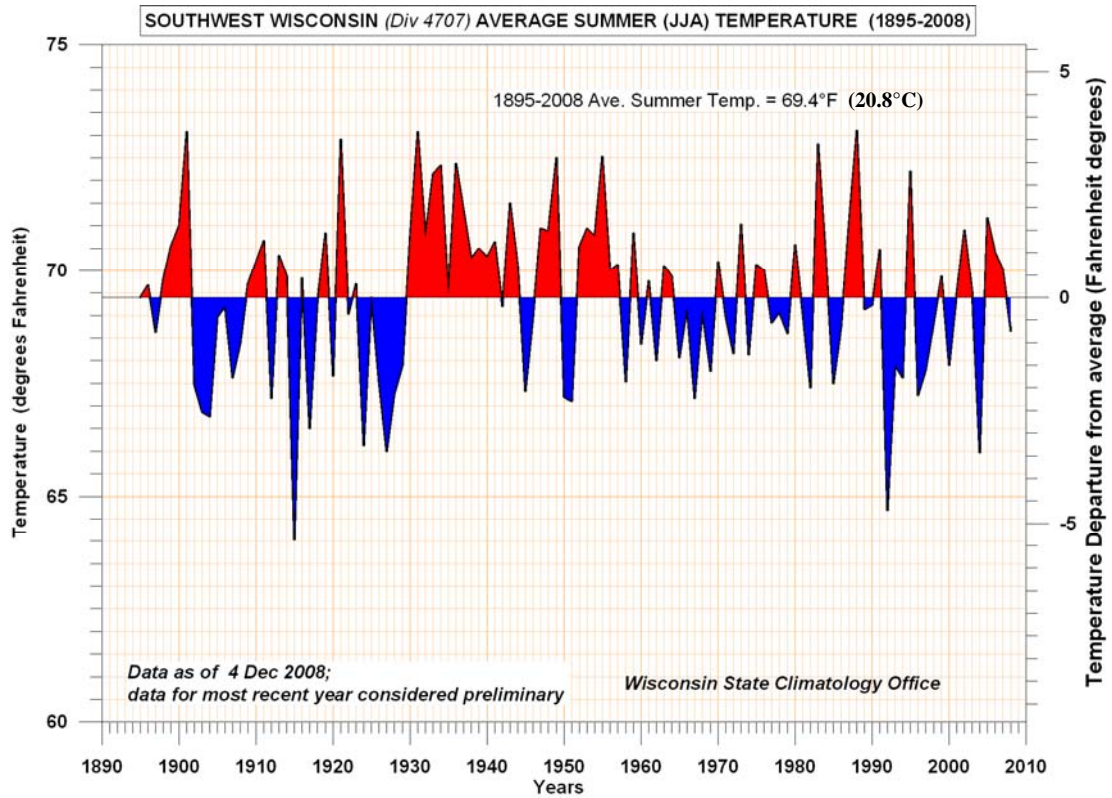
Figure 11 Average summer temperature for the years 1895-2009 in southwest Wisconsin. Temperature and temperature departure from average is measured in degrees Fahrenheit on the y-axis. The area in red represents years with above average summer temperature and the area in blue represents years with below average summer temperature.

Temperature has also experienced some seasonal changes from 1885 to 2006. Spring temperatures appear to be warming beginning in the mid-1970s (figure 10). Summer and fall temperatures show little or no change from 1885 to 2006 (figures 11 and 12, respectively). Winter temperatures appear to increase beginning in the late 1970s or early 1980s to present (figure 13).

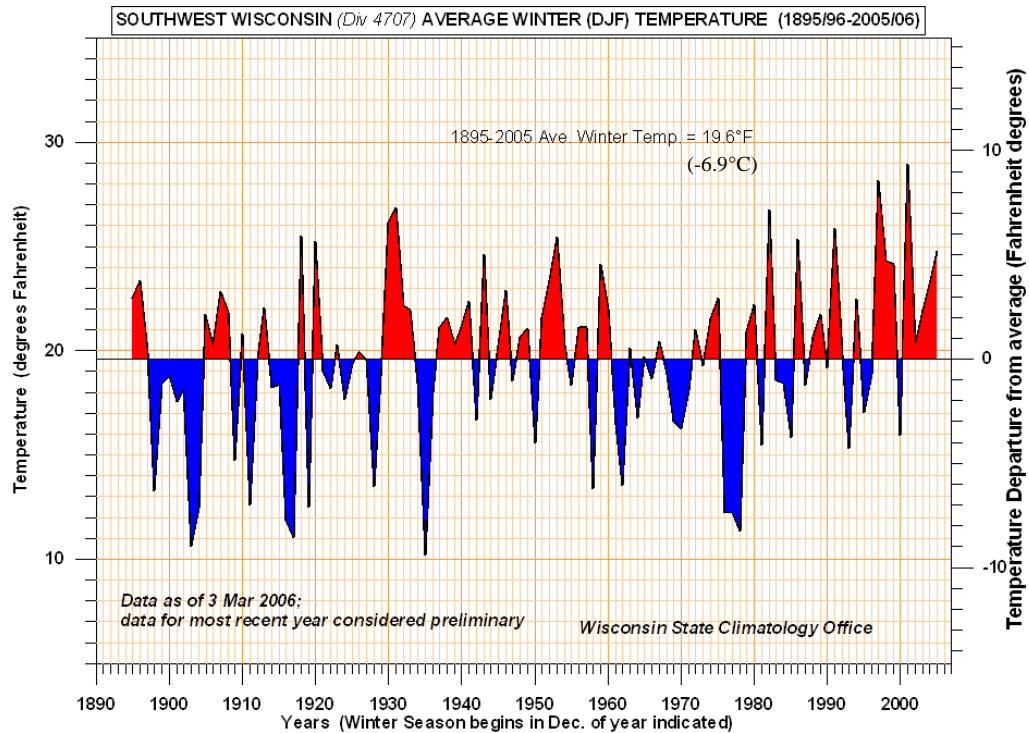
Figure 13 Average winter temperature for the years 1895-2005 in southwest Wisconsin. Temperature and temperature departure from average is measured in degrees Fahrenheit on the y-axis. The area in red represents years with above average winter temperature and the area in blue represents years with below average winter temperature.

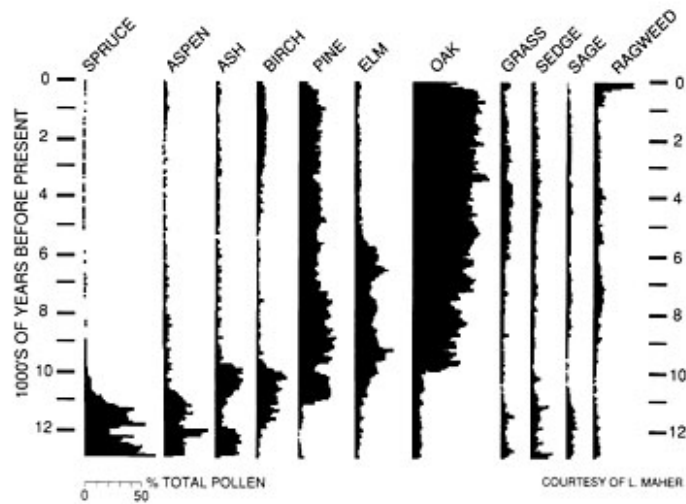
Figure 15 Graph of percentage of pollen from Maher's Devil's Lake core. Years indicated are radiocarbon years.

Since the last glaciation, several major plant communities colonized and disappeared as ecotones shifted to the north and east. Maher (1982) studied a soil core from Devil's Lake and recorded the type and abundance of pollen dating from 12,500 years ago to present (figure 15). Maher's (1982) core study shows that the plant community progression began with the boreal forest, followed by the northern conifers with mesic hardwoods, then the mesic forest, next the oak savanna, and last the oak forest and mesic forest (Lange 1990).

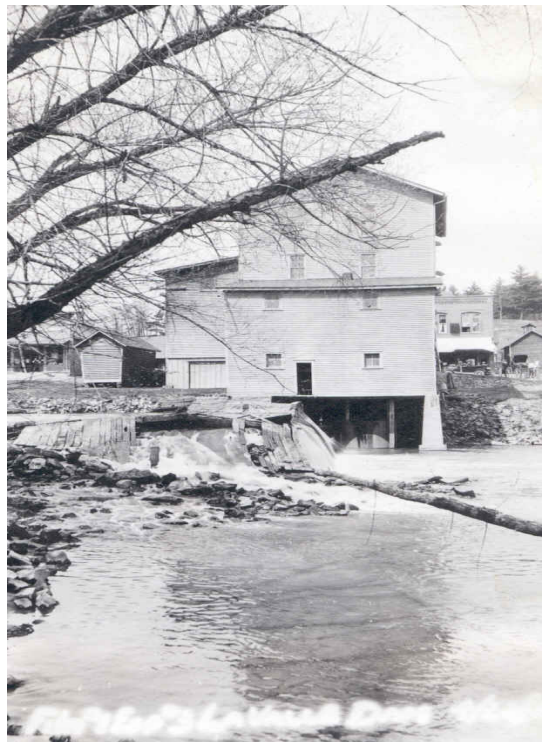
**Figure 20** Image of the La Valle dam from the late 1800s or early 1900s. Obtained from Martin Doyle at University of North Carolina, Chapel Hill.

successfully for a few years and the manufacturing of broom handles quickly became a part of the enterprise (Butterfield 1919). In 1869, Sanford decided to build a grist mill propelled by the same waterpower running the saw mill, barrel factory, and broom handle factory (Butterfield 1919). As part of the grist mill, a large three-story building was erected just below the dam and was furnished with the necessary machinery to run a grist mill. This enabled the citizens of La Valle to use home-made flour and increased the popularity of La Valle for settlement (figure 20, Butterfield 1919).

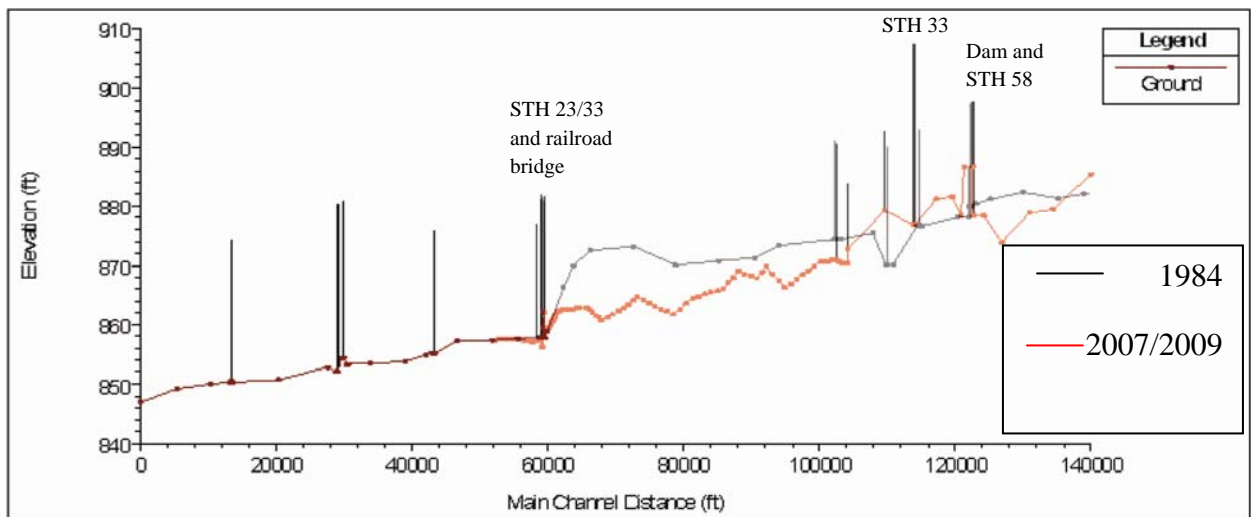
Figure 25 Comparison of the longitudinal profiles for 1984 and 2007/2009. The black line represents the 1984 survey and the red line represents the 2007/2009 survey.

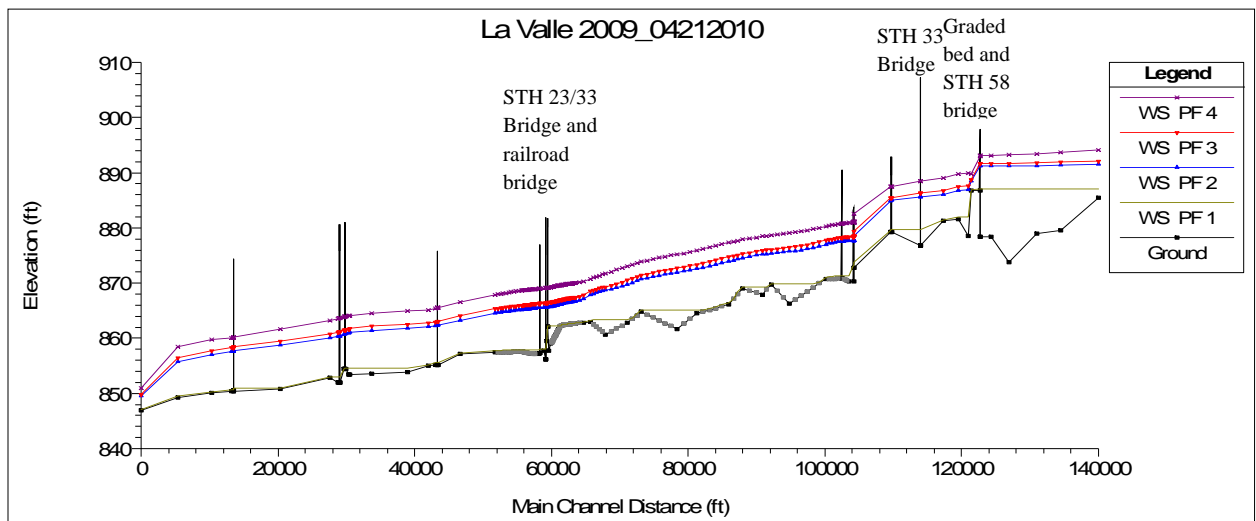
**Figure 26 Longitudinal profile and water surface elevation simulations for 2007/2009 survey. Colored lines represent the water surface profiles at the four simulated discharges. The black line is the ground elevation so represents the longitudinal profile. The green water surface is for a discharge of 0.25 cfs (0.007 cms); the blue water surface is for a discharge of 350 cfs (9.91 cms); the red water surface is for a discharge of 444.19 cfs (12.58 cms); and the purple water surface is for a discharge of 850 cfs (24.08 cms).**

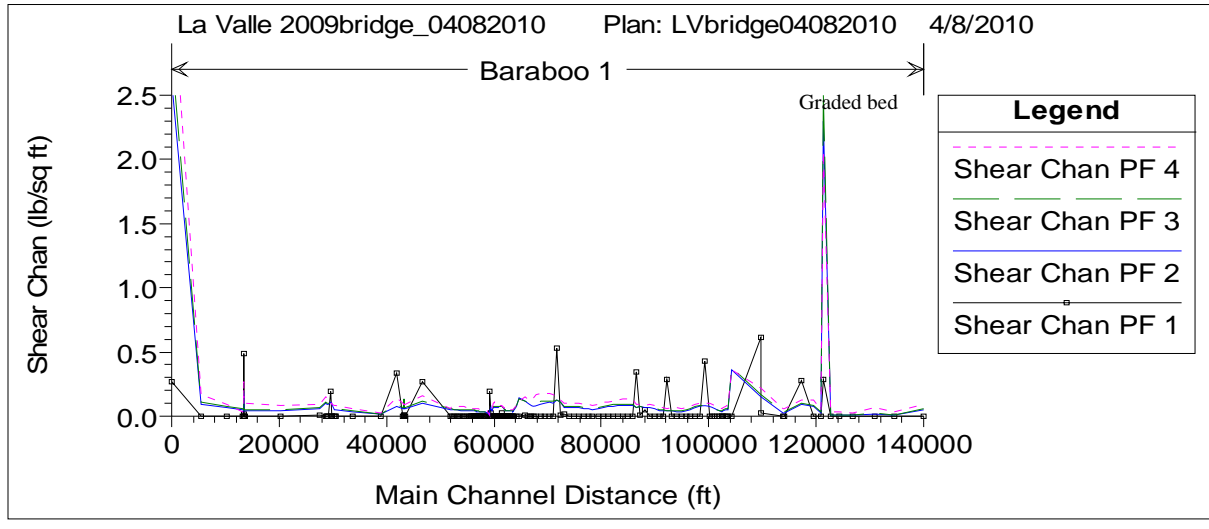
Figure 30 Simulation for 2007/2009 channel shear stress. The black line is for a discharge of 0.25 cfs (0.007 cms); the blue line is for a discharge of 350 cfs (9.91 cms); the green line is for a discharge of 444.19 cfs (12.58 cms); and the pink line is for a discharge of 850 cfs (24.08 cms).

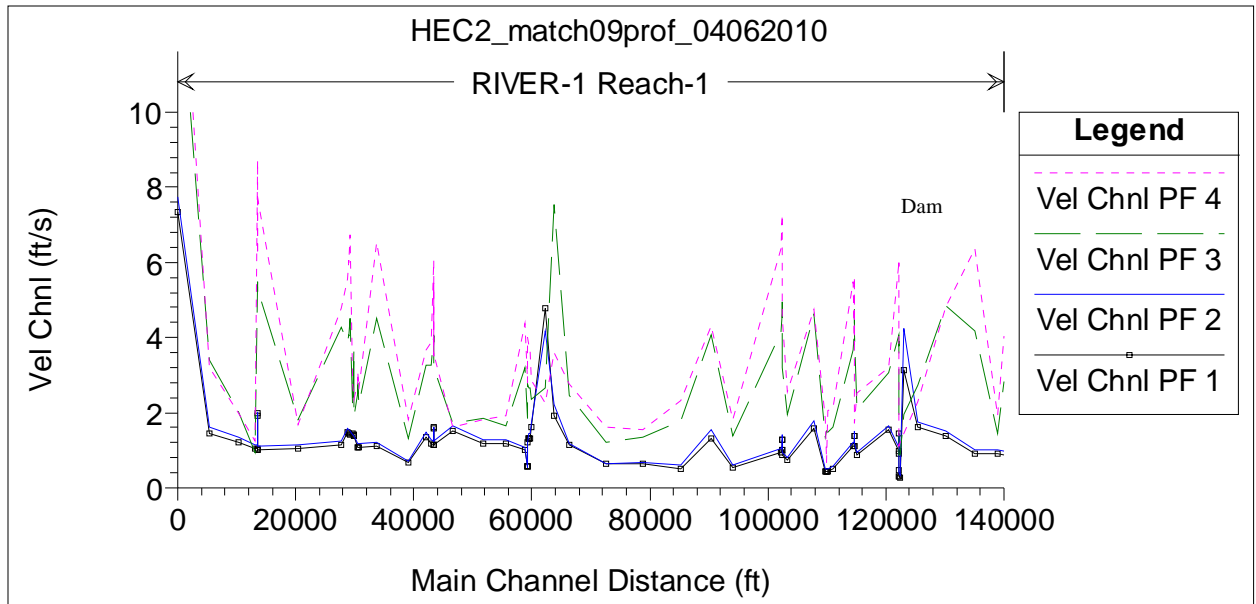
Figure 31 Simulation for 1984 channel velocity. The black line is for a discharge of 350 cfs (9.91 cms); the blue line is for a discharge of 444.19 cfs (12.58 cms); the green line is for a discharge of 5300 cfs (150.08 cms); and the pink line is for a discharge of 11,000 cfs (311.49 cms).

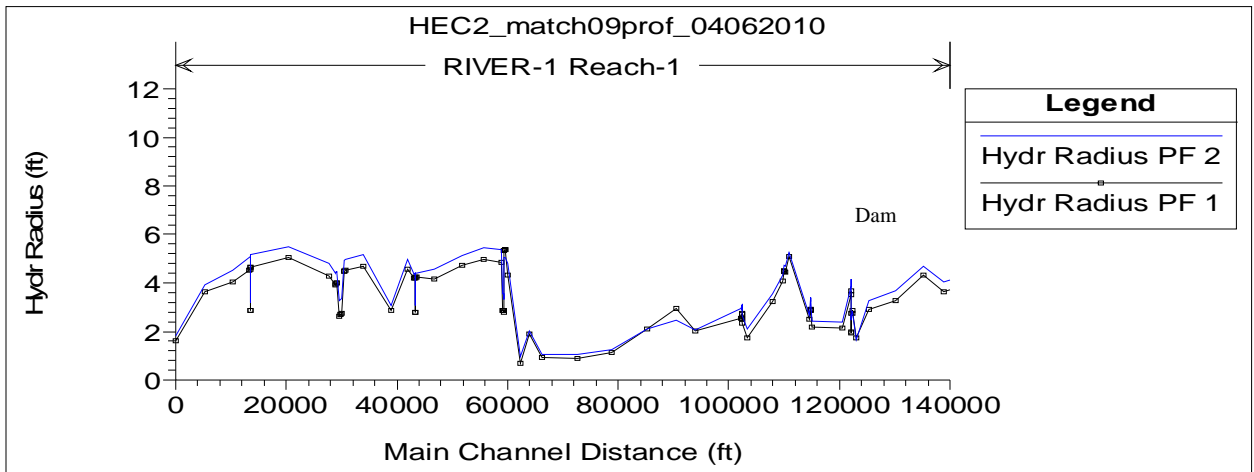
Figure 33 Simulation for 1984 hydraulic radius. The black line represents hydraulic radius at a discharge of 350 cfs (9.91 cms) and the blue line represents hydraulic radius at a discharge of 444.19 cfs (12.58 cms).

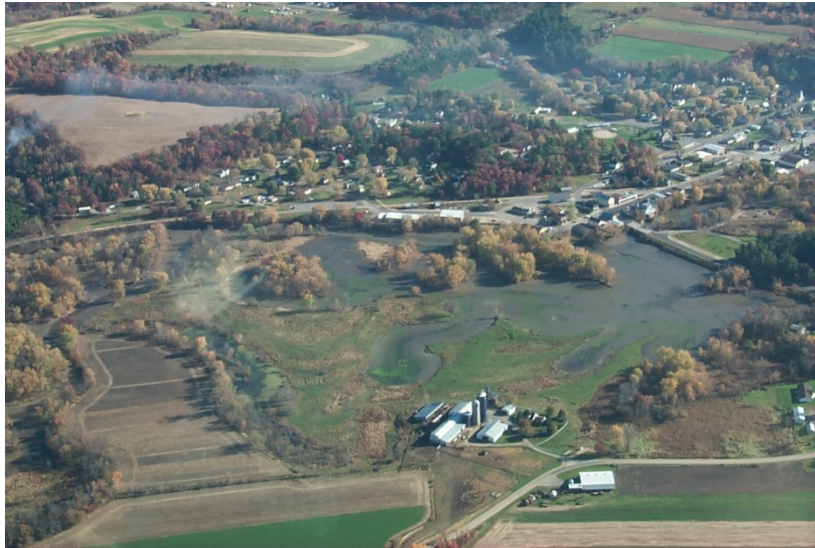
Figure 37 Photo courtesy of Emily Stanley and Martin Doyle. Picture of La Valle dam reservoir during the January 1999 drawdown, approximately one year before removal. River flows from left side of picture towards the right side of picture.

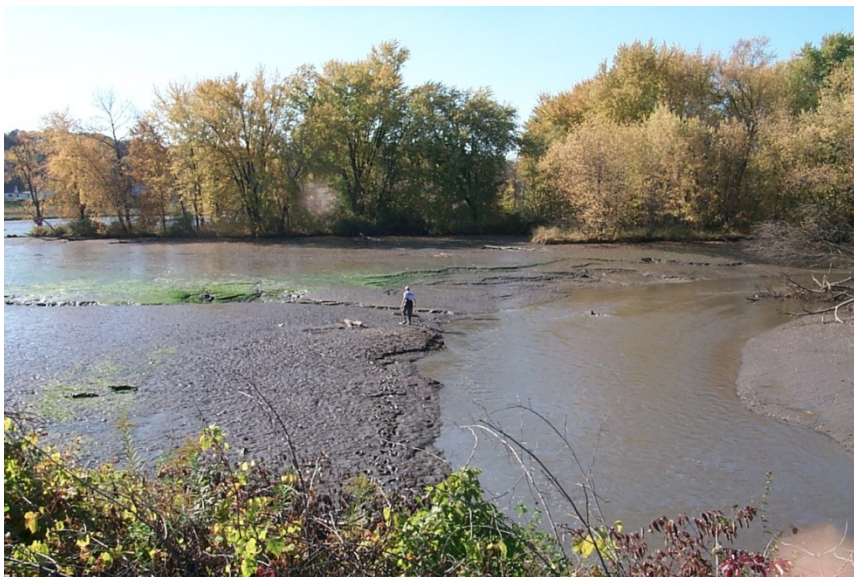
Figure 38 Photo courtesy of Emily Stanley and Martin Doyle. Picture of La Valle dam reservoir during the January 1999 drawdown, approximately one year before removal.

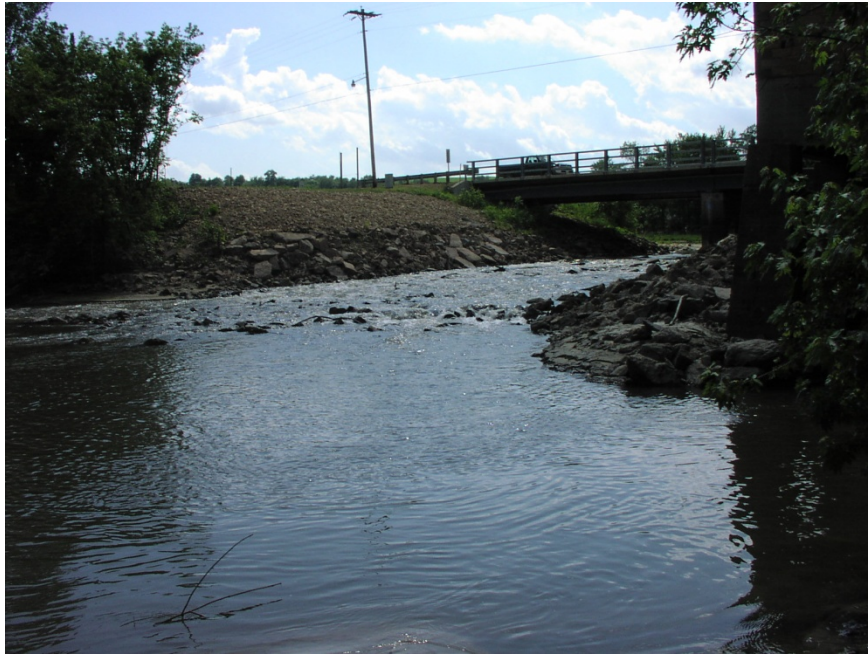
**Figure 39** Photo courtesy of Emily Stanley and Martin Doyle. Picture of the dam site, looking upstream; taken after removal.

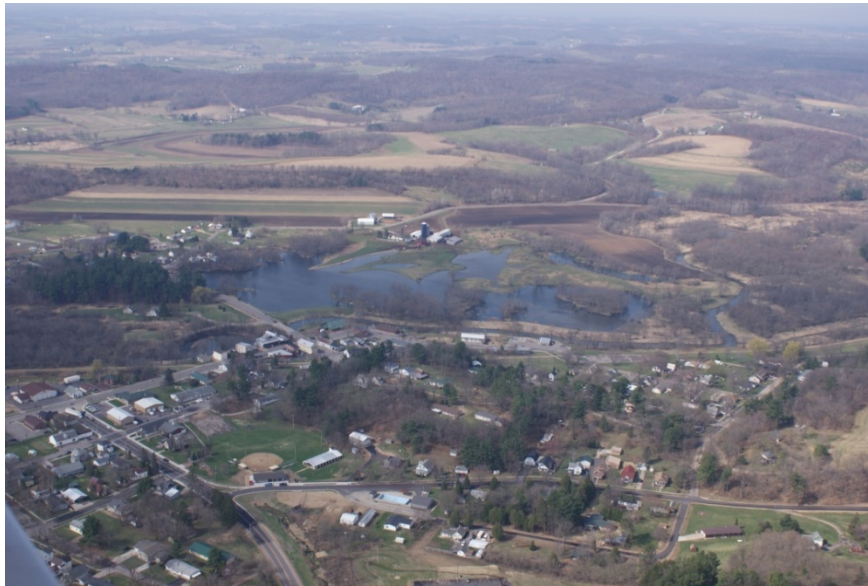
**Figure 40** Photo courtesy of Alicia Jepsen. Picture of the preserved mill pond; taken in 2007. River flows from right side of the photo towards the left side of the photo.

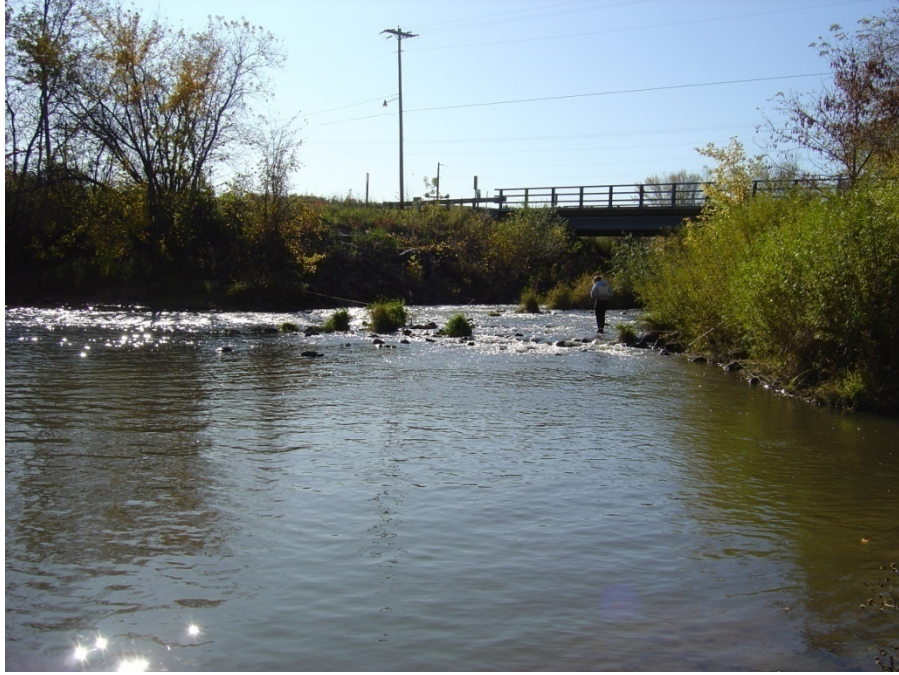
**Figure 41** Photo courtesy of Samantha Greene and Jena Krause. Picture of the dam site in October 2009, looking upstream.
