**Dante Fratta and Jose Pincheira
Department of Civil and Environmental Engineering
University of Wisconsin Madison**

WHRP 08-06

**EVALUATION OF FIBERGLASS WRAPPED
CONCRETE BRIDGE COLUMNS**

Final Report

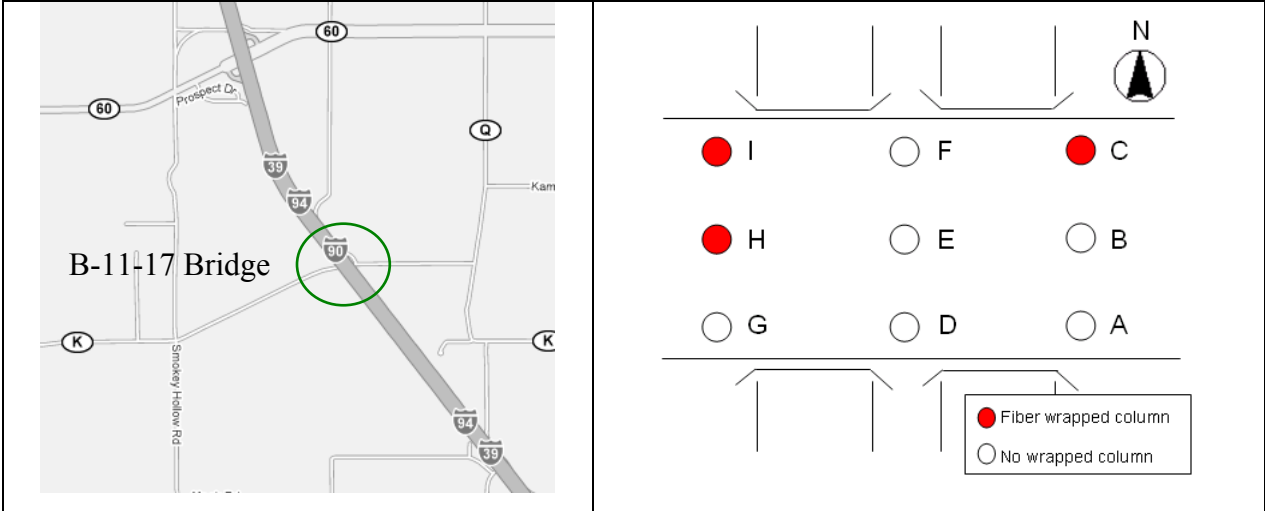
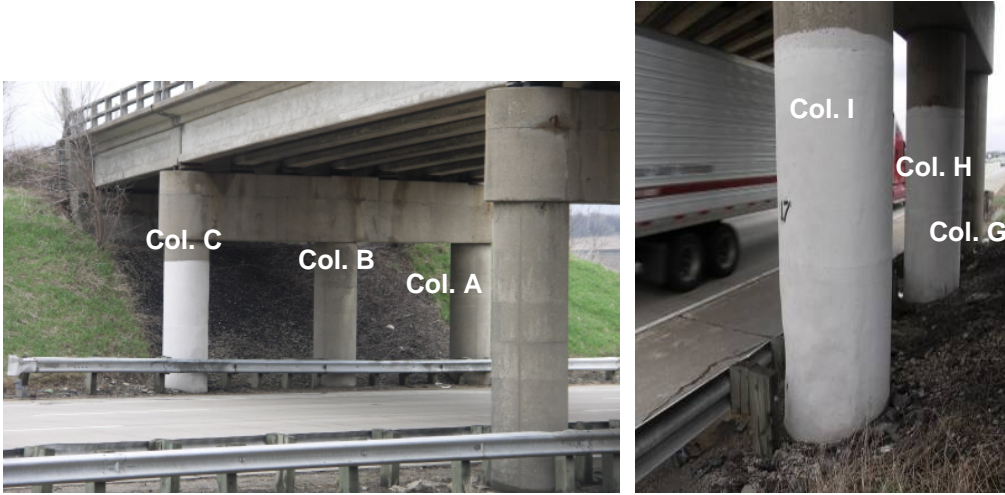
Figure 3.2: Location of B-11-17 bridge in Columbia Co., WI and arrangement of columns (map: after Google Maps 2008).

This bridge is located under county road K on interstate highway I-90/94 in Columbia Co., WI. The bridge has nine concrete columns and three of these columns have been repaired using fiberglass wraps (Figure 3.2). In this bridge, WisDOT has used the fiberglass wraps in at least two different maintenance operation cycles. The wrap applications on these bridge columns were implemented between years 1997~1998 and 2003~2005 to upgrade the structural condition of the bridge following regular inspections. Table 3.4 summarizes the inspection findings for this bridge and the timeline of degradation and repairs is summarized in Figure 3.3.

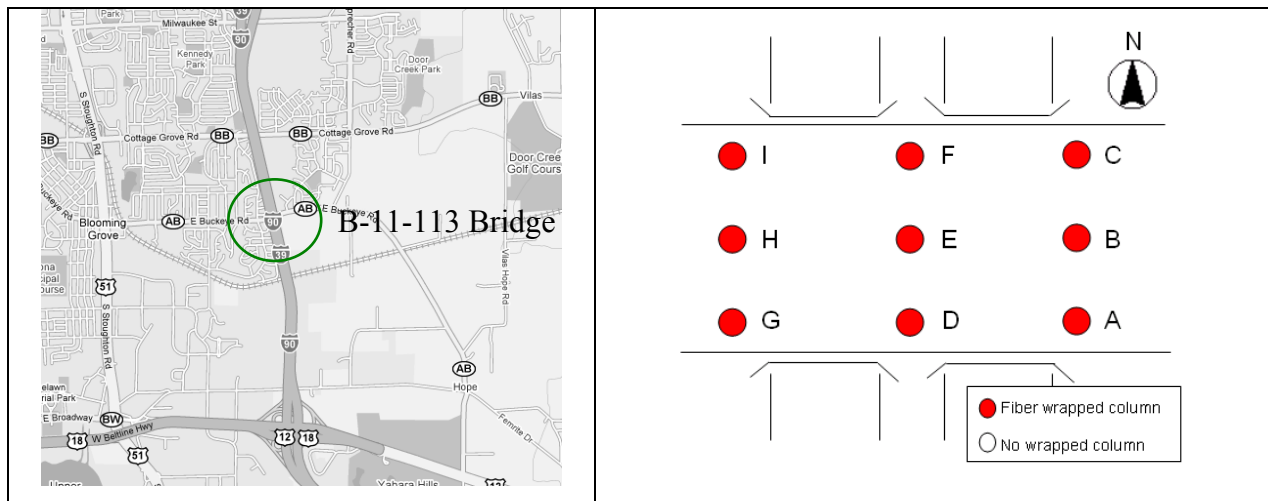
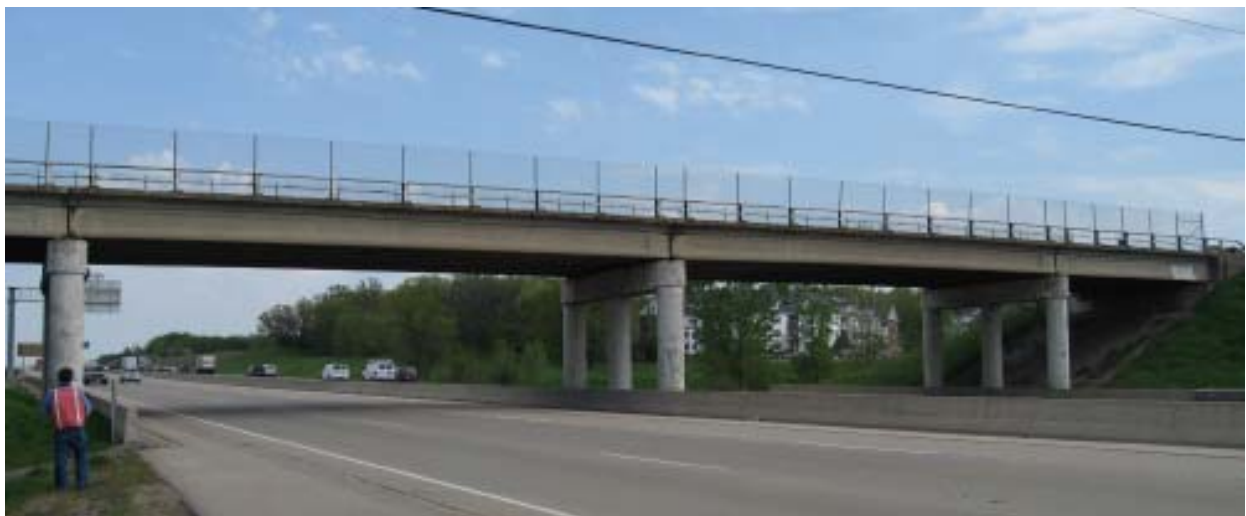
Figure 3.4: Location of B-11-113 bridge in Dane Co., WI and arrangement of columns (map: after Google Maps 2008).

This bridge is located under county road AB on interstate highway I-90 (Figure 3.4). The bridge has nine concrete columns and all of them have been repaired using fiberglass wraps. WisDOT has used the fiberglass wraps in two occasions. The wrap applications on these bridge columns were implemented between years 1996-1997 and 2001-2003 to upgrade the structural condition of the bridge columns following the regular inspection reports documented in Table 3.5. The timeline of degradation and repairs is summarized in Figure 3.5.

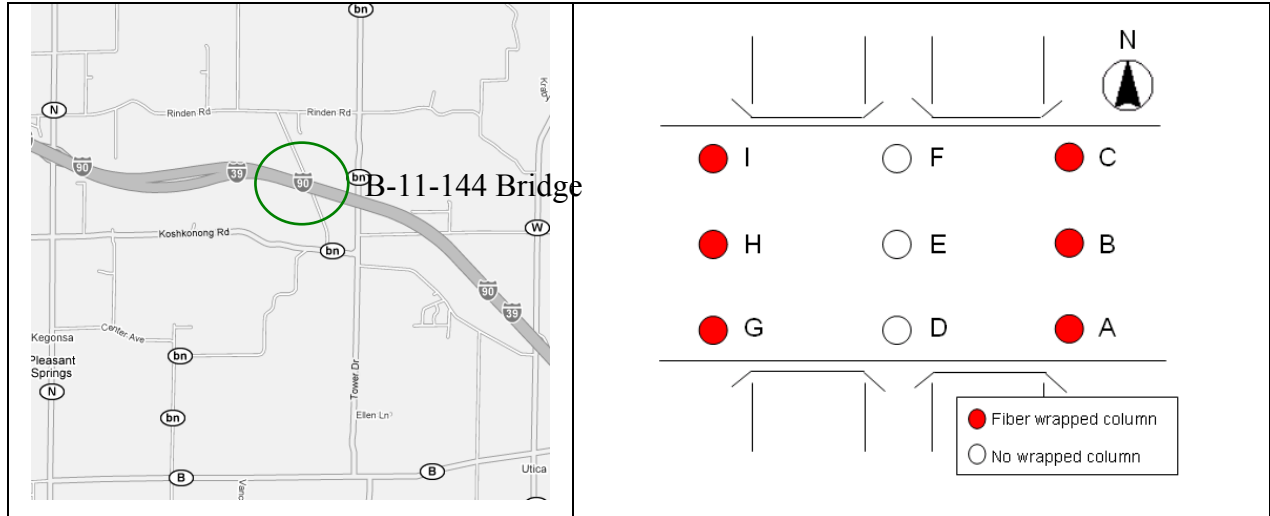
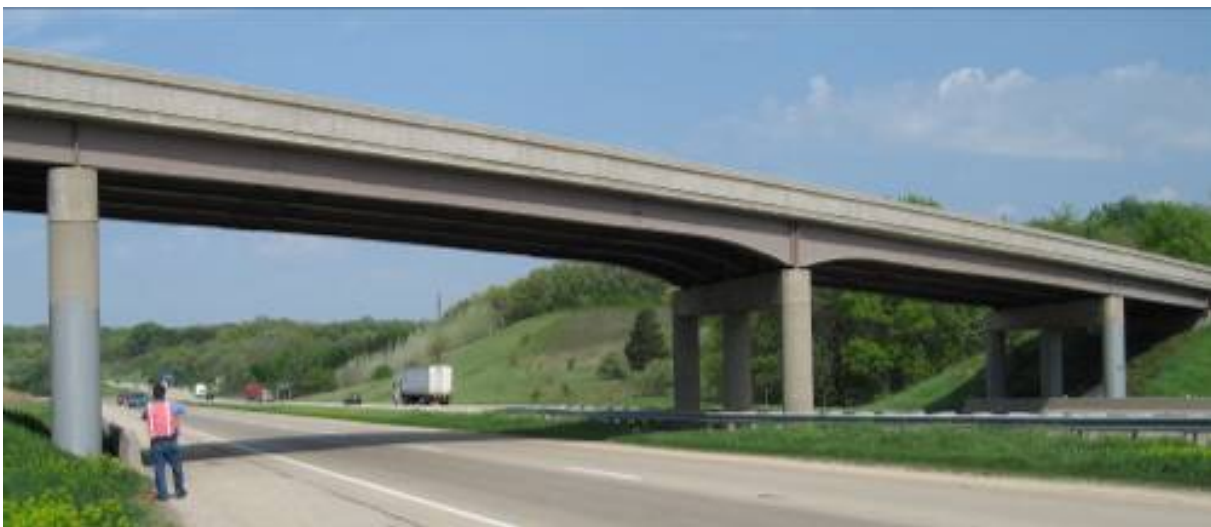
Figure 3.6: Location of B-11-144 bridge in Dane Co., WI and arrangement of columns (map: after Google Maps 2008).

This bridge is located under Church St. on interstate I-90 in Dane Co., WI. The bridge has nine concrete columns and six of these columns have been repaired using fiberglass wrap as shown in Figure 3.6. WisDOT has used the fiberglass wraps in two different occasions to repair the columns in this bridge. WisDOT wrapped the columns 2002-2004 and in 2006 to upgrade the structural condition. Table 3.6 and Figure 3.7 summarize the timeline of degradation and repairs in the columns.

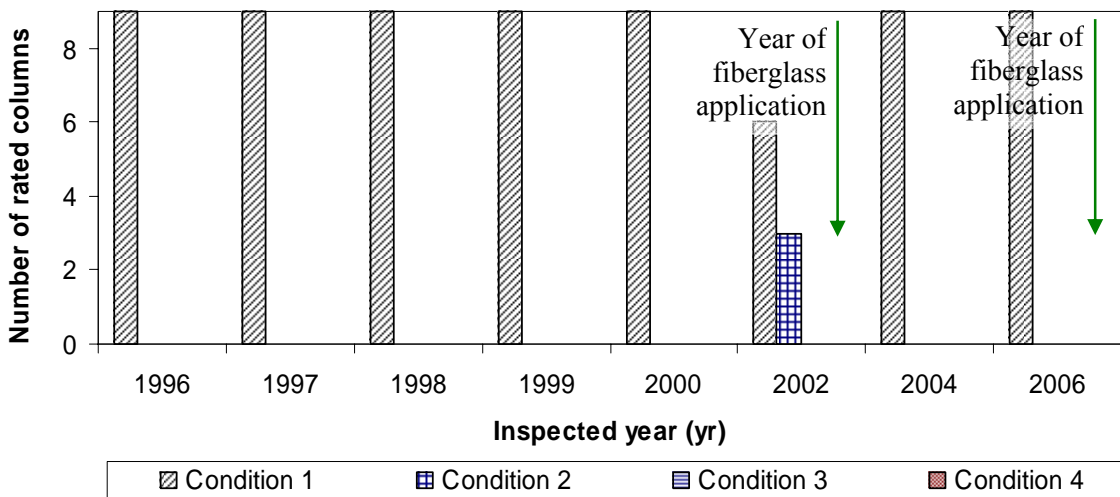
Year	Relevant inspection report comments
12/1996 ~ 11/2000	Columns A, B, and C have fiber wraps, all look good. Columns G, H, and I have fiber wraps, all look good.
2/2002	Columns A, B, and C have fiber wraps, all look good. Columns G, H, and I have fiber wraps, all look good. Fiber wrap at column G is starting to break open.
2/2004	Columns A, B, and C have fiber wraps, all look good. Columns G, H, and I have fiber wraps, all look good.
9/2004	Columns A, B, and C have fiber wraps. Columns G, H, and I have fiber wraps.
9/2006	Columns A, B, and C have fiber wraps, all look good. Columns G, H, and I have fiber wraps, all look good.

Figure 3.7: Timeline of inspected conditions of columns and maintenance operations in the B-13-144 bridge (Condition rating definitions are summarized in Table 3.3).

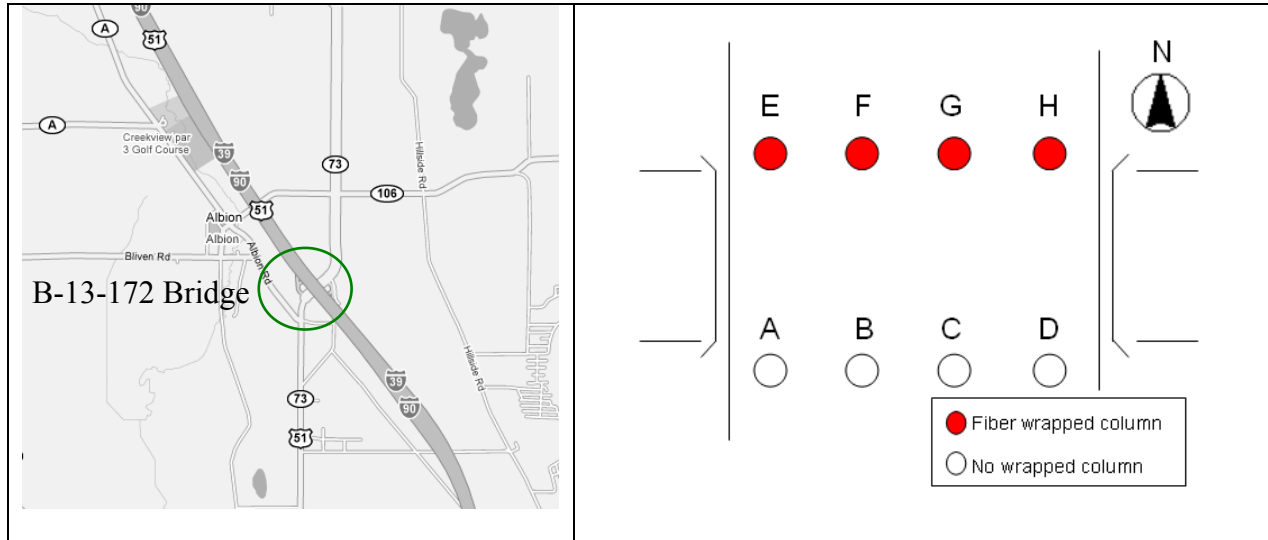
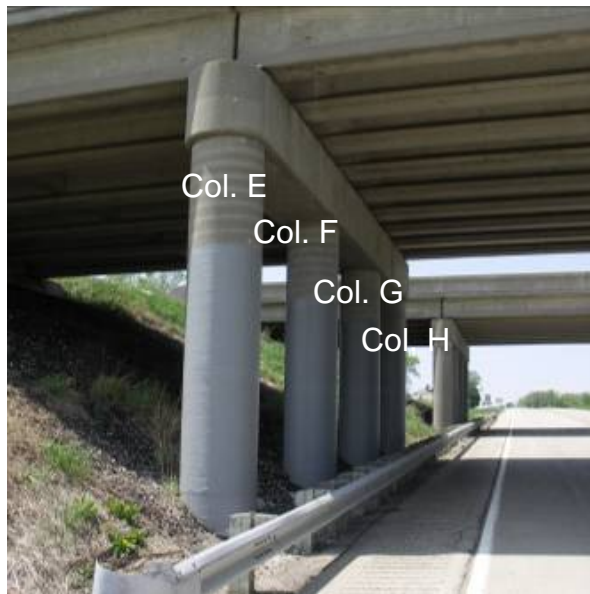
Figure 3.8: Location of B-11-172 bridge in Dane Co., WI and arrangement of columns (map: after Google Maps 2008).

This bridge is located under interstate highway I-90 Westbound on US road 51 Northbound. The bridge has eight concrete columns and four of them have been repaired using fiberglass wraps as shown in Figure 3.8. WisDOT has used the fiberglass wraps in two occasions. The wrap applications on these bridge columns were implemented between years 2002-2004 and in 2006

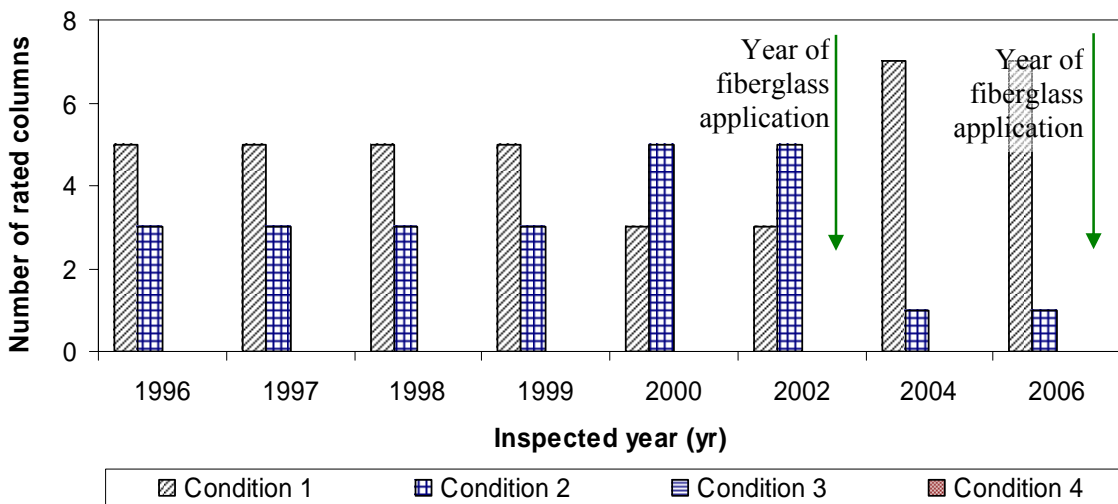
Year	Relevant inspection report comments
11/1996 ~ 2/2002	Columns E, F, G, and H have concrete patches. These patches have some cracks and sound hollow.
1/2004	Columns E, F, G, and H have concrete patches and patches have random cracks and sound hollow. All columns were wrapped and sealed.
9/2004	Columns E, F, G, and H have fiber wraps. Delamination/cracking in column F (or G?).
9/2006	Columns E, F, G, and H have fiber wraps. All columns look good.

Figure 3.9: Timeline of inspected conditions of columns and maintenance operations in the B-13-172 bridge (Condition rating definitions are summarized in Table 3.3).

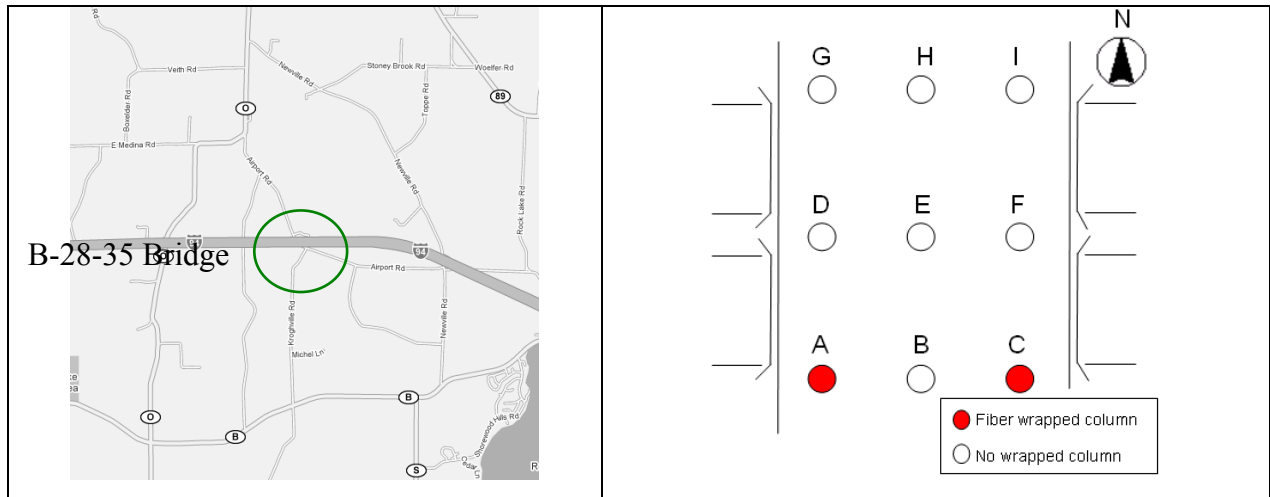
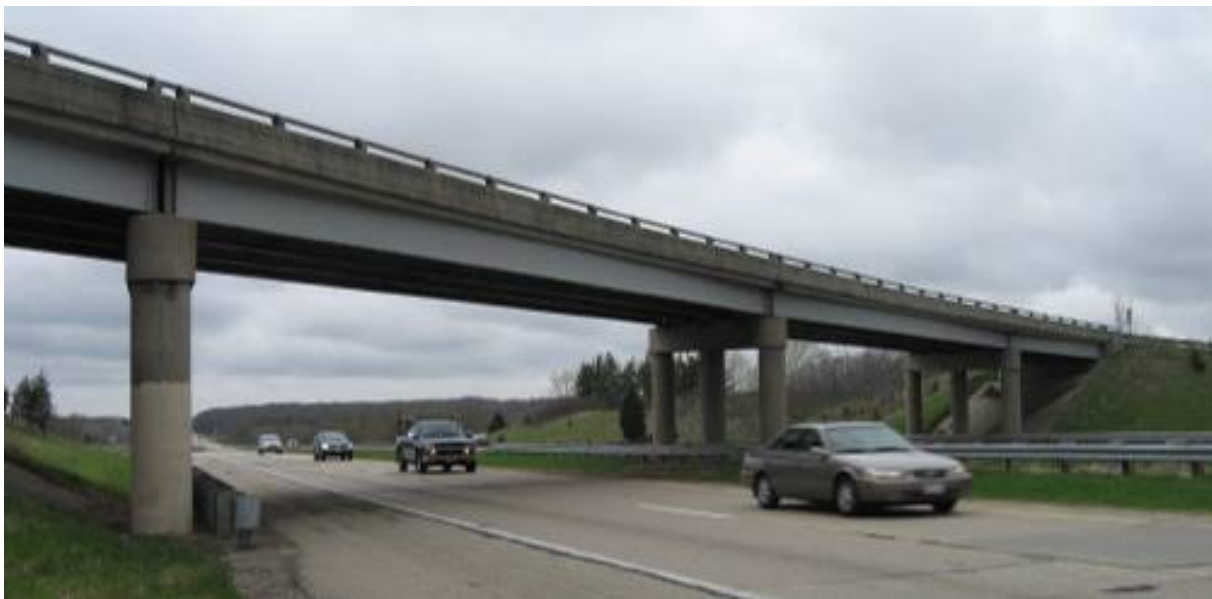
Figure 3.10: Location of B-28-35 bridge in Jefferson Co., WI and arrangement of columns (map: after Google Maps 2008).

This bridge is located under Airport Road on interstate highway I-94 in Jefferson Co. The bridge has nine concrete columns and two of them have been repaired using fiberglass wraps as shown in Figure 3.10. WisDOT has used the fiberglass wraps in two occasions. The wrap applications on these bridge columns were implemented in the mid 1990s to upgrade the structural condition of the bridge columns as documented in Table 3.7. The timeline of degradation and repairs is summarized in Figure 3.11.

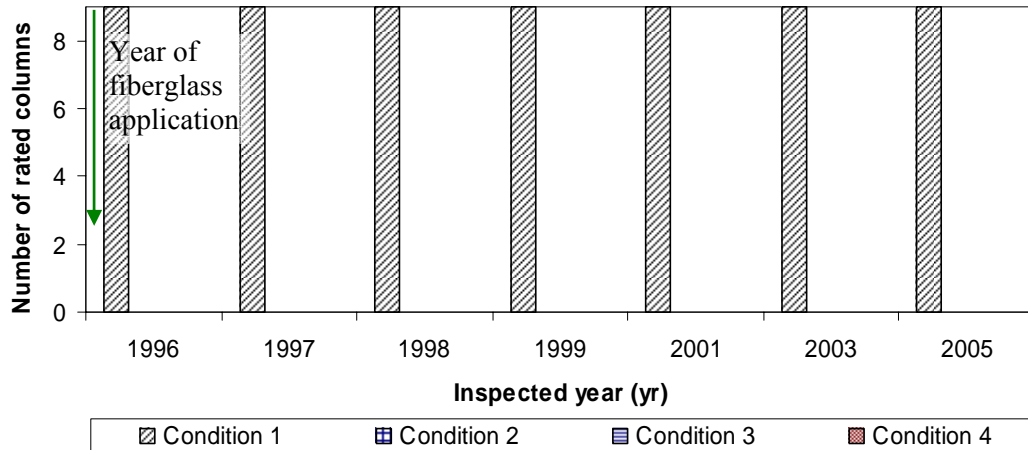
Year	Relevant inspection report comments
6/1996 ~ 6/2005	Columns A, B, and C have fiber wrap and look good. Other columns look good.

Figure 3.11: Timeline of inspected conditions of columns and maintenance operations in the B-28-35 bridge (Condition rating definitions are summarized in Table 3.3). Mid 1990s is the estimated wrapping year.

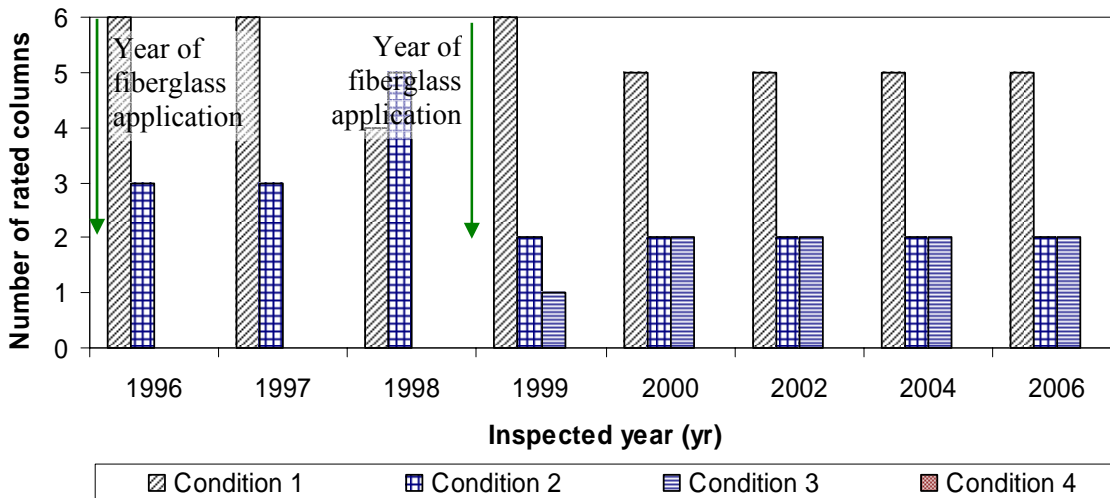
Year	Relevant inspection report comments
10/1996 ~ 11/1999	Columns A, B, and I are wrapped. There a few cracks in the three columns (A, B, I).
5/2000	Columns A, B, and I are wrapped
2/2002 ~ 2/2004	Columns A, B and I have fiberglass wraps. Column F has high rust steel, popout spalls. Column H has vertical cracks at bottom.
9/2004	Columns A, B and I have fiber wraps. Column F has high rust steel popout spalls. Column H has vertical cracks and delamination at bottom.
9/2006	Column A & B has fiber wraps and both columns look good. Column A has a couple rust stains. Column F has high rust steel popout spalls. Column H has vertical cracks and delamination at bottom. Column I has fiber wrap 1/3 up and it looks good.

Figure 3.13: Timeline of inspected conditions of columns and maintenance operations in the B-28-40 bridge (Condition rating definitions are summarized in Table 3.3).

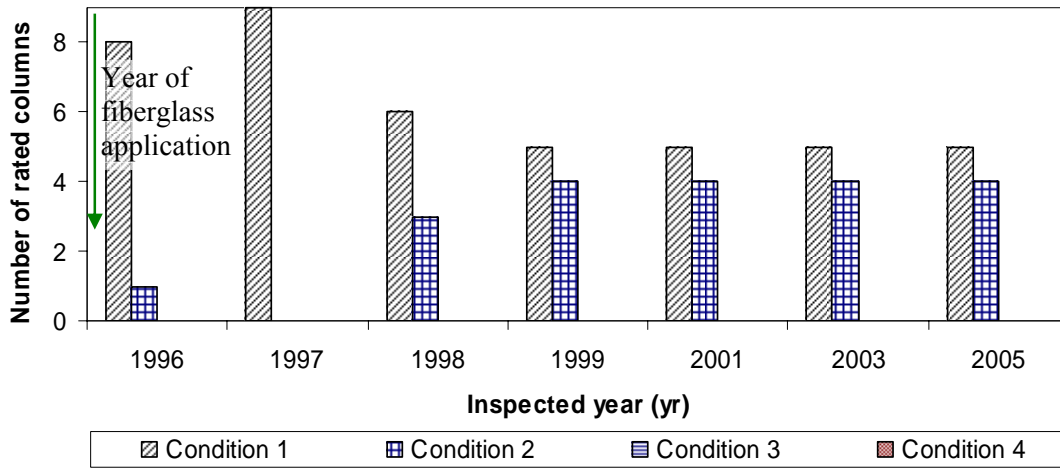
Figure 3.15: Timeline of inspected conditions of columns and maintenance operations in the B-28-43 bridge (Condition rating definitions are summarized in Table 3.3).

Year	Relevant inspection report comments
6/1996 ~ 6/2005	Columns A, B, and C have concrete collars one third up. Column G has a fiber wrap one third up. Column I has numerous cracks in concrete collars.

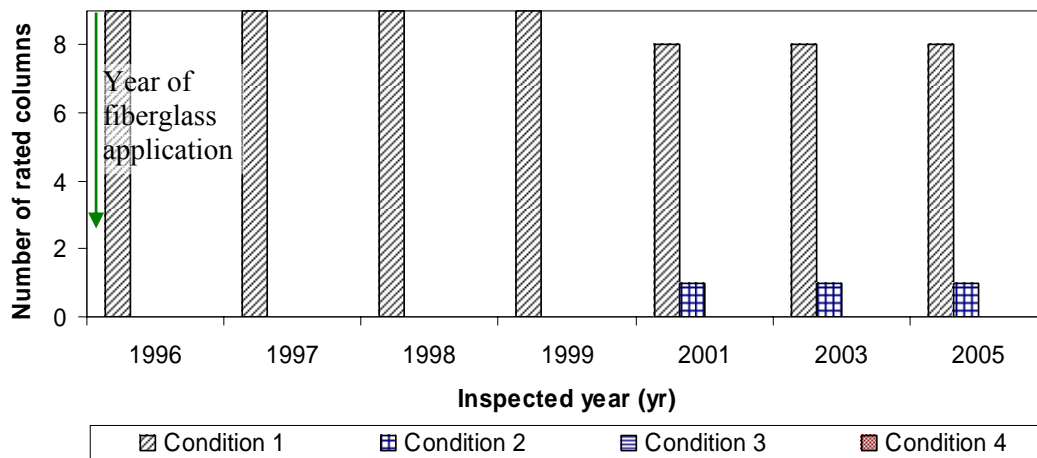
Figure 3.17. Timeline of inspected conditions of columns and maintenance operations in the B-28-45 bridge (Condition rating definitions are summarized in Table 3.3).

Year	Relevant inspection report comments
7/1997	Columns A and B are wrapped.
3/1998 ~ 3/1999	Columns A and B are wrapped.
6/2001 ~ 6/2005	Columns A and B have been wrapped halfway up. Column D has a small spalled out area half way up, no exposed rebar.

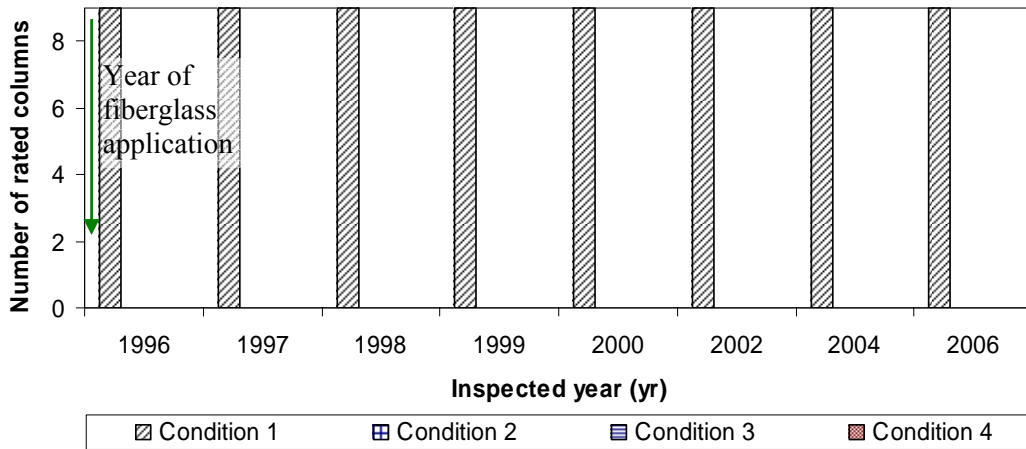
Figure 3.19: Timeline of inspected conditions of columns and maintenance operations in the B-28-50 bridge (Condition rating definitions are summarized in Table 3.3).

Year	Relevant inspection report comments
3/1996 ~ 3/1999	Fiberglass wrap on column A looks good. Fiberglass wrap on column G looks good.
5/2000 ~ 9/2006	Fiberglass wrap on column A looks good. Couple of vertical cracks remaining. Fiberglass wrap on column G looks good. Couple of vertical cracks remaining.

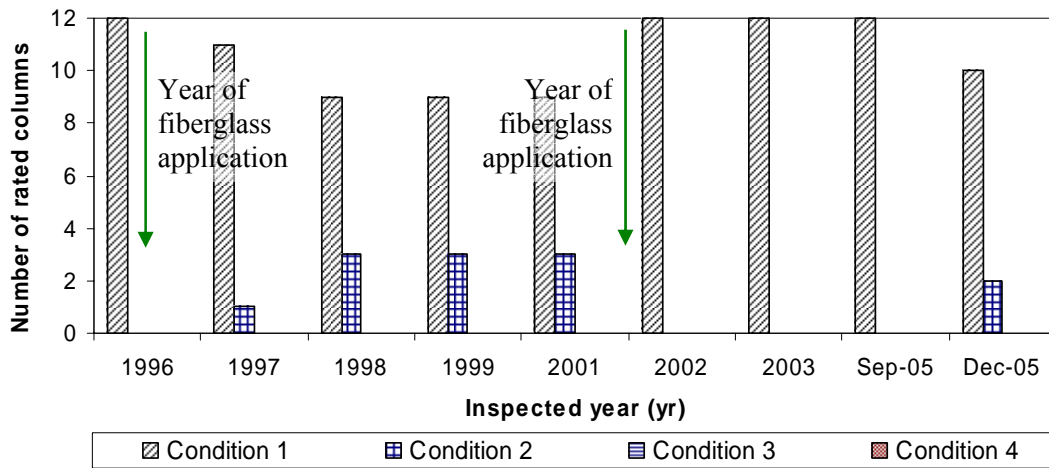
Figure 3.21: Timeline of inspected conditions of columns and maintenance operations in the B-53-65 bridge (Condition rating definitions are summarized in Table 3.3).

Year	Relevant inspection report comments
11/1996 ~ 9/2005	Columns I and K are wrapped with fiberglass. Columns A, C and D are wrapped with fiberglass. These columns have cracks and delaminations.
12/2005	Columns I & K are wrapped with fiberglass. The fiberglass wrap in column I is debonding and column is spalling. Columns A, C and D are wrapped with fiberglass. The fiberglass wrap in column A is debonding and column is spalling. The fiberglass wrap in column C is starting to debond. The fiberglass wrap in column D is in ok condition. Column B has hairline cracks & delaminations. There is no fiberglass wrap on it.

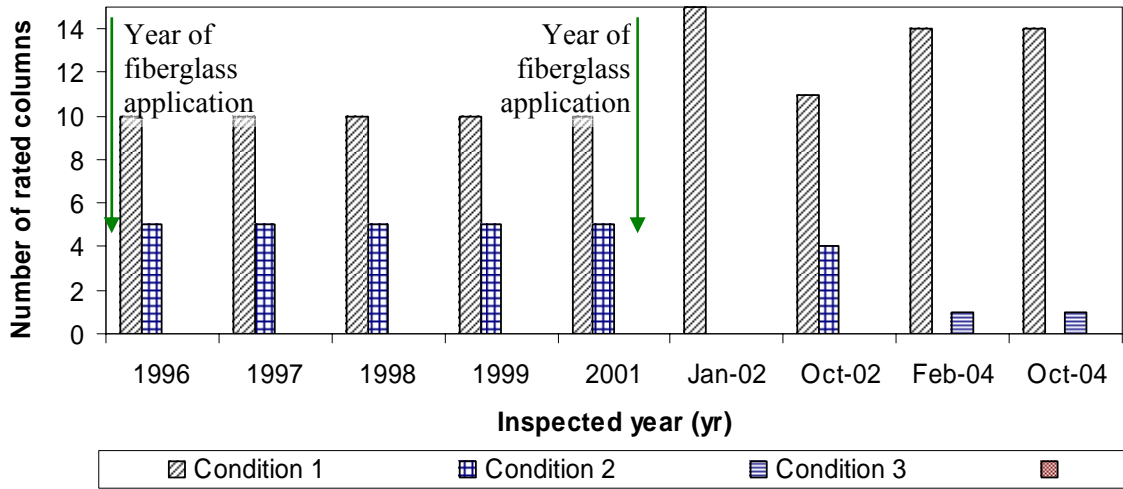
Figure 3.23: Timeline of inspected conditions of columns and maintenance operations in the B-53-66 bridge (Condition rating definitions are summarized in Table 3.3).

Year	Relevant inspection report comments
11/1996 ~ 11/1999	Fiberglass wrapped columns K and M have some vertical cracks. Column L has delaminated area.
7/2001	Columns A, B and D were fiber wrapped in 2000 and painted gray. They look good.
10/2002 ~ 10/2004	Column K has old fiberglass wrap and the wrap is busting out.
10/2006	Column K and M have old fiberglass wraps and are busting out at bottom. Columns A, B & D were fiber wrapped in 2000 and painted gray. They look good.

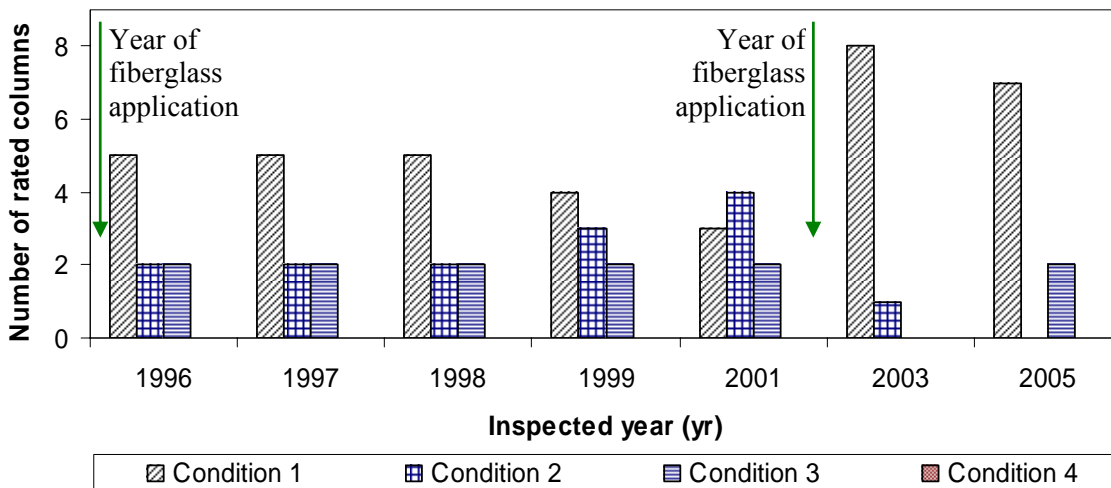
Figure 3.25: Timeline of inspected conditions of columns and maintenance operations in the B-53-71 bridge (Condition rating definitions are summarized in Table 3.3).

Year	Relevant inspection report comments
10/1996	Columns A, B, and C are all fiberglass wrapped. Column E has one concrete collar has several cracked rust stains
10/1997	Columns A, B, and C are all fiberglass wrapped. Column C has several cracks with rust stains. Column E has a concrete collar has horizontal cracks, sounding was good.
4/1998	Columns A and B have fiberglass wrap on the lower half. Columns C has a complete fiberglass wrap.
3/1999	Columns A and B have fiberglass wrap on the lower half. Columns C has a complete fiberglass wrap.
7/2003	Columns A, B, C, and D are wrapped. The fiberglass wrapping in column C has failed near the ground line. Column E has a collar.
7/2005	Columns G and H both have bottom half spalling out. Column E has a collar. Column A is completely wrapped in fiberglass. Columns B and C are wrapped half height in fiberglass. The wrap in column C is coming off.

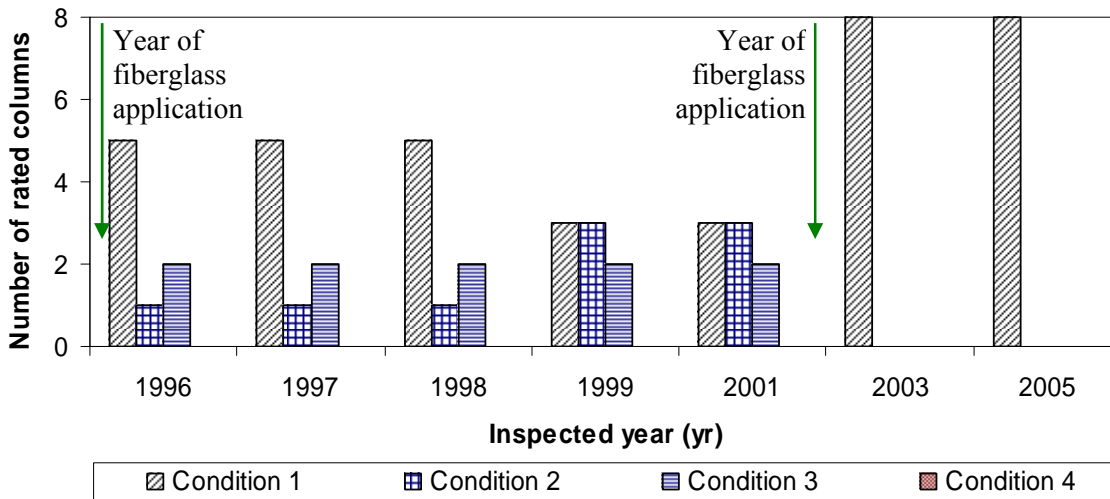
Figure 3.27: Timeline of inspected conditions of columns and maintenance operations in the B-53-75 bridge (Condition rating definitions are summarized in Table 3.3)

Year	Relevant inspection report comments
10/1996 ~ 7/2001	Columns A, B, C, and D are cracked and delaminated in the bottom half. Column G is delaminated, exposed rusty rebar.
7/2003 ~ 7/2005	Columns A, B, C, and D are wrapped.

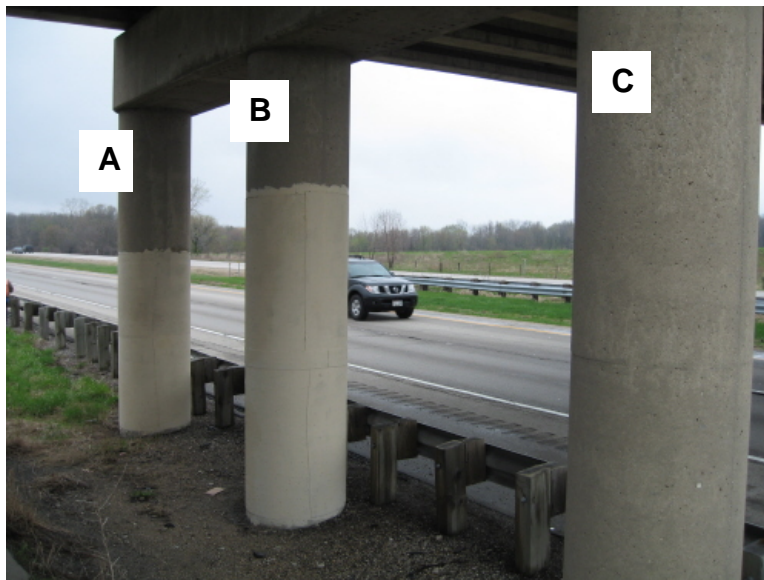
Figure 4.3: Tested columns in the Bridge B-28-45 (Eastbound).

P-wave velocity profiles and tomographic images were collected on three columns along of eastbound shoulder of Bridge B-28-45. Two of these columns (columns A and B) were coated with fiberglass wraps while the third column (Column C) was in its as-built condition, as shown in Figure 4.3. Columns A and B did not show external signs of distress while Column C showed cracks on the surface facing traffic.

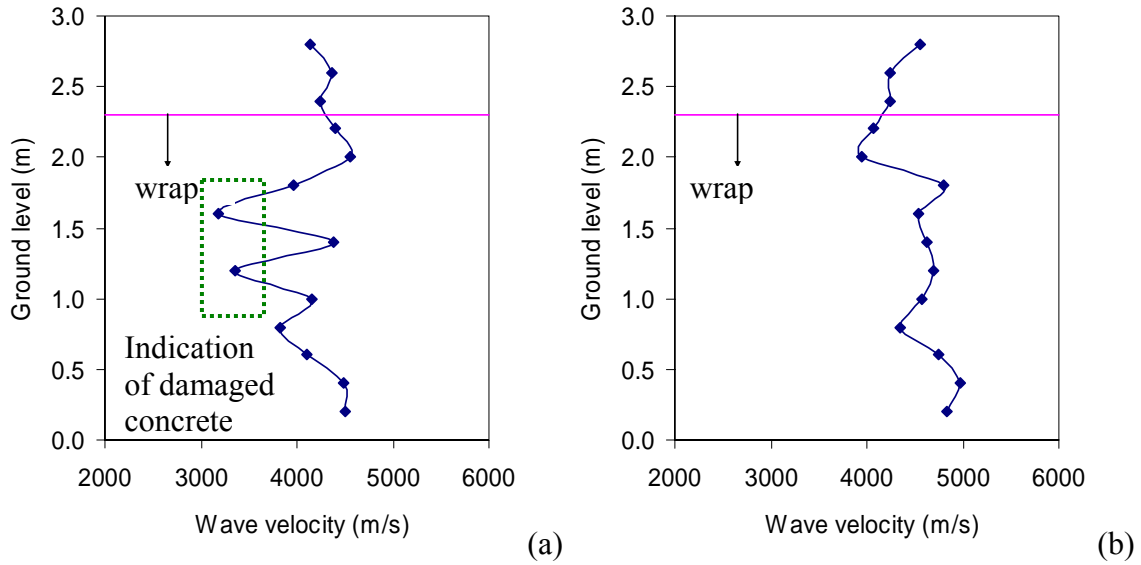
Figure 4.4: Horizontal P-wave velocity profiles on Bridge B-28-45 column A: (a) vertical plane parallel to traffic and (b) vertical plane perpendicular to traffic.

Average P-wave velocity profiles along vertical planes parallel and perpendicular to the traffic direction for column A are presented in Figure 4.4. The figure shows a significant reduction in the P-wave velocity and thus areas of weaker concrete at 1.2 m and 1.5 m high in the vertical plane parallel to the traffic direction. Because these measurements provide average P-wave velocities only and the local position of the weaker concrete material cannot be determined (e.g., how far from the concrete surface), P-wave data were also collected to obtain tomographic images of the vertical planes. These tomographic images are presented in Figure 4.5. The local distribution of P-wave velocity shown in Figure 4.5b indicates that the areas of degraded concrete facing the traffic direction.

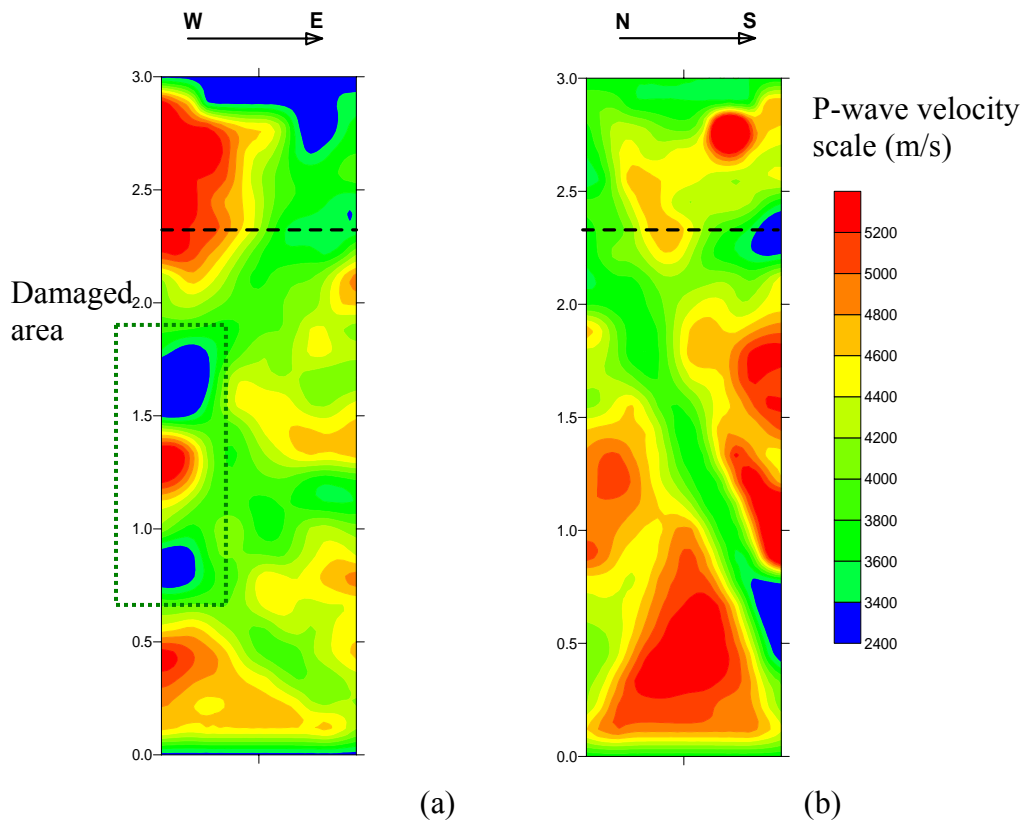
Figure 4.5: P-wave velocity tomographic images on Bridge B-28-45 column A: (a) vertical plane parallel to traffic and (b) vertical plane perpendicular to traffic.

does not seem to coincide with the damaged areas predicted in the same column using the P-wave velocity tomography (see Figure 4.5). Furthermore, the high volumetric water content (that is, low electromagnetic wave velocity) in the cross section tomographic image (Figure 4.23) appears in the center of the column. This observation seems puzzling. Traffic splashing should show higher water content on the concrete surface however the surface may also dry faster.

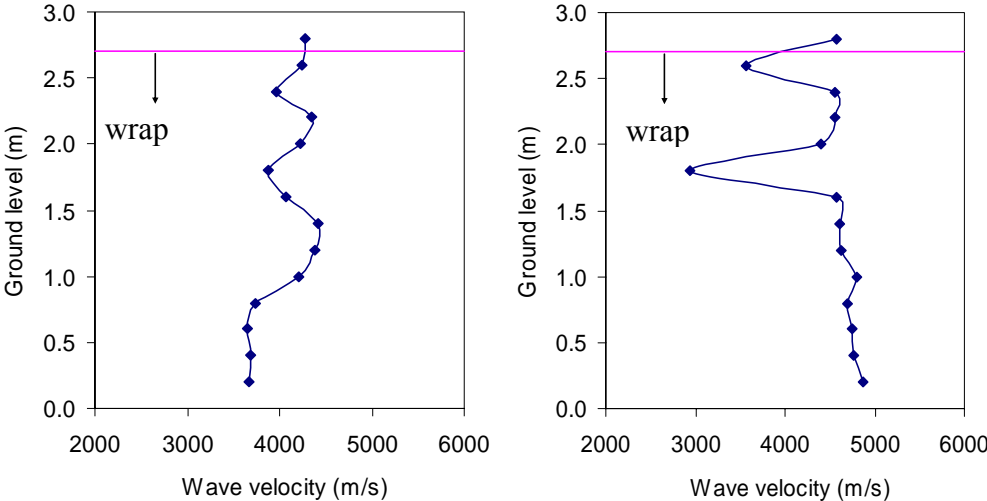
Figure 4.6: Horizontal P-wave velocity profiles on Bridge B-28-45 column B: (a) vertical parallel to traffic and (b) vertical plane perpendicular to traffic.

Similar P-wave velocity profiles and tomographic images along vertical planes were collected for Bridge B-28-45 column B, as shown in Figure 4.6. While the tomographic images presented in Figure 4.7 do not seem to indicate definite locations of the damaged concrete areas, the tomographic images along two horizontal cross-sections (Figure 4.8) clearly constrain the location of damaged area on the concrete facing the traffic direction.

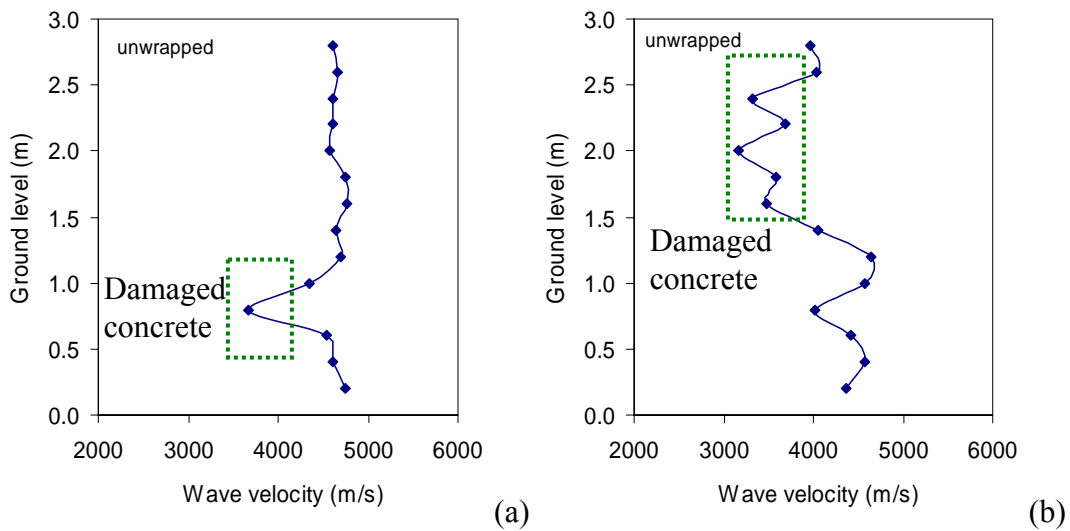
Figure 4.9: Horizontal P-wave velocity profiles on Bridge B-28-45 column C: (a) vertical plane parallel to traffic and (b) vertical plane perpendicular to traffic.

To provide a benchmark to the measurements conducted on the fiberglass wrapped columns A and B, P-wave velocity tests were also conducted on column C (unwrapped column) of Bridge B-28-45. Both horizontal P-wave velocity profiles (Figure 4.9) and tomographic images (Figure 4.10) along vertical planes parallel and perpendicular to traffic directions coincide in the locating areas of degrading concrete. These concrete areas face the traffic direction. Thus, it is likely that the damage observed in columns A and B using the wave propagation techniques reflect the degradation caused by the rebar corrosion even after the columns were treated with fiberglass wrap.

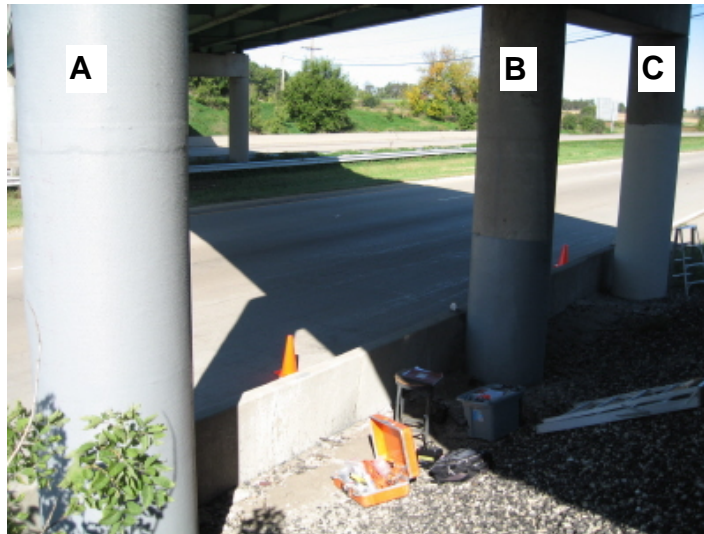
Figure 4.11: Tested columns in the Bridge B-53-71 (Northbound).

P-wave velocity profiles and tomographic images were collected on three columns along of eastbound shoulder of Bridge B-53-71. Two of these columns (columns A and C) were treated with fiberglass wrap along at least two third of the column high, while the third B was treated to less than half its height as shown in Figure 4.11. Column C was re-wrapped in 2007 due to corrosion damage at the bottom of the column (see Figure 3.1)

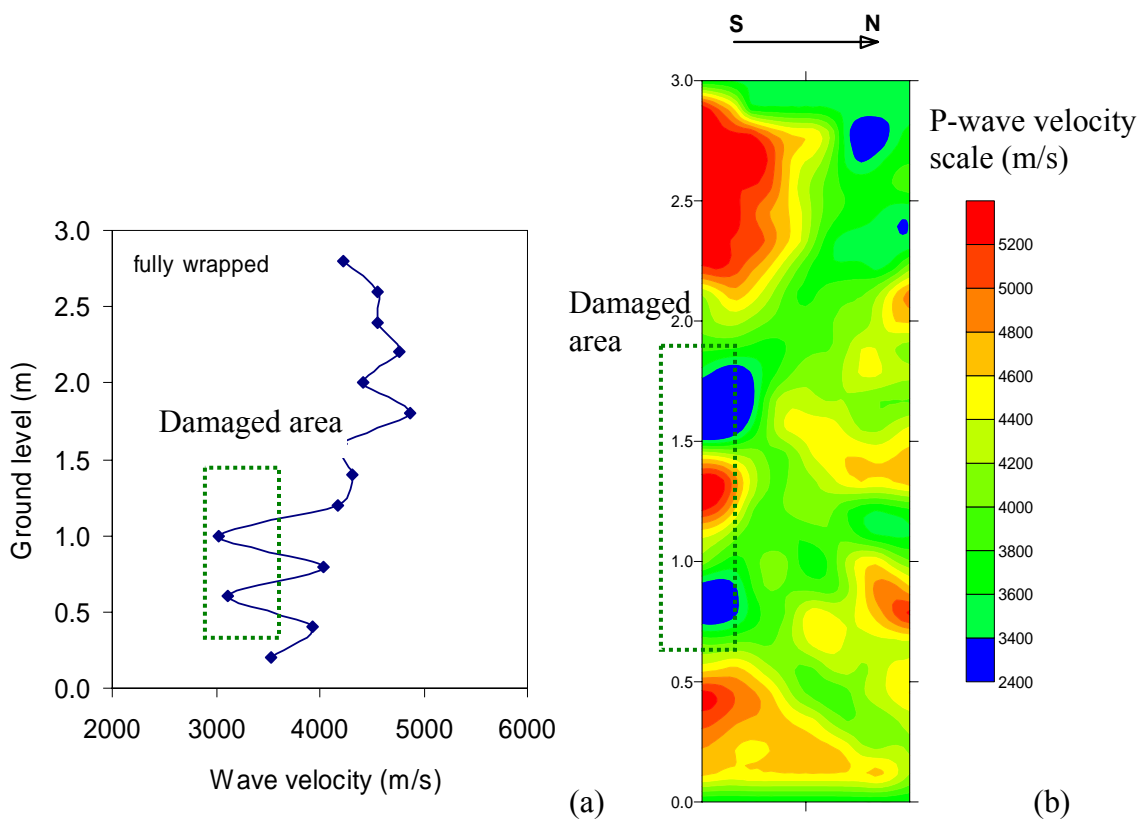
Figure 4.12: P-wave velocity results in Bridge B-53-71 column A along vertical plane parallel to traffic: (a) P-wave velocity profile and (b) tomographic imaging.

The average P-wave velocity profile and a tomographic image collected along a vertical plane parallel to traffic direction in column A are presented in Figure 4.12. These results show areas of weaker concrete at 0.6 to 1.2 m levels above ground. The results seem to show that despite of the repairs done with fiberglass wrapping (including replacing damage concrete with new mortar), areas of damaged concrete remains.

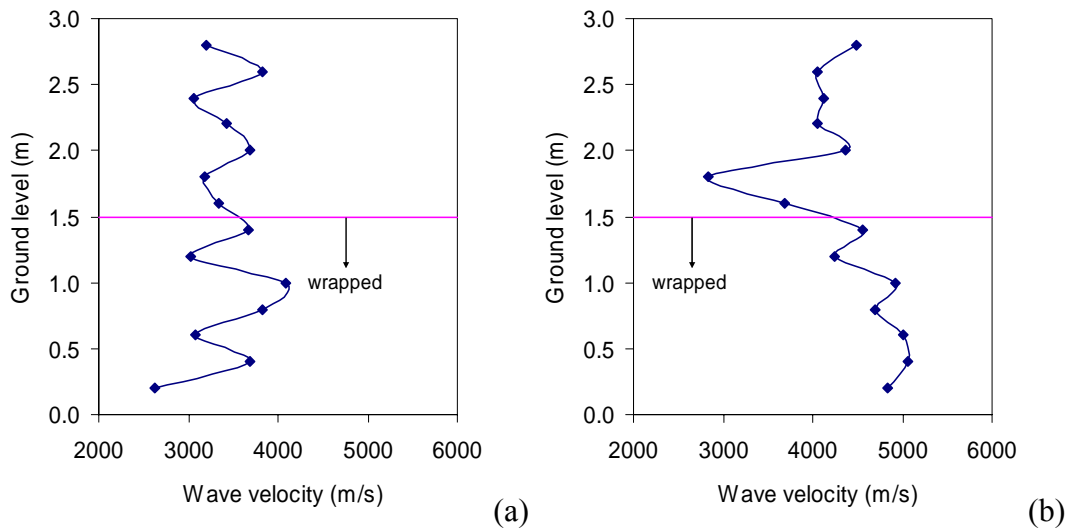
Figures 4.13 and 4.14 summarize the P-wave velocity profiles and tomographic images obtained in Bridge B-53-71 column B. This column shows relative low P-wave velocities along the vertical plane parallel to the traffic direction (Figures 4.13a and 4.14a) and higher P-wave velocities in the vertical plane perpendicular to the traffic direction. However even this plane shows pockets of low P-wave velocity both in areas above and below the fiberglass wrap level (see for example the drop on P-wave velocity at the 1.8 m level in Figures 4.13b and 4.14b).

Figure 4.13: Horizontal P-wave velocity profiles in Bridge B-53-71 column B: (a) vertical plane parallel to traffic and (b) vertical plane perpendicular to traffic.

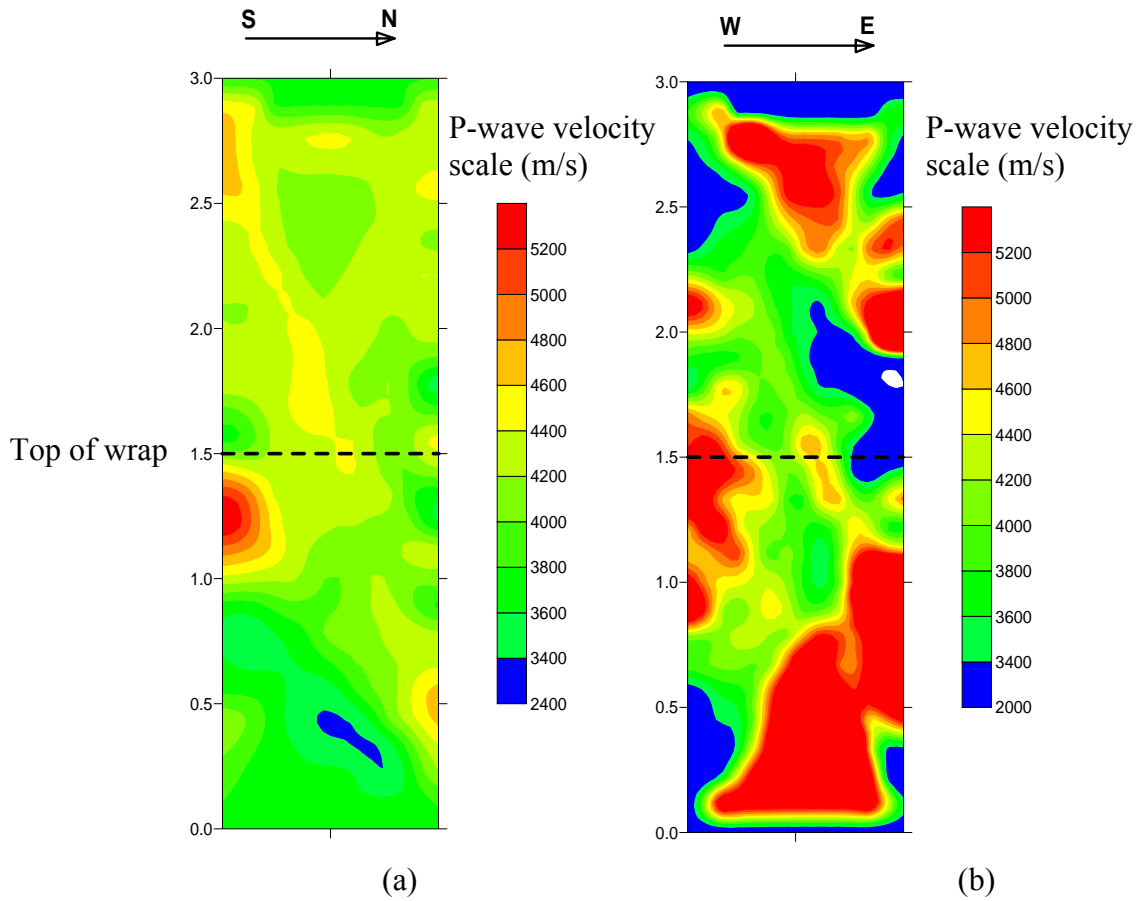
Figure 4.14: Horizontal P-wave velocity tomographic images of Bridge B-53-71 column B: (a) vertical parallel to traffic and (b) vertical plane perpendicular to traffic.

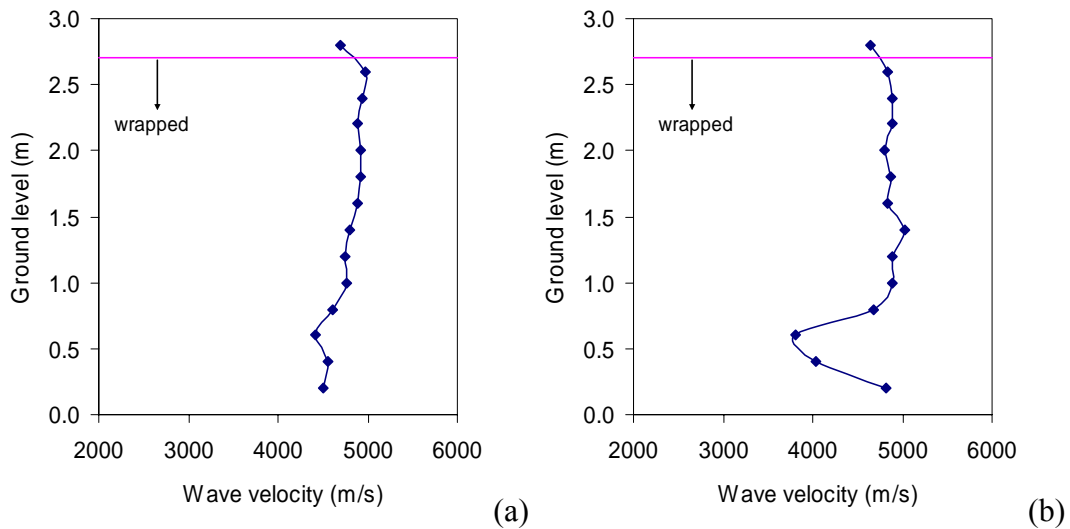
Finally, Figures 4.15 and 4.16 show the horizontal P-wave velocity profiles and tomographic images along vertical planes parallel and perpendicular to traffic directions coincide in the locating areas of degrading concrete for column C. This column was treated twice with fiberglass wrap, most recently in 2007. Overall, the P-wave velocity profiles indicate good concrete quality

Figure 4.15: Horizontal P-wave velocity profiles in Bridge B-53-71 column C: (a) vertical parallel to traffic and (b) vertical plane perpendicular to traffic.
