**Dante Fratta and Jose Pincheira
Department of Civil and Environmental Engineering
University of Wisconsin Madison**

WHRP 08-06

**EVALUATION OF FIBERGLASS WRAPPED
CONCRETE BRIDGE COLUMNS**

Final Report

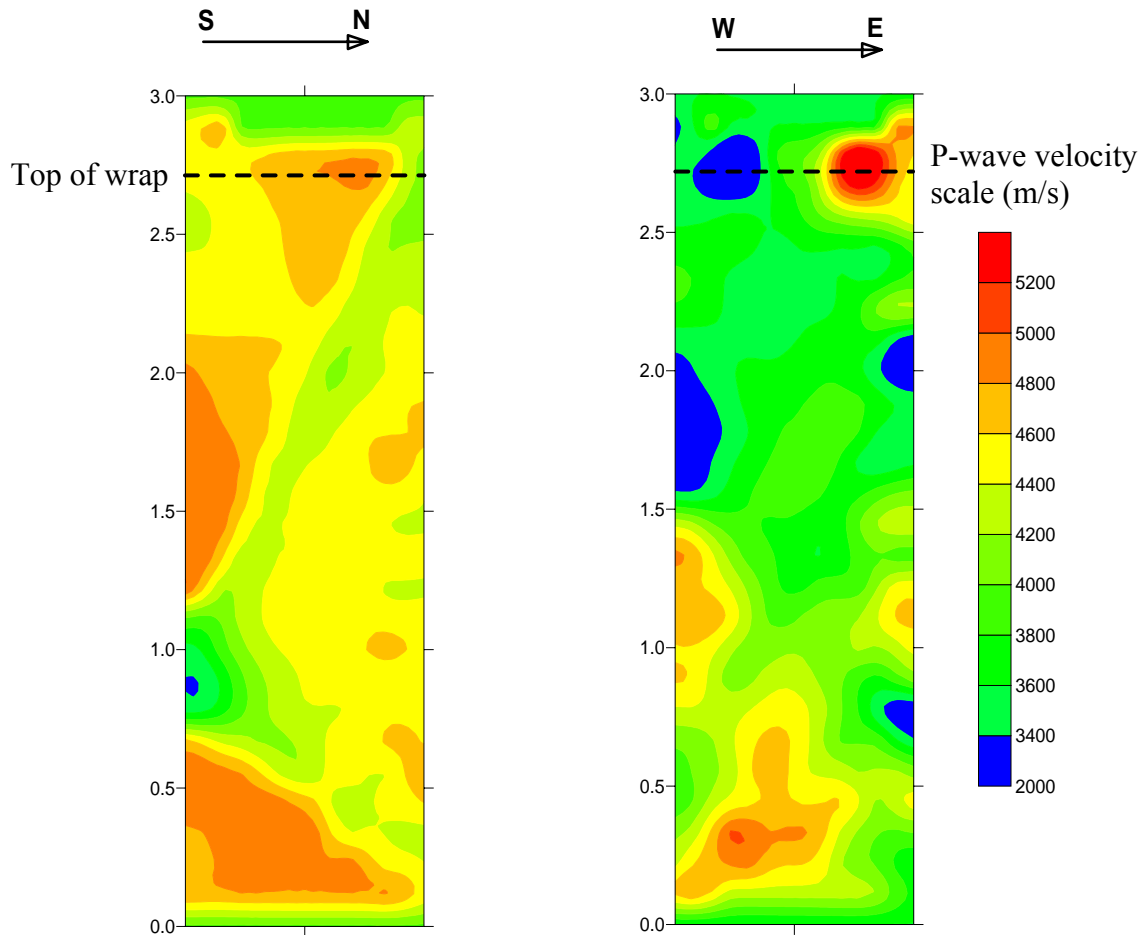
Finally, Figures 4.15 and 4.16 show the horizontal P-wave velocity profiles and tomographic images along vertical planes parallel and perpendicular to traffic directions coincide in the locating areas of degrading concrete for column C. This column was treated twice with fiberglass wrap, most recently in 2007. Overall, the P-wave velocity profiles indicate good concrete quality

Figure 4.16: Horizontal P-wave velocity tomographic images of Bridge B-53-71 column C: (a) vertical parallel to traffic and (b) vertical plane perpendicular to traffic.

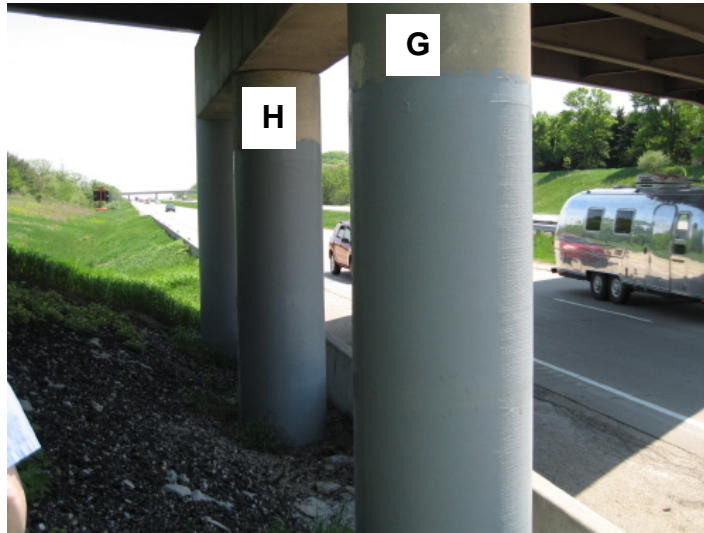
P-wave velocity profiles and tomographic images were collected on two columns along of eastbound shoulder of Bridge B-13-144. Two of these columns (columns G and H) were treated with fiberglass wrap (Figure 4.17). These wrapped columns seem to be in very good condition, however P-wave velocity profiles and tomographic images indicate that the concrete is damaged in the bottom 1.5 m of both columns (Figure 4.18 and 4.19). WisDOT regular inspection reports also indicate that column G had experience fiberglass wrapping failure and needed replacement.

Figure 4.17: Tested columns in the Bridge B-13-144 (Southbound).

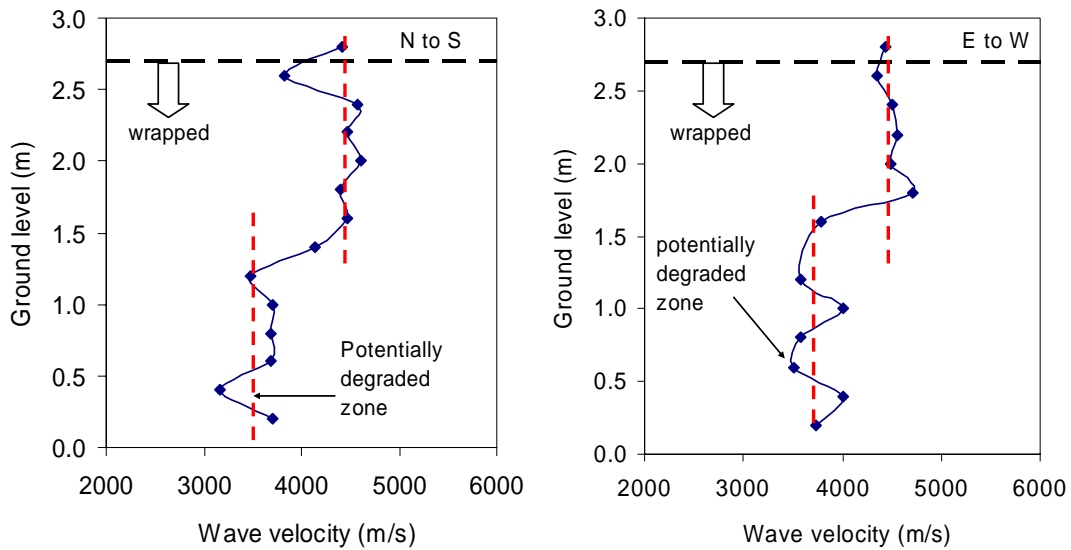
Figure 4.18: Horizontal P-wave velocity profiles in Bridge B-13-144 column H: (a) vertical parallel to traffic and (b) vertical plane perpendicular to traffic.

Finally half cell potential data were collected in Bridge B-13-144 column B during fall 2007. This column was wrapped and there was evidence of distress in the P-wave velocity survey (see Figure 4.18b). Figure 4.36 summarize the half cell potential data results. The data indicate high probability of corrosion. This activity seems to be especially high in the splash zone.

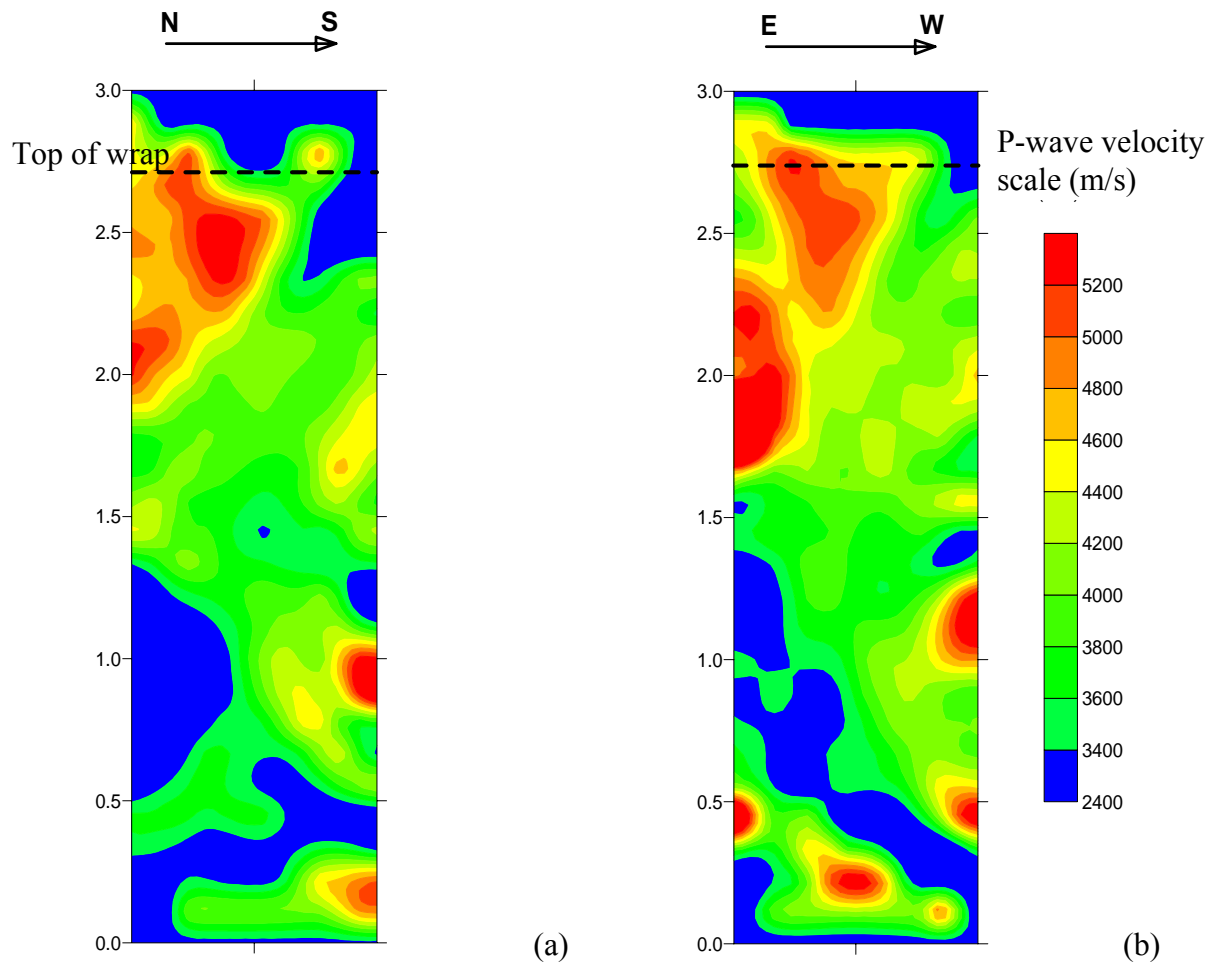
Figure 4.19: Horizontal P-wave velocity tomographic images of Bridge B-13-144 column H: (a) vertical parallel to traffic and (b) vertical plane perpendicular to traffic.

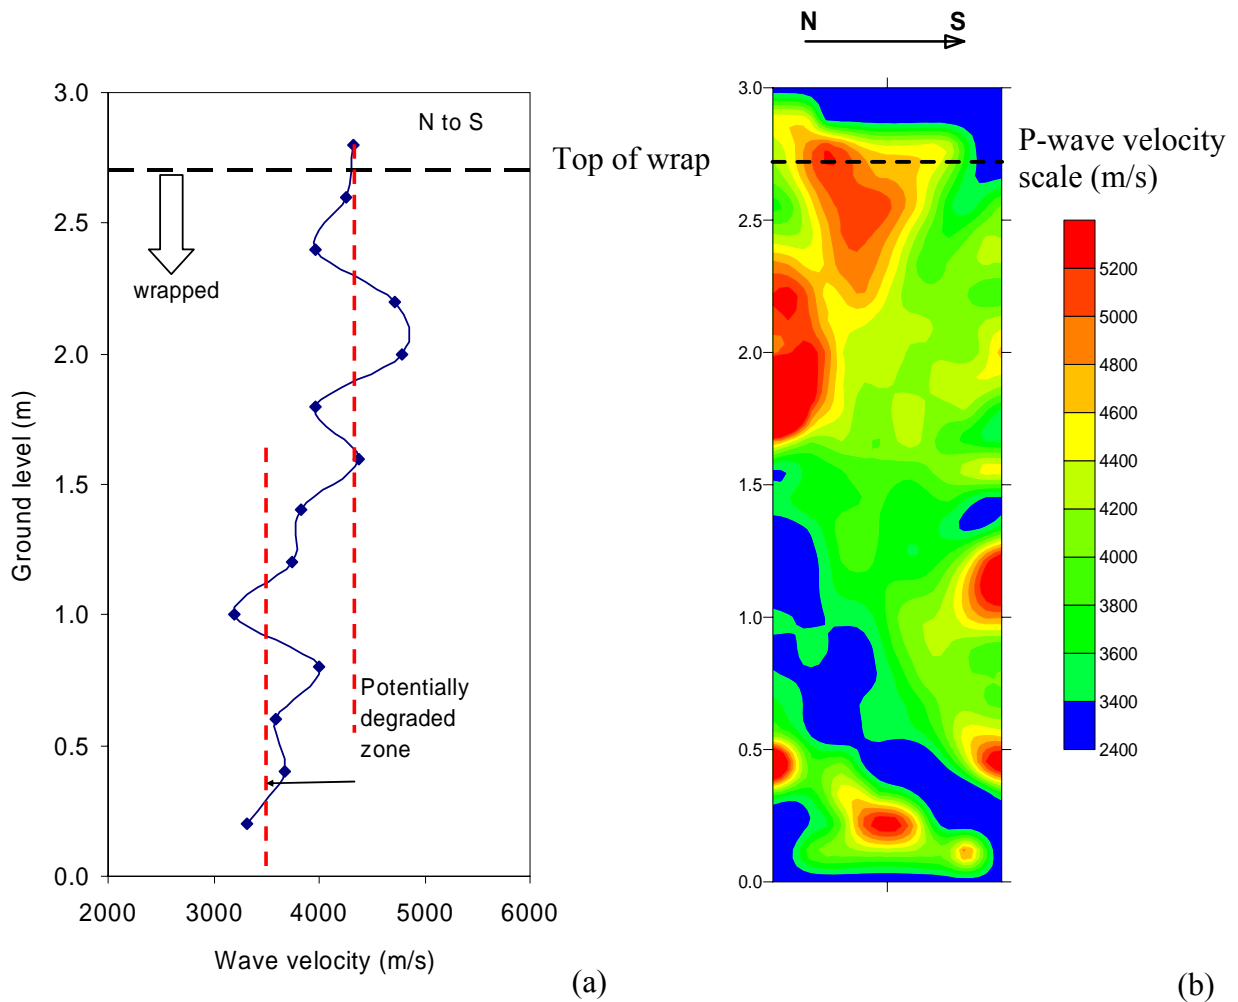
Figure 4.20: P-wave velocity results in Bridge B-13-144 column G along a vertical plane parallel to traffic: (a) P-wave velocity profile and (b) tomographic imaging.

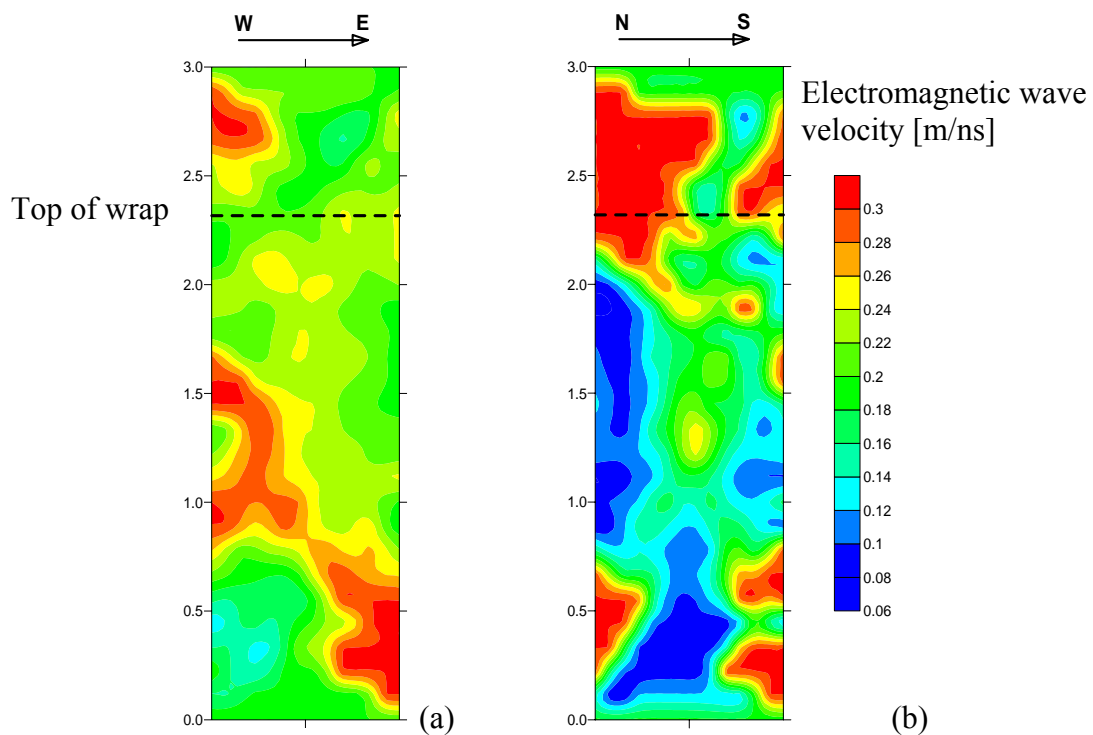
GPR data were collected in all three columns tested columns of Bridge B-28-45 (i.e., columns A, B and C). Figure 4.22 documents the GPR tomographic results along vertical planes: parallel and perpendicular to traffic directions. The lower electromagnetic wave velocity recorded along the midsection on north face of the column (Figure 4.22a) seems to indicate greater volumetric water content behind the fiberglass wrap. The location of this area of high volumetric water content

Figure 4.22: GPR tomographic images of Bridge B-28-45 Column A: (a) parallel to traffic and (b) perpendicular to traffic.

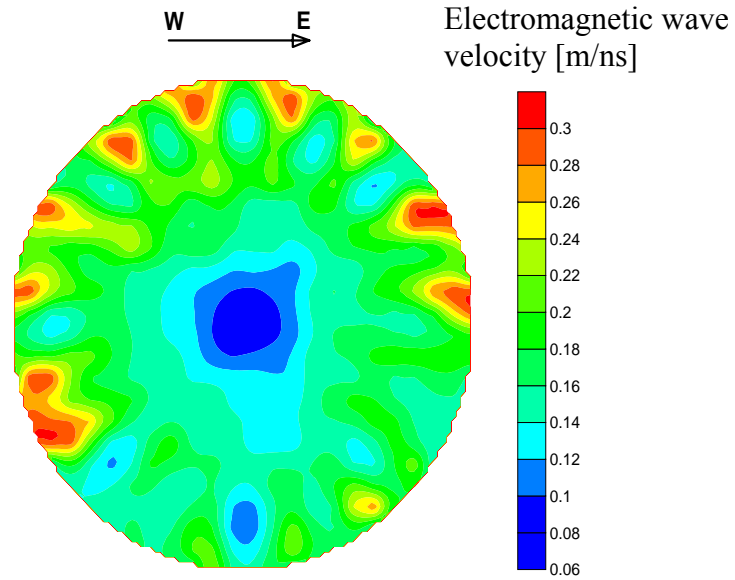
does not seem to coincide with the damaged areas predicted in the same column using the P-wave velocity tomography (see Figure 4.5). Furthermore, the high volumetric water content (that is, low electromagnetic wave velocity) in the cross section tomographic image (Figure 4.23) appears in the center of the column. This observation seems puzzling. Traffic splashing should show higher water content on the concrete surface however the surface may also dry faster.

Figure 4.23: GPR tomographic images of Bridge B-28-45 Column A along 0.4 m high horizontal plane.

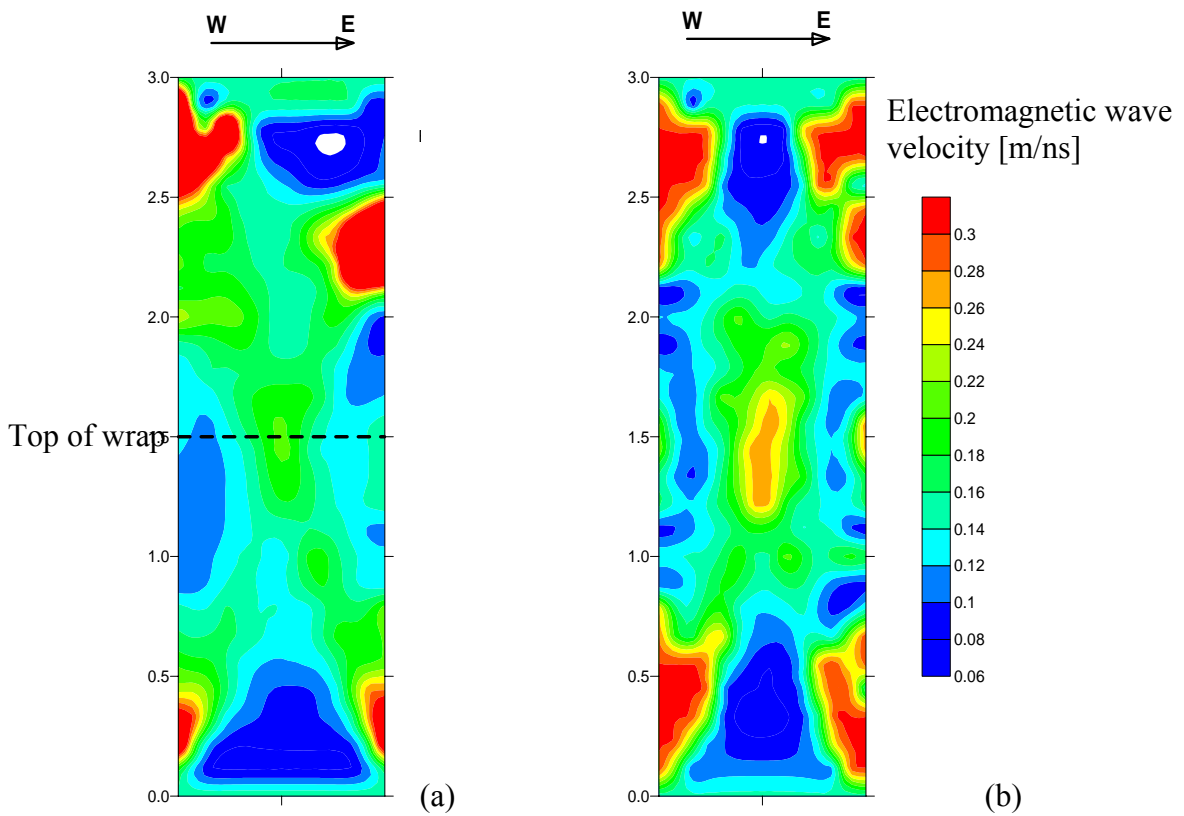
Finally, Figure 4.24 shows the tomographic images of Bridge B-28-45 columns B and C (Column C does not have fiberglass wrap). Once again the results show greater water content areas (that is low electromagnetic wave velocities) at the center of the column in the lower section of the column or the top of column where little splashing would be expected.

Figure 4.24: GPR tomographic images of Bridge B-28-45: (a) column B and (b) column C (parallel to traffic)

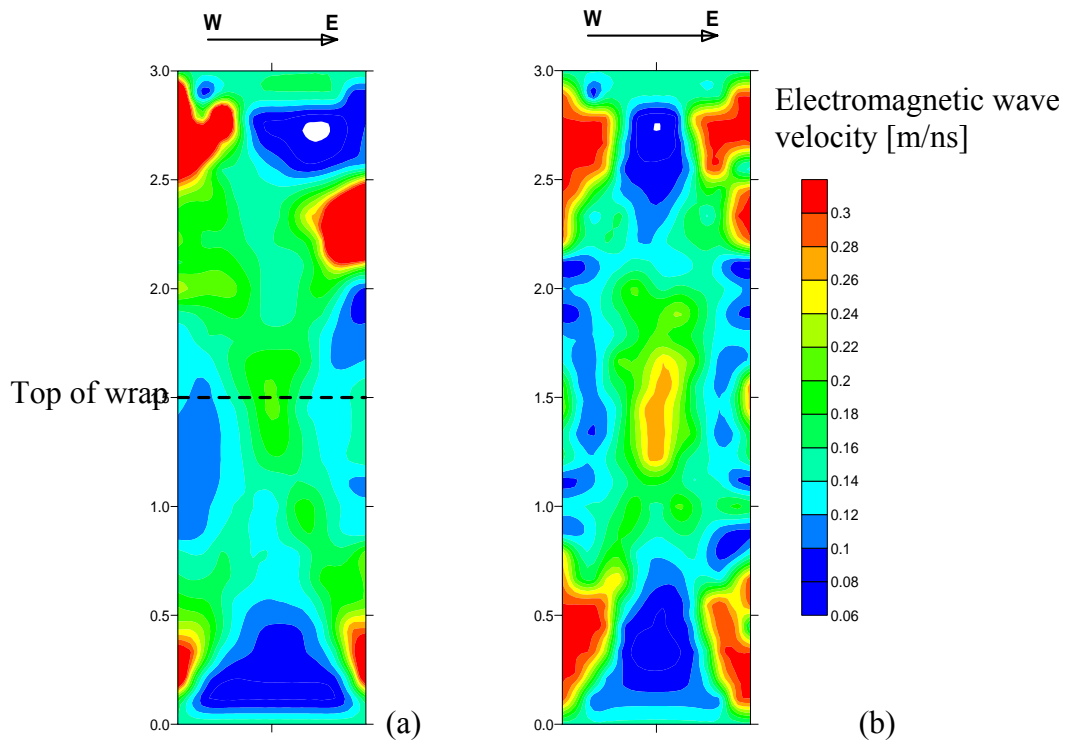
Figure 4.25 shows tomographic images of Bridge B-13-144 columns H and G. Once again puzzling results are obtained. Areas with large water contents (that is, areas with low electromagnetic wave velocities) appear at the center of the column in the lower section of the column or the top of column where little splashing would be expected.

Figure 4.25: GPR tomographic images of Bridge B-13-144: (a) column H and (b) column G (plane parallel to traffic).

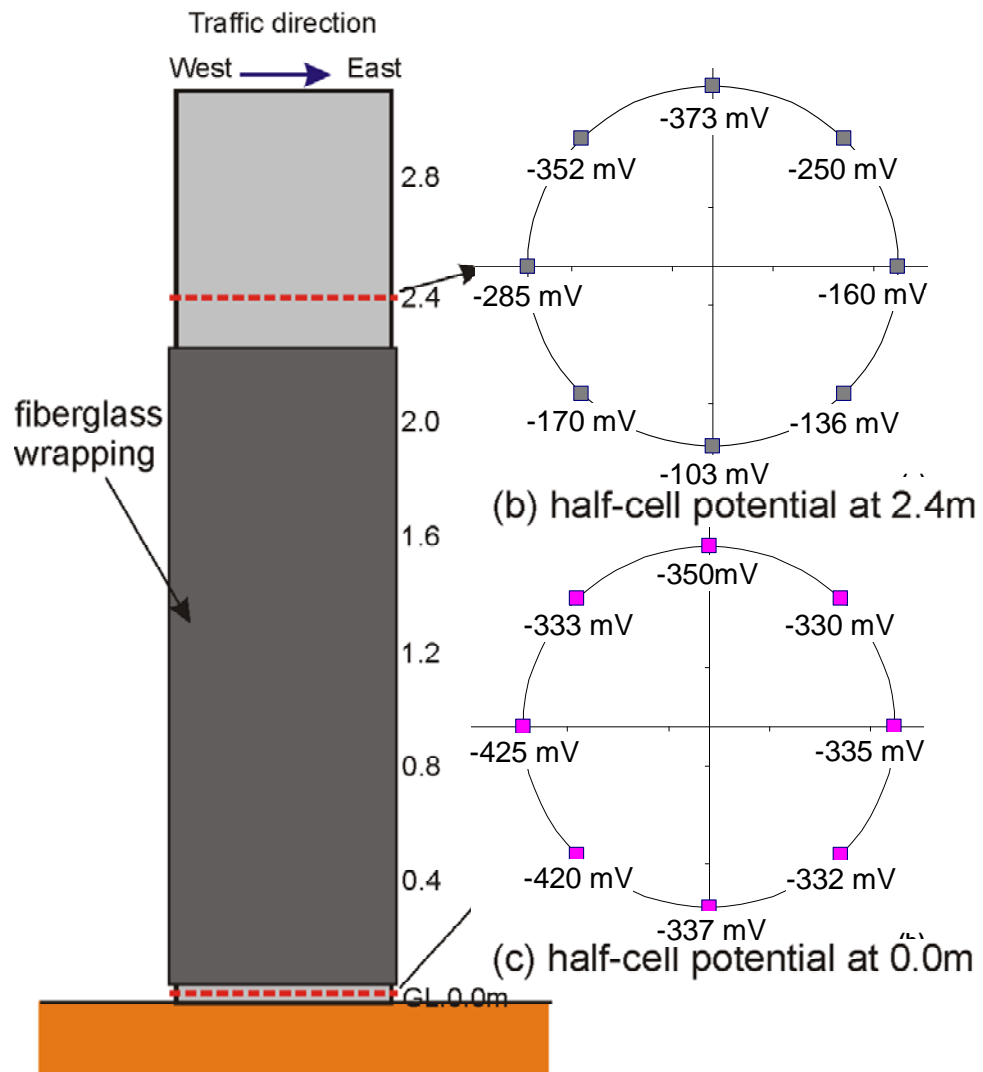
stronger at the bottom of the columns. Similar measurements were performed during the summer 2008. These results are summarized in Figures 4.30 and 4.31 and show a continuation of corrosion activity although the results are somehow smaller. The variation of the results may be caused by several environmental conditions such as changes in column moisture, temperature, etc.

Figure 4.30: Half cell potential measurement in Bridge B-28-45 column A (summer 2008): (a) above wrap and (b) below wrap.

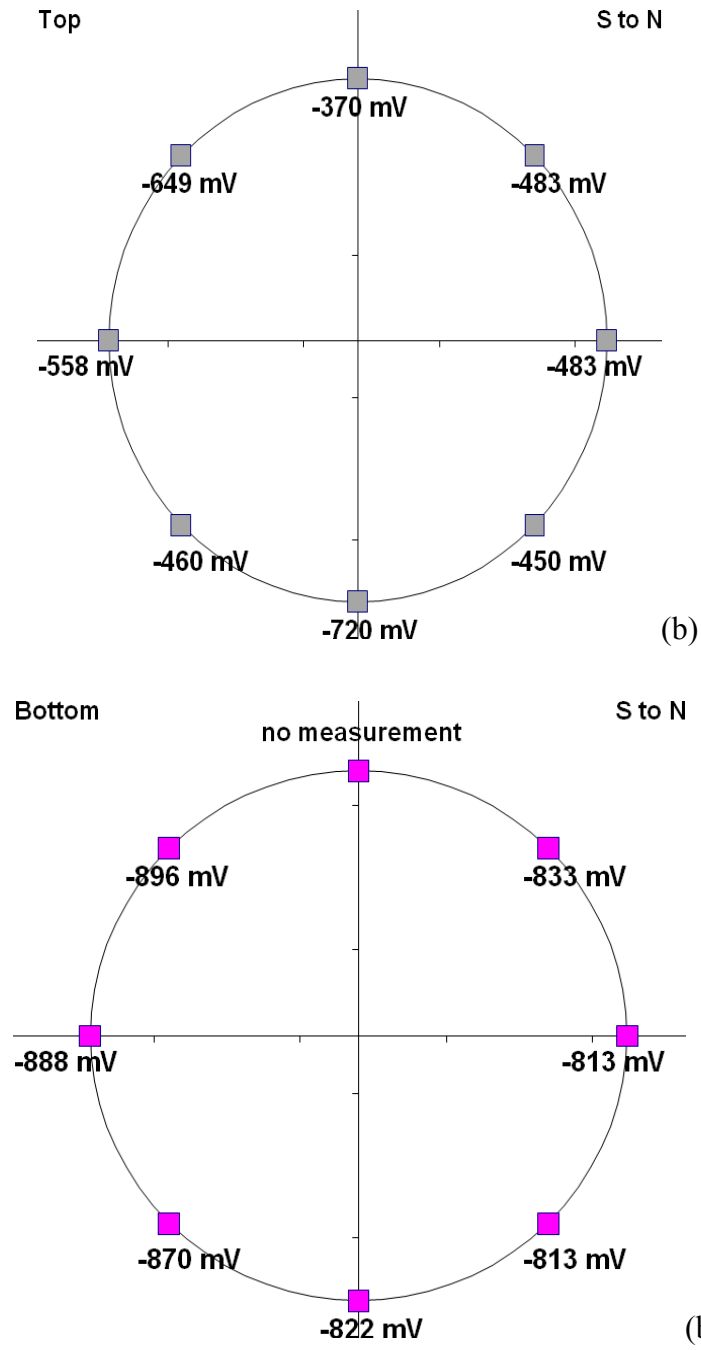
wrap than above the wrap. These data are evidence of the continuing corrosion in spite of the fiberglass wrapping application. These results were confirm using half cell potential data from bridge B-53-71 column C. Figure 4.35 show half-cell data obtained just above and just below the fiberglass wrap. The bottom collected just below the fiberglass wrap show strong evidence of corrosion activity. It seems from these data that moisture and Cl^- are still reaching the columns maintaining the conditions for corrections activity.

Figure 4.35: Half cell potential measurements in bridge B-53-71 column C: (a) just above the fiberglass wrap and (b) just below the fiberglass wrap.
