**Investigation of  
Vertical Members  
to Resist Surficial  
Slope Instabilities**

WHRP 07-03

Wisconsin Highway Research Program Project ID 0092-05-09

Final Report

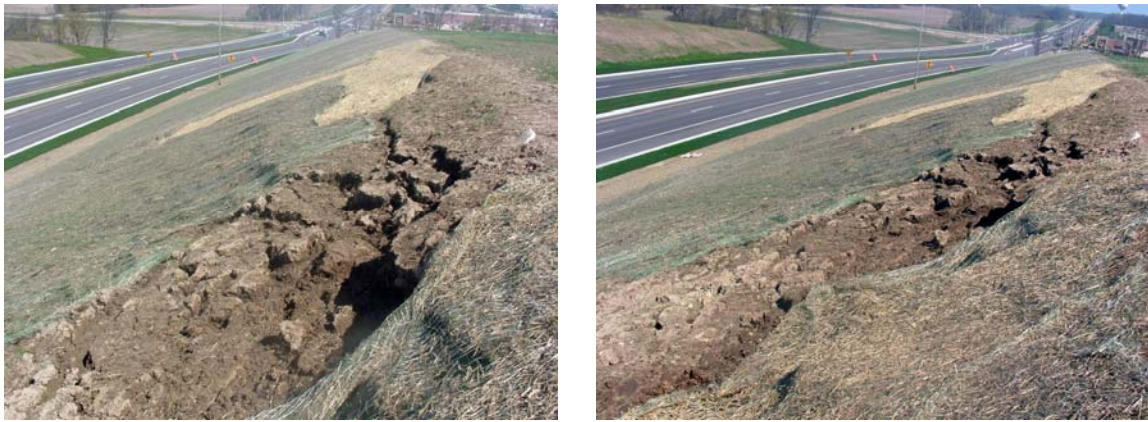
Figure 2.3: Pictures of surficial slope failure along STH-164 in Waukesha County, Wisconsin (cut slope).

of surficial failures. Evans (1972) defined the failure surface depth of shallow slope to be equal to or less than 4 ft. Loehr et al. (2000) characterized the depth of shallow slope failure as less than 10 ft. Field observations by WisDOT engineers at sites of shallow slope failures indicated that the failure surface depth ranges from approximately 2 to 4 ft. The research team performed field measurements of the depth of a shallow slope failure at STH-164 in Waukesha County (Figure 2.3) and found that the average depth of failure surface is about 2 ft.

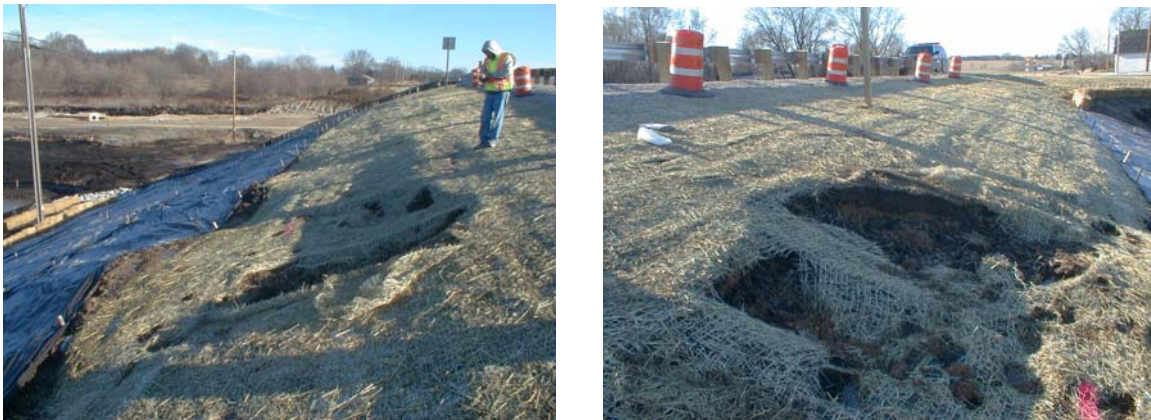
Figure 2.4: Pictures of surficial slope failure along CTH A near Burlington, Wisconsin (embankment slope).

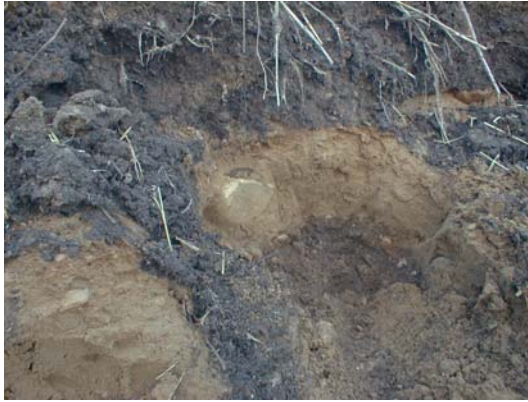
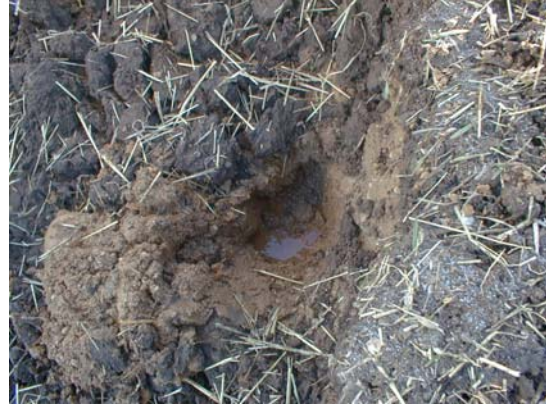
(a) Thin clay layer underlying cohesionless soil

(b) Water accumulated in the hole

Figure 2.9: Shallow slope failure at CTH A near Burlington (a) thin layer of clay underlying cohesionless soil; (b) water perched on clay layer seeping through the soil.

The surficial slope failure on the CTH A embankment near Burlington, Wisconsin is believed to have occurred as a result of saturated surficial soil due to prolonged rainfall and snowmelt. The principal investigator and a WisDOT engineer visited the site of the slope approximately two weeks after the failure. They noticed that the surficial soil of the slope was fully saturated with frozen water in some locations. As shown in Figure 2.9a, there is a cohesionless soil layer below the clay blanket, which comprises the top soil cover of the slope. Below the cohesionless soil is a thin clay layer with apparent lower permeability. This layer may act as a drainage barrier, allowing the water to perch on it and rise in the upper surficial soil. When the team excavated a small hole in front of the cohesionless soil layer, water filled the hole very quickly, indicating the abundant presence of water, as shown in Figure 2.9b. When the water rose in the upper surficial soil, the shear strength of the soil was reduced, causing the instability of the surficial soil.

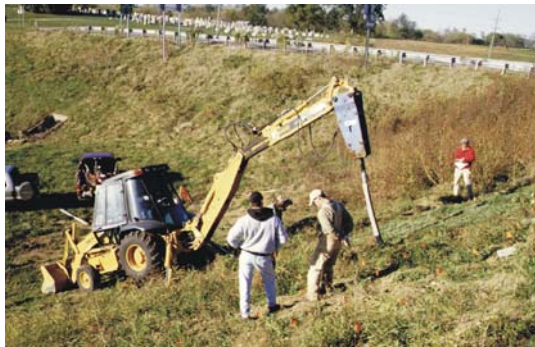
Figure 2.15: Installation of recycled plastic pins to stabilize surficial failures (after Loehr et al., 2000).

Installation of recycled plastic pins can be achieved by different methods. Sommers et al. (2000) used the modified pavement breaker and the pseudo vibratory driving system for vibratory installation of recycled plastic pins to stabilize shallow slope failures. Figure 2.15 depicts installing recycled plastic pins to stabilize shallow slope failures.

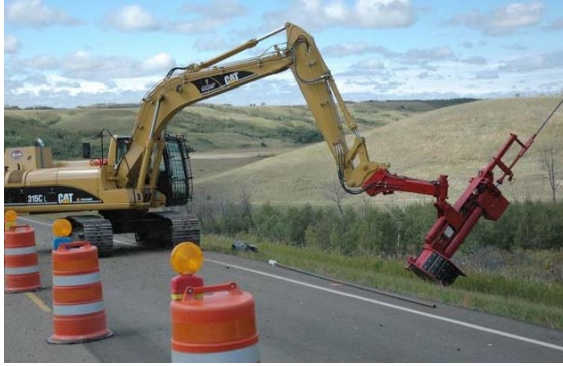
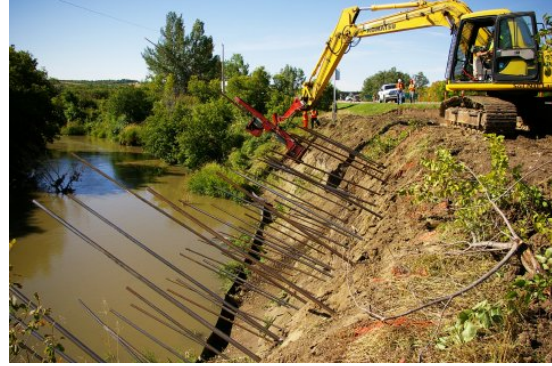
(a) Soil nail launcher

(b) Installation of launched soil nails

Figure 2.16: Soil nail launcher used to repair slope failures (SNL, 2007).

Launching soil nails is a proprietary method of Soil Nail Launcher, Inc., which was recently introduced. In this method, soil nails are inserted into the slope face at a high speed utilizing high pressure compressed air. The device that launches the nail is called the soil nail launcher (SNL), which can be attached to the end of an excavator, as shown in Figure 2.16a. Installing launched soil nails is depicted in Figure 2.16b. Typical soil nails can be solid or hollow steel bars. Galvanized soil nails also can be used in highly abrasive environments because they provide resistance to corrosion. Typical dimensions of hollow non-galvanized steel bars are an outer diameter of 1.5 in. (0.12 in wall thickness) and length of 20 ft., as shown in Figure 2.17. The minimum yield strength of the steel bars is 36 ksi. After installing launched soil nails, the slope surface can be treated with erosion mat, steel mesh, and shotcrete. Figure 2.18 shows a slope stabilized with launched soil nails.

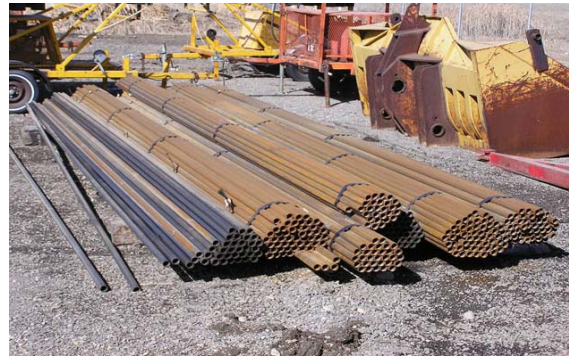
Figure 2.17: Launched soil nails of 1.5 in. diameter and 20 ft. in length (SNL, 2007).

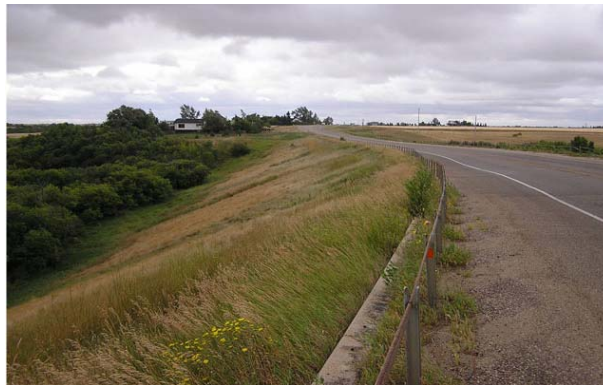
Figure 2.18: Highway 363 slope south of Moose Jaw, Saskatchewan, was stabilized with launched soil nails (SNL, 2007).

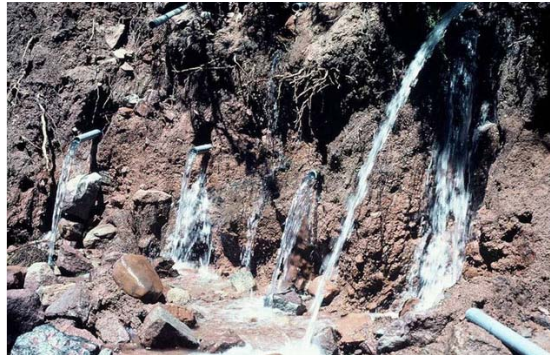
Figure 2.19: Horizontally launched hollow perforated nails act as drains (SNL, 2007).

Hollow perforated nails also can be used as horizontal drains to remove water from slopes and prevent development of pore water pressures that lead to reduced soil strength, as shown in Figure 2.19.

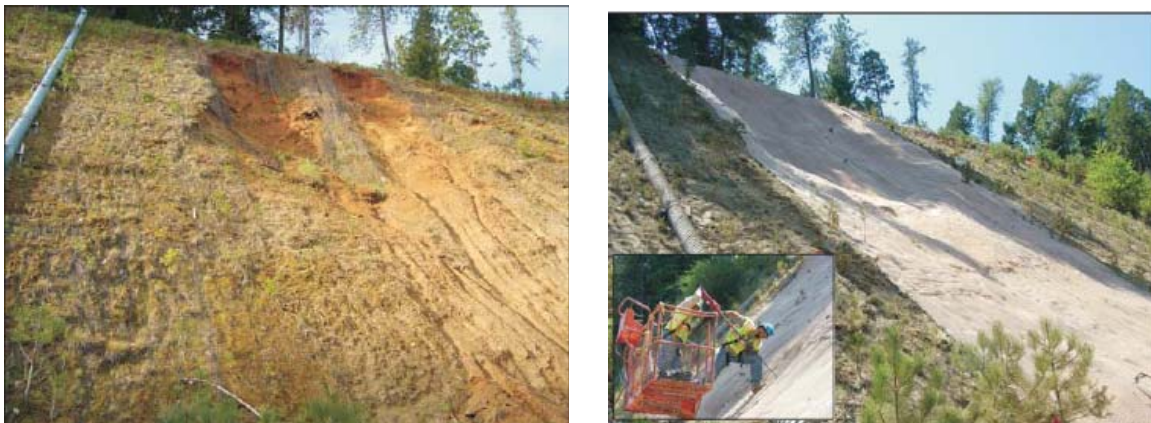
(a) Surficial slope failure

(b) Slope repair using earth anchors

Figure 2.24: Slope failure and repair along the Highway 26 cut slope in Calaveras County, CA, (Platipus, 2007).

Earth anchors are used to stabilize a surficial failure along the Highway 26 cut slope. The 1H:1V slope failed after a heavy rainy season. Figure 2.24a depicts the shallow slope failure. The Platipus S4 anchor was used to repair the shallow slope failure. The construction was fast and simple and at 5 ft. spacing. It was reported that Caltrans (California DOT) was satisfied by this repair method, particularly the speed and simplicity of construction (Platipus, 2007). Figure 2.24b depicts the repaired slope.

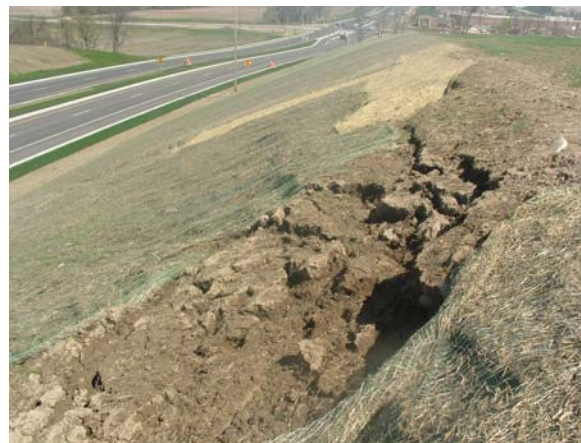
(c) Picture of the shallow slope failure

Figure 2.26: Shallow slope failure of the reconstructed STH 164 at Sta. 299+00.

A shallow slope failure was observed about four months after the slope was graded. An initial field survey showed that the failure occurred on the east side of the road with an approximate length of 300 ft. The failure consisted of a surficial topsoil layer sliding down the face of the slope, which was sparsely vegetated when the slide occurred. The slope failure occurred in an earth cut section and continued to worsen during the spring thaw until it covered two thirds of the slope length from the top. Figure 2.26b shows details of the slope failure and Figure 2.26c depicts the failure. A field investigation and survey were conducted to collect information and soil samples at the slope failure site. Field observations showed that the soil was wet, with moisture content variation between 28 and 32%. Water was allowed to sheet drain over the face of the slope.

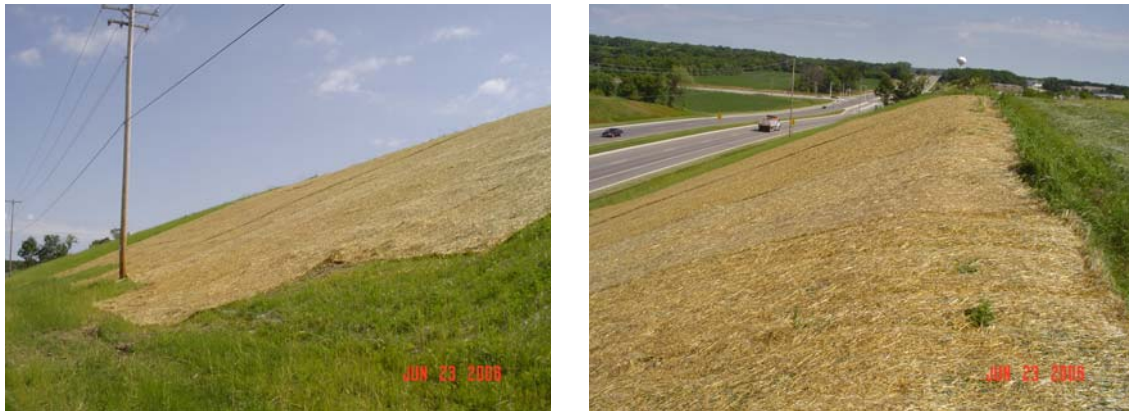
Figure 2.27: Pictures of the repaired shallow slope failure at STH-164.

Repair of the failed area was conducted about six months after the slope failure occurred. The failed material was left to dry and the slope was then re-graded to the pre-failure grades using a small bulldozer. After regrading, the slope was seeded and covered with an erosion control mat. Thereafter, measurement of the topsoil depth was performed by pushing a steel probe manually at 3-ft. intervals. Topsoil depth ranged from approximately 5 to 18 in. Within several weeks of repairs, vegetation was growing on the slope face. Currently, vegetation continues to grow and further failures have not been observed. Figure 2.27 depicts the repaired slope.

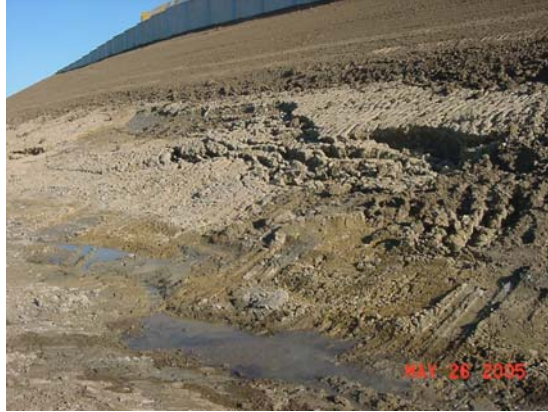
Figure 2.28: Shallow slope failure at STH-16 with water seeping out of the slope face.

The slope failure consisted of the surficial topsoil layer sliding down the face of the slope. The failure surface generally was parallel to the face of the slope and the underlying stable material and also resembled an infinite slope failure. During the original grading activities in the failure area, a significant amount of seepage was observed from the cut slopes onto the face of the slope. Figure 2.28 depicts the slope failure.

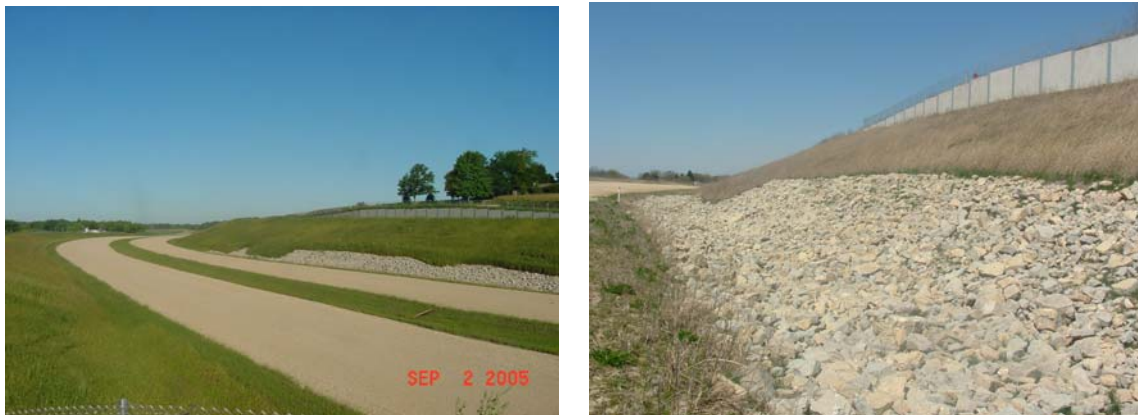
Figure 2.29: Riprap repair of shallow slope failure at STH-16.

The slope was repaired shortly after failure by removing the failed soil mass and replacing it with a layer of riprap or other large stone. Typically, a heavy riprap geotextile is placed on the slope prior to the riprap placement. A “keyway” typically is excavated at the toe of the slope prior to placement of the riprap. The “keyway” stabilizes the mass of riprap. The original slope configuration was not changed during repair and repeat slope failures have not occurred. Figure 2.29 shows a picture of the repaired slope. This repair method is generally effective, although it has the potential to cause additional failures if used incorrectly. One case of potential failure is when the underlying soil is weak and soft and it cannot resist the increased driving forces from the riprap. This method is not considered visually appealing.

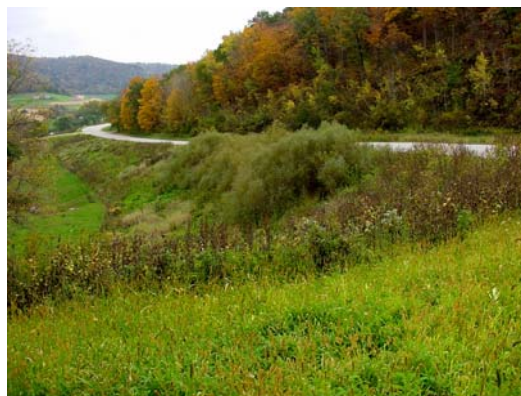
(b) Stabilized slope

Figure 2.30: Live staking application at County Trunk Highway K.

The live staking (shown in Figure 2.30) used on CTH K has worked well. The slopes remain stable and water seeping from the face of the slope no longer is observed. The live staking reinforced the soils and increased the factor of safety of the slope.

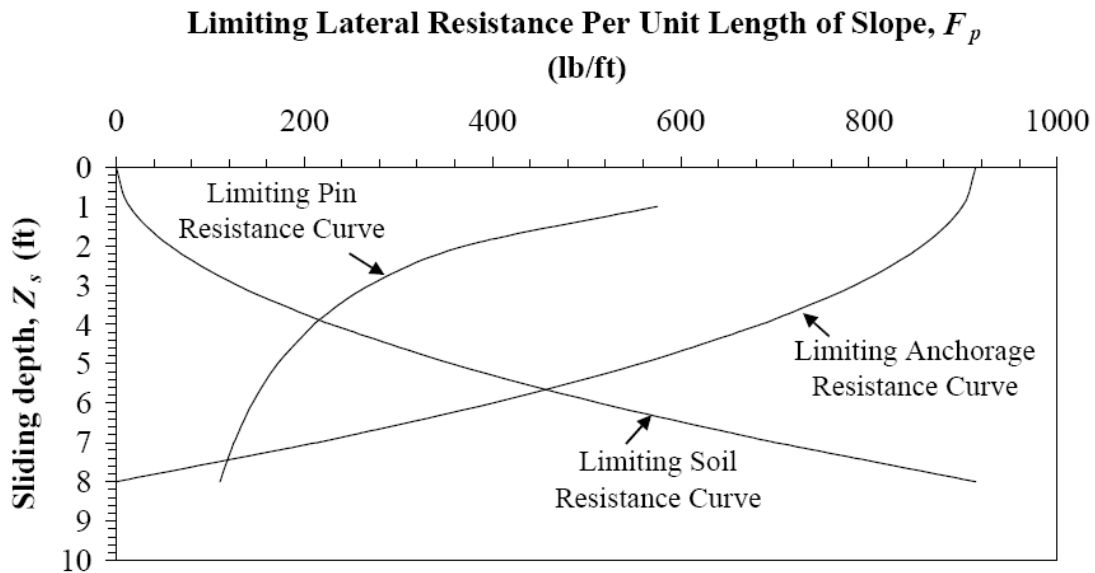
Figure 3.5: Typical distributions of limit resistance developed for the three limit states considered (After Loehr et al., 2004).

Separate limit resistance curves can be developed for each limit state (failure mode), as illustrated in Figure 3.5. These limit resistance curves are dependent on soil type and reinforcing element strength and stiffness. From these individual curves, a “composite” limit resistance curve that corresponds to the most critical component of resistance at each sliding depth is established by taking the component with the least resistance (i.e., the critical failure mode) at each sliding depth.

The distribution of limiting resistance for the anchorage limit state can be calculated by computing the total resisting force for different sliding depths (Figure 3.5). The limiting resistance for Failure Mode 2 increases from zero for a sliding surface passing through the lower end of the reinforcement (no anchor) to a maximum for very shallow sliding surfaces, as shown in Figure 3.5. Figure 3.8b shows the calculated limit resistance curve for Failure Mode 2.

The factor  $\alpha$  is a function of the sliding depth because the distribution of moment, and the maximum moment are functions of the sliding depth. Thus, the process is repeated for different sliding depths to establish a limit resistance curve for Failure Mode 3, as shown in Figure 3.5. A similar approach is used to consider shear. Nevertheless, Loehr et al. (2004) indicated that bending moments are the controlling factor for recycled plastic members. Additional details regarding the calculation of  $\alpha$  are provided in Loehr and Bowders (2003).

A “composite” limiting resistance curve that accounts for all of the failure modes is obtained by taking the least of the three limit resistance curves shown in Figure 3.5. Such a curve is shown in Figure 3.10. This composite curve then is used in a conventional slope stability analysis to determine the factor of safety for a reinforced slope.

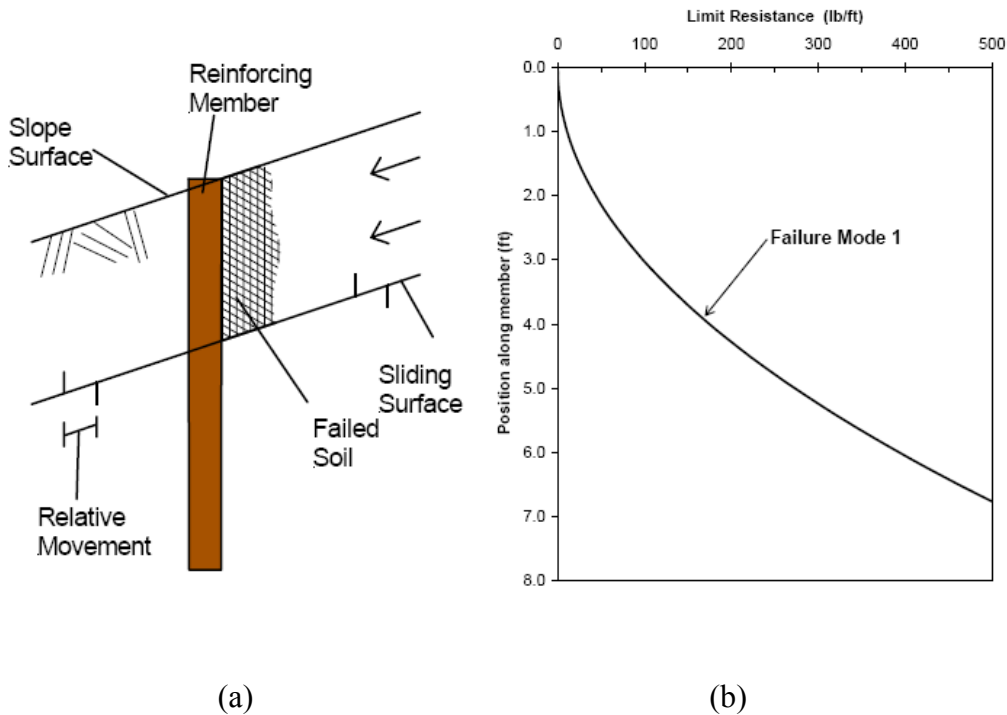
Figure 3.6: (a) Schematic illustrating Failure Mode 1 and (b) Limit resistance curve for failure mode 1 (Loehr & Bowders, 2007).

This mode considers failure of the soil above the sliding surface in which the sliding soil flows around or between reinforcing members, as depicted in Figure 3.6a. To calculate the limit resistance for this failure mode, the lateral pressure at which failure of the soil will occur must be estimated. This pressure is referred to as the “limit soil pressure” and is denoted  $p_u$ . The method proposed by Ito and Matsui (1975) is used here to calculate the limit soil pressure. This method is versatile - it can be extended to members composed of non-conventional materials. The method also is conservative. Other methods available for calculating the limit soil pressure generally are based on load tests for full-scale conventional steel and concrete piles, which are considerably different in size and

To establish a complete limit resistance curve describing the total resistance for Failure Mode 1 as a function of sliding depth (Figure 3.5) the sliding surface is assumed to intercept with the reinforcing element at different depths. For each depth, the total limit resistance force is calculated by integration, as described above. It is noted from Figure 3.5 that the total resistance increases from a minimum value at the ground surface to a maximum value at the tip of the reinforcing element. Figure 3.6b shows the calculated limit resistance curve for Failure Mode 1.

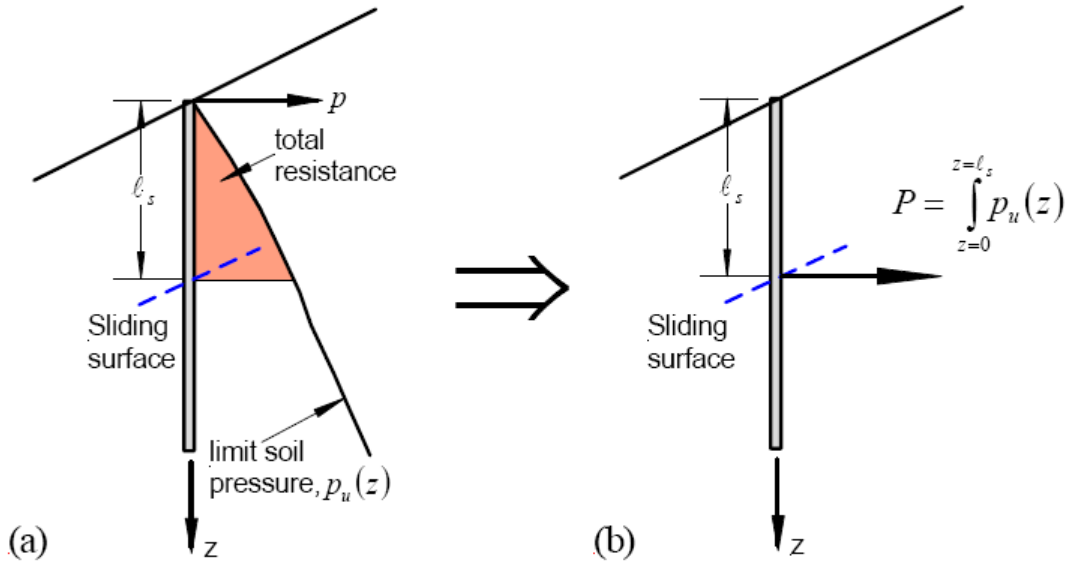
Figure 3.7: Schematic illustrating calculation of limit resistance force: (a) limit soil pressure and (b) equivalent lateral resistance force (after Loehr et al. 2007).

Again, the limit soil pressure will cause the soil to fail laterally. This limit pressure is dependent on the vertical effective stress that varies with depth. Assuming that the limit soil pressure is mobilized simultaneously along the length of the reinforcing member above the sliding surface, the total limit resistance (Failure Mode 1) can be obtained by integrating the limit soil pressure over the length of reinforcement above the sliding surface, as shown in Figure 3.7. This total limit resistance force is assumed to act at the sliding surface, as shown in Figure 3.7b. This makes it simply accounted for in a stability analysis.

where  $M_{max}$  is the maximum moment determined from elastic analyses and  $M_{ult}$  is the moment capacity of the member. The factor  $\alpha$  is then applied to the limiting soil pressures (Equation 3.5) to determine the factored pressures to avoid structural failure of the reinforcing member in bending. The limit resistance is computed using the factored pressure distribution in a manner similar to that used for the other limit states considered (Figures 3.7 and 3.9).

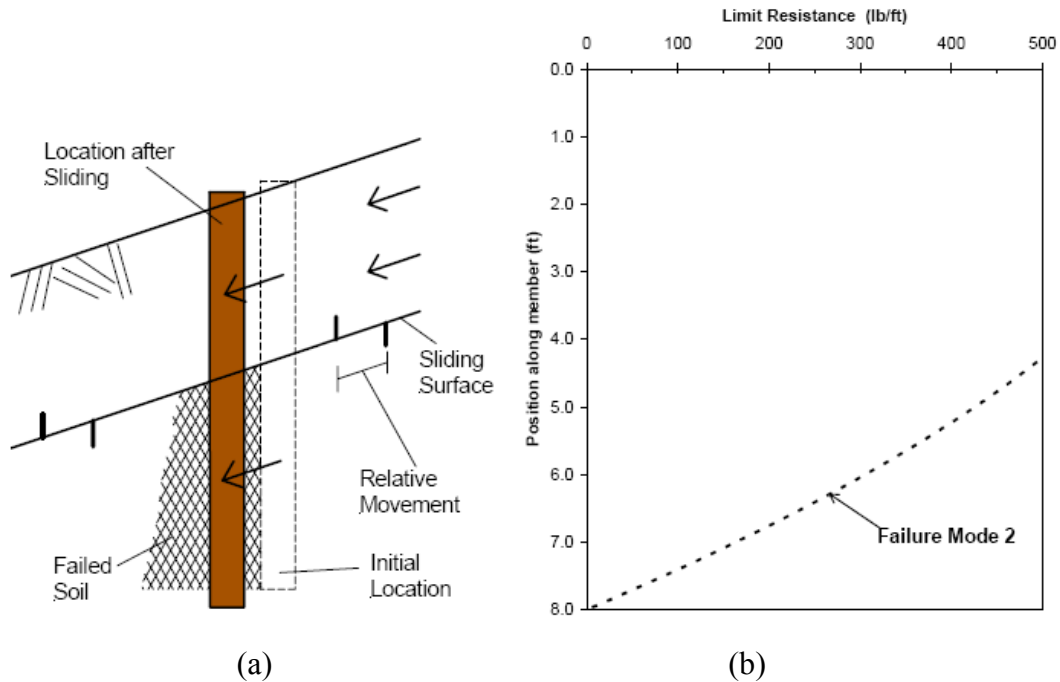
Figure 3.8: (a) Schematic illustrating Failure Mode 2 and (b) Limit resistance curve for Failure Mode 2 (Loehr & Bowders, 2007).

In this mode, the soil below the sliding surface is assumed to fail while the reinforcing member is anchored in the moving soil above the sliding surface, as shown in Figure 3.8a. The limit state considers insufficient anchorage length of the reinforcing member beyond the sliding surface that provides passive resistance equal to or greater than that exerted by the sliding soil mass on the part of the reinforcing element above the sliding surface. The passive failure of the soil below the sliding surface is assumed to be governed by the same limit soil pressure ( $p_u$ ) used for Failure Mode 1 and a similar procedure is used to calculate the limiting anchorage resistance. This is calculated by integrating the limiting soil pressure ( $p_u$ ) over the length of the reinforcing element extending from the sliding surface to the tip of the member, as shown by the shaded zone in Figure 3.9. Again, it is assumed that the full limiting soil pressure is mobilized over the entire length of the reinforcing member below the sliding surface. The total resisting force for a particular sliding depth also is replaced with an equivalent force for stability analysis (Figure 3.9b).

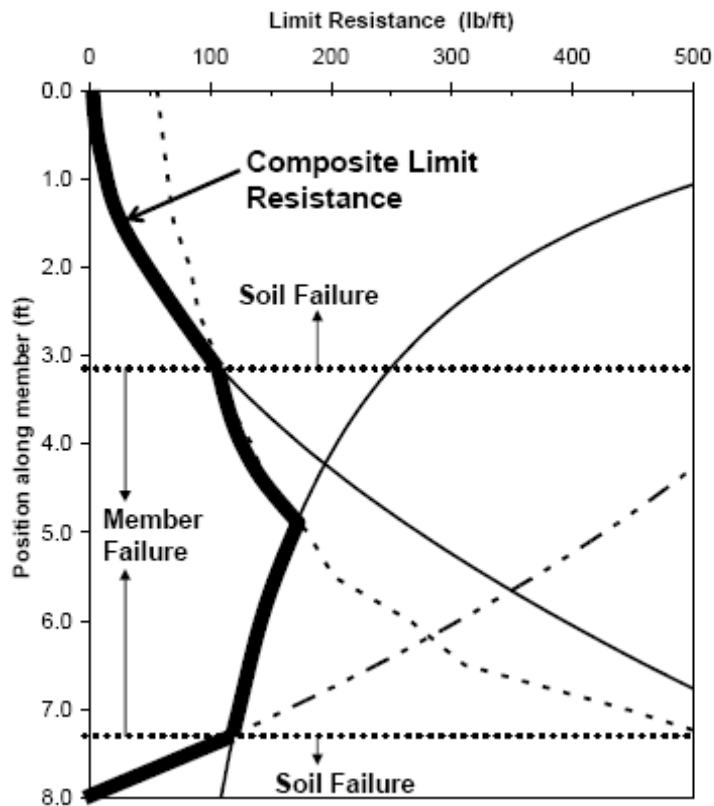
Figure 3.10: Composite limit lateral resistance distribution for recycled plastic reinforcing member (After Loehr & Bowders, 2007).

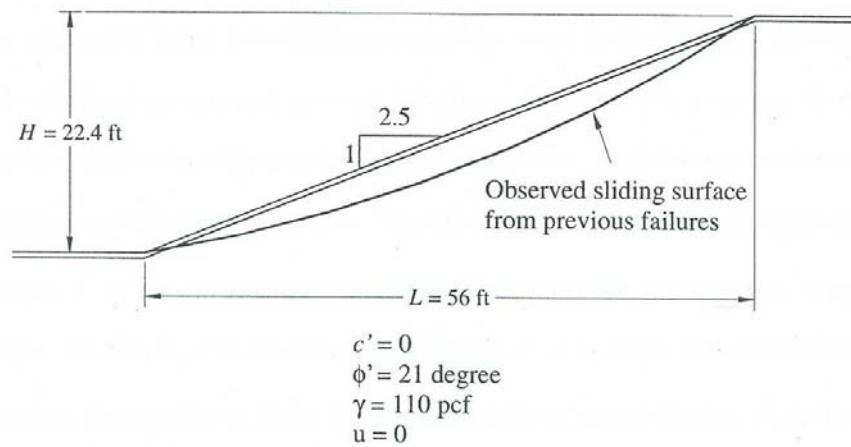
Figure 3.13: Estimated slope geometry and conditions and the observed sliding surface used in the analysis (after Liew, 2000).

Based on field observations, Liew (2000) used the slope geometry and soil properties and conditions shown in Figure 3.13 to conduct his analysis. The slope was analyzed with the observed sliding surface and no presence of pore water pressures ( $u=0$ ) and with assuming the presence of 0.5 ft. upper cohesive soil layer ( $c \approx 50$  psf). By considering the un-reinforced slope condition, it was determined that for  $FS = 1$  the lower soil should have  $\phi' = 20.4^\circ$  and  $c \approx 0$ . Subsequent analysis was conducted to design a slope reinforcement scheme using  $\phi' = 20.4^\circ$ ,  $c \approx 0$ , and  $u=0$ .

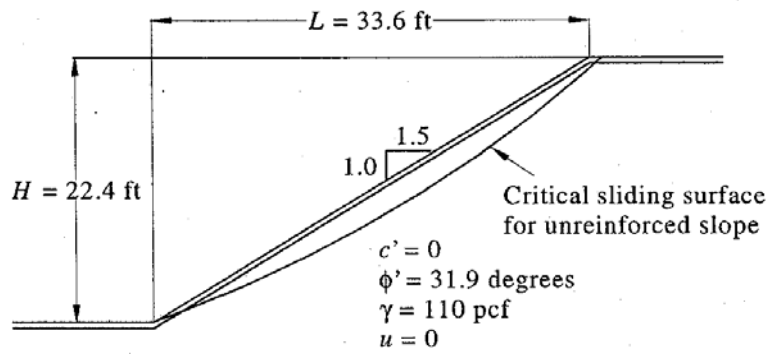
(a) Steep slope

(b) Intermediate slope

(c) Flat slope

Figure 3.16: Slope geometries and soil and site conditions assumed in the parametric study (after Liew 2000).

Slope geometries of 1.5H:1V, 2.5H:1V, and 3.5H:1V were investigated to determine the influence of slope inclination on the factor of safety. The analysis was conducted on slope geometries, soil properties, and conditions shown in Figure 3.16. Soil properties were back-calculated assuming each un-reinforced slope has a factor of safety  $FS=1$ . Results of the parametric study are presented in Table 3.3. The results indicate that the factor of safety generally increases when the transverse spacing decreases for a given longitudinal spacing. In addition, the results suggest that slope reinforcement with structural members significantly improves the factor of safety for steeper slopes at a higher degree compared with flatter slopes with reinforcing members installed at the same spacing.

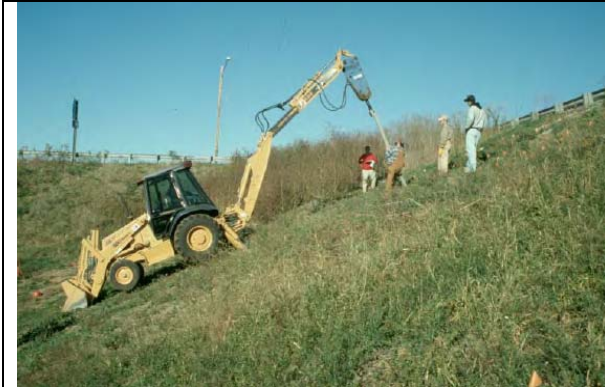
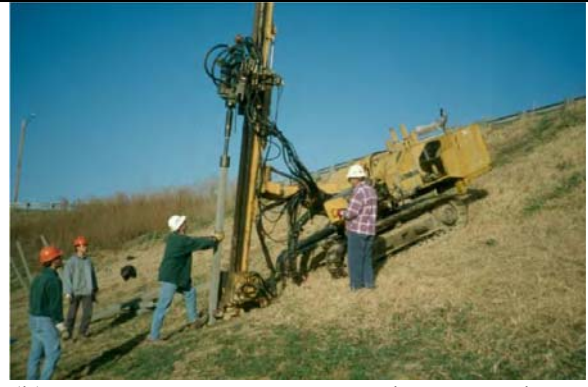
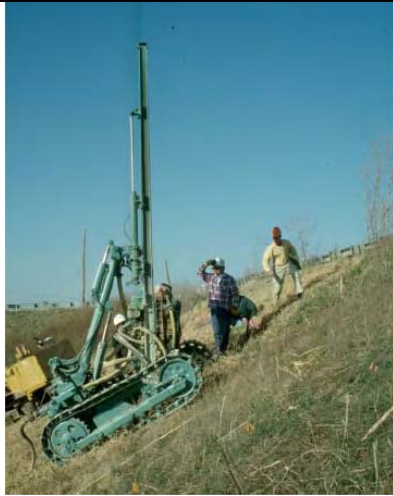
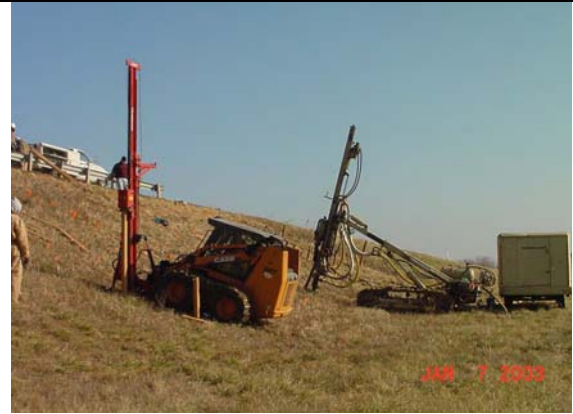
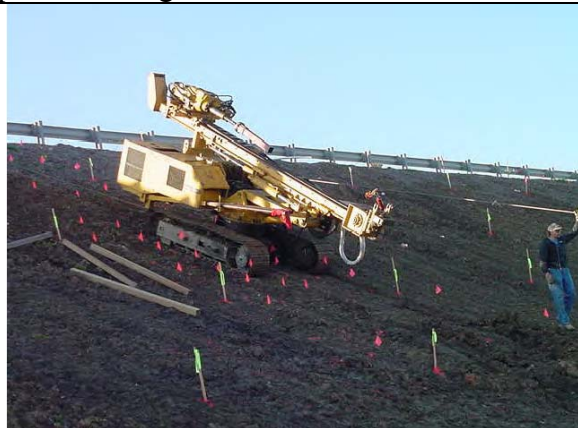
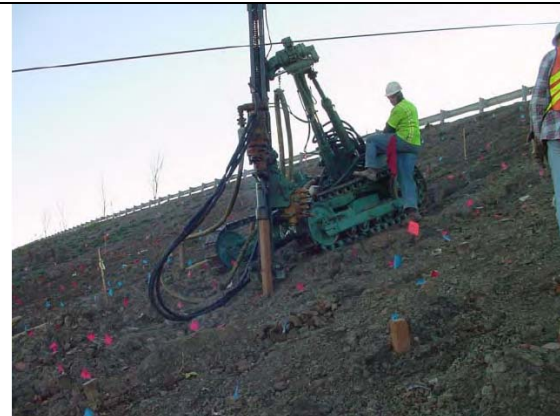
(a) Backhoe mounted hammer

(b) Davey-Kent DK100B track-mounted hydraulic rig

(c) Ingersoll Rand CM150 track-mounted pneumatic rig

(d) Ingersoll Rand ECM350 pneumatic hammer drill (background) and drop-weight hammer rig (foreground)

(e) Davey-Kent DK100B track-mounted hydraulic rig

(f) Ingersoll Rand CM150 track-mounted pneumatic rig

Figure 3.18: Equipment used to install plastic pins, steel pipes, and wooden posts at different sites of surficial slopes failures in Missouri (after Loehr and Bowders, 2007).

Loehr et al. (2000) and Loehr and Bowders (2007) presented a comprehensive analysis of the reliability and performance of construction methods and the equipment used for surficial slope stabilization using plastic, steel pipes, and wooden structural members. Table 3.12 summarizes their study, in which different equipment types were used to stabilize five surficial slope failures in Missouri. The equipment is depicted in Figure 3.18. Based on this study, Loehr and Bowders (2007) reached the following conclusion:

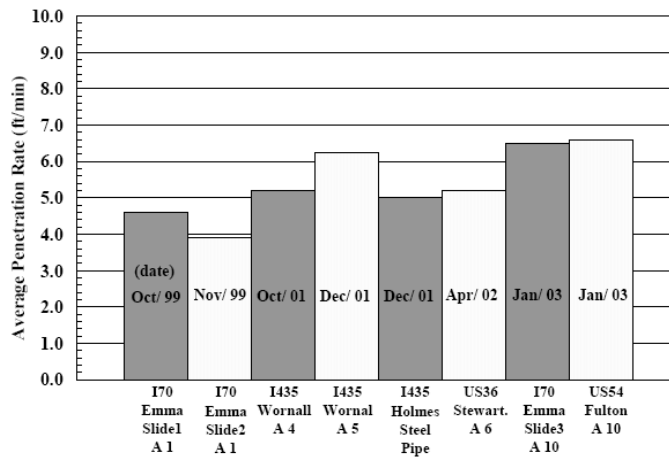
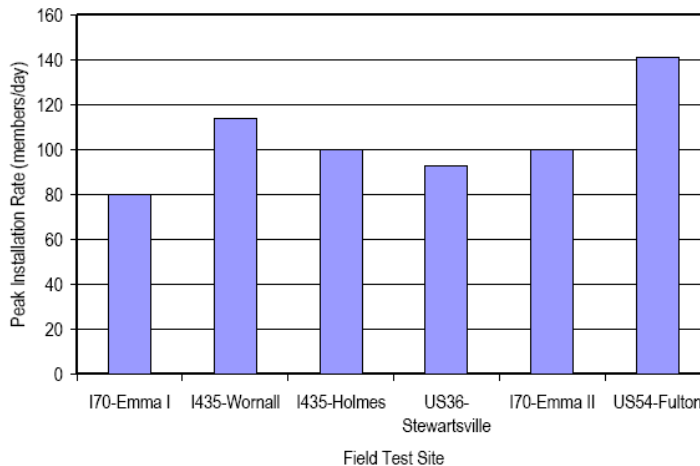
(a) Average penetration rates

(b) Peak installation rates using one installation rig

Figure 3.19: Performance of installation structural members used in the stability of surficial slope failure (after Loehr and Bowders 2007).

- Different equipment types were used successfully to install structural members (recycled plastic pins, steel pipes, and timber posts) of relatively small size. The equipment comprised some form of a percussion or impact hammering device to install the members in the ground.
- The average penetration rates (set up time not included) observed were about 6 ft./min. and peak installation rates exceeded 140 members per day for a single piece of equipment. The approximate average penetration rates are 4 ft./min. (~100 members/day). Figure 3.19 shows the installation performance in terms of the penetration rates.

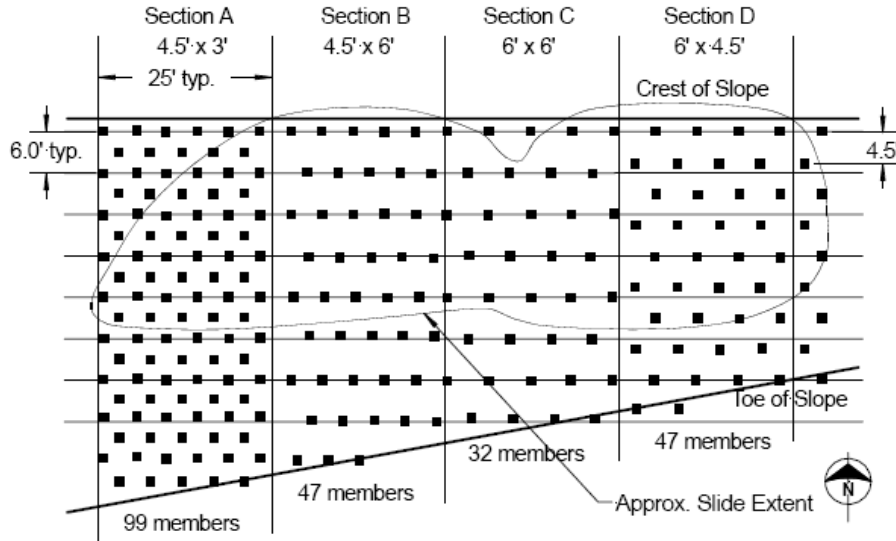
Figure 3.22: Plan view of selected stabilization schemes for slide area S3 at the I-70 Emma test site (Loehr and Bowders, 2007).

Failure areas S1 and S2 were stabilized in November 1999 while failure areas S3 and S4 were regraded to the original slope and established as control sections. Monitoring of the slope showed that areas S1 and S2 stabilized with 3 ft.  $\times$  3 ft. square plastic pins performed very well while control sections S3 and S4 failed in spring 2001. Additional stabilization was carried out for failure area S3 using more widely spaced patterns, as presented in Figure 3.22. Slide area S4 was regraded again to its original slope and maintained as a control section.

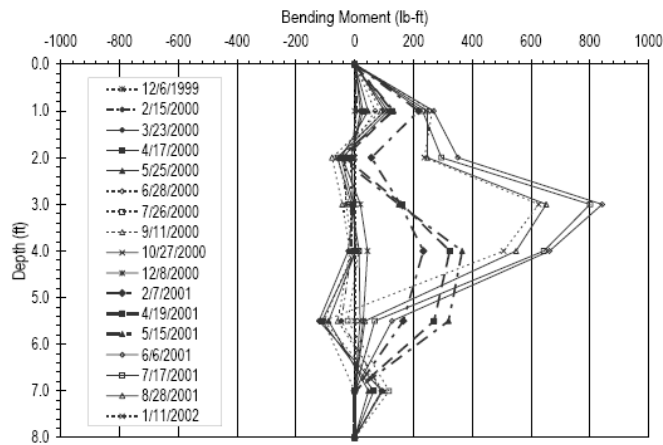
Figure 3.25: Measured bending moments in instrumented member IM-H at I-70 Emma test site during Phase I (Loehr and Bowders, 2007).

Field performance data for slide areas S1, S2, and S3 from November 1999 to December 2002 were collected and analyzed. The data suggests that significant initial stresses and moments were developed in the members due to installation. The distribution of axial stresses in one of the instrumented members is presented in Figure 3.24. The distribution of bending moments in another instrumented member is depicted in Figure 3.25. As shown in both figures, the distribution of axial stresses and bending moments is parabolic, with maximum values near the mid-member point and negligible values at the member ends.

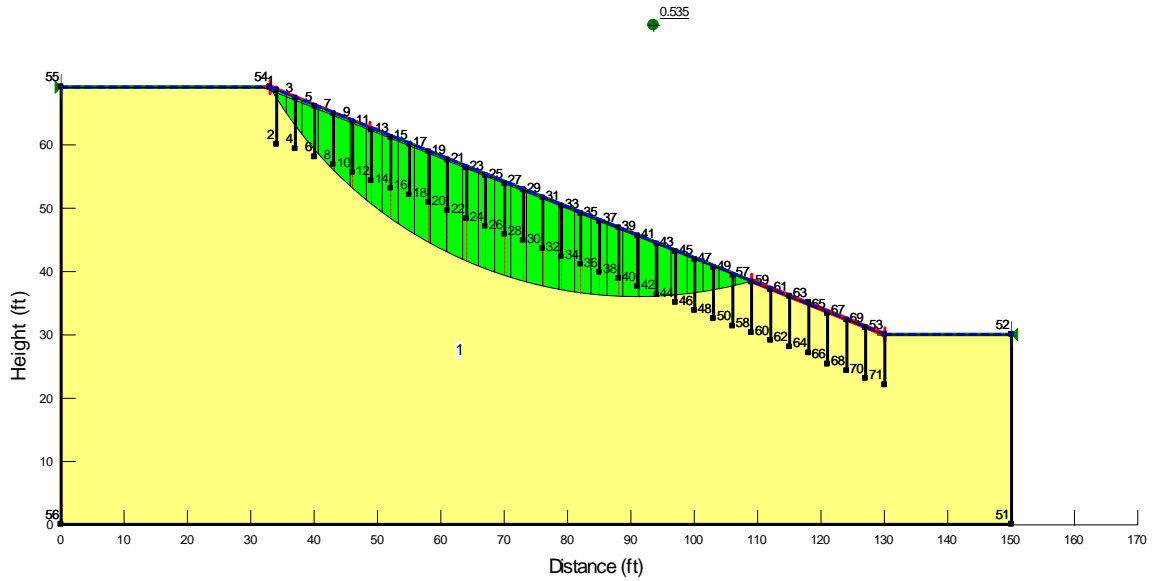
Figure 3.36: Slip surface of STH-164 slope that consists of a saturated homogenous soil layer ( $\phi' = 20^\circ$ ) reinforced with 8-ft. vertical structural members.

The effect of installing a structural member on the stability of surficial slope failure is investigated. Figure 3.35 presents the geometry of the STH-164 slope with a dry homogeneous soil layer stabilized with vertical structural members. Based on the information collected from the literature, these structural members can be plastic lumber with 3.5 in.  $\times$  3.5 in. in a cross-sectional area. The allowable shear capacity is 4.5 kips (considering a factor of safety of 2). Eight-foot long reinforcing structural members are installed vertically with a spacing of 3 ft.  $\times$  3 ft. Stability analysis with reinforcing structural members showed that the factor of safety increased from 0.907 (without reinforcing members) to 1.205 with reinforcing members in the case of homogenous dry cohesionless soil. In addition, the slip surface moved deeper from  $d_{max} = 2$  ft. to about  $d_{max} = 15$  ft., which means that installing these vertical structural members has eliminated the surficial soil stability problem. When the analysis was conducted with a saturated soil, the factor of safety decreased to 0.535, as shown in Figure 3.36. The slip surface also is located deeper than what is considered shallow failure.

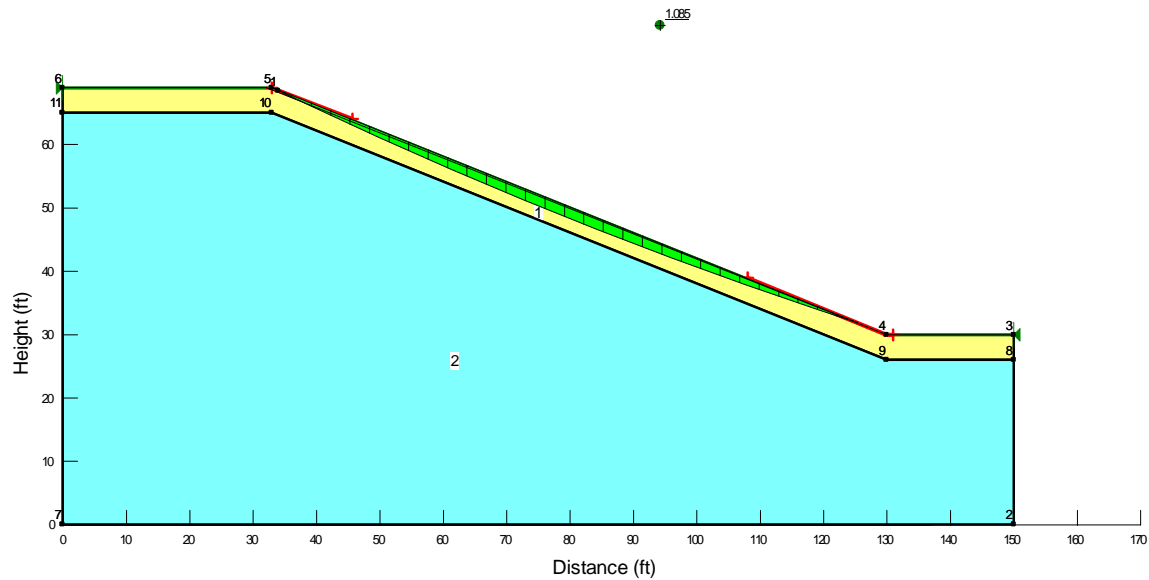
Figure 3.38: Surficial slip surface of the STH-164 slope with upper soft dry soil ( $c' = 20$  psf and  $\phi' = 15^\circ$ ) and lower stiff dry soil ( $c' = 200$  psf and  $\phi' = 28^\circ$ ).

Stability analyses also were conducted using the slope geometry of STH-164 with the assumption that the slope consists of two soil layers: a 4-ft. thick upper soft soil layer and a lower stiff soil layer. The upper soil layer is assumed to possess different combinations of shear strength parameters and saturation conditions. The lower soil layer is assumed to have shear strength parameters  $c' = 200$  psf and  $\phi' = 28^\circ$ . The saturated unit weight of the upper and lower soil layers is  $\gamma_{sat} = 115$  and  $\gamma_{sat} = 120$  pcf, respectively, to maintain the upper soil layer as the soft medium and subsequently to experience the surficial instability. Figure 3.38 depicts the results of the stability analysis of the slope with the shear strength parameters  $c' = 20$  psf and  $\phi' = 15^\circ$  for the upper soil layer. The soil is assumed to be dry. The analysis using  $c' = 20$  psf and  $\phi' = 20^\circ$  indicated that the slope would undergo surficial slope failure with  $d_{max} = 2$  ft. The factor of safety for this case is 1.085. The slope with the given geometry, soil properties, and conditions is stable.

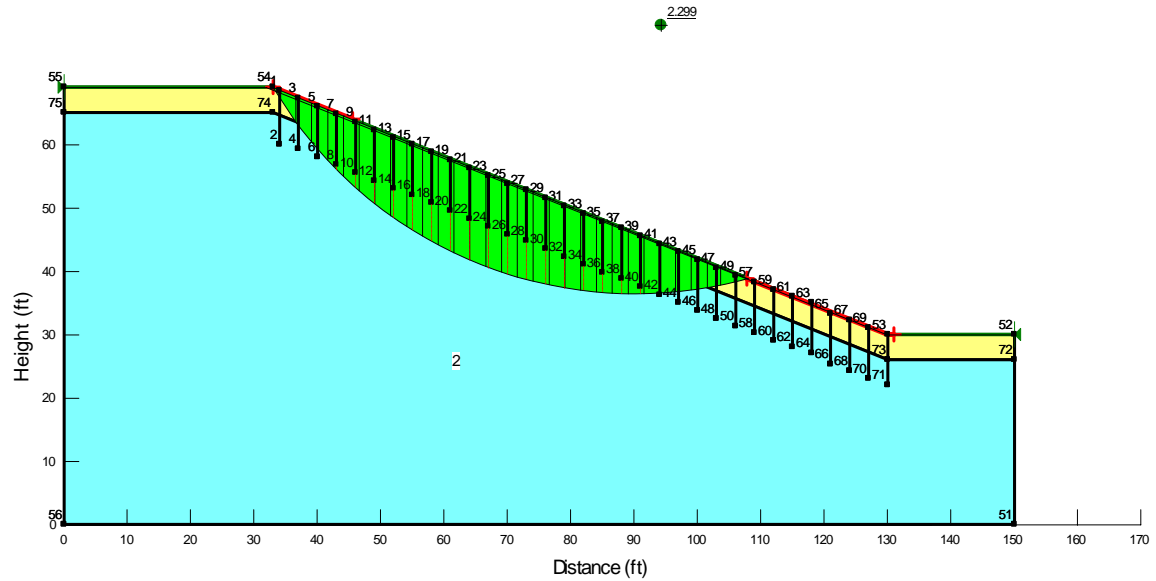
Figure 3.40: Slip surface of STH-164 slope that consists of a dry homogenous soil layer ( $c' = 200$  psf and  $\phi' = 15^\circ$ ) reinforced with 8-ft. vertical structural members.

The effectiveness of structural members in alleviating surficial slope failures of layered soil systems is investigated. Figure 3.40 presents the geometry of the STH-164 slope with dry soil layers stabilized with vertical structural members. Plastic lumber members with 3.5 in.  $\times$  3.5 in. cross-sectional area, allowable shear capacity of 4.5 kips, and a length of 8 ft., were used in the analysis. The structural members are placed with a spacing of 3 ft.  $\times$  3 ft. Stability analysis with reinforcing structural members showed that the factor of safety increased from  $FS = 1.085$  without reinforcing members to  $FS = 2.299$  with reinforcing members in the case of dry soil with upper soft soil strength parameters of  $c' = 20$  psf and  $\phi' = 15^\circ$ . In addition, the maximum depth of the slip surface increased from depth  $d_{max} = 2$  ft to about  $d_{max} = 15$  ft., which means that installing these vertical structural members has improved the surficial soil stability. When the analysis is conducted with saturated soils, the factor of safety decreased to  $FS = 1.299$ , as shown in Figure 3.41. The maximum depth of slip surface also increased to  $d_{max} = 14.5$  ft.
