WISCONSIN HIGHWAY RESEARCH PROGRAM # 0092-04-12

**EXPANDED STUDY ON THE EFFECTS OF AGGREGATE COATING
AND FILMS ON CONCRETE PERFORMANCE**

FINAL REPORT

THE WISCONSIN DEPARTMENT OF TRANSPORTATION

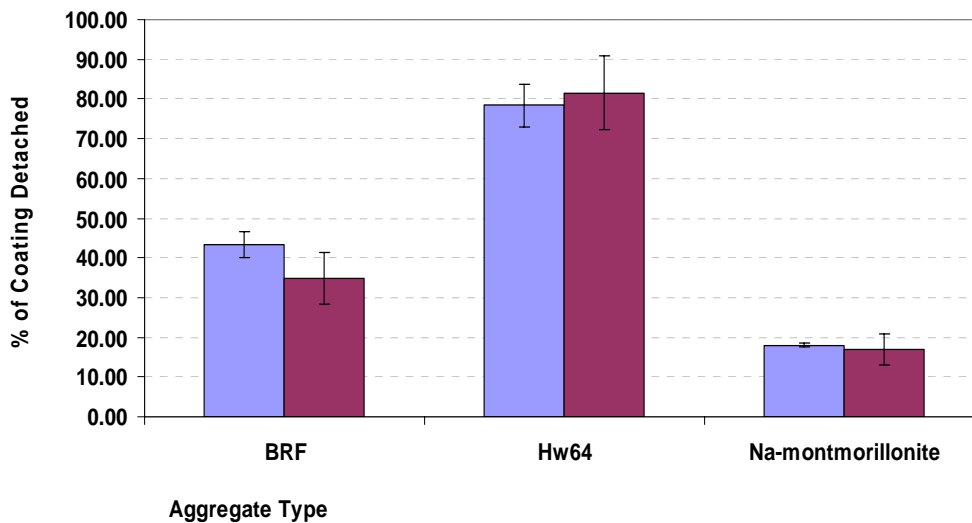
From these studies we were able to establish experimental conditions under which the shaker would yield the same percentage of detached clay coatings as that of the laboratory mixer. One set of variables that conforms to this requirement is: 250 g of coated aggregate in 1L capacity bottle and 15 minutes of shaking. These are the experimental conditions used in this study. The comparison between shaker experimental conditions vs. mixer normal conditions was represented in Figure 5.

Figure 5 - Comparison of Coating Detached between (■) Mixer and (■) Shaker Conditions.

during mixing conditions (see Figure 5). There are not specific data for Hw53 on that respect but base on its nature, where only chlorite clay was detected, it is expected that these microfines will have also a high tendency to get dispersed in the cement paste. In contrast they show a slight decrease in the ITZ porosity and in the amount of unhydrated cement in both, ITZ and bulk, with respect to the control.

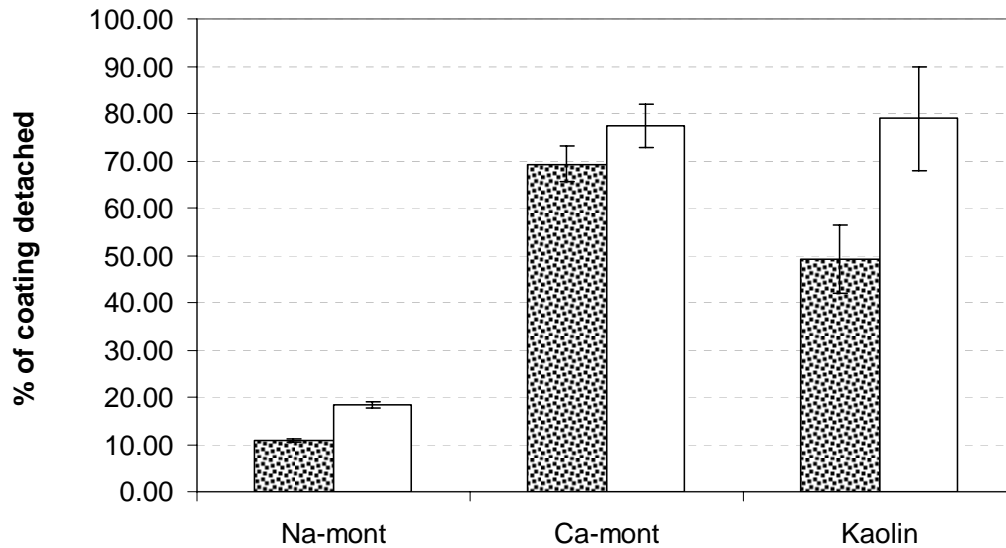
It should also be noted that subsequent experiments to determine the detachment of clays were then performed at two different pH values: 7 and 12. The quantity of clay that was detached was measured gravimetrically as explained in the experimental section. The percentages of detached clay are represented in Figure 6. This figure shows that the degree of

The pH of the aqueous phase also plays a role in the detachment of the coating. The extraction of clay is significantly increased when the pH is raised to a value of 12. The influence of the pH is especially significant in the case of the NaM. The concentration of clay in the aqueous phase for each of the studied systems is reported in Table 10.

Figure 6 - Percentage of Clay Coating Removed with Respect to the Total Mass of Coating at Two Different pH Values at (▣) Natural Clay pH (~7) and (□) pH 12

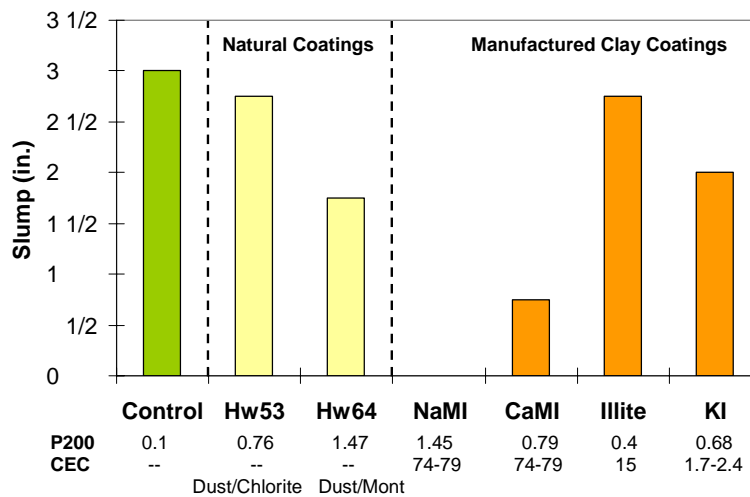
0.76% did not have an impact on slump. The Hw64 coating, also a mixture of dust and a clay from the montmorillonite group with a P200 of 1.47%, significantly decreased the slump of the mixture when compared with the control (1-¾ in vs. 3 in, respectively). This difference in behavior between the two natural coatings could be explained by the fact that the clay present in Hw64 had a high water adsorption capacity and also because its P200 value was approximately twice that of the Hw53 coating. The influences of these coatings in the amount of air entraining agent needed to reach desirable air content (6 % ± 1%) and the final air content obtained is represented in Figure 16. The Hw53 microfines appeared to decrease the necessary amount of air entraining agent to reach the same final air content as control, 26 vs. 37 ml, respectively. The coating in Hw64 sample demanded the same amount of air entraining agent as the control, however the final amount of air content obtained was slightly different (5.0% for Hw64 and 5.8% for control).

Figure 15 - Slump Values for Concrete prepared with Coated Aggregates

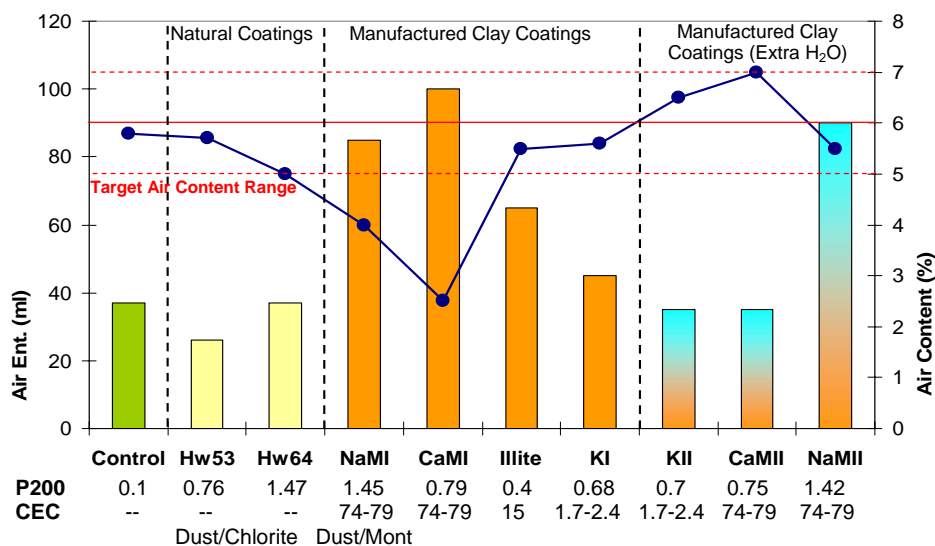
therefore the low water adsorption capacity of the illite. As in the previous samples, the influence of the clay coatings on slump depends on the nature of the clays and the amount of the coating. The influence of the nature of the clay is clearly illustrated when the KI and CaMI samples are compared. In this case, both batches have the similar value of P200, around 0.70%, but different CEC and therefore different water adsorption capacity. The results show that the decrease in slump is higher in clays with high CEC and therefore high water adsorption capacity. Some of the natural clay coatings have an impact in the required air entrainment dosage and the final amount of air achieved. The higher impact is produced by the coatings with higher water absorption capacity such as NaMI and CaMI. In both samples, the addition of high amounts of AEA, 85 and 100 ml respectively, produced batches with air contents still under the target range proposed for this study. More precisely, the air content achieved in batch NaMI was 4% and only 2.5% in batch CaMI. These two batches were only able to meet the air content requirements when extra water was added to them to keep workable. For the NaMII batches 20% extra water was added and for the CaMII batches 40% extra water was added. The addition of 90 ml of AEA in batch NaMII was enough to produce an air content of 5.5%. In CaMII, with only 35 ml of AEA the resulting air content was 7%. The 4.4% of extra water added in batch KII, made it possible to achieve a higher air content than KI, 6.5% vs. 5.6% respectively, despite less AEA, 35 vs. 45 ml.

Figure 16 - Effects in (Bars) Air Entrainment and (—●—) Air Content of Aggregate Coatings

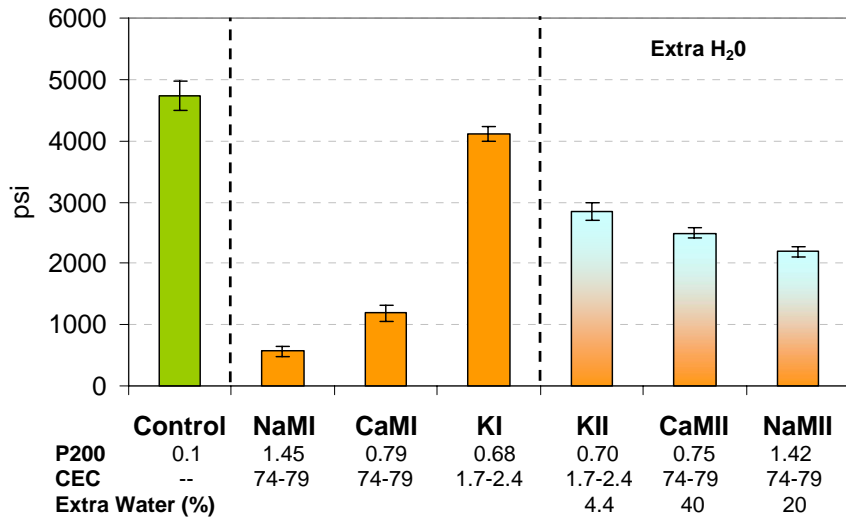
water, reveals an increase in compressive strength from 563 to 2194 psi. A similar pattern can be observed when comparing batches CaMI and CaMII, 40% of extra water increased the compression strength from 1189 psi (CaMI) to 2495 psi (CaMII).

Figure 18 - Effect of Extra Water Addition on Compressive Strength (28 days) for Batches with Manufactured Coatings

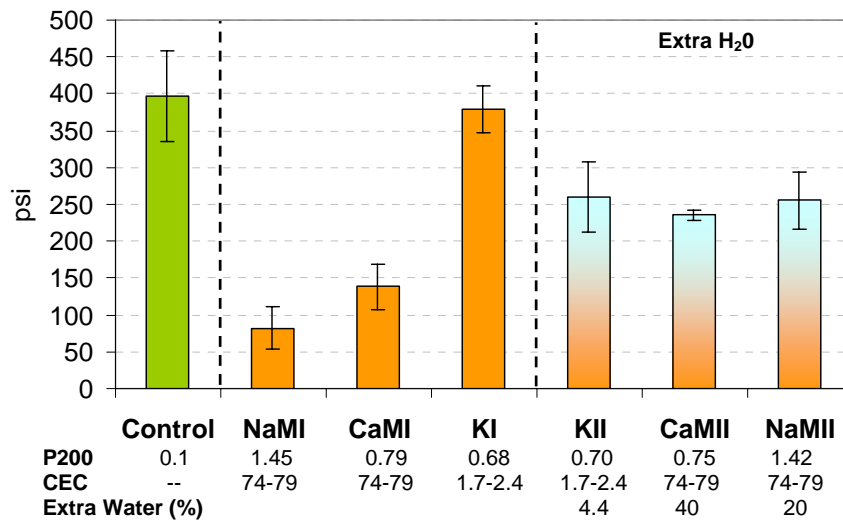
Manufactured Clay Samples: The tensile strength of manufactured clay samples showed a similar behavior as observed for compressive strength. Two of the clays with high impact on compressive strength also dramatically decreased the tensile strength. The tensile strength loss was 80% in batch NaMI and 65% in batch CaMI with respect to the control. The reasons for these significant decreases are the same argued for the compressive strength. The negative effects of both coatings are partially ameliorated by the addition of extra water. The tensile strength rose from 82 psi in NaMI batch to 255 psi in NaMII batch, and from 138 psi to 236 psi in batches CaMI and CaMII, respectively.

Figure 20 - Effect of Extra Water Addition on Tensile Strength for Batches with Manufactured Coatings

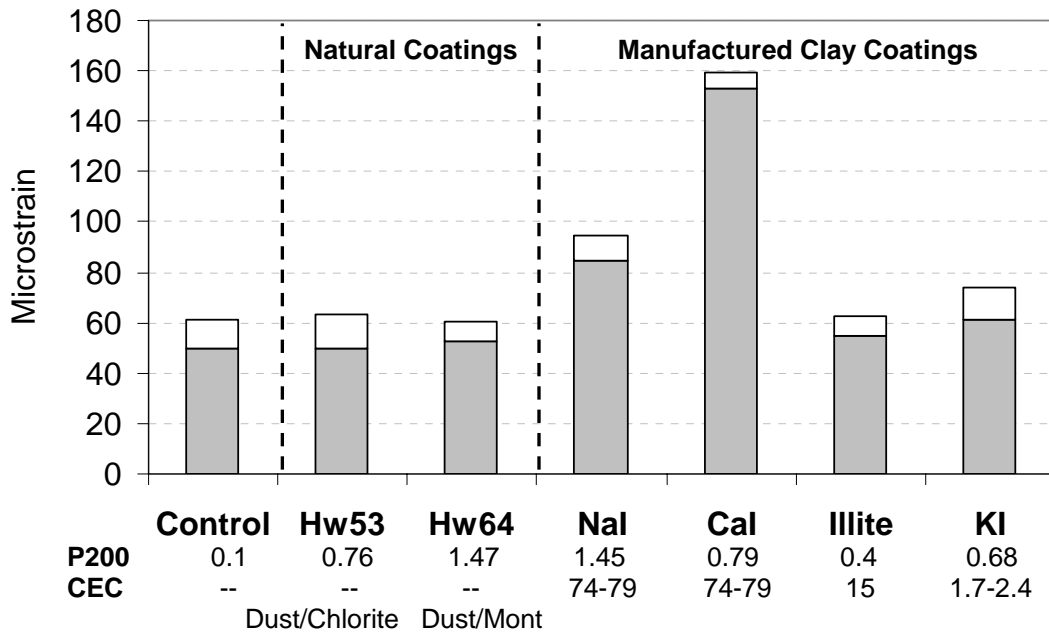
Natural Coating Samples: The drying shrinkage measured for batches made with natural coatings is the same as control, no significant difference was found under the curing conditions used. All the shrinkages fell in the range of 400 to 650 microstrain .

Figure 21 - Drying Shrinkage Values for Natural and Manufactured Coatings, (■) 56 Days and (□) 120 Days

Manufactured Clay Samples: The shrinkage of the four types of manufactured clay samples fell within a wide range, between 600 microstrain for the innocuous clay, up to 1600 microstrain for the most harmful clays. The 0.4% P200 value for the illite coating did not produce significant changes with respect to the control shrinkage. That was not the case for the kaolin clay, where only 0.3% more coating than with Illite, produced a significant increase of 15% in the shrinkage at 120 days with respect to the control ($p = 0.016$). Nevertheless, the greatest increases in shrinkage were registered for the NaMI and CaMI batches. At 120 days, the shrinkage increased from 660 microstrain in the control up to 940 microstrain in NaMI batch and to 1600 microstrain with the CaMI batch. This last case was significant especially when almost half of the amount of CaMI coating (0.79%) with respect to NaMI coating (1.49%) coating was able to instigate a significantly higher shrinkage. Both clays have similar structure and CEC capacity. The only difference resides in the nature of the exchangeable cation. This difference will determine the behavior in water, for example NaM will suffer a destacking or defoliation process in water known as “macroscopic swelling” while the CaM in the presence of water will tend to increase the size of its particles in one direction due to the incorporation of water molecules in between the layers of its structure. This process is called “crystalline swelling”.

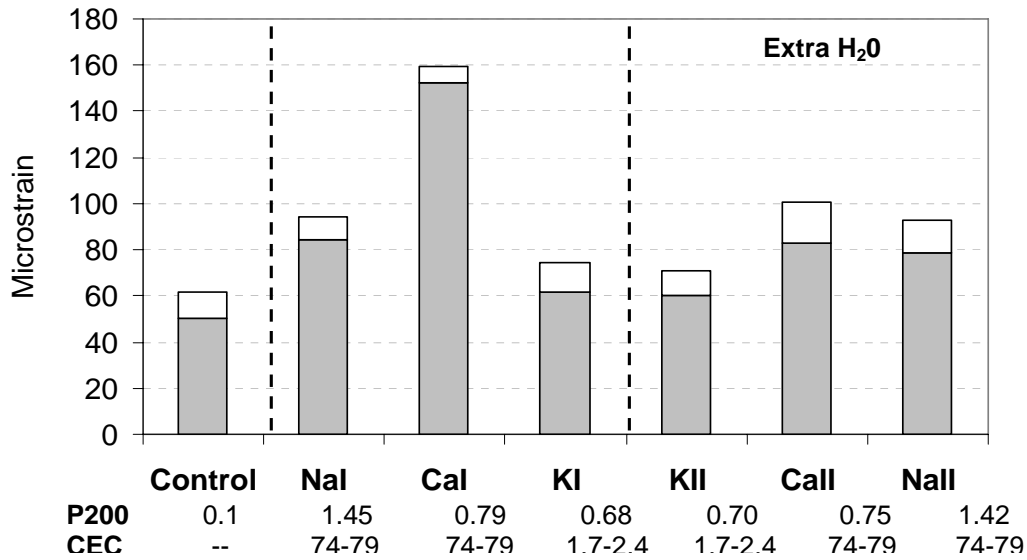
Figure 22 - Effect of Extra Water on Drying Shrinkage for Manufactured Clay Coatings, (■) 56 Days and (□) 120 Days

The effect of extra water on the shrinkage is represented in Figure 22. In contrast to what would be expected, the additions of extra water in the batches did not increase the amount of shrinkage. The addition of 4.4 and 20% extra water in KII and NaMII batches respectively, did not change the value of drying shrinkage at 120 days registered in batches KI and NaMI. However the addition of 40% extra water in the CaM decreased the shrinkage by 37% at 120 days. The analysis of the shrinkage histogram for manufactured clay coatings presented in Figure 23 brings additional information about the drying shrinkage mechanism with extra water in the batches.

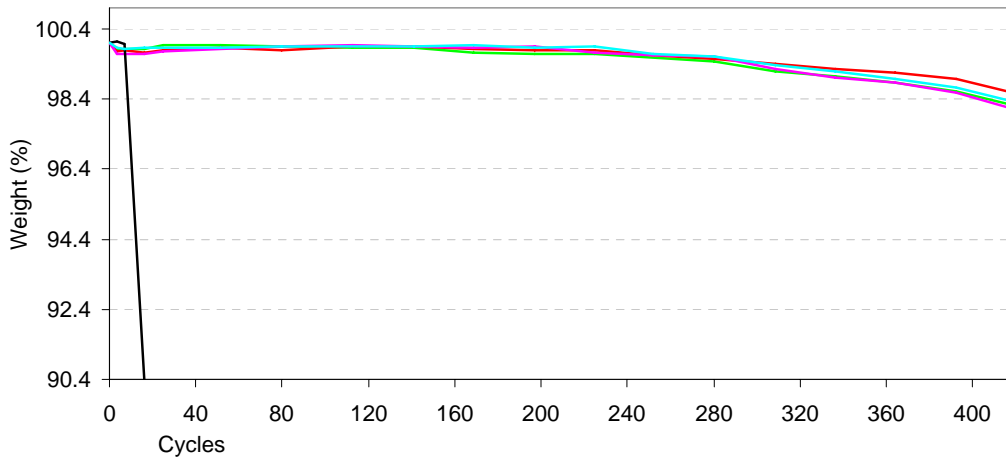
concrete. The stiffness and weight degradation of the samples were monitored during 420 freeze-thaw cycles. Results of these studies are illustrated in Figures 24 and 25.

Figure 25 - Weight Durability of Batches control (—), Hw53 (—), Hw64 (—), KI (—), and NaMI (—)

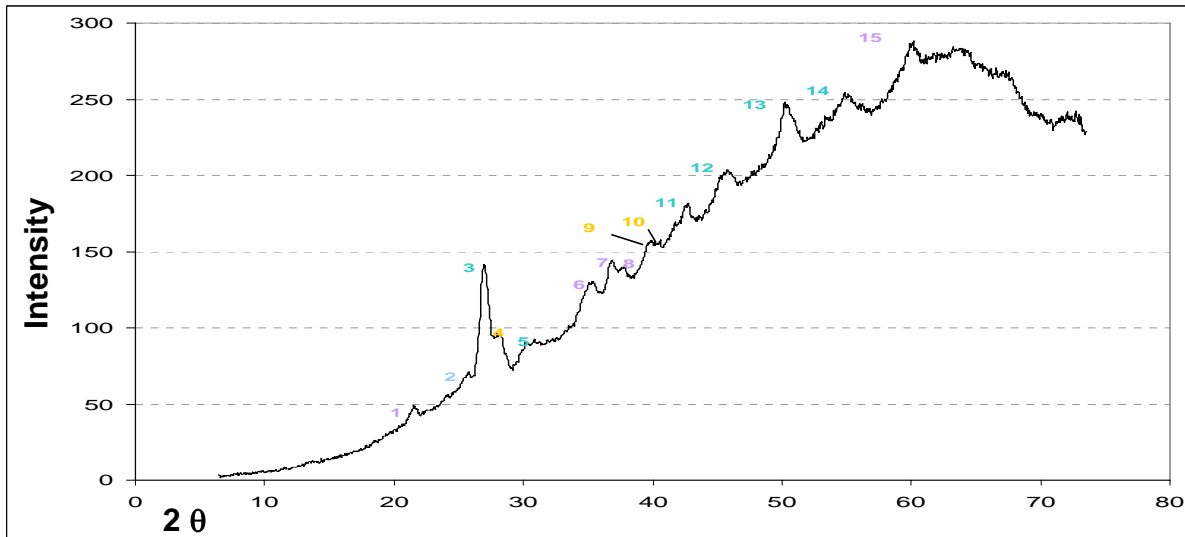
Figure I.1 – Diffractogram of Natural Coating from Black River Falls Coarse Aggregate

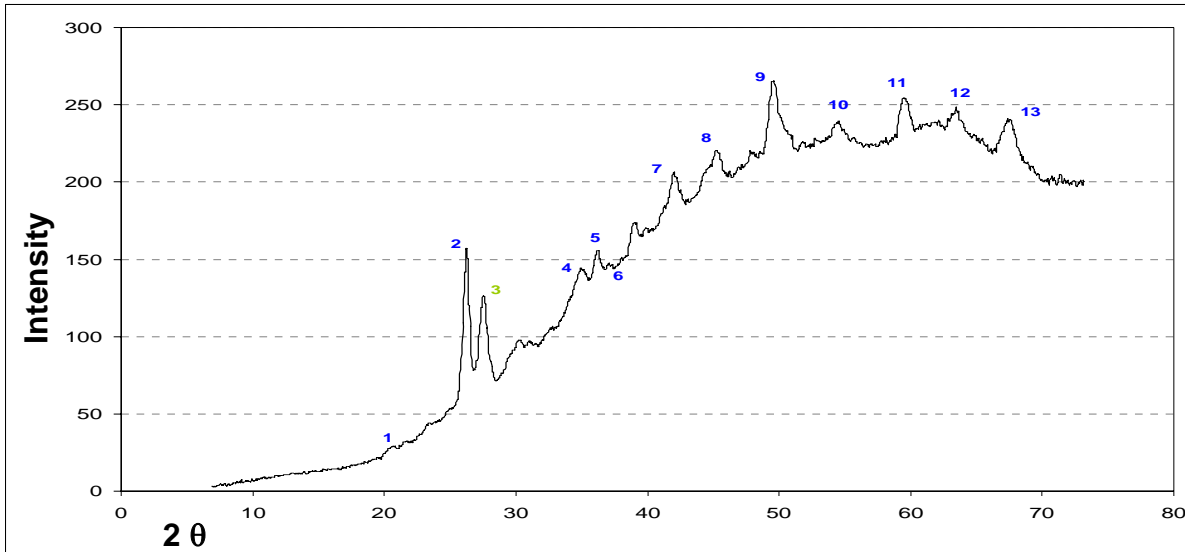
Figure I.2 – Diffractogram for Sedimentable Fraction of Natural Coating from Highway 53 Coarse Aggregate

Peak	2 θ	d (Å)	Intensity	2 θ	Intensity	Compound
1	21	4.340		20.850	22	Quartz
2	26.25	3.483	157.1853	26.652	100	
3	27.55	3.322	126.5536	28.871	20	Calcium Chlorate
4	36.15	2.549	155.7189	36.542	8	Quartz
5	39.2	2.358	172.587	39.456	8	
6	40.3	2.296	169.6576	40.284	4	
7	42.05	2.204	206.7014	42.470	6	
8	45.45	2.047	218.6491	45.809	4	
9	49.7	1.882	262.7996	50.141	14	
10	54.7	1.722	237.234	54.869	4	Quartz
11	59.7	1.589	252.4605	59.948	9	
12	63.65	1.500	245.8048	64.001	1	
13	67.7	1.420	239.7841	67.750	6

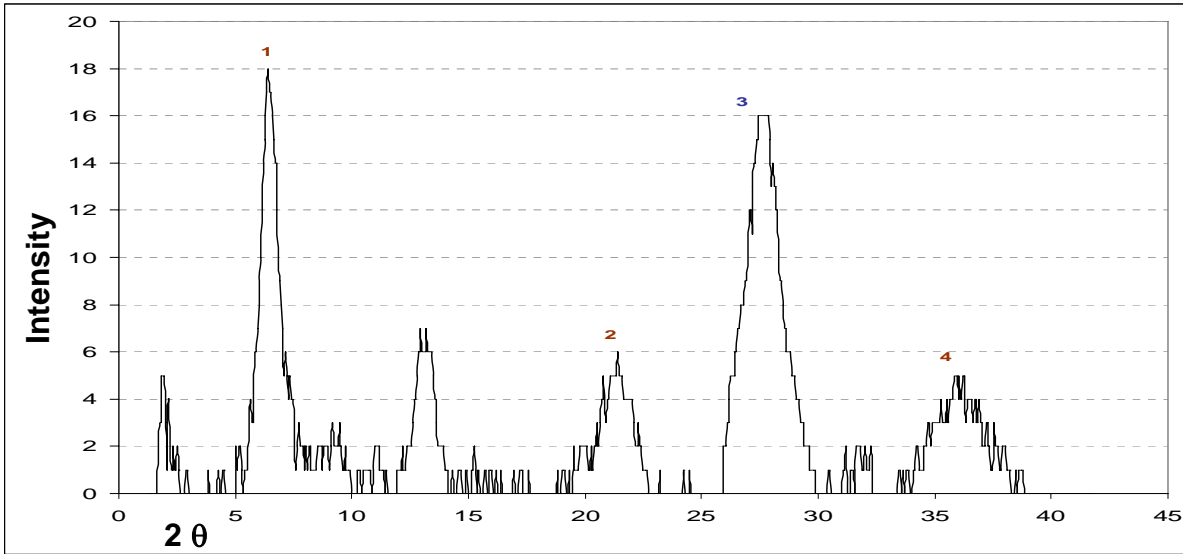
Figure I.4 – Diffractogram of Natural Coating from Highway 64 Coarse Aggregate

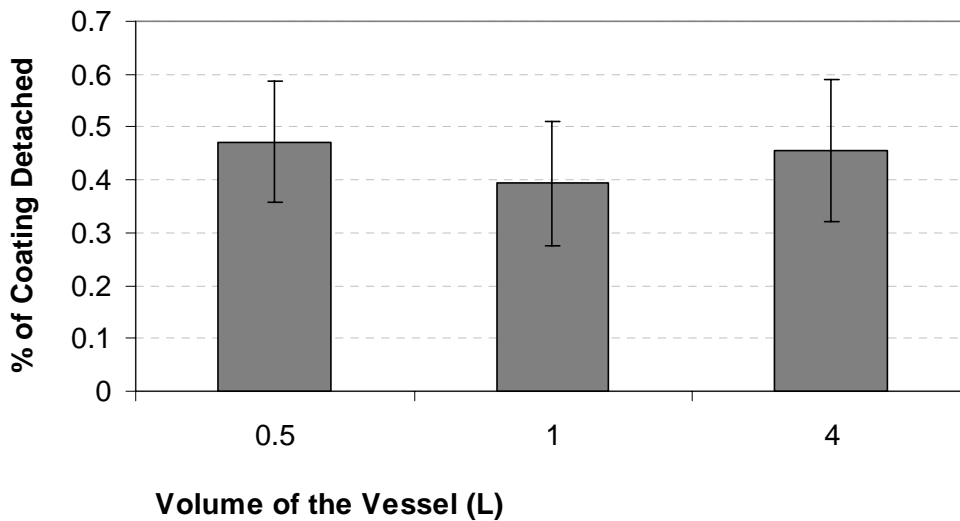
2 – Volume of the Vessel

Figure II.2 – Influence of Vessel Size in the Detachment of Coatings.

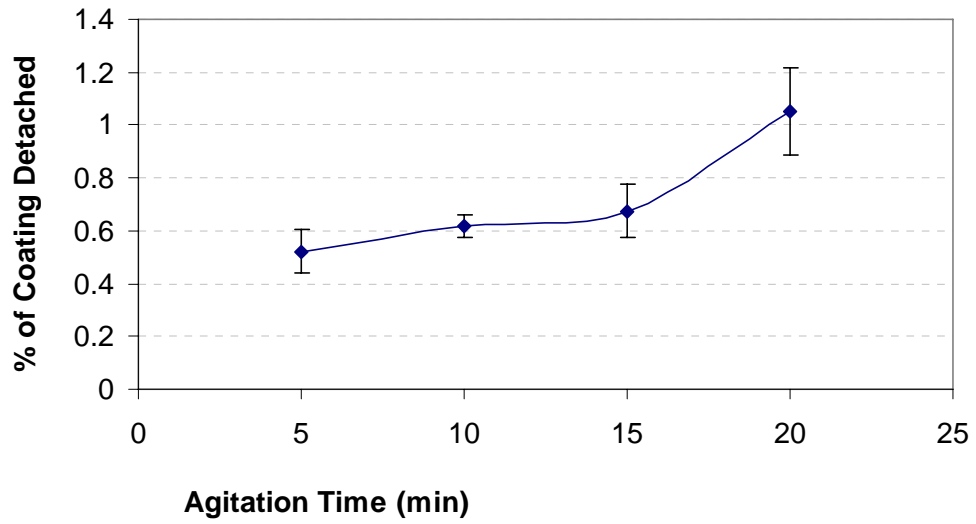
3 – Time of Agitation

Figure II.3 – Influence of Agitation Time in the Detachment of Coatings.

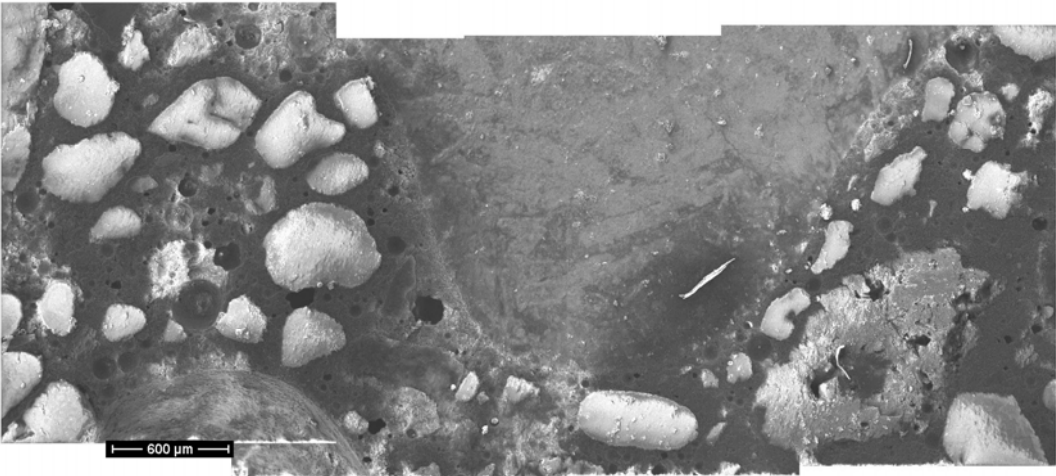
Figure IV.2 – Hardened Air Void Distribution of Hw53 Sample
