An In-Depth Analysis of the Intersection Located at United States Highway 53 and  
County Trunk Highway V

A Research Paper  
Submitted in Partial Fulfillment of the  
Requirements for the  
Master of Science Degree  
in  
Risk Control

The Graduate School  
University of Wisconsin-Stout

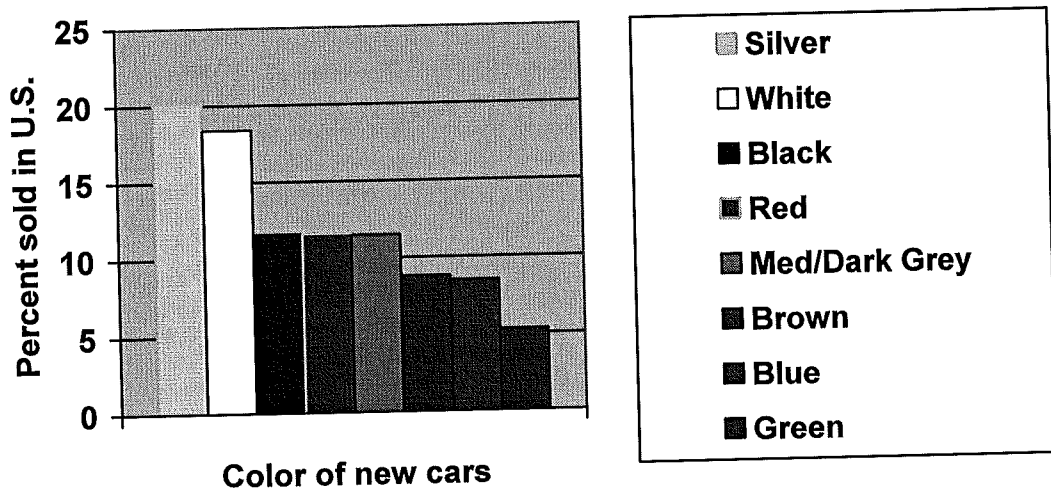
Figure 1. Percentage of new cars sold in the United States by color.

According to *DuPont Automotives* (2003) the percentage of new cars sold in the United States are in the following table:

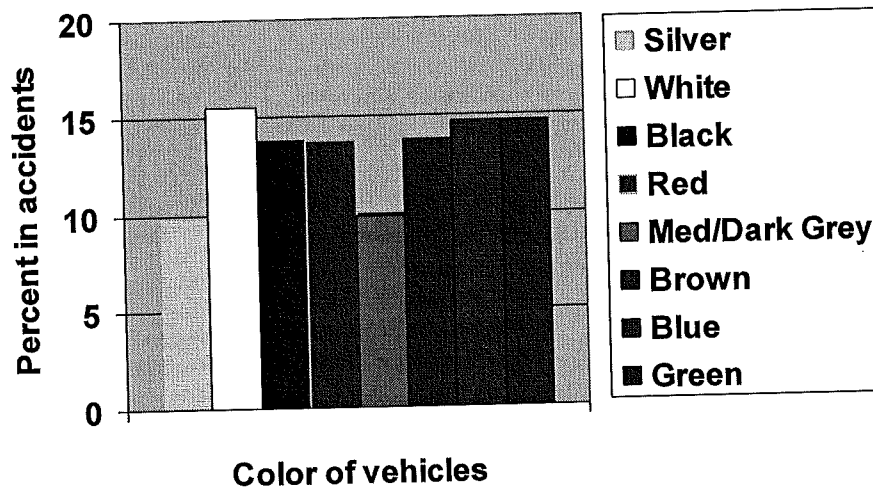
Figure 2. Percent of vehicles involved in accidents at the intersection of US Hwy 53 and CT Hwy V by color

The following table illustrates the percentage of the color of cars involved in accidents at the intersection of US Hwy 53 and CT Hwy V. This was determined by a total of 51 vehicle with identified colors of accident reports obtained from the Wisconsin DOT.

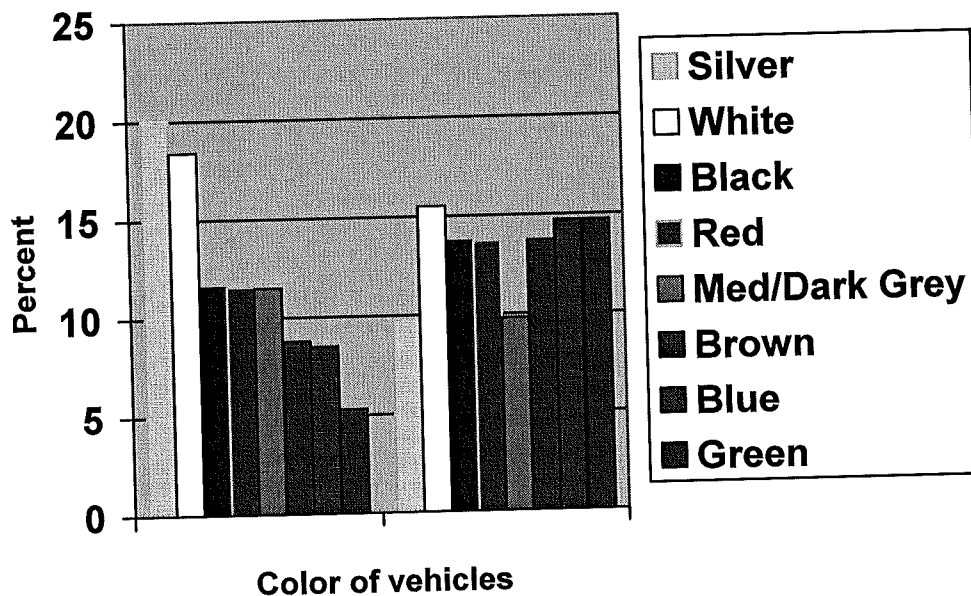
Figure 3. Color comparison of the percentage of new cars sold in the United States to the percentage of the color of vehicles involved in accidents at the intersection of US Hwy 53 and CT Hwy V.

The data indicates that brown, blue, and green vehicles are in a higher percentage of accidents at this intersection than the average number of those same colors sold in the United States. Additionally, silver, white, and grey vehicles are less likely than the average sold to be in accidents at this intersection. This is consistent with the study conducted by Furness in 2003.

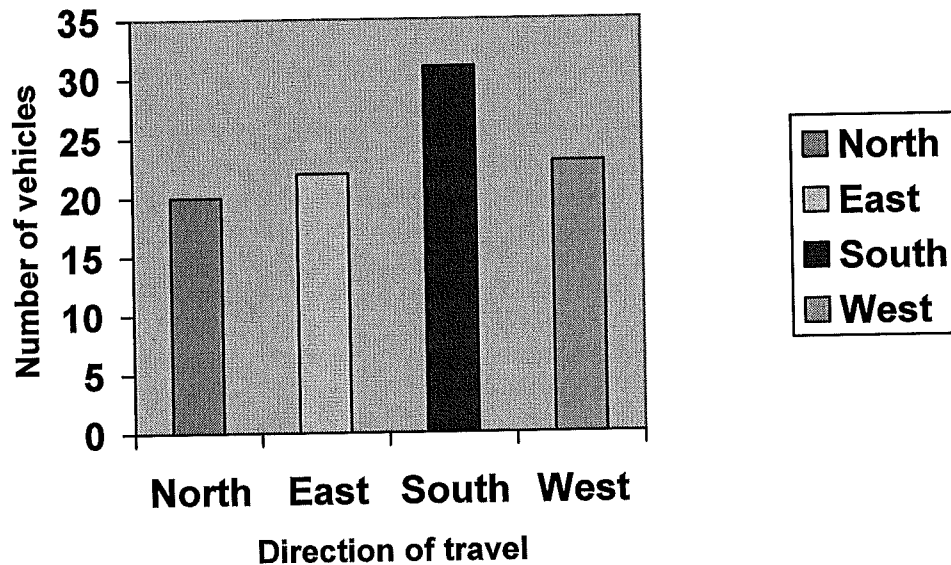
*Figure 4.* Direction of travel prior to being involved in an accident at the intersection of US Hwy 53 and CT Hwy V.

*Direction of travel.* Out of the data gathered on 96 vehicles involved in accidents that occurred, at the intersection located at US Hwy 53 and CT Hwy V between 1994 and 2007, these vehicles were traveling in the following directions prior to the accidents

occurring; 20 were traveling toward the north; 31 were traveling toward the south; 22 were traveling toward the east; 23 were traveling toward the west.

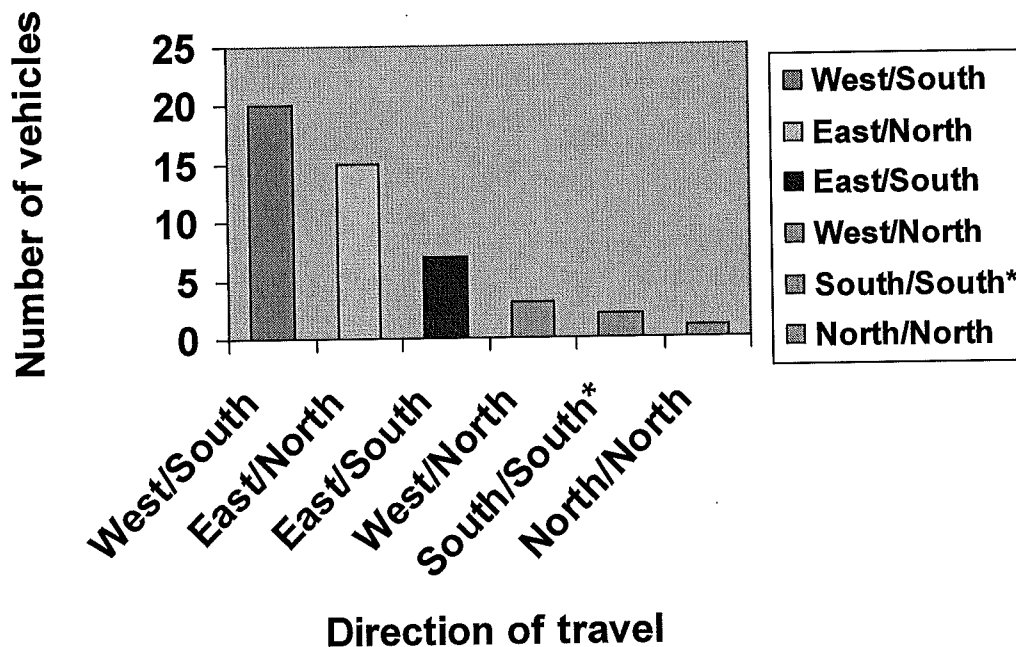
*Figure 5.* Direction of both vehicles involved in an accident at time of impact.  
 \*Two of the South to South accidents occurred immediately following an east bound vehicle turning south on US Hwy 53.

Out of the 48 accidents when the impacts occurred the following is the combination of directions both vehicles were traveling:

- 20 occurred when a vehicle traveling west on CT Hwy V struck or was struck by a vehicle traveling south on US Hwy 53
- 15 occurred when a vehicle traveling east on CT Hwy V struck or was struck by a vehicle traveling north on US Hwy 53
- 7 occurred when a vehicle traveling east on CT Hwy V struck or was struck by a vehicle traveling south on Us Hwy 53
- 3 occurred when a vehicle traveling west on CT Hwy V struck or was struck by a vehicle traveling north on US Hwy 53

- 2 occurred while both vehicles were traveling south
- 1 occurred while both vehicles were traveling north

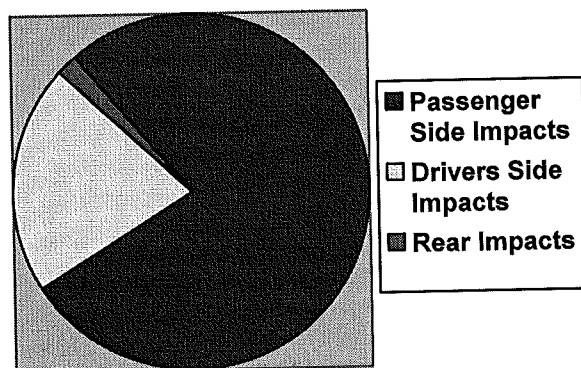
*Figure 6.* Impact area of vehicles involved in accidents that occurred at the intersection of US Hwy 53 and CT Hwy V.

This data clearly indicates that 37 of the accidents occurred when vehicles traveling east or west on CT Hwy V struck (or were struck by) vehicles on US Hwy 53 approaching from the passenger side. Ten of the accidents occurred while vehicles traveling east or west on CT Hwy V struck (or were struck by) vehicles traveling on US Hwy 53 approaching from the driver's side. Three occurred on US Hwy 53 while vehicles were traveling in the same direction.

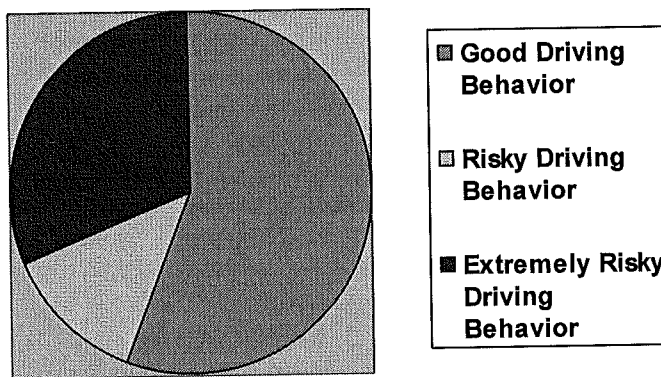
Figure 7. Classification of drivers' behaviors at CT Hwy V considering all vehicles observed.

*Drivers' behavior observation conclusions.* Out of 902 total vehicles observed negotiating the intersection from CT Hwy V onto or crossing US Hwy 53, the drivers exhibited the following driving behaviors:

- Drivers exhibiting good behavior 504 (55.9%)
- Drivers exhibiting risky behavior 114 (12.6%)
- Drivers exhibiting extremely risky behavior 284 (31.4%)

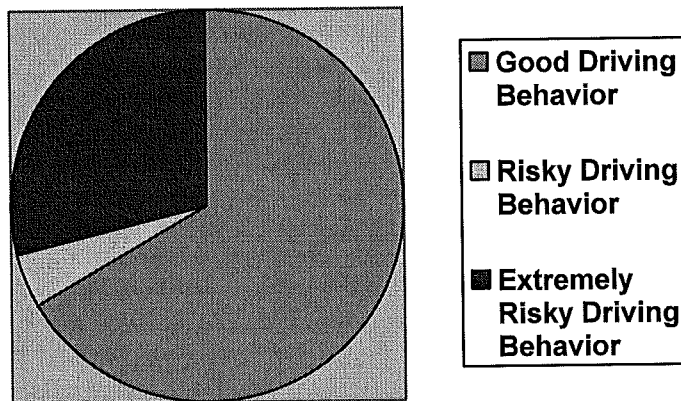
*Figure 8.* Classification of drivers' behavior at CT Hwy V when cross traffic was present on US Hwy 53.

Out of 902 total vehicles observed 521 drivers had to negotiate the intersection from CT Hwy V on to or crossing US Hwy 53 while there was cross traffic driving at speeds averaging 65 MPH. The following conclusions from the observations were made:

Drivers exhibiting good behavior with cross traffic	348 (73.7%)
Drivers exhibiting risky behavior with cross traffic	23 (4.4%)
Drivers exhibiting extremely risky behavior with cross traffic	150 (28.8%)

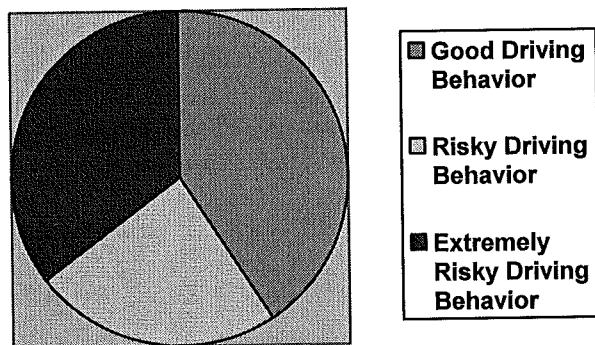
*Figure 9.* Classification of drivers' behaviors at CT Hwy V when there was no perceived cross traffic on US Hwy 53.

Drivers exhibiting good behavior without cross traffic	156 (40.9%)
Drivers exhibiting risky behavior without cross traffic	91 (23.9%)
Drivers exhibiting extremely risky behavior without cross traffic	134 (35.2%)

The data indicates when drivers perceive there is no cross traffic they display the riskiest driving behavior. This is potentially the most dangerous time to negotiate the intersection.

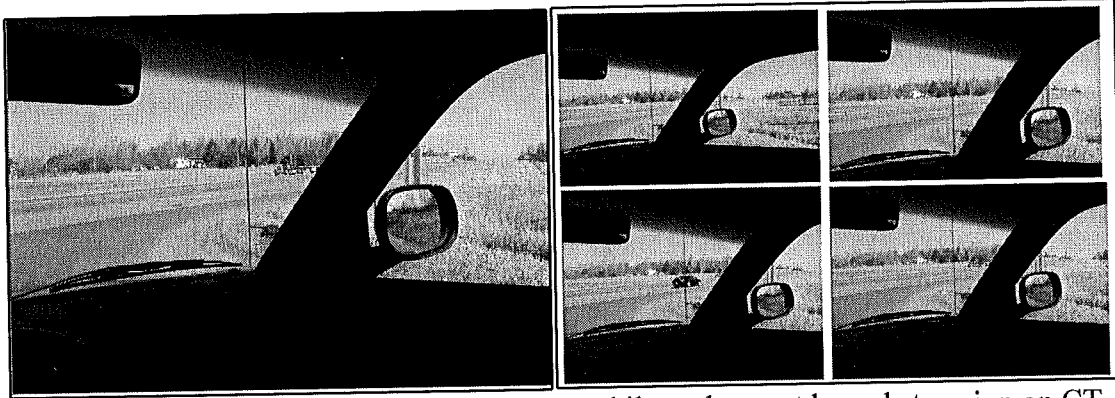
*Figure 10.* View of south bound US Hwy 53 while at the west bound stop sign on CT Hwy V. The semi truck shown on the left is hidden in the blind spot for 1.2 seconds in the sequence of pictures on the right.

*Blind spot measurements.* The blind spot created to the north, by a 1999 Dodge Ram pickup, facing west while stopped at the stop sign at the intersection of US HWY 53 and CT HWY V is approximately 187 feet from an average of 556 feet to 369 feet. It takes a car traveling on US HWY 53 approximately 1.67 seconds to cross through the blind spot if the Dodge is at a complete stop.

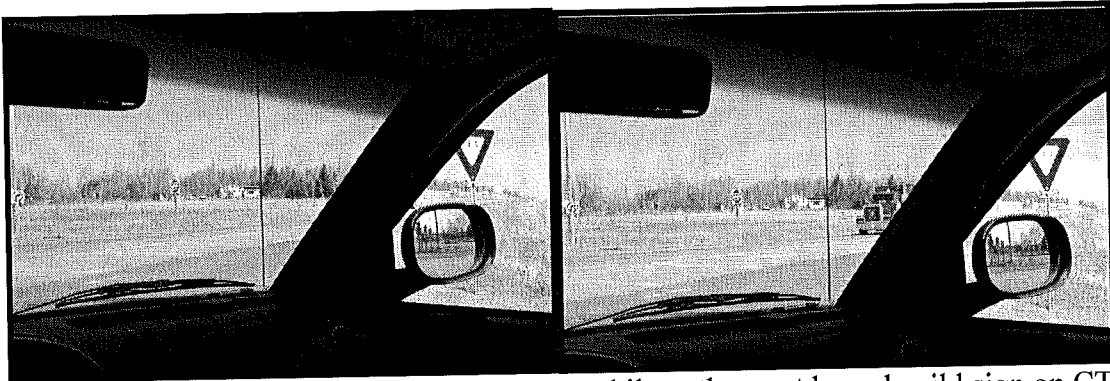
*Figure 11.* View of south bound US Hwy 53 while at the west bound yield sign on CT Hwy V, in the median. A semi truck is hidden in the left picture is emerging in the right picture. The subject vehicle is less than 24 feet from the potential impact area.

The blind spot created to the north, by a 1999 Dodge Ram pickup, facing west while stopped in the median at the intersection of US HWY 53 and CT HWY V, is approximately 148 feet from an average of 335 feet to 187 feet. It takes a car traveling on US HWY 53 approximately 1.32 seconds to cross through the blind spot if the Dodge is at a complete stop.

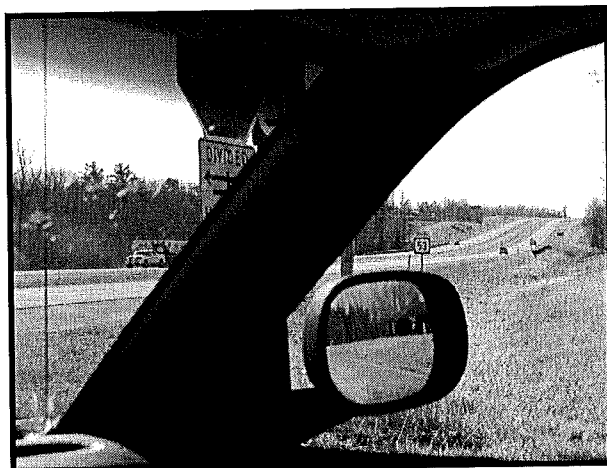
*Figure 12.* View of north bound US Hwy 53 while at the east bound stop sign on CT Hwy V, with SUV emerging from blind spot.

The blind spot created to the south, by a 1999 Dodge Ram pickup facing east while stopped at the stop sign at the intersection of US HWY 53 and CT HWY V, is approximately 152 feet from an average of 451 feet to 341 feet. It takes a car traveling on

US HWY 53 approximately 1.92 seconds to cross through the blind spot if the Dodge is at a complete stop.

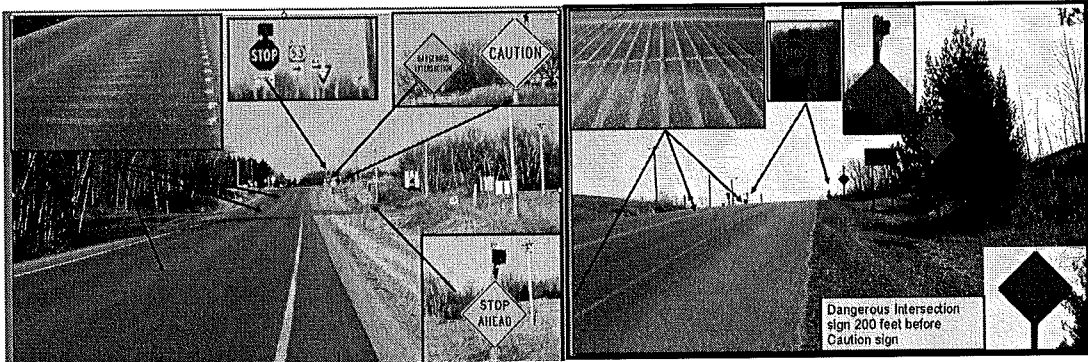
West bound approach on CT Hwy V

East bound approach on CT Hwy V

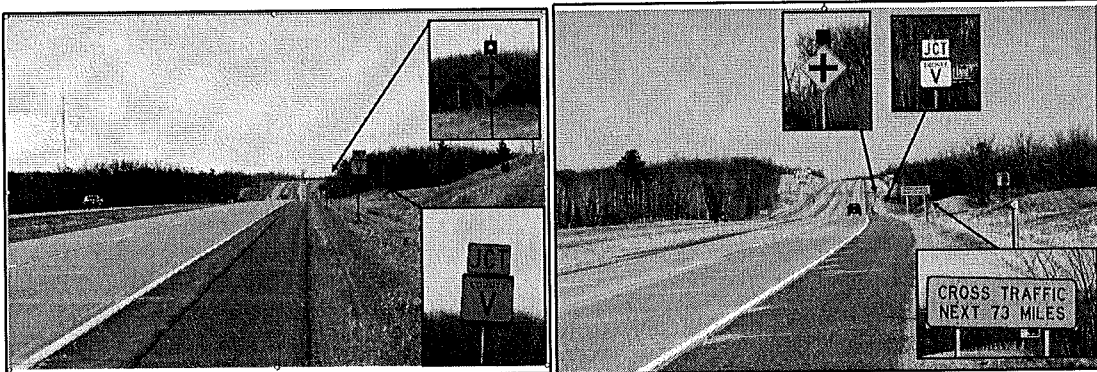
South bound approach on US Hwy 53

North bound approach on US Hwy 53

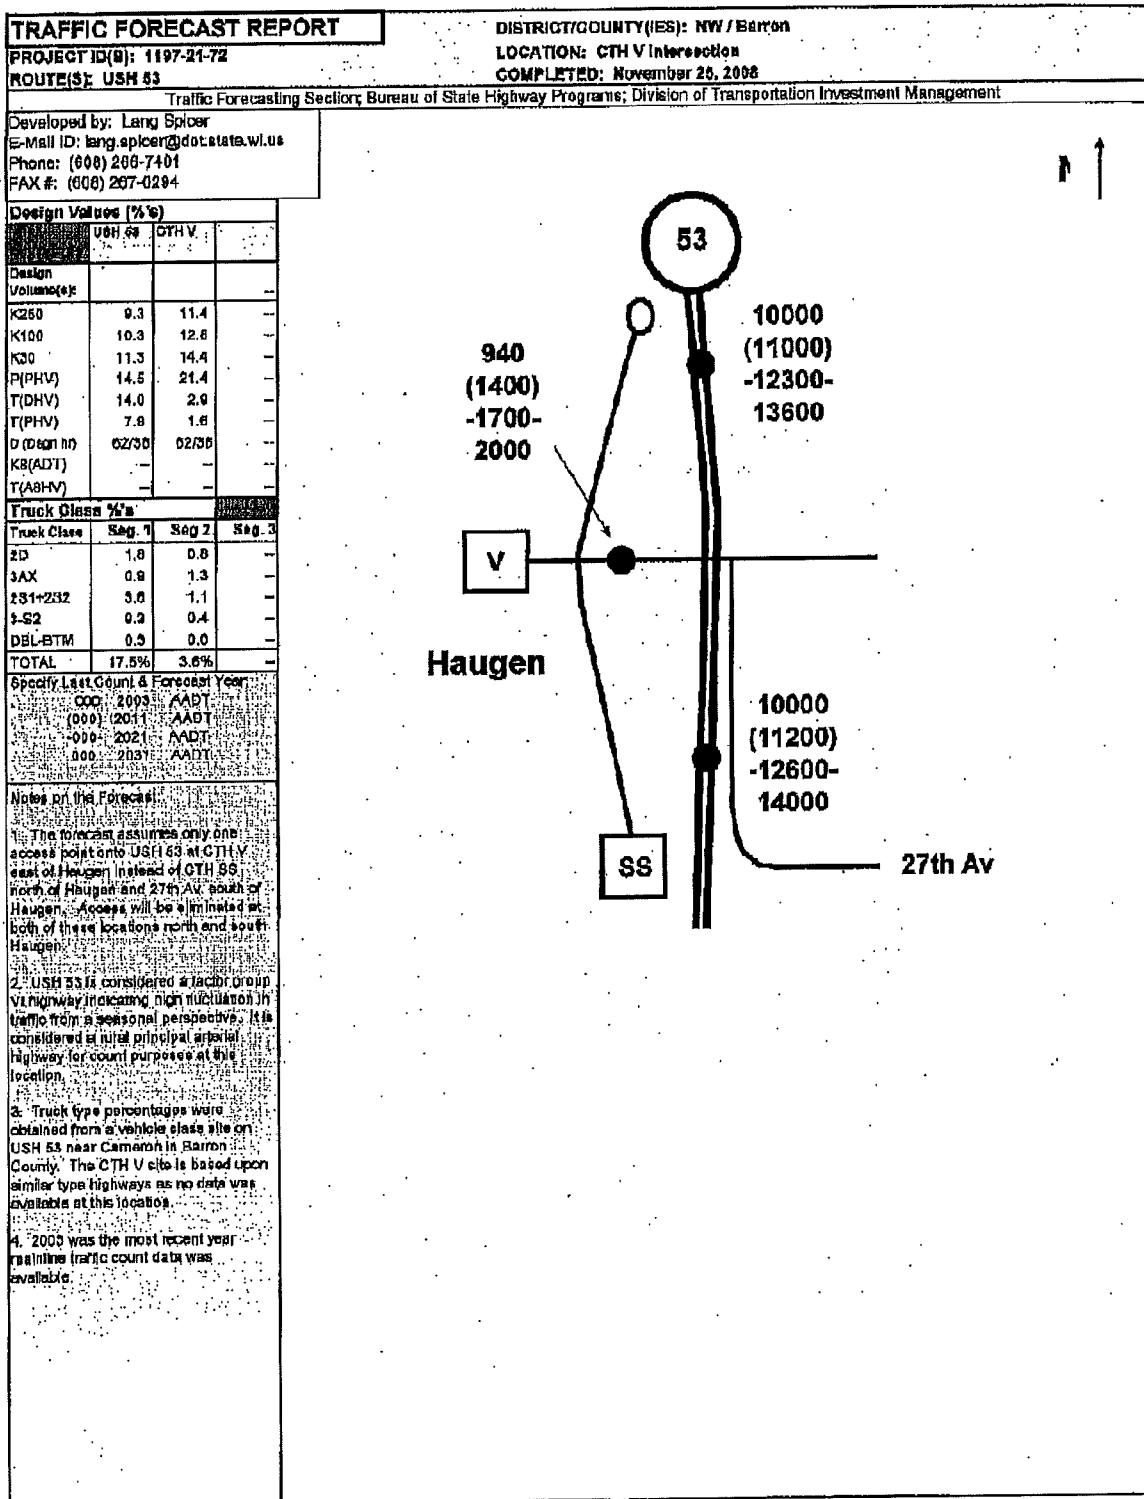
Appendix B: Wisconsin DOT Traffic Forecast

Traffic forecast report on the intersection of US Hwy 53 and CT Hwy V

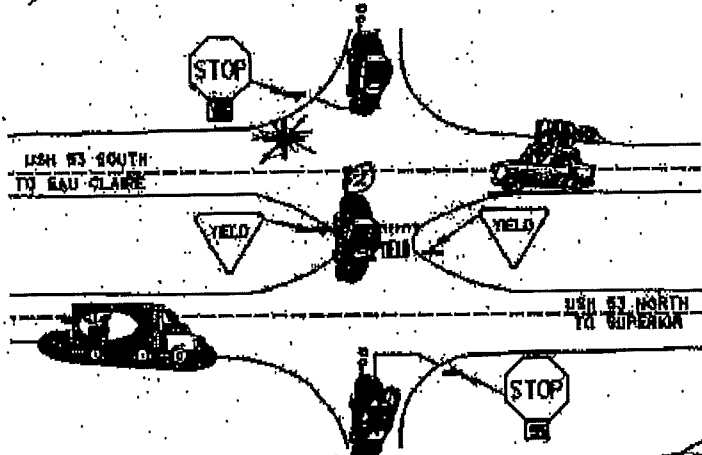
*The majority of crashes happen in the second two lanes because motorists fail to yield in the median.*

Placemat used to educate the public at restaurants along the US Highway 53 corridor from Superior to Rice Lake on the proper way to cross US High 53 at expressway intersections.

*Step 3: Look right, look left, look right AGAIN!*

*Step 4: When clear, cross or turn into second two lanes.*

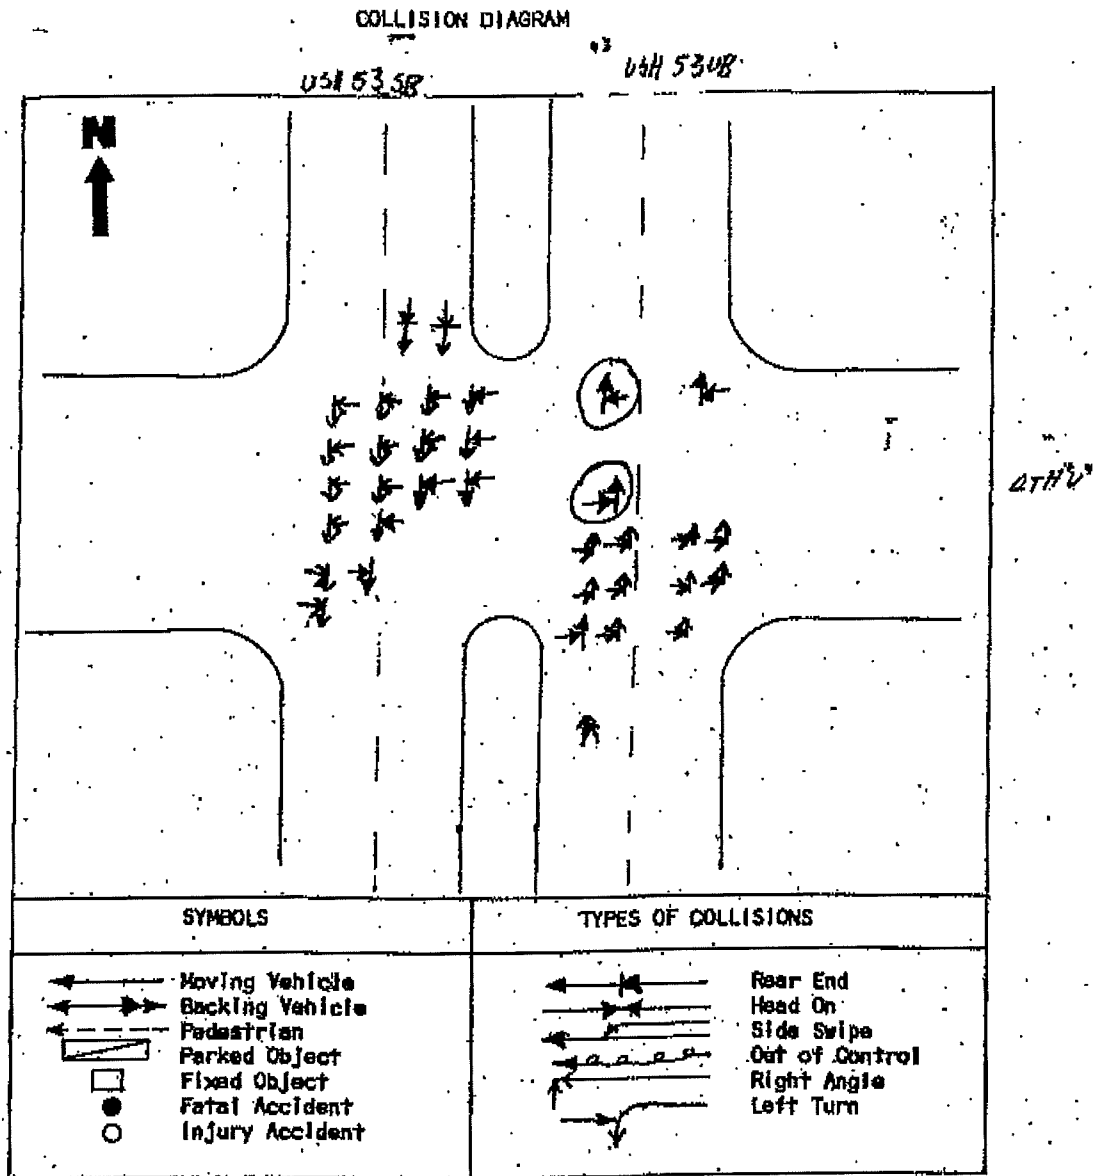
Appendix D 2: Crash Analysis Diagram

Intersection USH 53 and OTH U Barron County  
 Period 10 years From 1/1/94 <sup>thru</sup> 12/31/2003

○ 2004 fatal crash location
