**The Wisconsin State
Building Program
Research Project**

Authored by:
Jeffrey A. Lackney
Peter Park
Lawrence P. Witzling

Public Sector Case Study #1-1
 DNR SOUTHEAST HEADQUARTERS BUILDING

Private Sector Case Study #1-2
 WARZYN CORPORATE HEADQUARTERS BUILDING

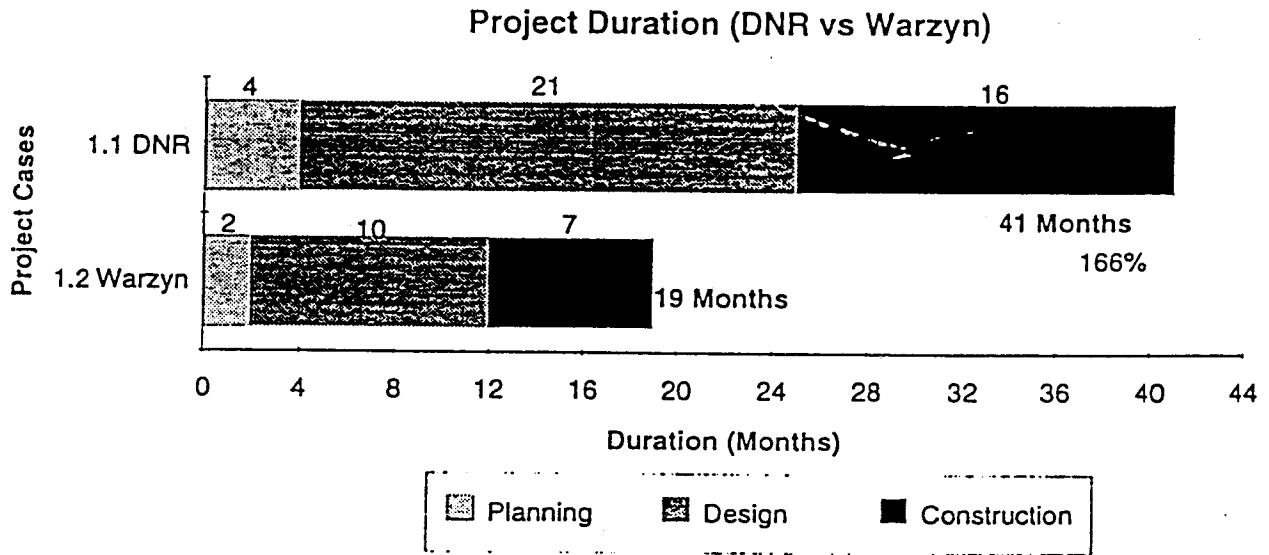
The following is a comparison of the duration of planning, design and construction activities that took place during the Facility Development Process.

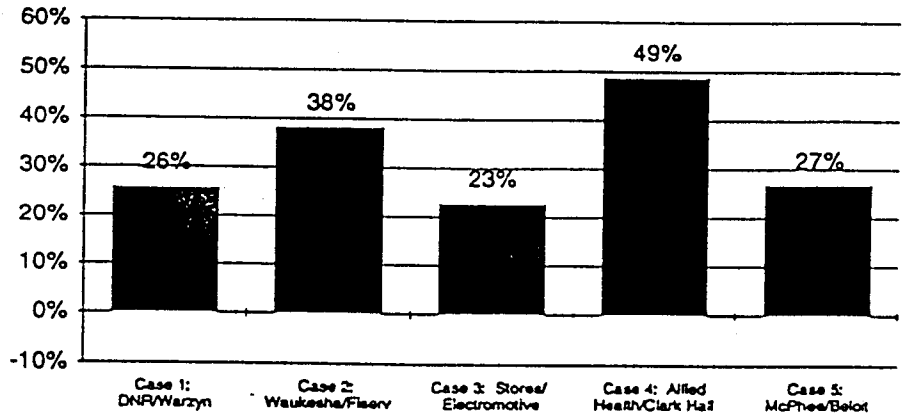
In summary, design and supervision cost MORE in all five public sector building cases due to more complex Structure and Procedures (Cases #1,2,3,4,5), and Methods of Contracting (Cases #1,2,3,4,5).
